Official Transcript of Proceedings  
NUCLEAR REGULATORY COMMISSION

Title: Advisory Committee on Reactor Safeguards  
Plant License Renewal Subcommittee

# Davis-Besse Nuclear Power Station License Renewal Application

Advisory Committee on Reactor Safeguards  
License Renewal Subcommittee Meeting  
September 19, 2012

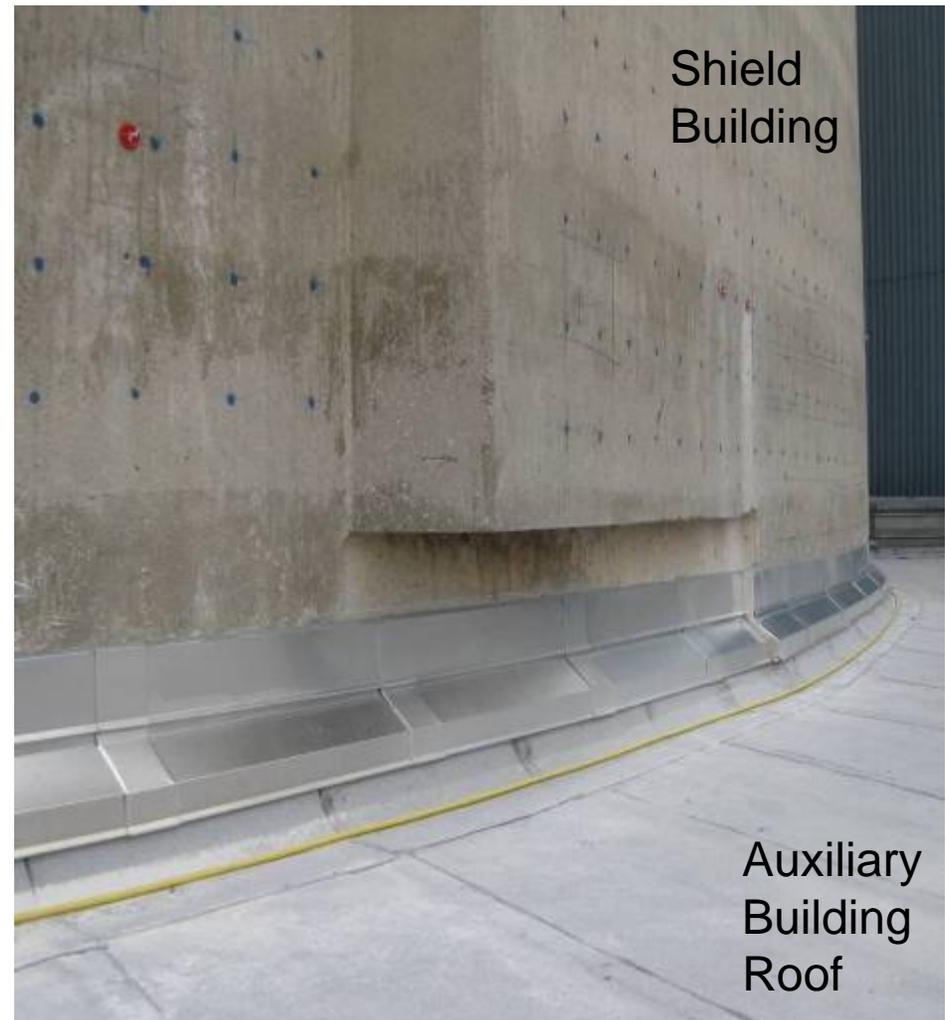
- The flute shoulders are a part of the Shield Building; concrete for shoulders and building shell was placed concurrently
- Evaluation of structural capacity of Shield Building does not credit flute shoulders
- Evaluated as a dead load in structural analysis

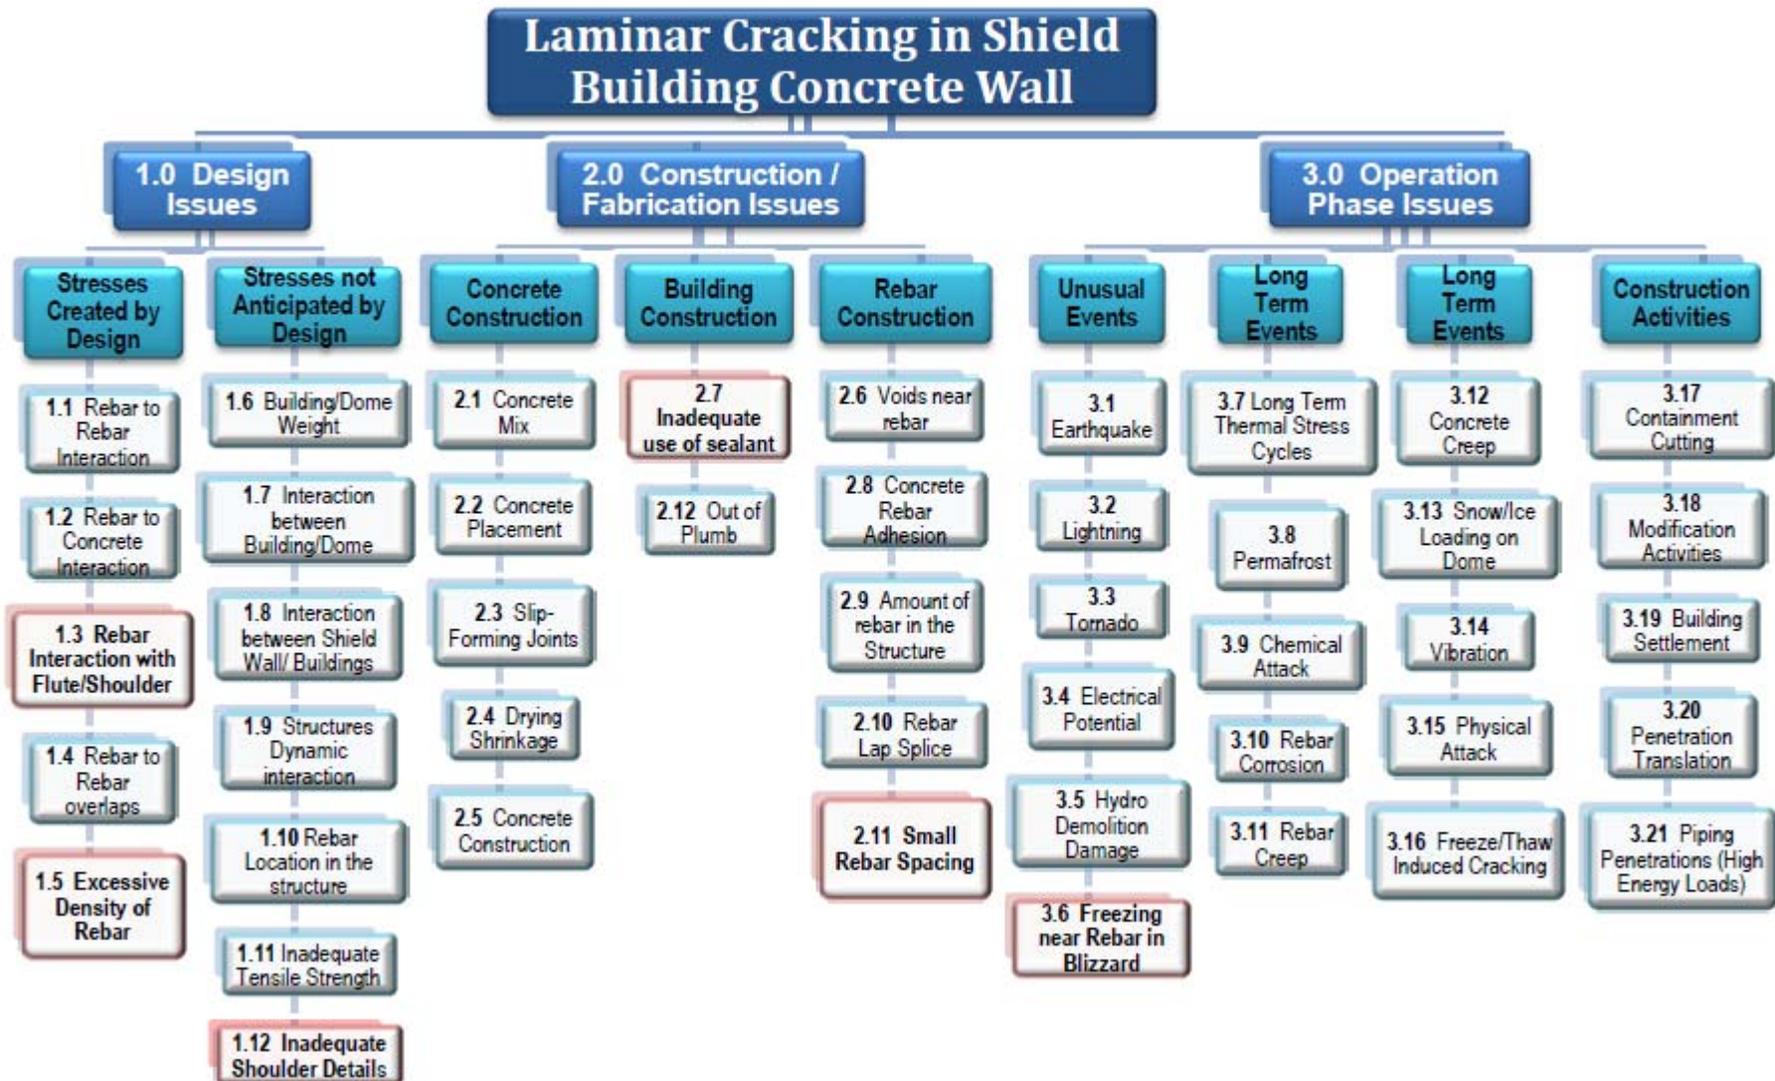
# Shield Building Root Cause Fault Tree

- Shoulder reinforcing details (discontinuity and no radial rebar)
- High density of rebar spacing
- High moisture, severe wind, and low temperature conditions

- **Root Cause**
  - Lack of concrete sealant
- **Preventive Action to Prevent Recurrence**
  - The exposed exterior surfaces of the Shield Building will be sealed
  - Contractor has started and is expected to be completed this year

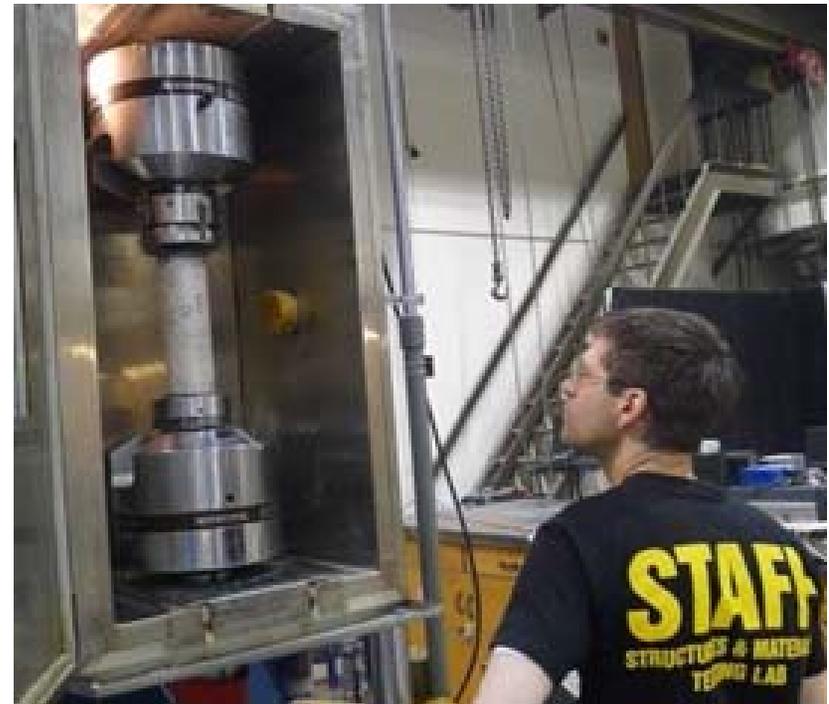
- **Concrete was subjected to a series of tests**
- **36 concrete cores from the Shield Building tested**
- **Concrete properties were determined**
- **Test results confirmed the concrete is sound and can be ruled out**

- **Typical concrete sample showing the laminar crack sheared the coarse aggregate**
- **Therefore, laminar crack occurred after the concrete achieved its strength**

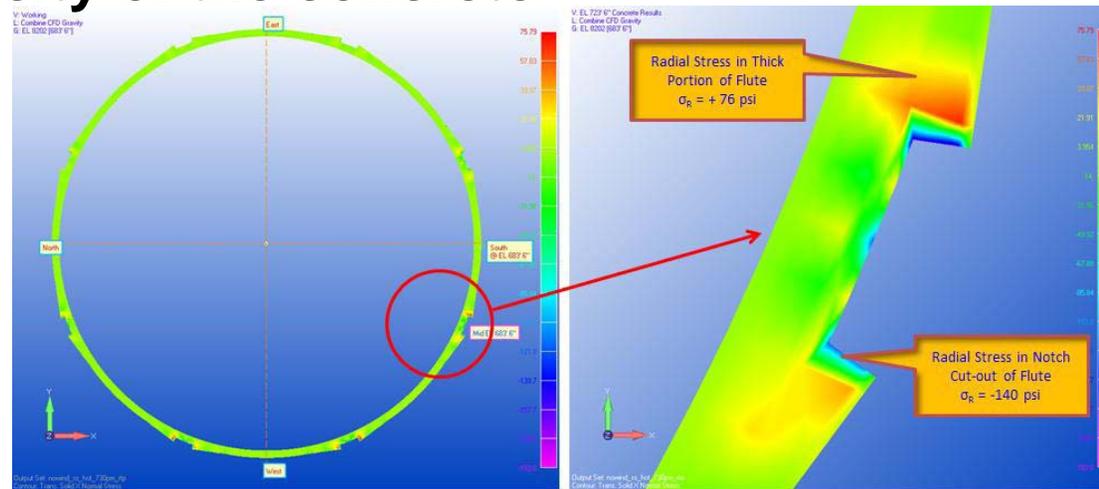
Overall View @ EL 683' 6"

- **Numerous computer analyses were performed for normal design conditions**
  - Self weight, wind loads
  - Thermal analyses (summer hot and winter cold conditions)
  - Fujita Category 2 tornado
- **Stresses were significantly below the normal tensile capacity of the concrete**

- **Analysis showed:**
  - Design stresses can not initiate the laminar crack
  - Significant stresses beyond what is normally analyzed would be required to crack the concrete

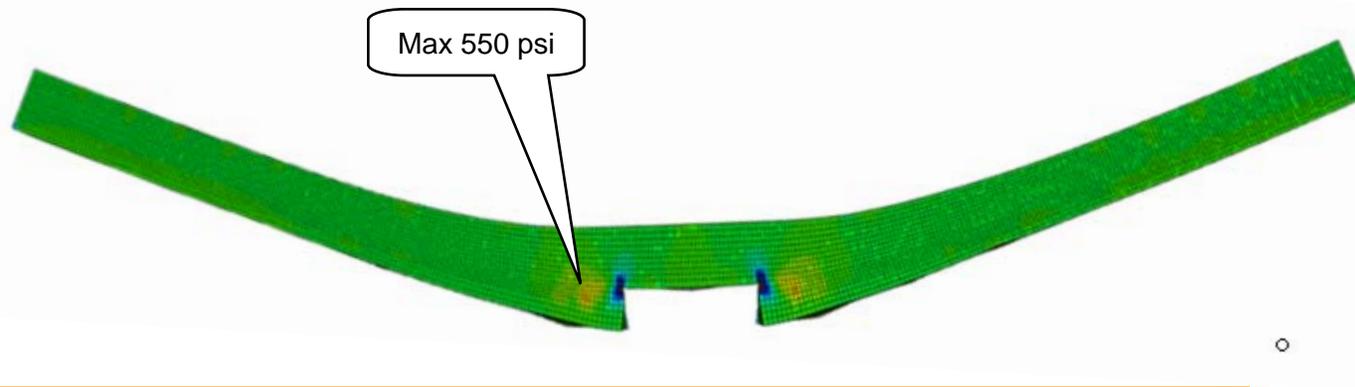
- A complex computer model of the Shield Building was developed
- Concrete properties from the concrete core tests were used
- Laboratory tests showed moisture infiltration up to four inches
- Maximum radial stress in the shoulder area were approximately the tensile capacity of the concrete
- High stresses were located in areas of observed cracking

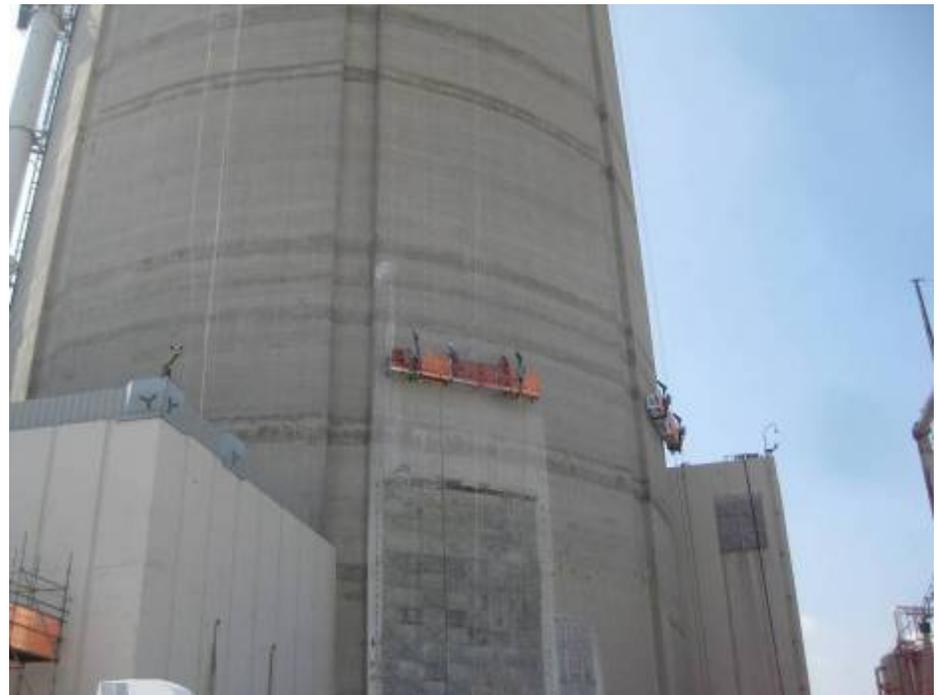
- **Complete IR examinations on the Shield Building wall and an independent structure**
  - All accessible areas of the Shield Building wall were mapped
  - Over 60,000 individual readings were obtained to fully characterize the condition of the building

- **The IR validated our original assessment that the laminar cracks are generally confined to:**
  - The shoulder areas
  - Top of the Shield Building
  - Near one corner of the Main Steam Line penetration
  - Southern exposure
- **Impulse Response reading on an independent site structure validated that laminar cracks are not present**
