Official Transcript of Proceedings
NUCLEAR REGULATORY COMMISSION

Title: Advisory Committee on Reactor Safeguards
Plant License Renewal Subcommittee

Davis-Besse Nuclear Power Station License Renewal Application

Advisory Committee on Reactor Safeguards
License Renewal Subcommittee Meeting
September 19, 2012

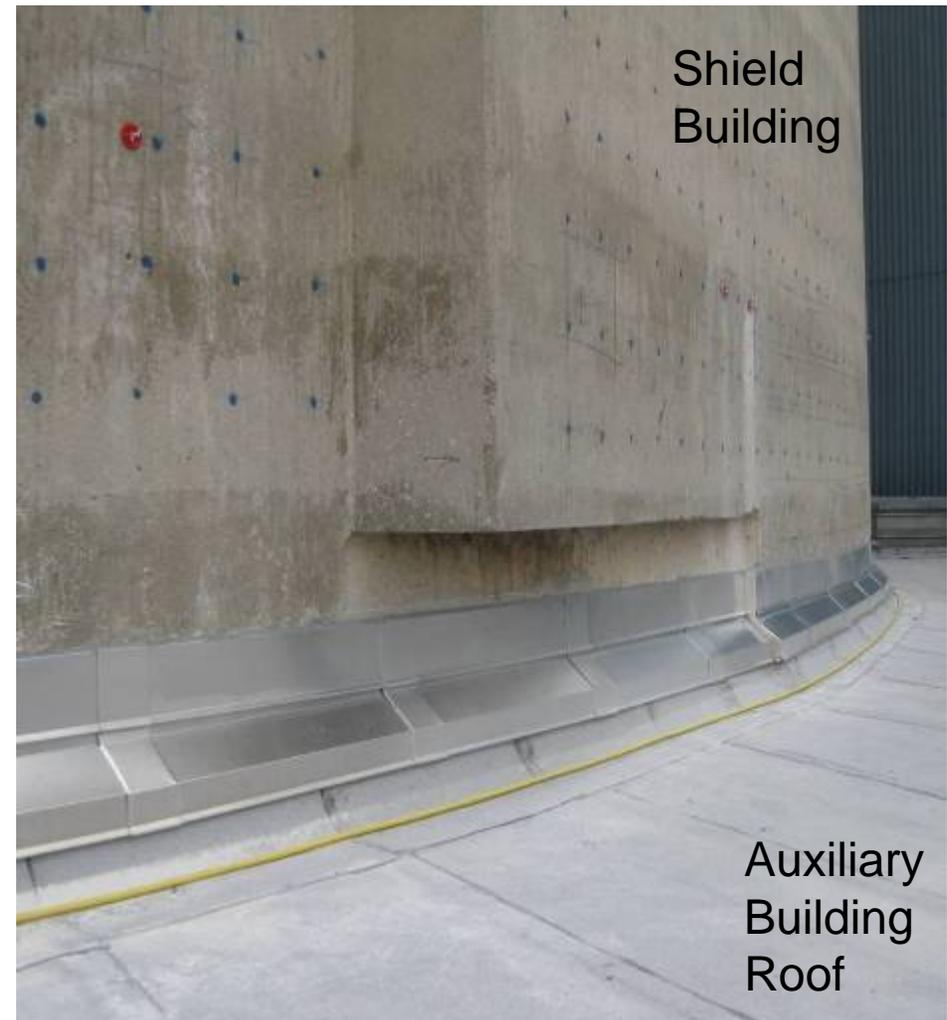
Shield Building Flute Shoulders

- The flute shoulders are a part of the Shield Building; concrete for shoulders and building shell was placed concurrently
- Evaluation of structural capacity of Shield Building does not credit flute shoulders
- Evaluated as a dead load in structural analysis

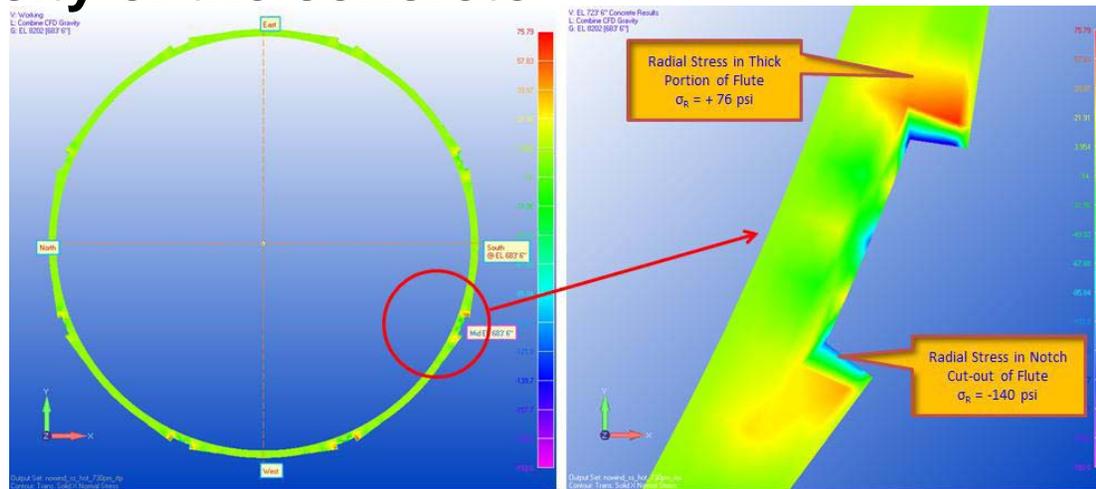
Overall View @ EL 683' 6"

- **Numerous computer analyses were performed for normal design conditions**
 - Self weight, wind loads
 - Thermal analyses (summer hot and winter cold conditions)
 - Fujita Category 2 tornado
- **Stresses were significantly below the normal tensile capacity of the concrete**

- **Analysis showed:**
 - Design stresses can not initiate the laminar crack
 - Significant stresses beyond what is normally analyzed would be required to crack the concrete

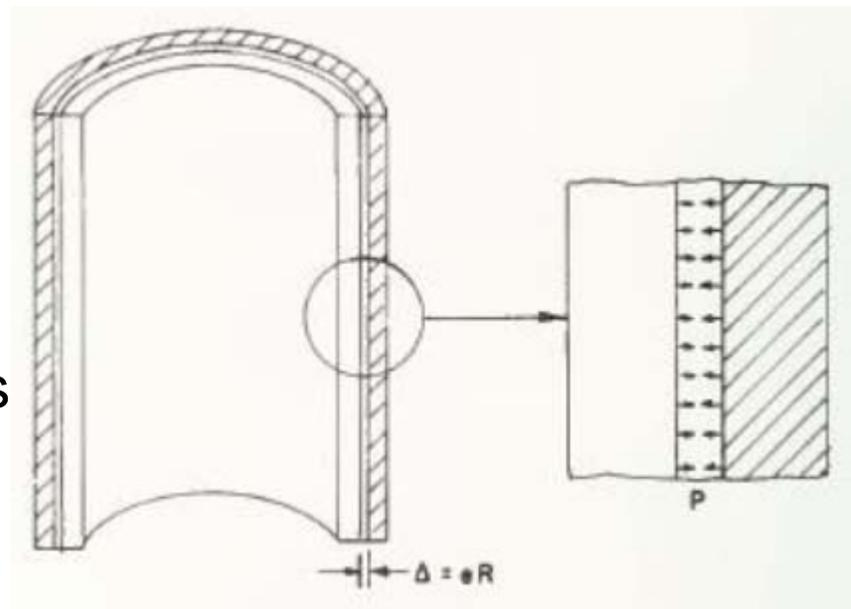
- **Water migrated into the concrete from the inside**

- Inner layer of the wall freezes and expands
- Outer layer of wall contracts
- Creates high radial stress
- Results in laminar cracking

- **Conclusion: Laminar cracking as a result of water freezing is a real potential**

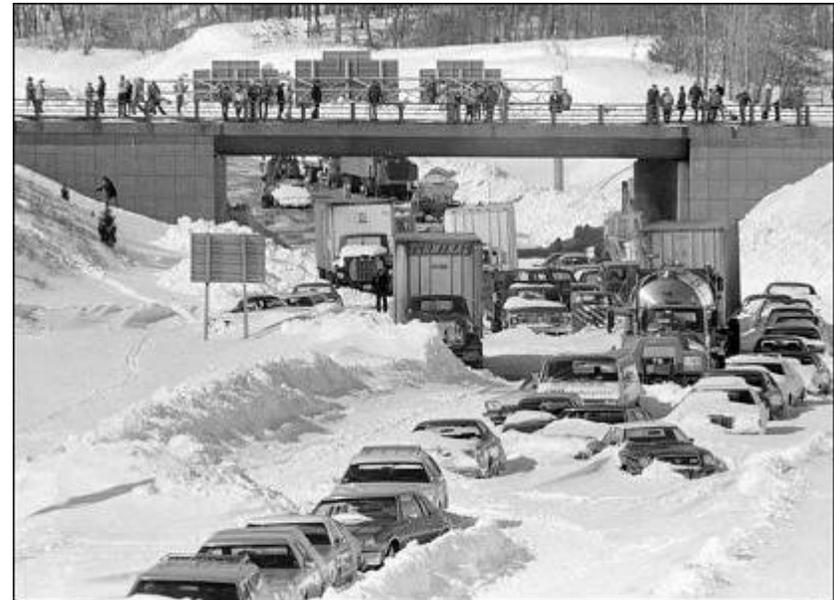
■ Scenario:

- Temperature near zero
- Sustained strong winds
- Moisture penetrated the Shield Building
- Moisture trapped in the outer layer of concrete crystallized
- Concrete expansion exceeded the tensile capacity of the concrete and propagated the crack

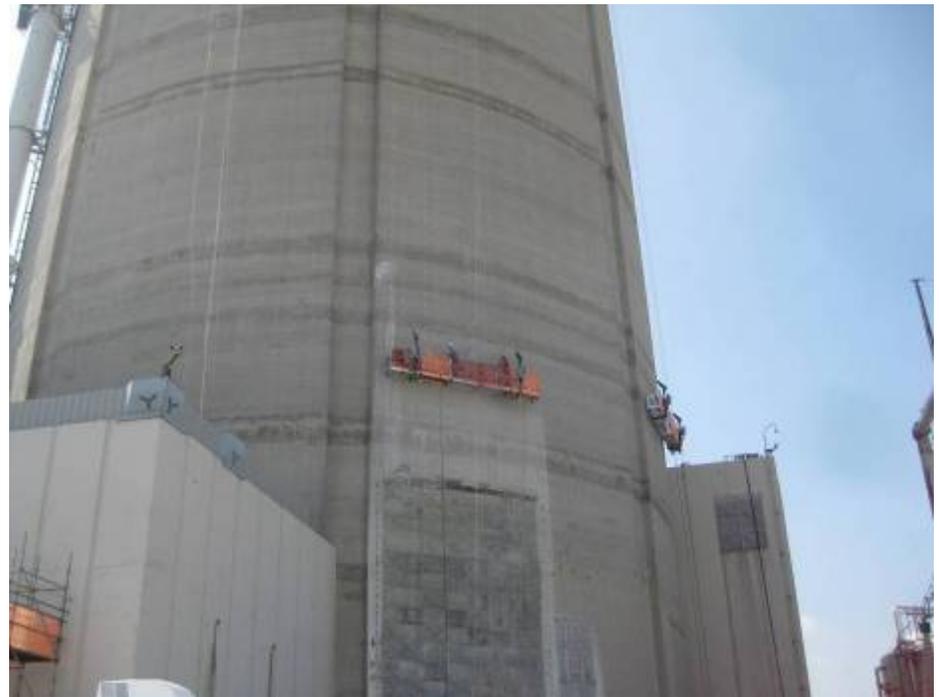
Additional Actions - IR Mapping

- **Complete IR examinations on the Shield Building wall and an independent structure**
 - All accessible areas of the Shield Building wall were mapped
 - Over 60,000 individual readings were obtained to fully characterize the condition of the building

- **The IR validated our original assessment that the laminar cracks are generally confined to:**
 - The shoulder areas
 - Top of the Shield Building
 - Near one corner of the Main Steam Line penetration
 - Southern exposure
- **Impulse Response reading on an independent site structure validated that laminar cracks are not present**
