Subject: 10CFR21 Reporting of Defects and Non-Compliance -
Engine Systems, Inc. Report No. 10CFR21-0106, Rev. 0

EMD (Detroit Switch) Temperature Switch – Potential Missing Set Screw

Report No. 10CFR21-0106

SYSTEM: Emergency Diesel Generator

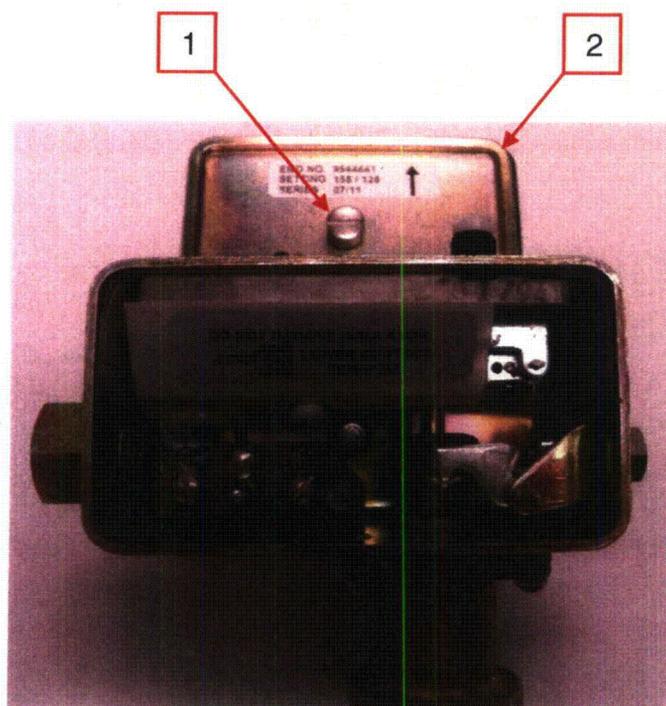
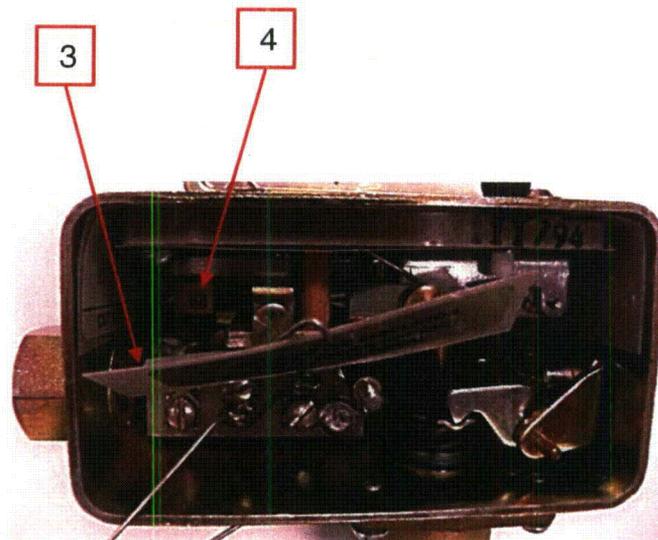
The set screw found in the temperature test fixture oil bath is 1/8" long with #6-32 threads. This is the same length, thread size and style as the set screw used in EMD/Detroit temperature switches to lock the differential adjustment screw.

All affected users should inspect the suspect switches (see Table 1) for presence of the set screw at their earliest convenience. If the set screw is missing, the temperature switch should be returned to ESI for rework.

1. Loosen the screw located in the center of the temperature switch cover.
2. Remove the cover, the mounting screw and cover gasket will remain attached to the cover.
3. Look behind the insulator to access the differential adjust screw.
4. Verify that set screw is installed.
 - a. If installed, re-install the cover; temperature switch is acceptable.
 - b. If not installed, return the temperature switch to ESI for rework.
