SUBJECT: Proposed Alternative – Request for Relief from Immediate ASME
Code Flaw Repair of Service Water System Manual Valve MV-SW136

Palisades Nuclear Plant
Docket 50-255
License No. DPR-20

PROPOSED ALTERNATIVE in Accordance with 10 CFR 50.55a(a)(3)(ii) Hardship or Unusual Difficulty Without Compensating Increase in Level of Quality and Safety

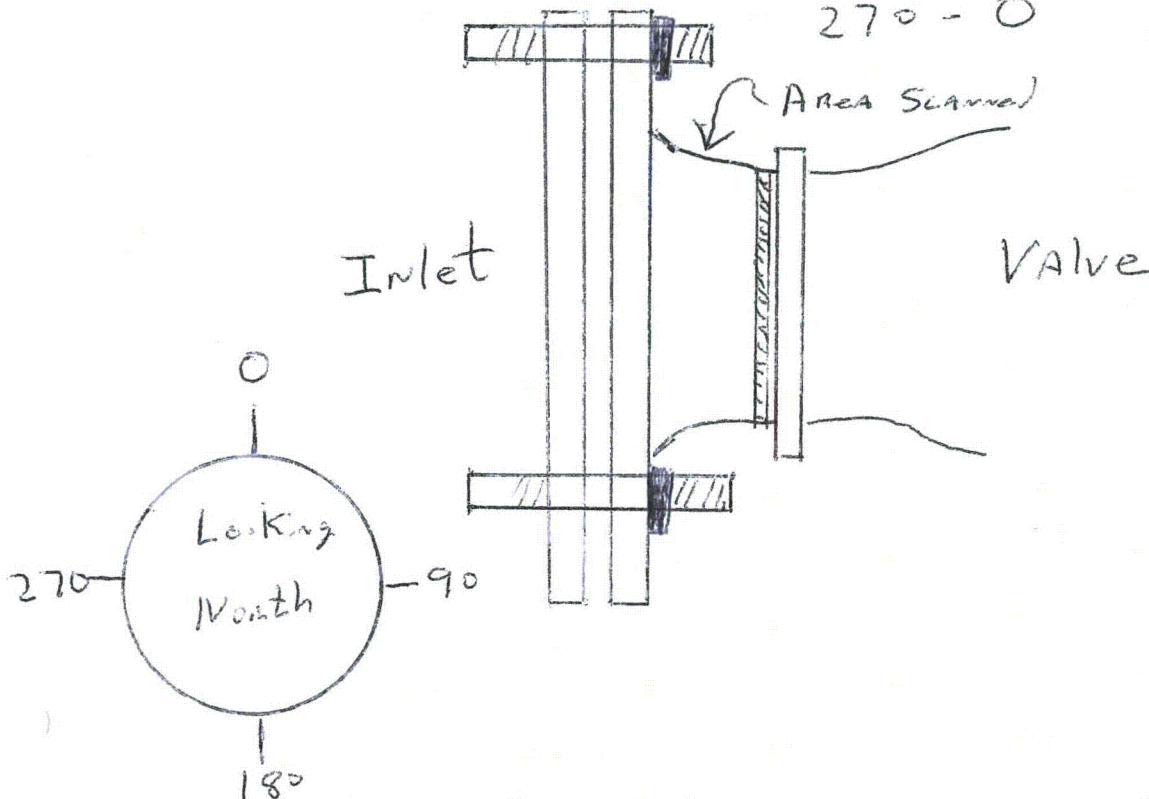
The continuous ultrasonic scan of the inlet flange funnel pipe found no ultrasonic readings to be lower than .298". A .283" diameter transducer was used to provide the best access, but due to the tapered configuration and the restrictions caused by the flange bolting and lack of direct access to the opposite side of the valve, this examination is considered to be best effort. The lowest readings were identified at the flange to valve weld, and became continually thicker as the flange was examined up the taper.

180 - 270 - .313"

270 - 0 .303"
