Seismic Walkdown Checklist (SWC) SWEL1- 089

Equipment ID No. EJ-1051 Equip. Class¹ 20, INSTRUMENTATION AND CONTROL PANELS

Equipment Description AUX FEEDWATER CONTROLS

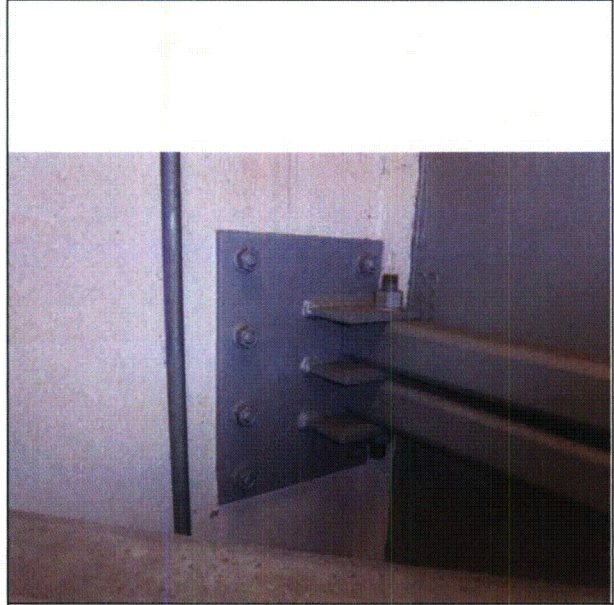
Note: *Equipment anchorage for seismic restraining brace.*

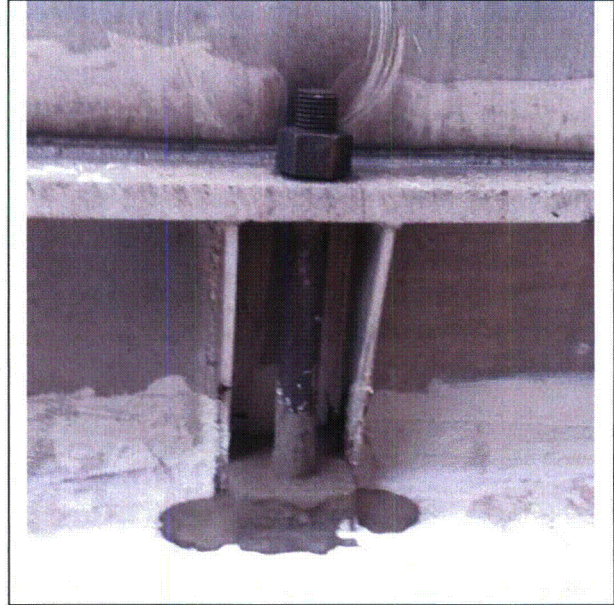
Note: Tank T-58 Anchor Bolt. 1 of 52

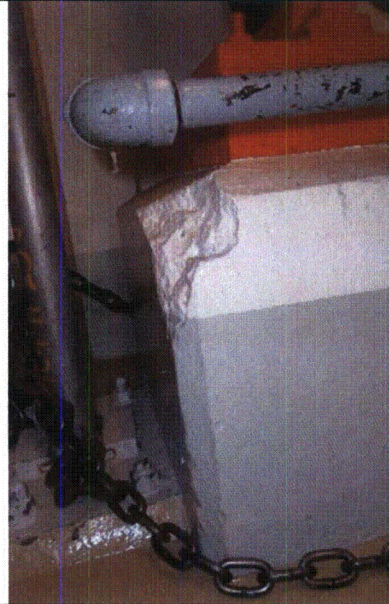
Note: Chipped concrete on corner of pump pedestal.

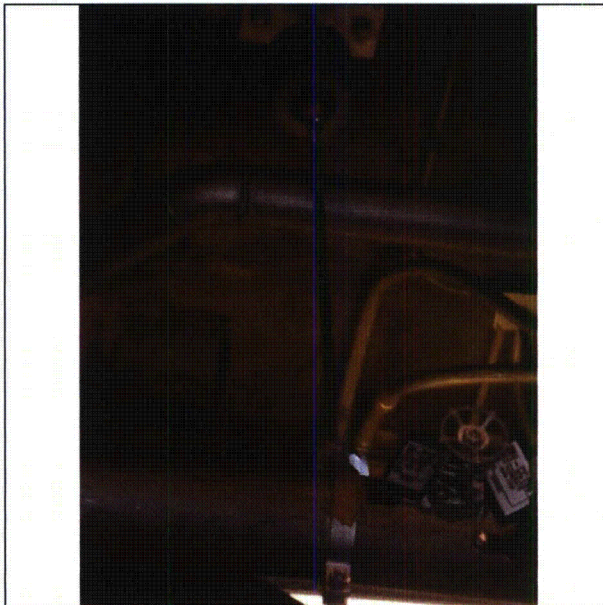
Note: Pipe Hanger Supported by Spring Canister Bent Around Pipe (close-up)

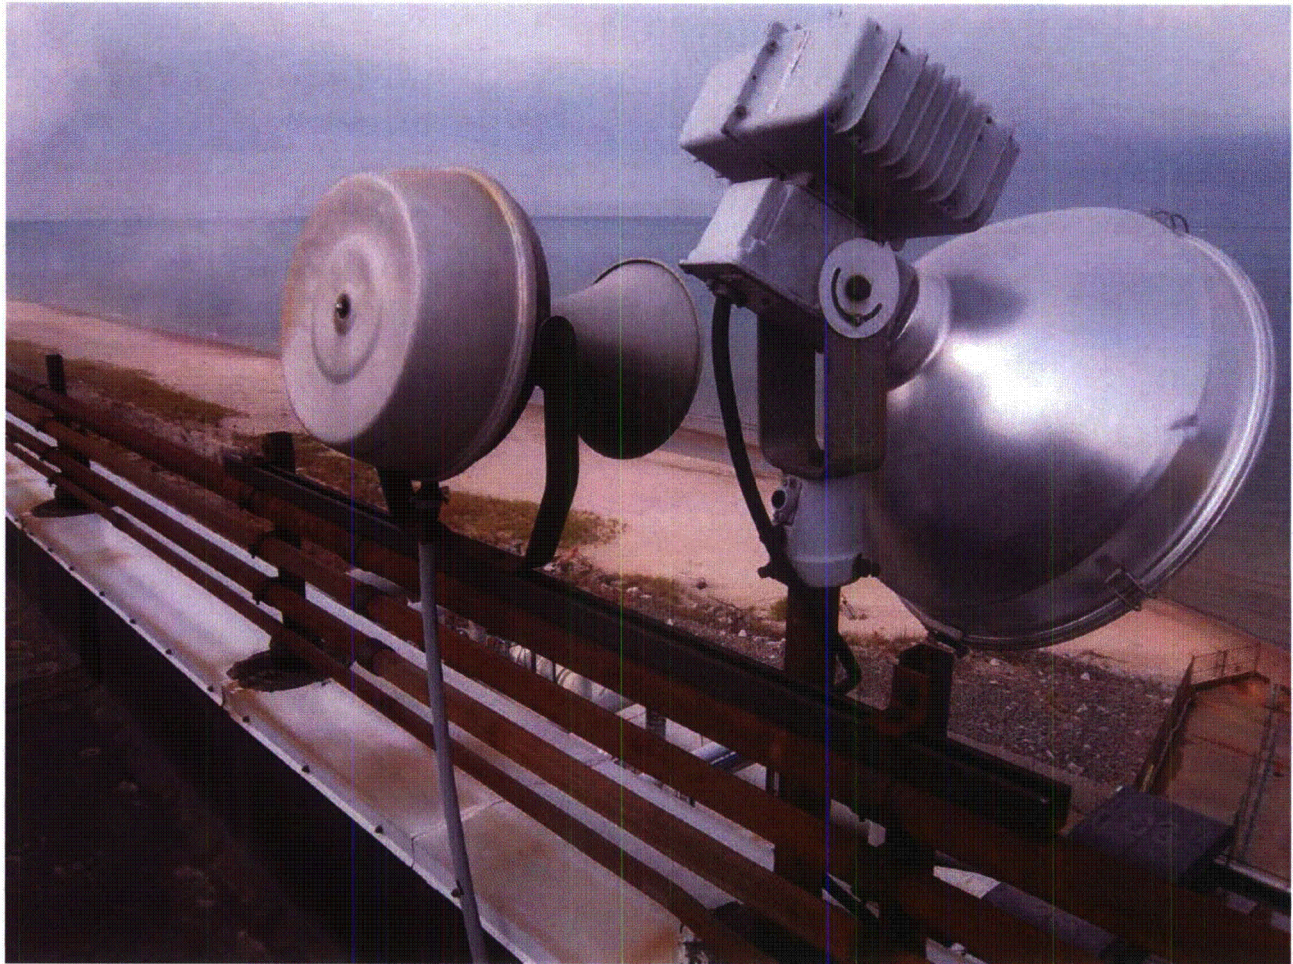
Sound and Lighting Located Above T-2, Taken From the Turbine Building.
