**ATTACHMENT (4)**

**AREA WALK-BY CHECKLIST**

## Area Walk-By Checklists (AWCs)

**Table A-1: Area Walk-By Checklists**

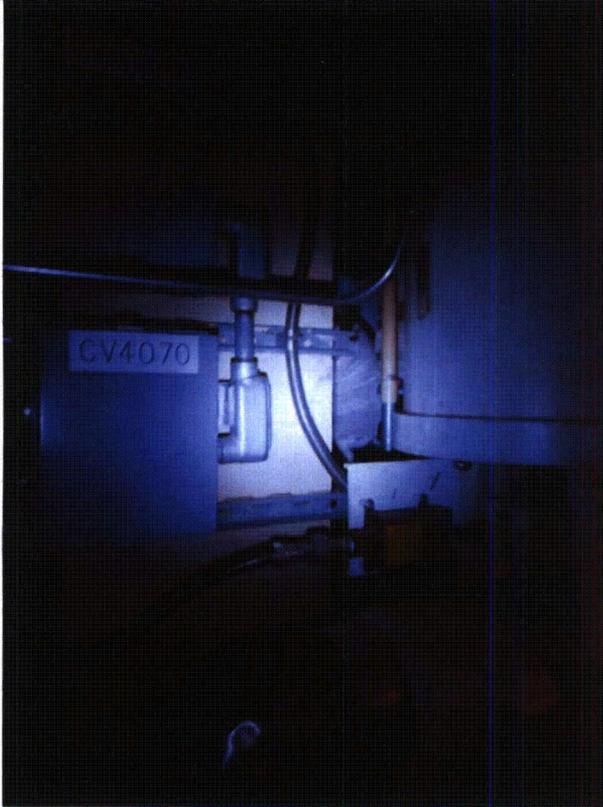
Area # AUX, 27, CAL-AB-309 8-9-12 060

| 4. | Does it appear that the area is free of potentially adverse seismic spatial interactions with other equipment in the area (e.g., ceiling tiles and lighting)?<br><i>There are some broken or missing platform gratings clips, but judged not to be a seismic concern.</i> | Yes |
| 5. | Does it appear that the area is free of potentially adverse seismic interactions that could cause flooding or spray in the area?<br><i>The overhead threaded fire piping is judged to be adequately supported and not a concern for spray or flooding.</i> | Yes |

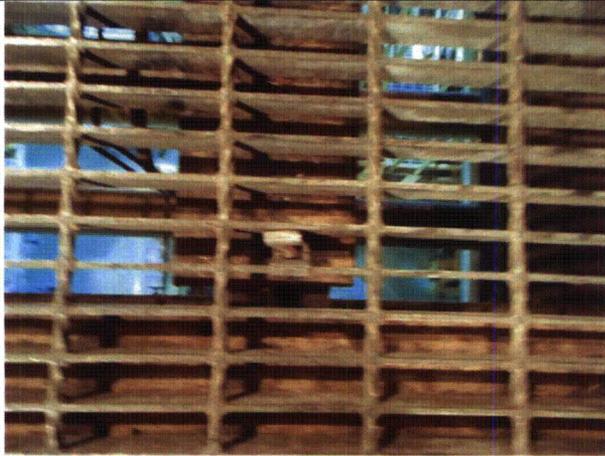
Area # AUX, 27, CAL-AB-310 8-9-12 085

| 5. | Does it appear that the area is free of potentially adverse seismic interactions that could cause flooding or spray in the area?<br><i>The overhead threaded fire piping is judged to be adequately supported and not a concern for spray or flooding.</i> | Yes |
| 7. | Does it appear that the area is free of potentially adverse seismic interactions associated with housekeeping practices, storage of portable equipment, and temporary installations (e.g., scaffolding, lead shielding)?<br><i>The equipment that is stored in the storage area will roll into each other, but not into cabinet RCP 22AP01, therefore not a concern. However it is recommended that better tie offs to provided.</i> | Yes |

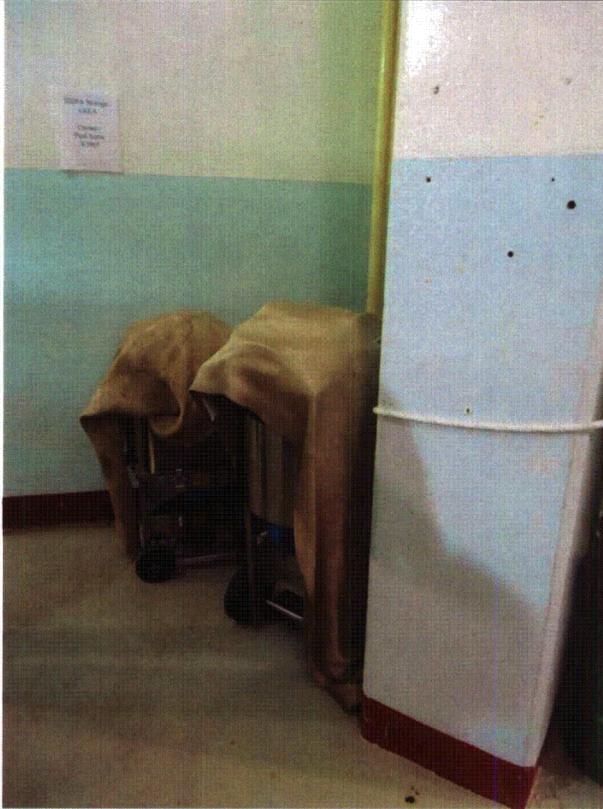
Area # AUX, 45, CAL-AB-408 8-8-12 147

2. Does anchorage of equipment in the area appear to be free of significant degraded conditions? No  
*There is a crack in the wall that runs through a fire protection panel's anchor bolt and conduit supports. This is a potential seismic concern and needs to be evaluated. CR-2012-009757*

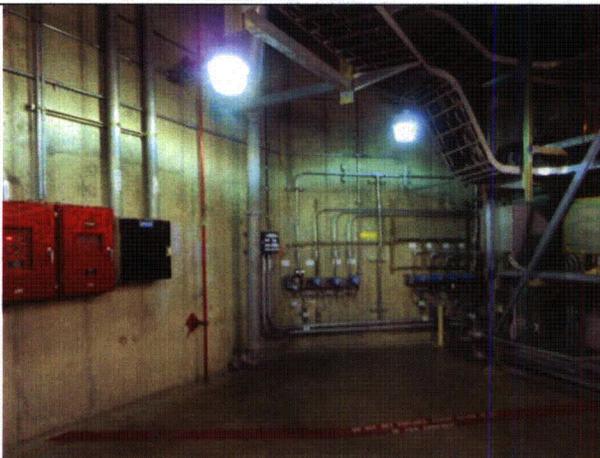
Area # AUX, 45, CAL-AB-409 8-7-12 054

*Unsupported measurement pole resting against wall near MCC, pole may fall and strike the MCC, therefore a potential seismic hazard. CR-2012-008679*
