ENTERGY	ENGINEERING STANDARD	EN-EP-S-002-MULTI	REV. 0
	Buried Piping and Tanks General Visual Inspection	PAGE 12 OF 12

ATTACHMENT 7.1	INSPECTION CHECKLIST
----------------	----------------------

Piping / Tank	IP3 AFW/Cond Return to CST (8-inch Line 1080) (Ref. WO # 279578-03)	INSPECTION DATE:	12/9/2011
ELEVATION:	pipe centerline @ EL. 11'-6"; grade @ El. 18' (approx.)	LOCATION DWG:	9321-F-23593
		INSPECTOR:	J. Peterson

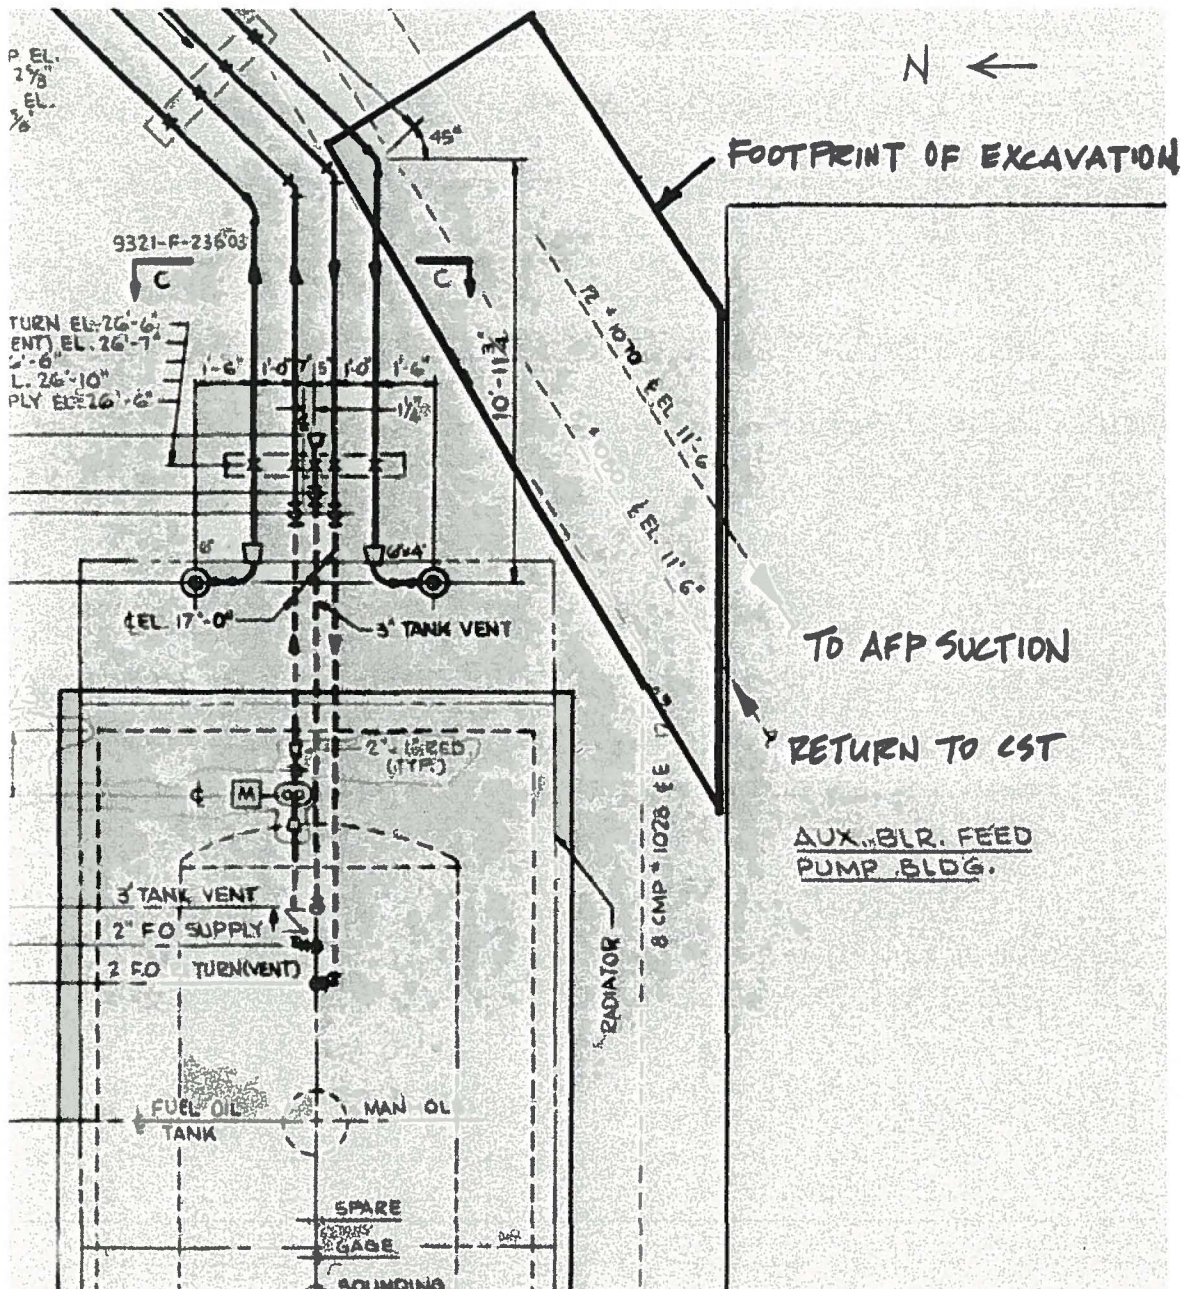
GENERAL APPEARANCE (Inspector): An approx. 16 ft. length of 8-inch Line 1080 was excavated, of which approx. 12 ft was exposed for its full circumference. The coating appearance was uniform in color, with no indications of degradation (blistering, peeling, flaking, cracking or separation of coating from the metal surface). The coating outerwrap appeared to be evenly applied, with the edges of overlapping layers wrap sealed with the coal tar enamel. Further, there was no discoloration or evidence of corrosion product under or at the edges of the wrap, and the coating surface was solid to the touch. Photos are attached.
