**G-Scan Assessment of
Various Buried Piping**

Inspection Dates: September 22nd and 23rd 2009

Submitted to:
Entergy Nuclear
Indian Point Energy Center
November 2009

Report No. 0900235.401.R0

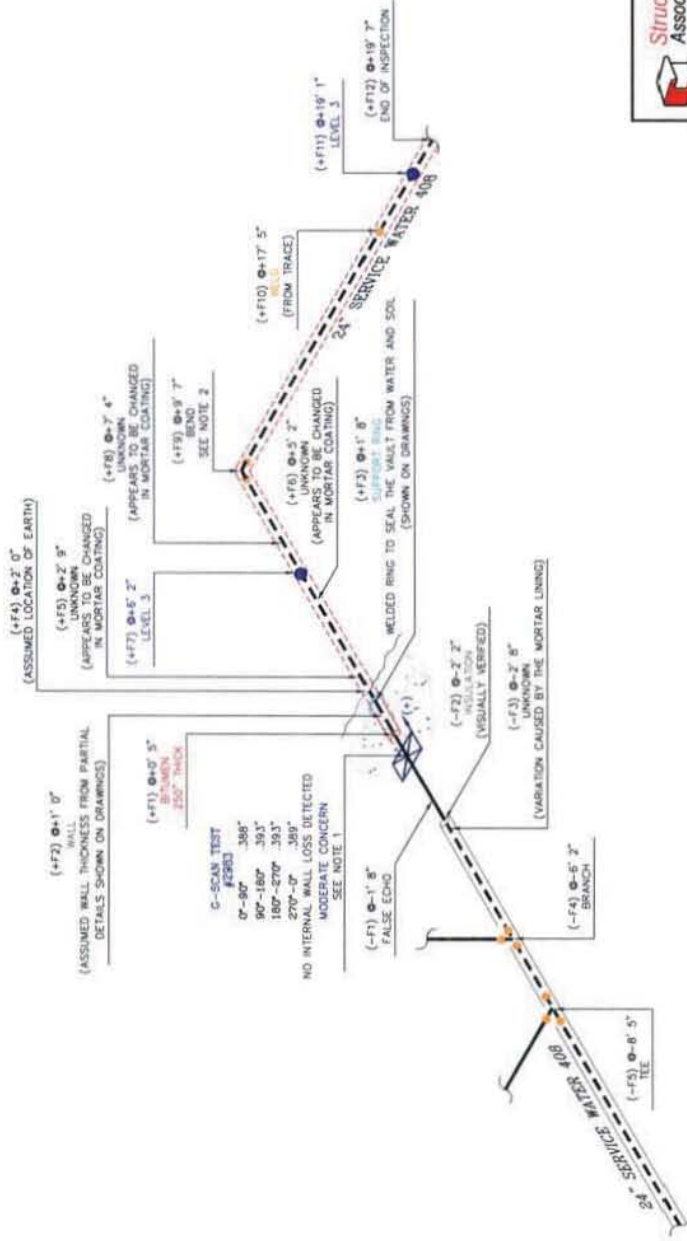
24" SERVICE WATER 408
 INDIAN POINT - VAULT AT UNIT 3
 G--SCAN TEST #2983

This shot was taken in the service water valve pit at Unit 3. The pipe ran through a concrete wall and then into soil. The piping is reported to have a mortar lining. At the location of the collar the pipe had paint. A bitumen coating that was 1/4" thick was noted as the pipe entered the vault wall. B-Scan readings are 0 to 90; 0.388", 90 to 180; 0.393", 180 to 270; 0.393" 270 to 0; 0.389" No internal wall loss was detected from the B-Scan tests.

Feature	Location	Class	Notes
A6	19'1"	Cat 2	Level 3
A5	7'4"	Cat 0	Appears to be a change in mortar coating
A4	6'2"	Cat 2	Level 3
A3	5'2"	Cat 0	Appears to be a change in mortar coating
A2	2'9"	Cat 0	Appears to be a change in mortar coating
A1	-2'8"	Cat 0	Variation caused by the mortar lining
B1	9'7"	1D Bend	The location of the bend does not correspond with the drawing but was selected here due to the initial weld response of the bend
E4	2'0"	Earth	Assumed location of earth
E3	1'0"	Wall	Assumed wall thickness from partial details shown on drawings.
E2	0'5"	Bitumen	0.25" Thick
E1	-2'2"	Entrance	Insulation visibly verified
F2	-6'2"	Branch	
F1	-8'5"	T	
R1	-1'8"	False Echo	
S1	1'8"	Support	Welded ring to seal the vault from water and soil shown on drawings.
U2	19'7"	End	
W1	17'5"	Weld	From trace

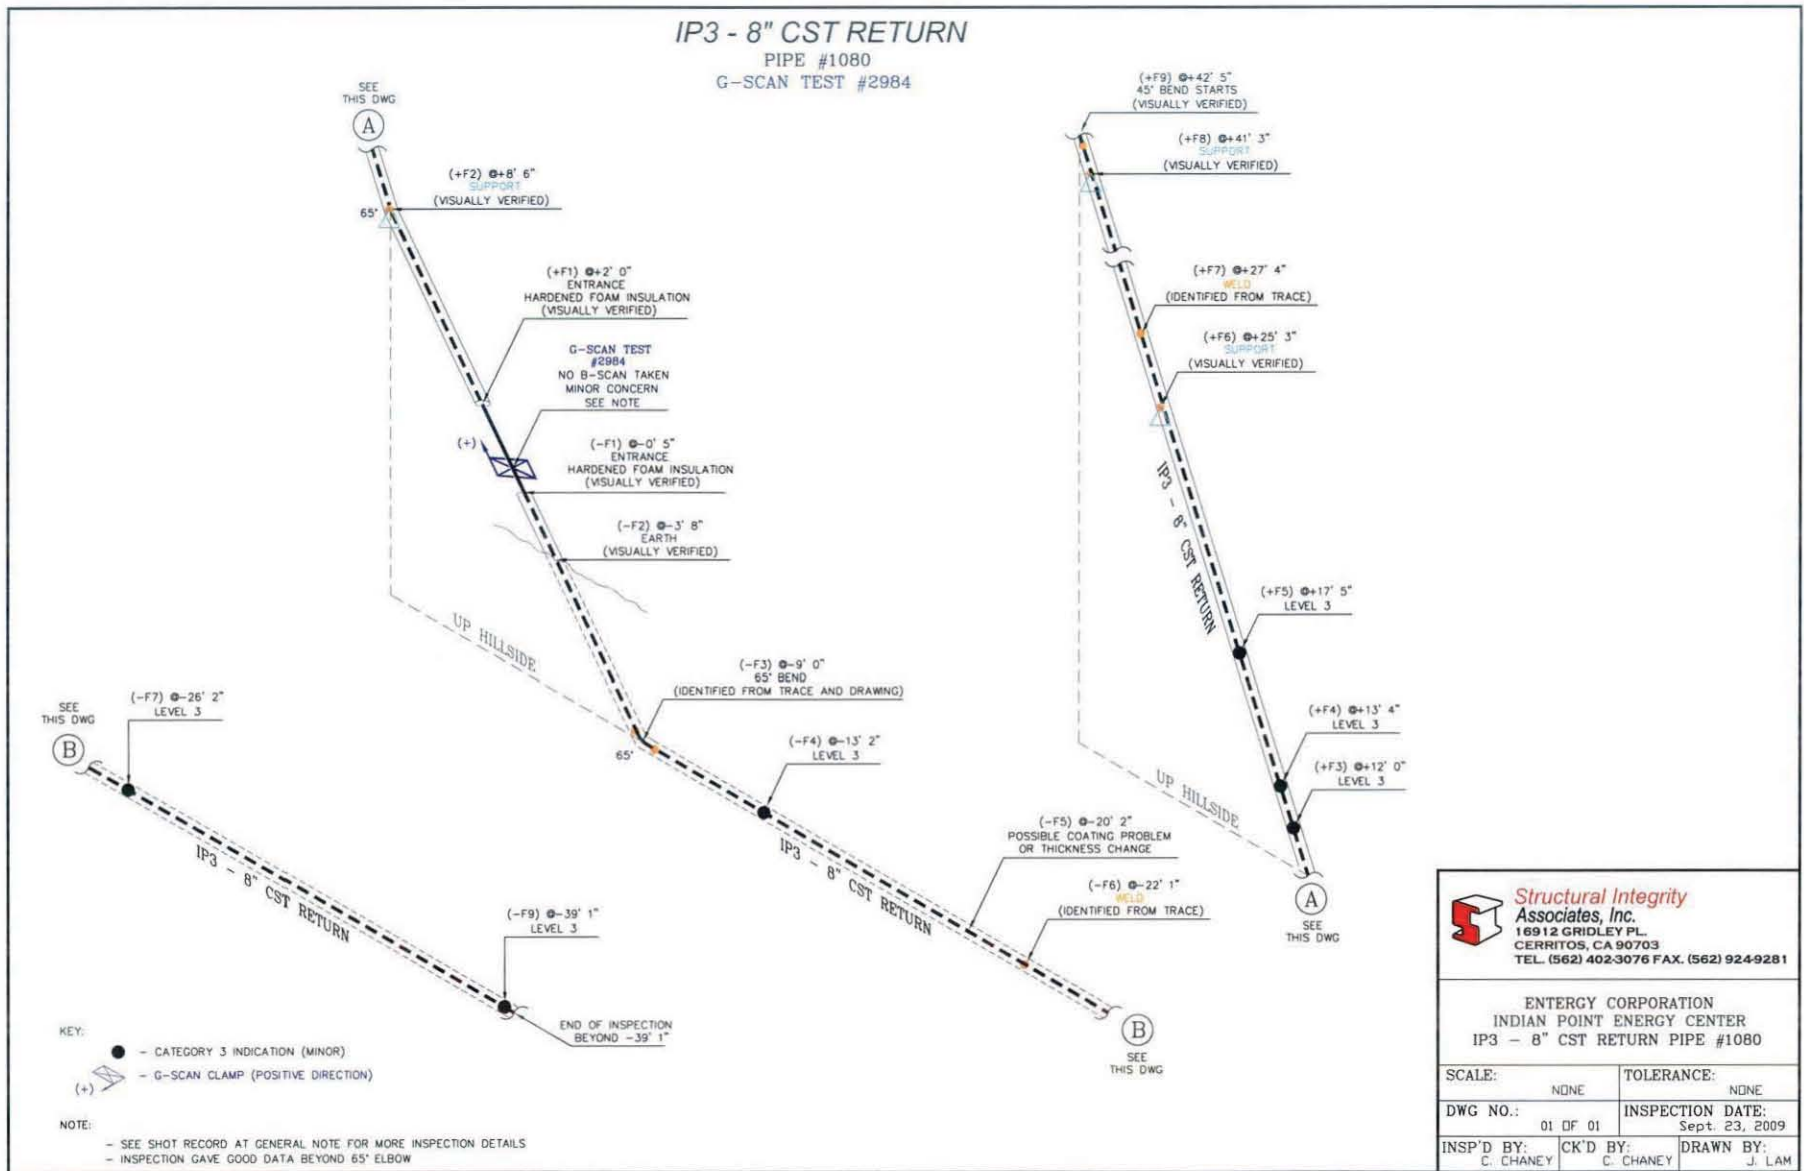
Figure 3.12: Location 3, Test Results from Shot 2984

Pipe #1080. This line runs up the hillside at a 65 degree angle on welded supports. In the other direction it runs into the earth and has a 65 degree bend approximately four feet below ground. Minor corrosion was observed in the trace above and below ground. This location has Level 3 indications.

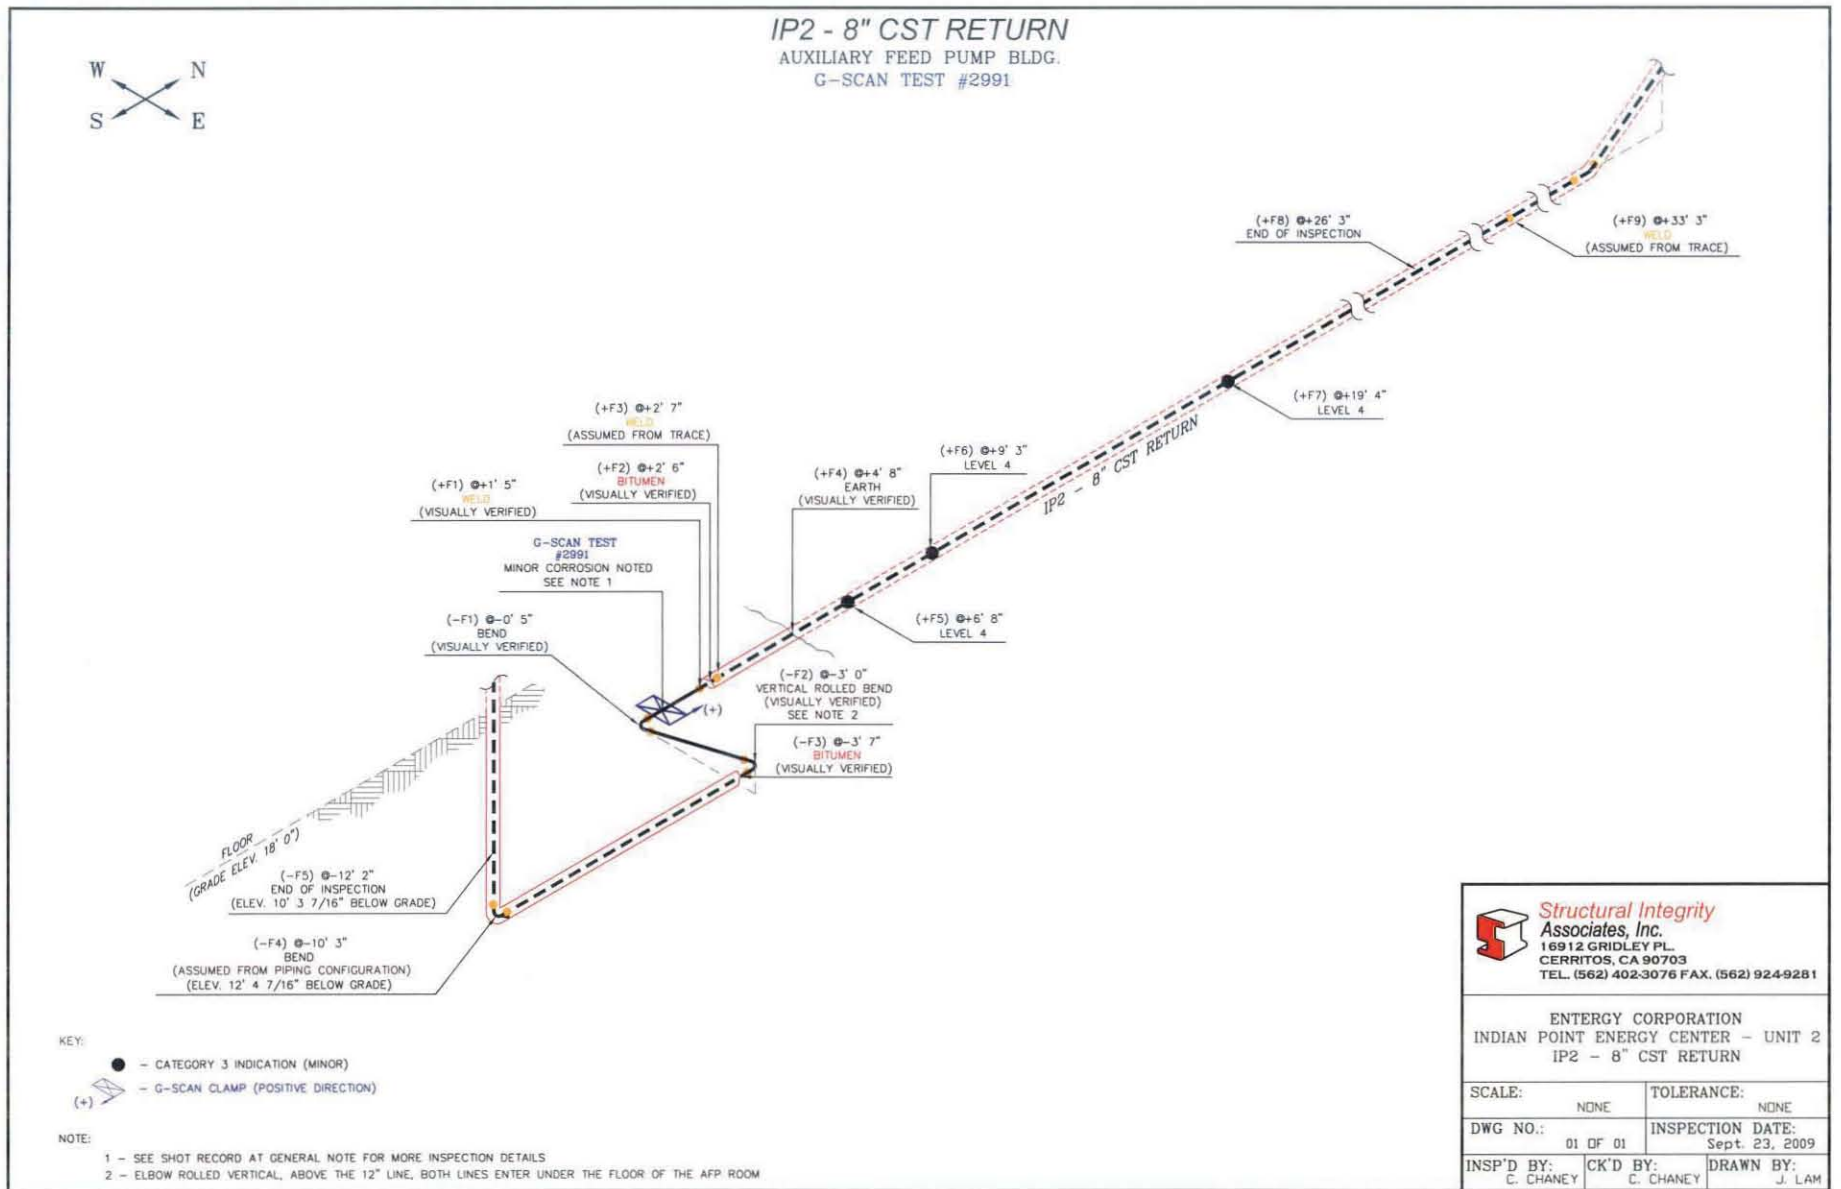
Figure 3.15: Location 4, Test Results from Shot 2991

4	2	Cond. Ret. To CST	1509	FRV Bldg Excavation	2991	3	This section of line had through wall leaks in February 2009. The leaking section of pipe was replaced in February 2009 and is the location of the transducer collar for this test. Minor corrosion indications were noted. This is a Level 3 area.
5	2	CST TO AFP	1505	FRV Bldg. Excavation	2993	2	Several indications are observed in the piping towards the elbow. Because of the nature of these indications they are categorized as Level 2 indications.
6	3	CST to AFP	1070	Unit 3 CST to AFP Bottom of Hill	2995	2	Minor corrosion of 0.025" deep was noted at the collar location. Several corrosion like indications were identified in the buried sections of the pipe. These indications are categorized as a Level 2.

Test ID: G3-76#2991 Pipe: IP2 - 8" CST Return Site: Indian Point, Unit 2 Location: Weld 1'5" Size: 8 inch Tested: 23 Sept 2009 12:55 Tested by: Craig Chaney				Ring: R2B08(900) Configuration: 3.3FR, T(0,1) Calibration: Automatic (2372.37 mV) Version: 3.97, Wavemaker G3-76 Client: Indian Point Procedure: GU 1.1 DACs: Call=10%, Weld=23%			
Summary: IP2-8" CST Return for Unit 2 in excavation that was in the feed regulator valve building. This section of line had through wall leaks in February 2009. This section of pipe was replaced in February 2009 and is the location of the transducer collar for this test. Minor corrosion indications were noted. This is a Level 3 test.							
Feature	Location	Class	Notes				
U1	-12'2"	End					
B1	-10'3"	Bend	Assumed from piping configuration				
E1	-3'7"	Bitumen	Visually verified				
B2	-3'0"	1D Bend	Visually verified				
B3	-0'5"	1D Bend	Visually verified				
W1	1'5"	Weld	Visually verified

It is recommended the Level 3 indications be monitored over time. The indications in the FRV building may be further explored with direct examination, pressure tested or monitored over time. This piping may benefit from localized cathodic protection to mitigate further degradation.

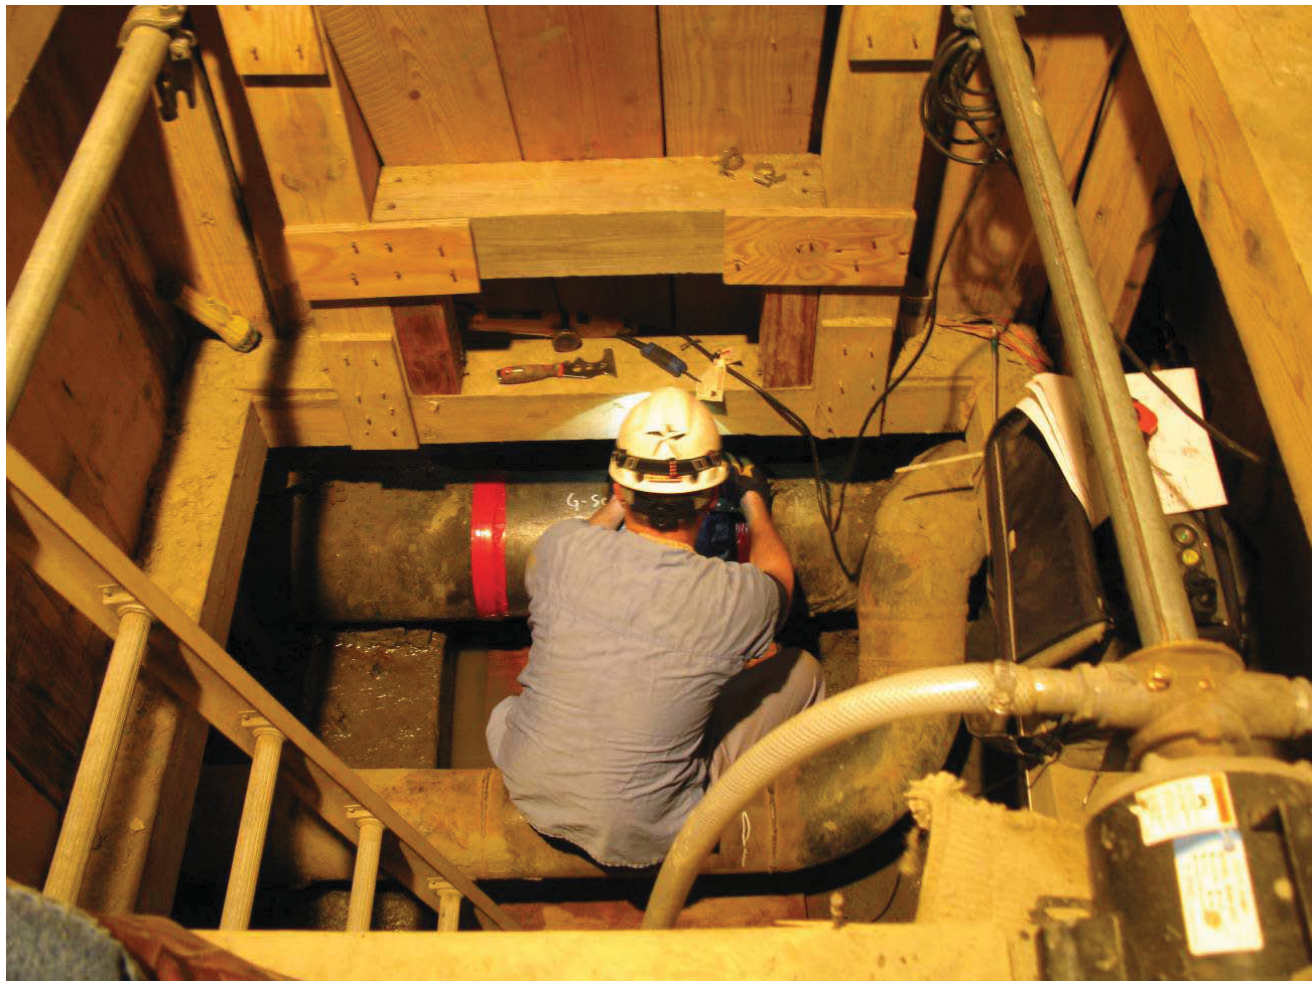
Figure 3.16: Location 5, 12-inch Line in an excavation in the AFP Building

Figure 3.16 shows Location 5 on a 12-inch condensate supply line to the AFW pumps in an excavation in the auxiliary feed pump building.

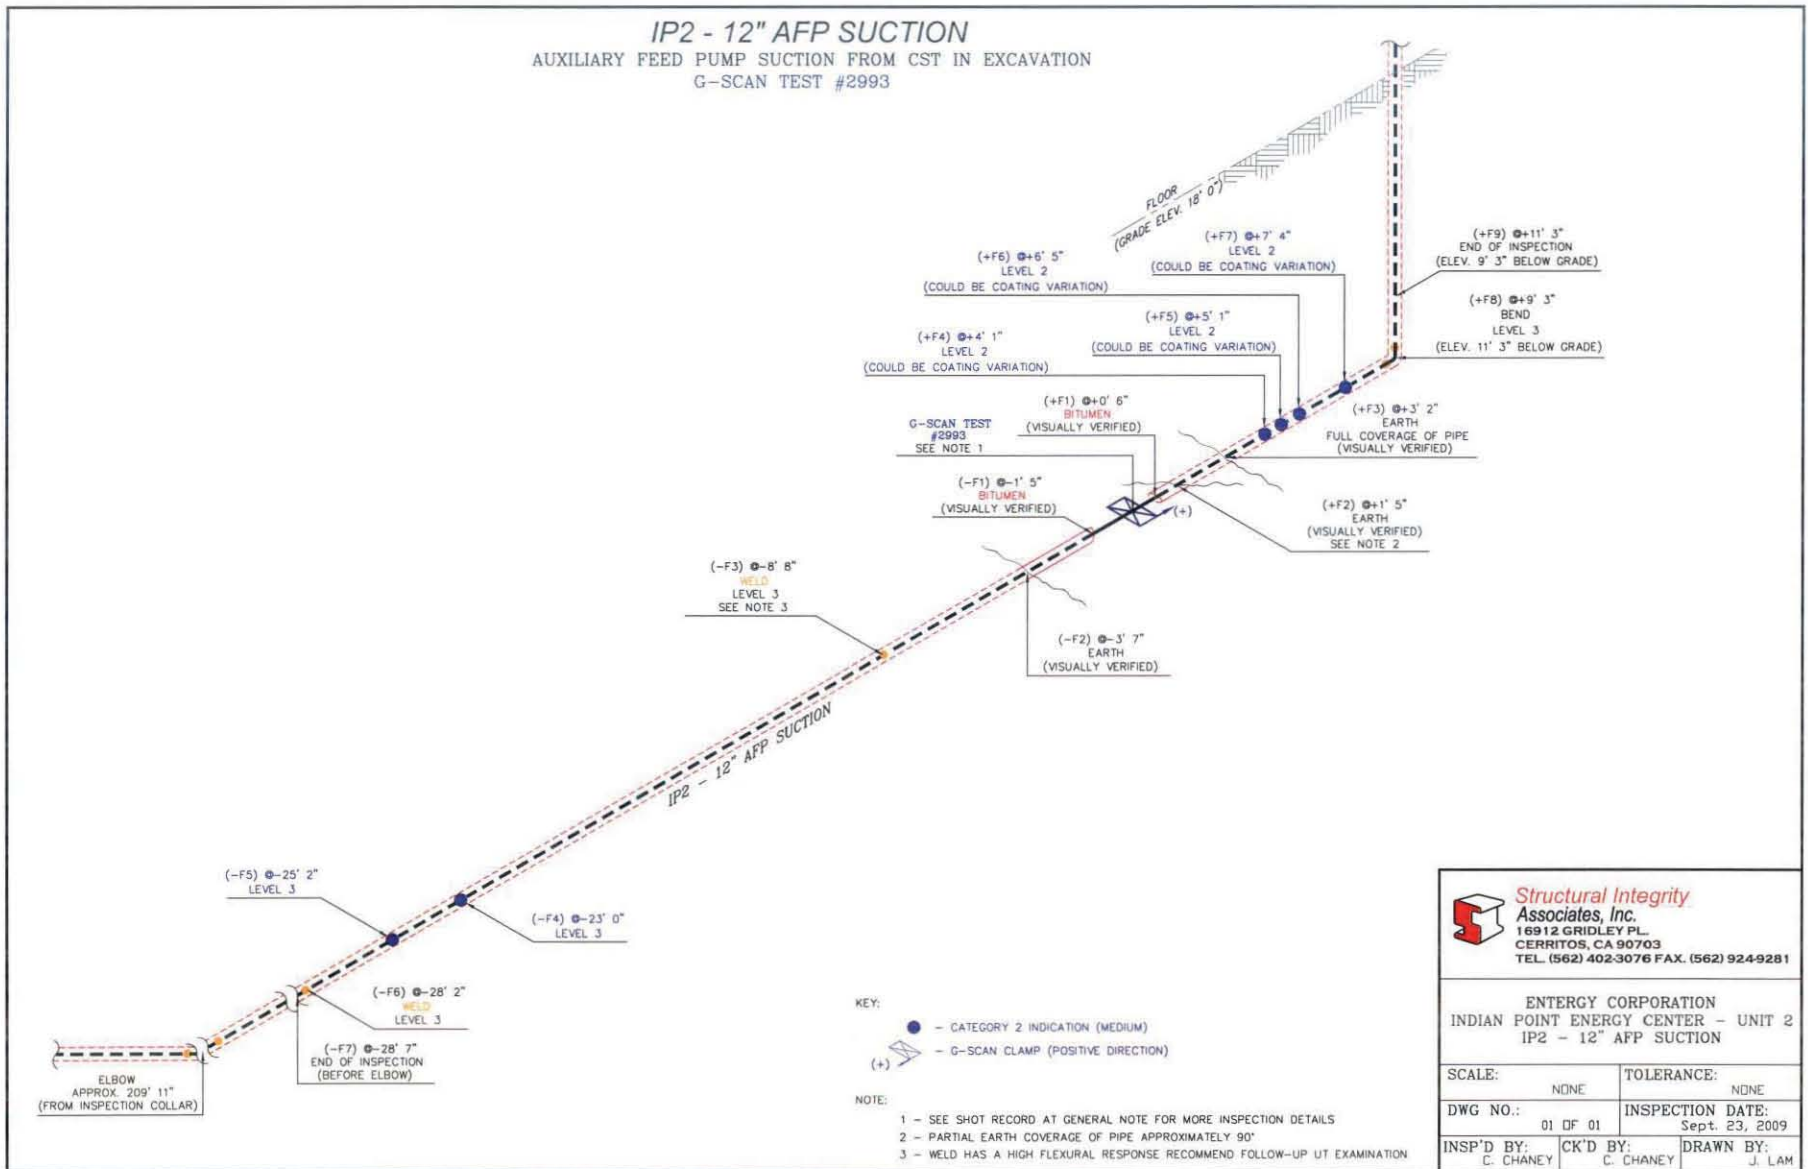
Figure 3.18: Location 5, Test Results from Shot 2993

Test ID: G3-76#2993 Pipe: IP2 - 12" AFP Suction Site: Indian Point Location: Wall 3'0" Size: 12 inch Ring: R2B12(1368) Configuration: 7.4FR, T(0,1) Calibration: Automatic (6864.49 mV) Version: 3.97, Wavemaker G3-76 Tested: 23 Sept 2009 Tested by: Craig Chaney Client: Indian Point Procedure: GU 1.1 DACs: Call=10%, Weld=23%			
Summary: Unit 2 12" Aux Feed Pump Suction from CST in excavation. Several indications are observed in the piping towards the elbow. Because of the nature of these indications they are categorized as Level 2 indications.			
Feature	Location	Class	Notes
E1	-3'7"	Earth	Visually verified
E2	-1'5"	Bitumen	Visually verified
E3	0'6"	Bitumen	Visually verified
E4	1'5"	Earth	Visually verified Partial earth coverage of pipe approximately 90 degrees
E5	3'2"	Earth	Visually verified Full coverage of pipe
A3	4'1"	Cat 2	Could be coating variation. Level 2
A4	5'1"	Cat 1	Could be coating variation. Level 2

A5	6'5"	Cat 3	Could be coating variation. Level 2
A6	7'4"	Cat 1	Could be coating variation. Level 2
B1	9'3"	Bend	Level 3
U2	11'3"	End	
W2	-8'8"	Weld	Weld has a high flexural response recommend follow-up UT examination, Level 3
A2	-22'11"	Cat 2	Level 3
A1	-25'2"	Cat 2	
W1	-28'2"	Weld	Level 3
U1	-28'7"	End

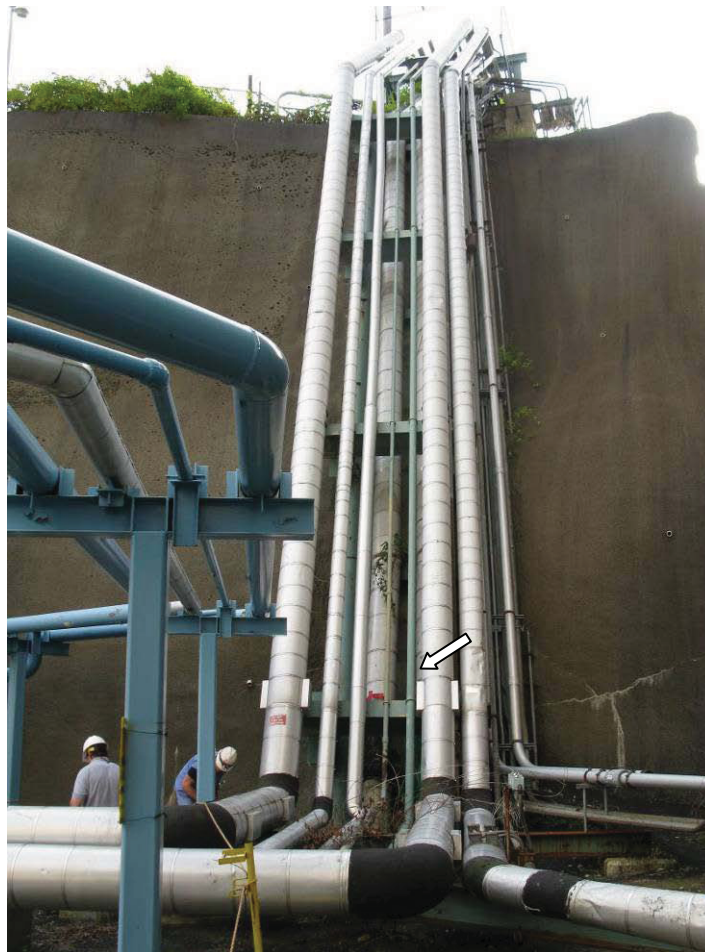
Figure 3.19: Location 6, 12-inch Line from CST to AFP Building

Figure 3.19 shows Location 6 on a 12-inch line from condensate storage tank to the AFP building at the bottom of the hill.

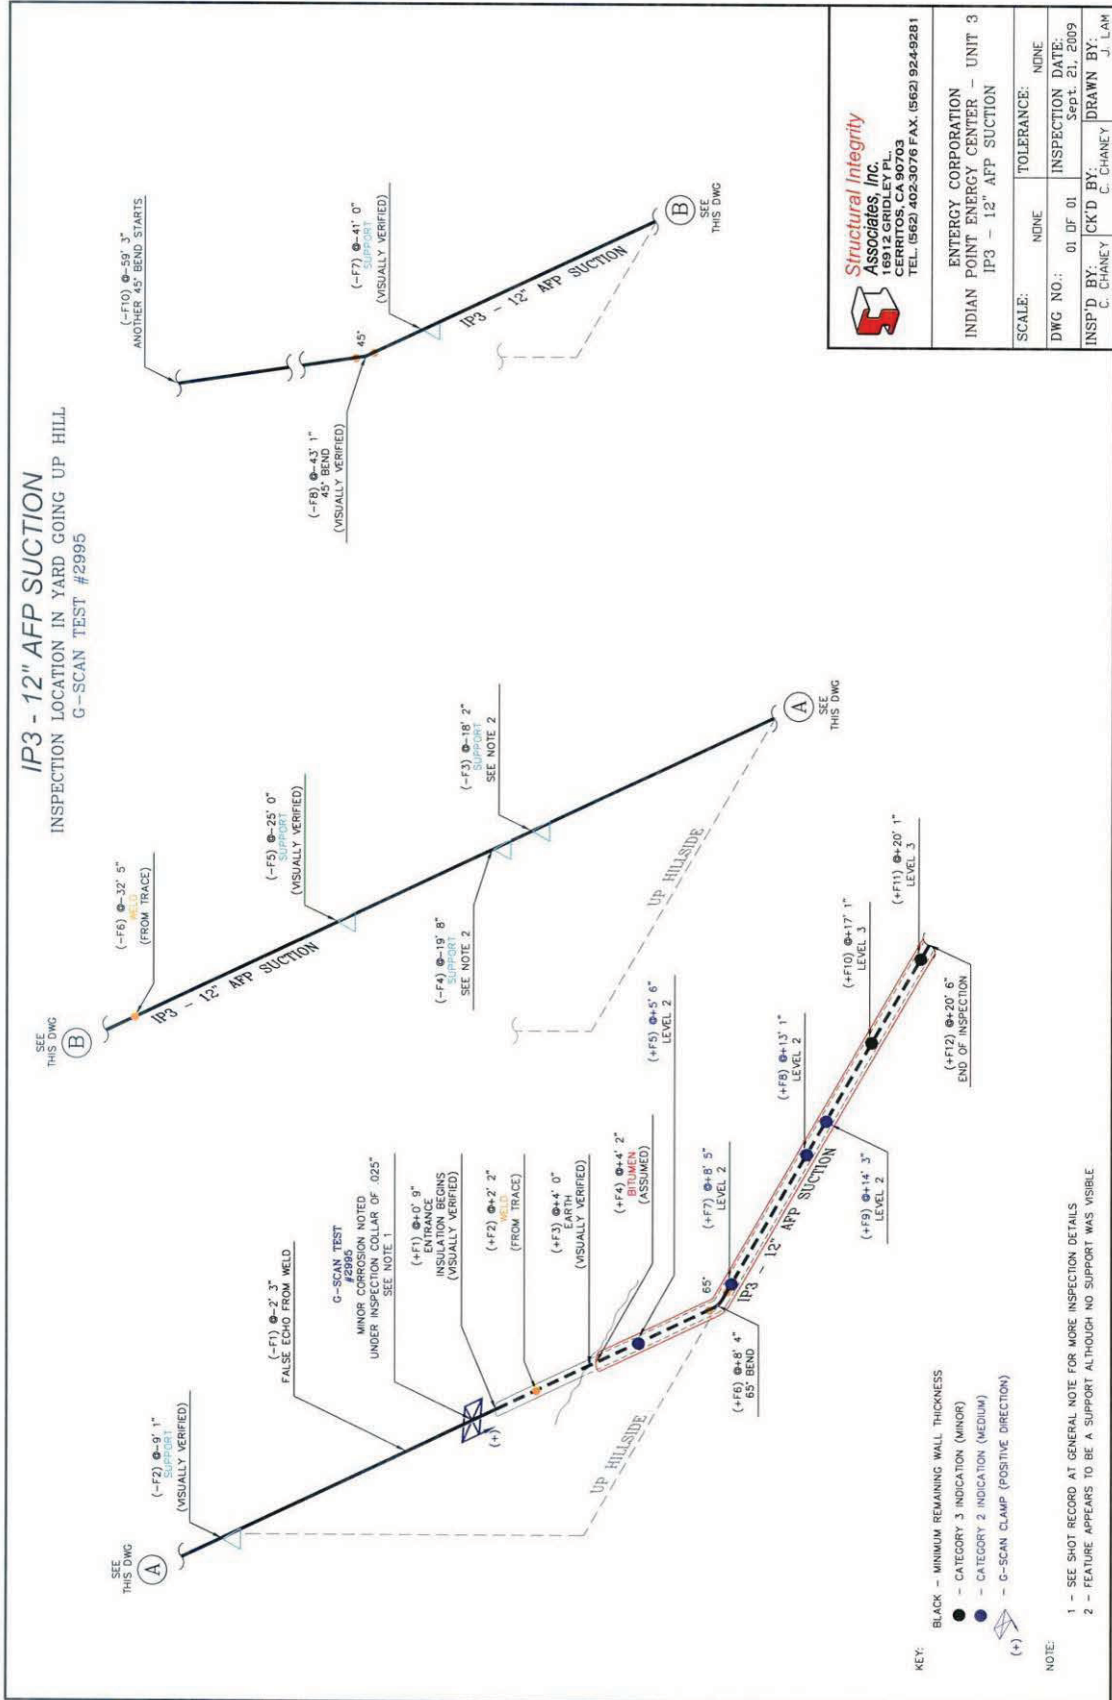
Figure 3.21: Location 6, Test Results from Shot 2995

Test ID: G3-76#2995 Pipe: IP3 - 12" AFW Suction Site: Indian Point Location: Earth +3'11" Size: 12 inch (.250") Tested: 23 Sept 2009 Tested by: Craig Chaney				Ring: R2B12(1368) Configuration: 8.4FR, T(0,1) Calibration: Automatic (2571.19 mV) Version: 3.97, Wavemaker G3-76 Client: Indian Point Procedure: GU 1.1 DACs: Call=10%, Weld=23%			
Summary: IP3 - 12" AFP Suction shot taken in the yard going up the hill. Minor corrosion noted under the collars of 0.025". Several corrosion like indications were identified in the buried section of the pipe. These indications are categorized as a Level 2.							
Feature	Location	Class	Notes				
U1	-44'7"	End					
B1	-59'3"	45 deg Bend					
B2	-43'1"	45 deg Bend	Visually verified				
S1	-41'0"	Support	Visually verified				
W1	-32'5"	Weld	From trace				
S2	-25'0"	Support	Visually verified				
S3	-19'8"	Support	Feature appears to be a support although no support was visible
