United States Nuclear Regulatory Commission Official Hearing Exhibit	
In the Matter of: Entergy Nuclear Operations, Inc. (Indian Point Nuclear Generating Units 2 and 3)

ENTERGY	ENGINEERING STANDARD	EN-EP-S-002-MULTI	REV. 0
	Buried Piping and Tanks General Visual Inspection	PAGE 11 OF 12

Piping / Tank	10-inch City Water/Fire Water Line at the IP2 Maintenance Training Facility (MTF)	INSPECTION DATE:	11/23/09
ELEVATION: 120' EL. (approx. grade)	LOCATION DWG: NYPA-3899-G-202-0, zone C-11	INSPECTOR:	R. Allen

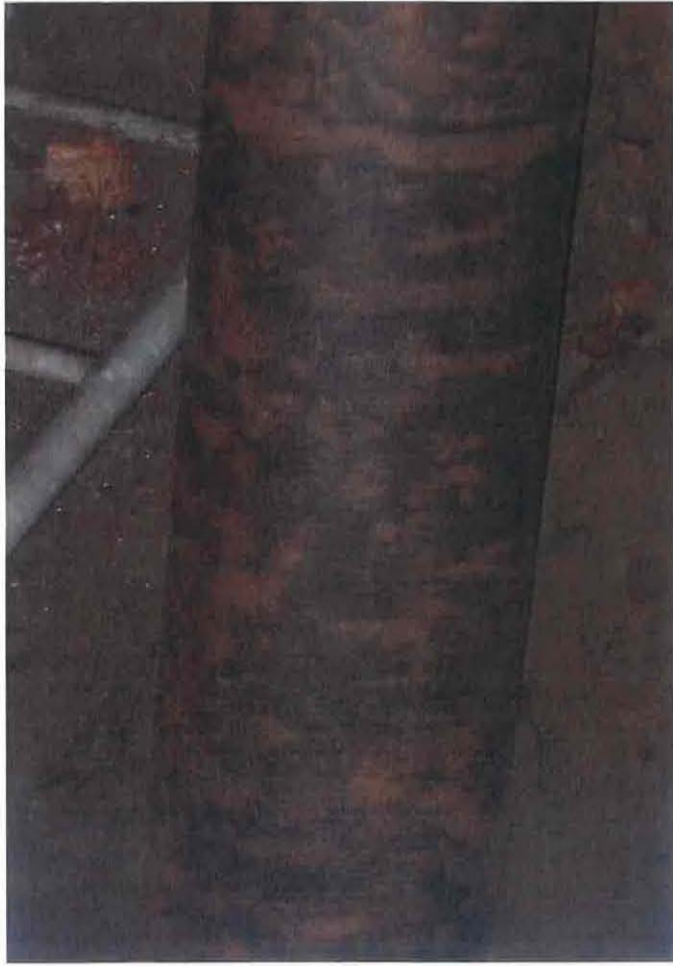
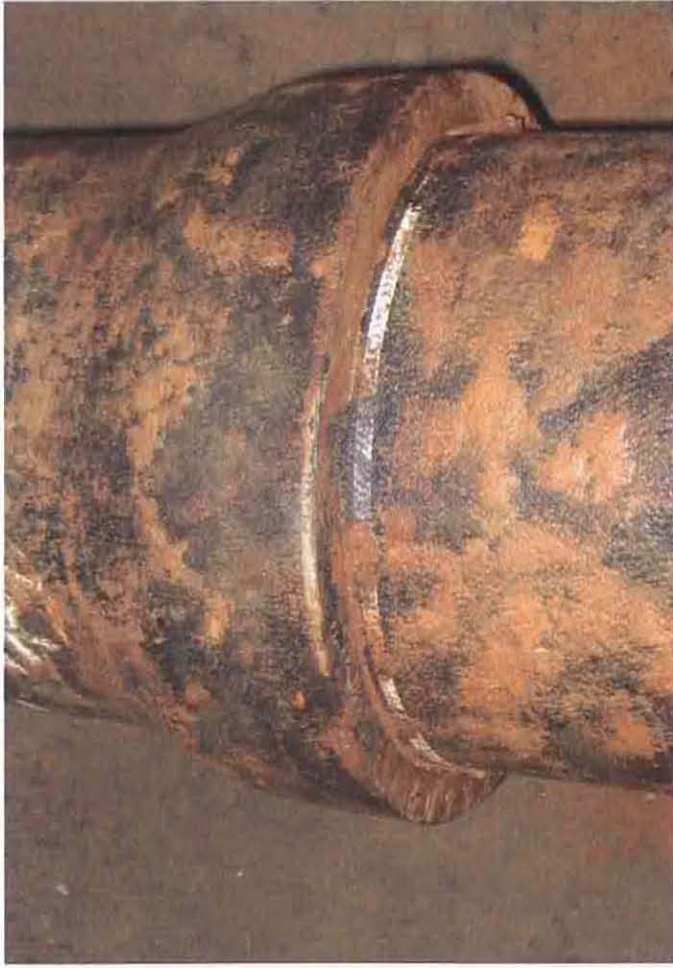
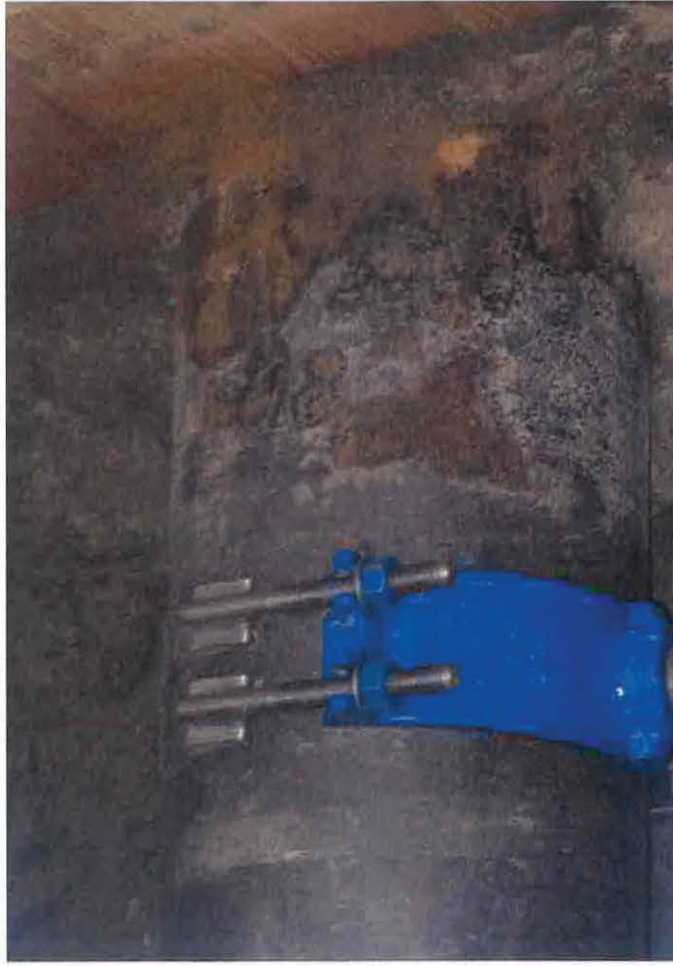
GENERAL APPEARANCE (Inspector): See attached photo documentation. Piping at the installed saddle (west) end of the excavation was relatively clean of soil adhering to the OD of the pipe, without requiring much cleaning. The east end of the piping required use of a water spray bottle to wet and clean off the hardened red clay-like soil adhering to the pipe OD to get to the pipe exterior. The pipe was coated with a painted on protective coating, which was observed to be in very good condition with no signs of discontinuities, peeling, separation, blistering, flaking, etc.

COMMENTS (Inspector): Opportunistic inspection of underground 10-inch fire water main running from Broadway in Westerly direction to the Interim Radwaste Storage Facility. Section of line on the south side of the Maintenance Training Facility (MTF) excavated as part of installation of a 1-inch tie-in to supply water to the MTF. (Ref. EC 13314). Approx. 8 foot length of piping was inspected. Section included a bell & spigot piping joint, and new saddle for a 1-inch branch supply to the MTF. Pipe in very good condition, no deficiencies noted.

10" City Water / Fire Line to Tipton Waste Storage Facility. Orangeish - mat' on pipe OD was hardened red-clay-like soil, which could be removed w/ water spray + light wiping.
