United States Nuclear Regulatory Commission Official Hearing Exhibit	
In the Matter of:	Entergy Nuclear Operations, Inc. (Indian Point Nuclear Generating Units 2 and 3)

ATTACHMENT 7.1

INSPECTION CHECKLIST

Piping / Tank	16-inch City Water Line from CWST	INSPECTION DATE:	10/21/09
ELEVATION: 120' EL. (approx. grade)	LOCATION DWG: 138057, zone D-5	INSPECTOR:	J. Peterson

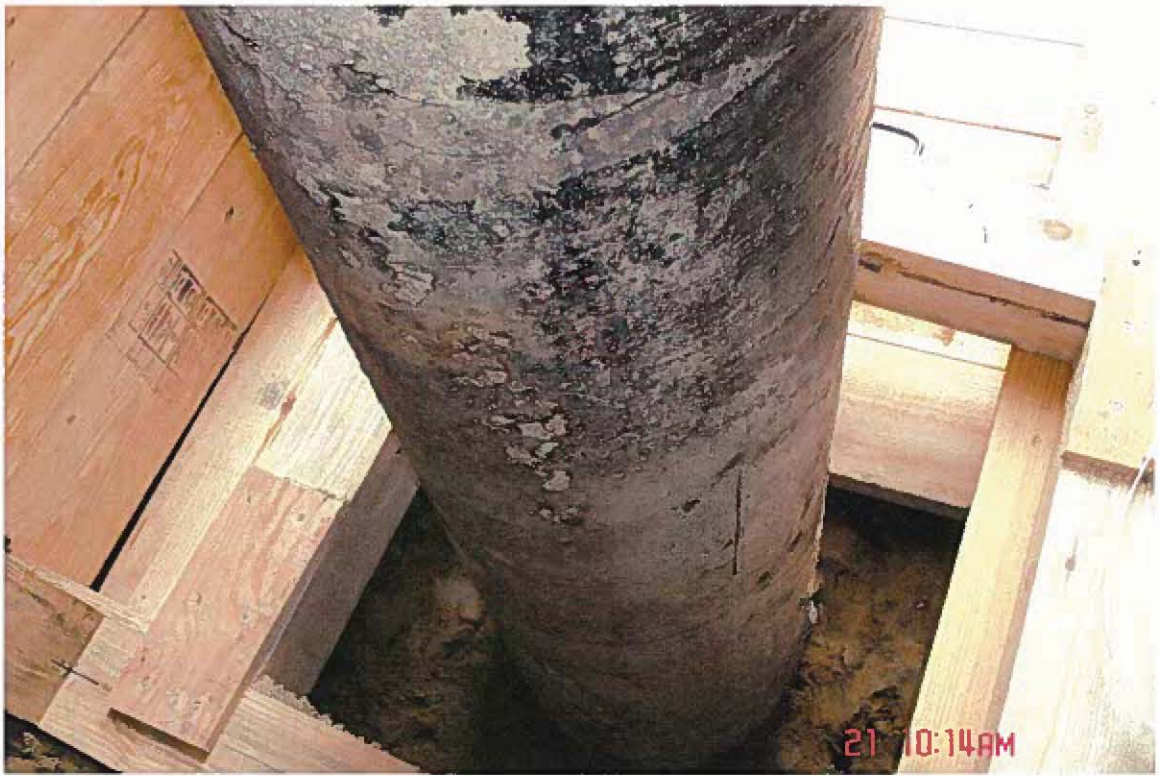
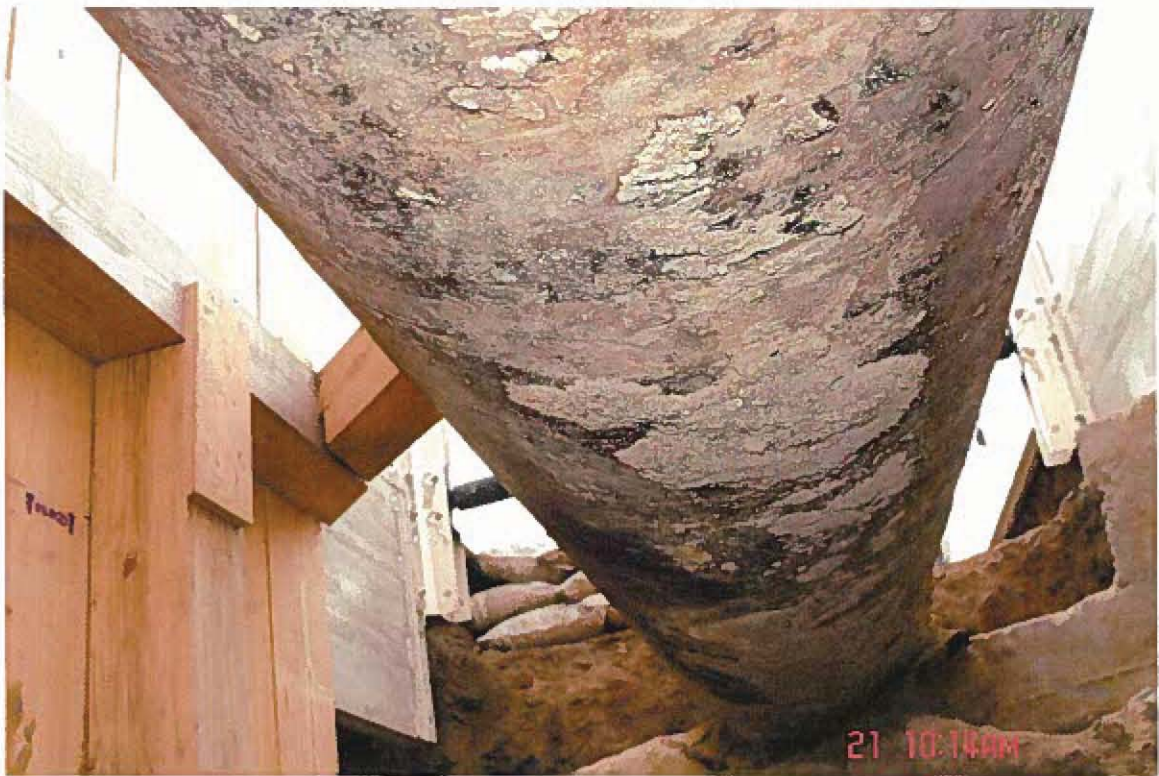
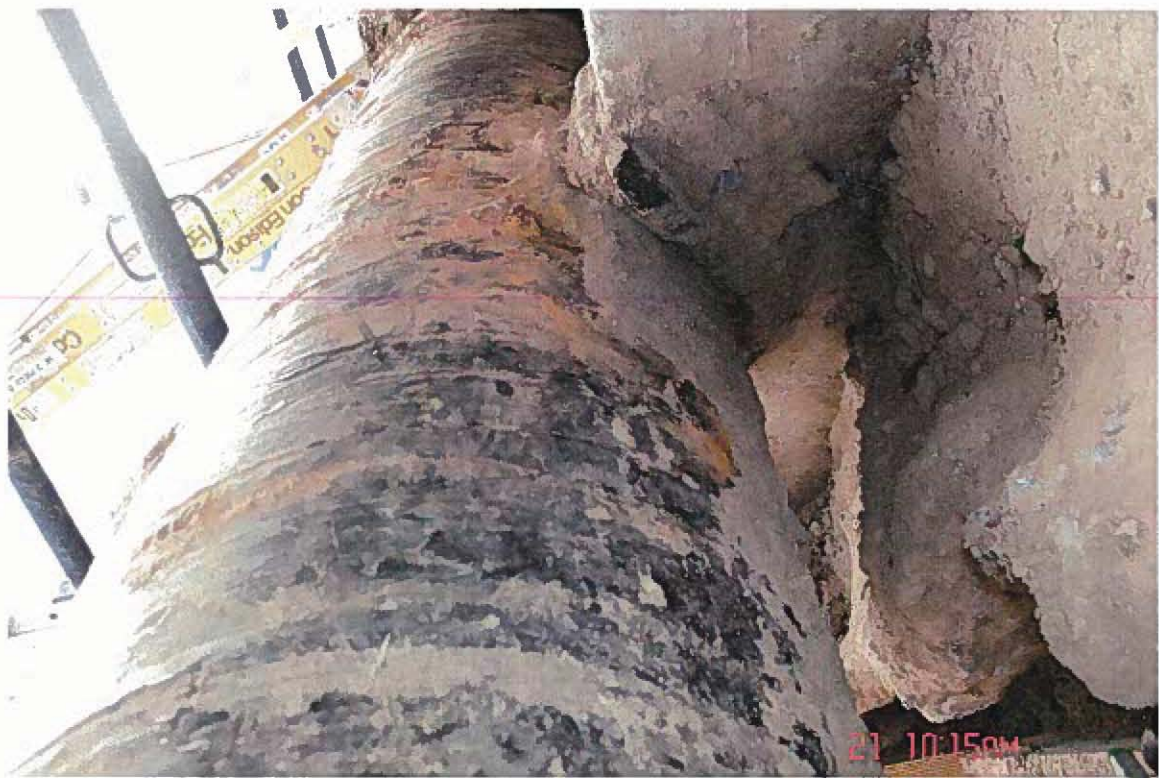
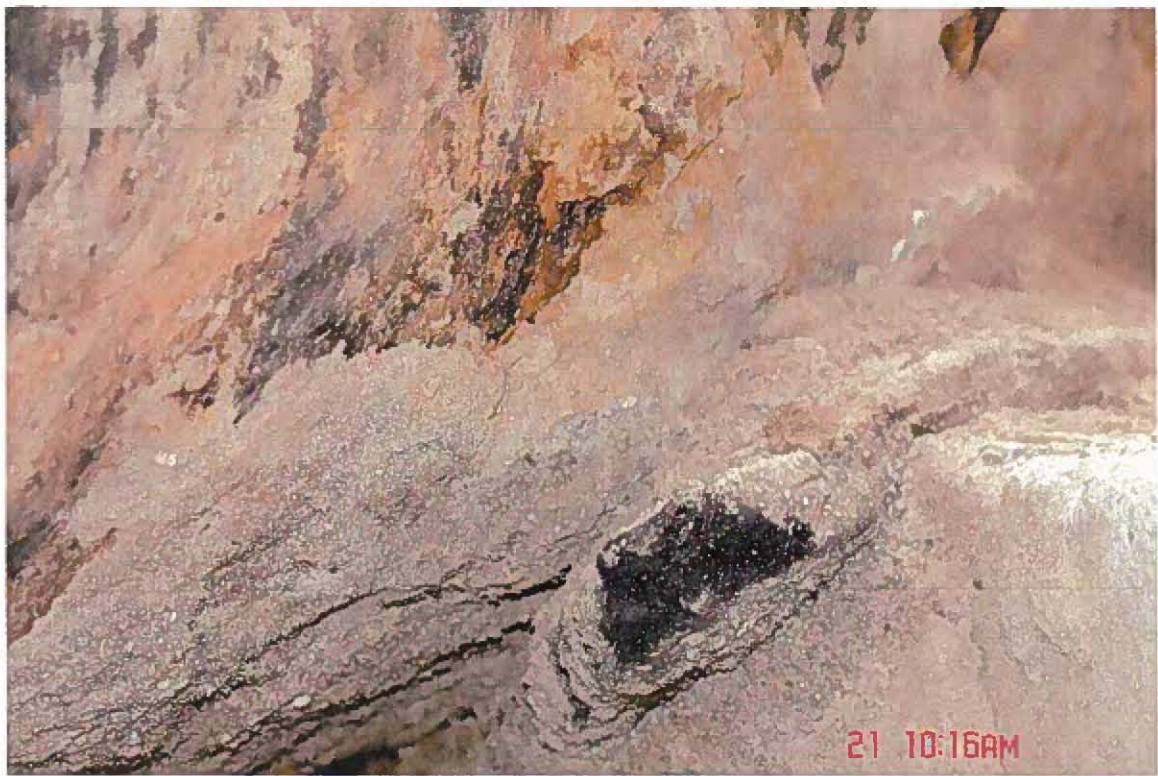
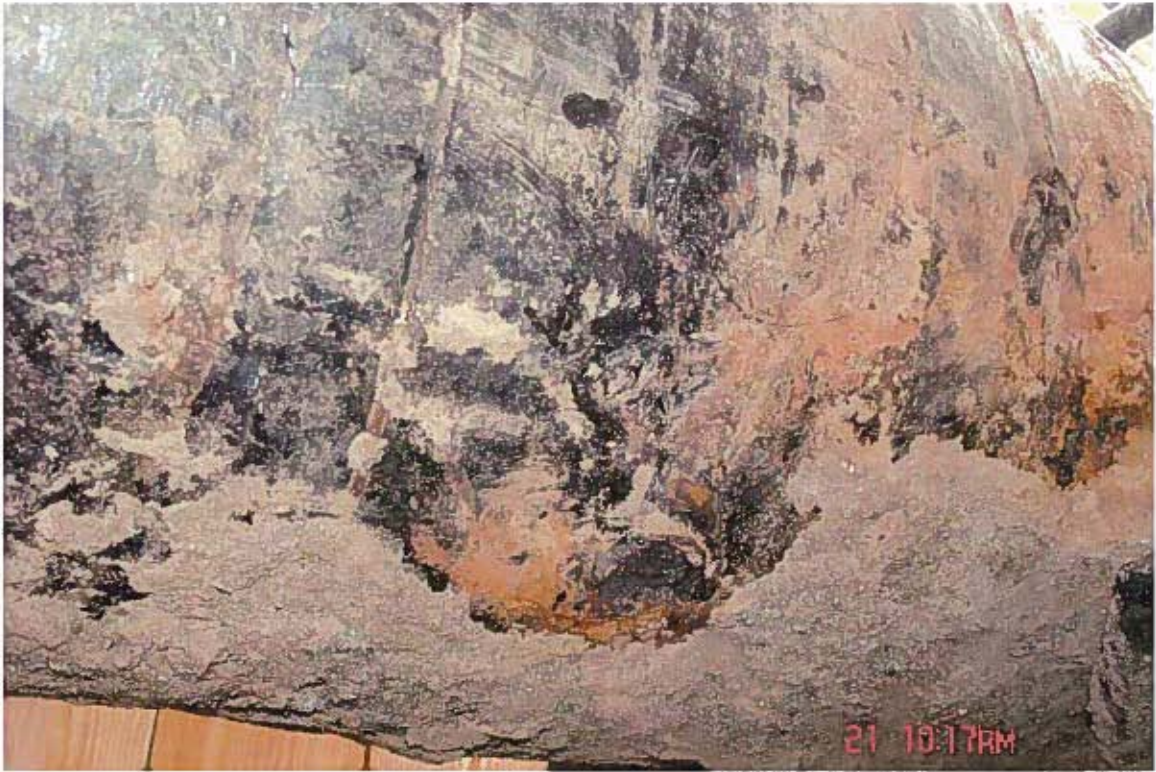
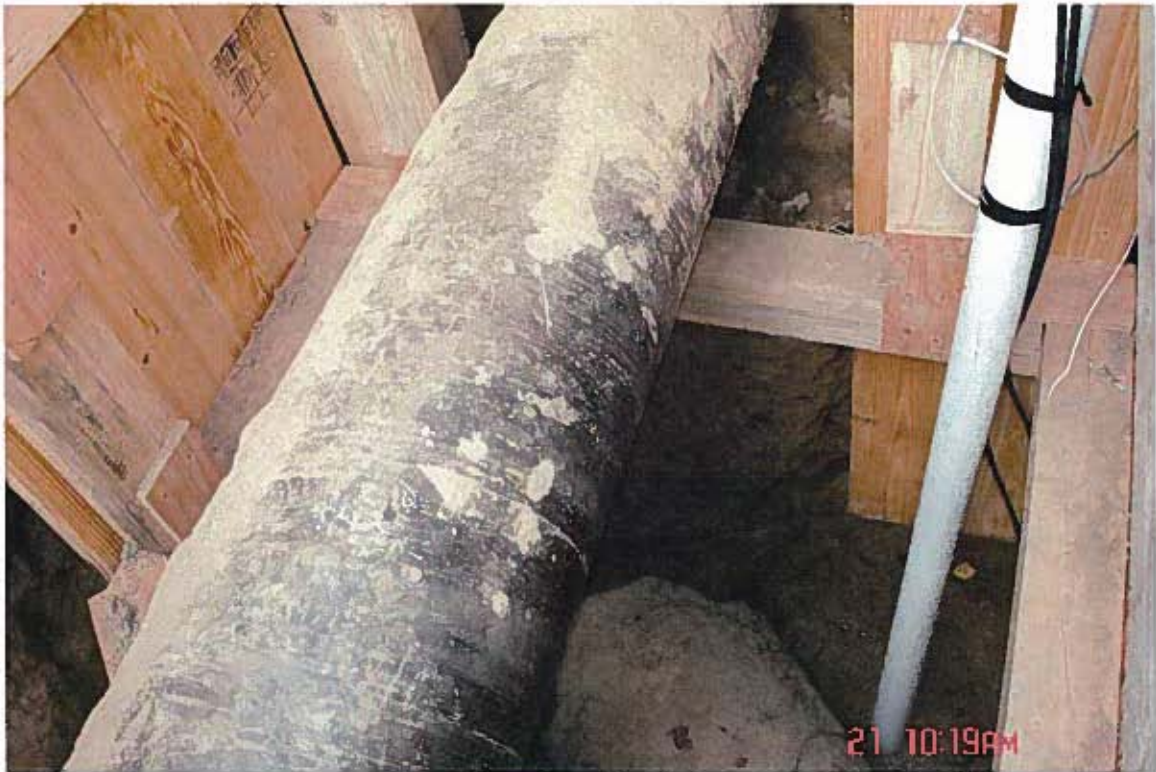
16-INCH-LINE-FROM-  
CWST-102109 025.jpg

GENERAL APPEARANCE (Inspector): The entire lengths of the excavated 16-inch city water piping (2 places) was inspected and determined to be in good condition, with the external coating and wrap intact. No evidence of coating degradation was observed. See attached photo documentation.
