Seismic Walkdown Checklist (SWC)

Project: Byron 1 SWEL

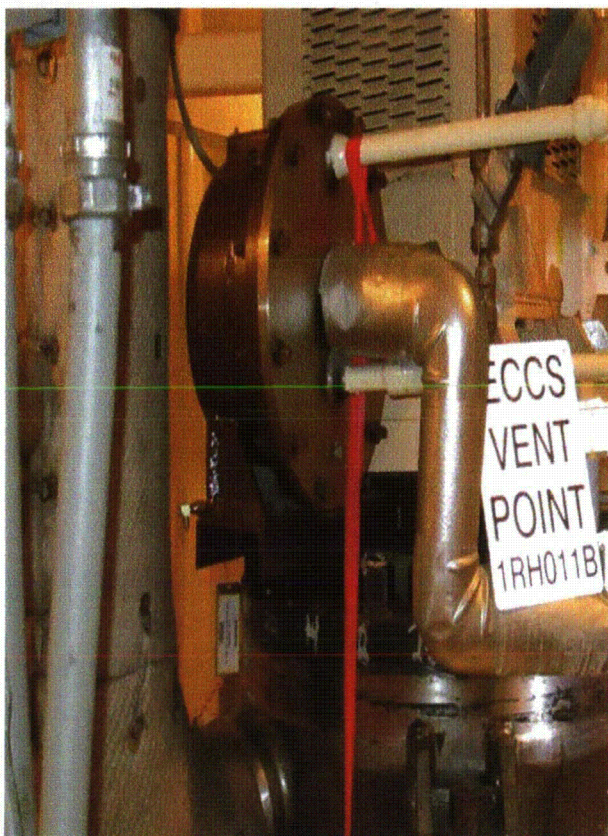
1RH01PB-A Byron 1 & 2 8-21-12 035

11. Have you looked for and found no adverse seismic conditions that could adversely affect the safety functions of the equipment? Yes
No structural/seismic issues

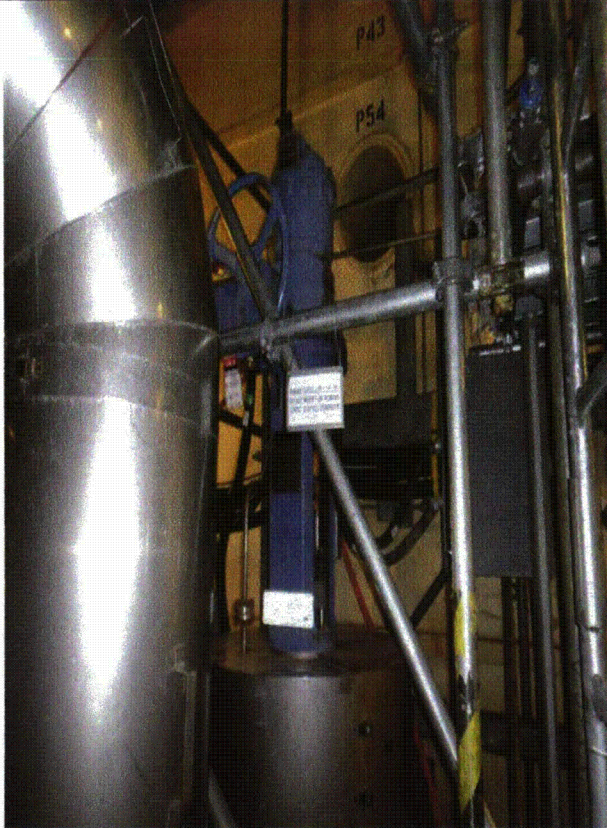
1RH8702A BYRON 021

1. Is anchorage configuration verification required (i.e., is the item one of the 50% of SWEL items requiring such verification)? No
2. Is the anchorage free of bent, broken, missing or loose hardware? Yes
3. Is the anchorage free of corrosion that is more than mild surface oxidation? Yes
4. Is the anchorage free of visible cracks in the concrete near the anchors? Yes
5. Is the anchorage configuration consistent with plant documentation? (Note: This question only applies if the item is one of the 50% for which an anchorage configuration verification is required.) Not Applicable
6. Based on the above anchorage evaluations, is the anchorage free of potentially adverse seismic conditions? Yes
Tank anchorage consists of pipe trunnions welded to embedded plates on pressurizer coffin wall and is judged acceptable.

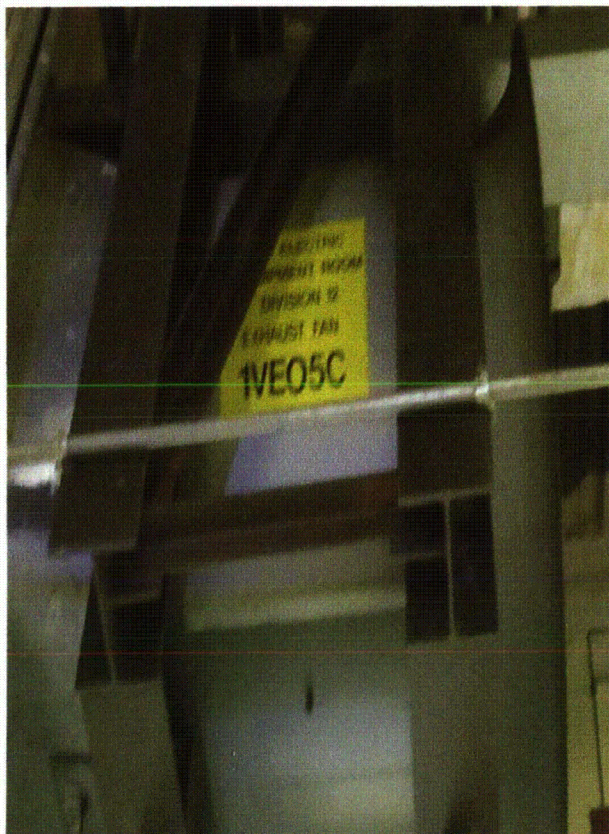
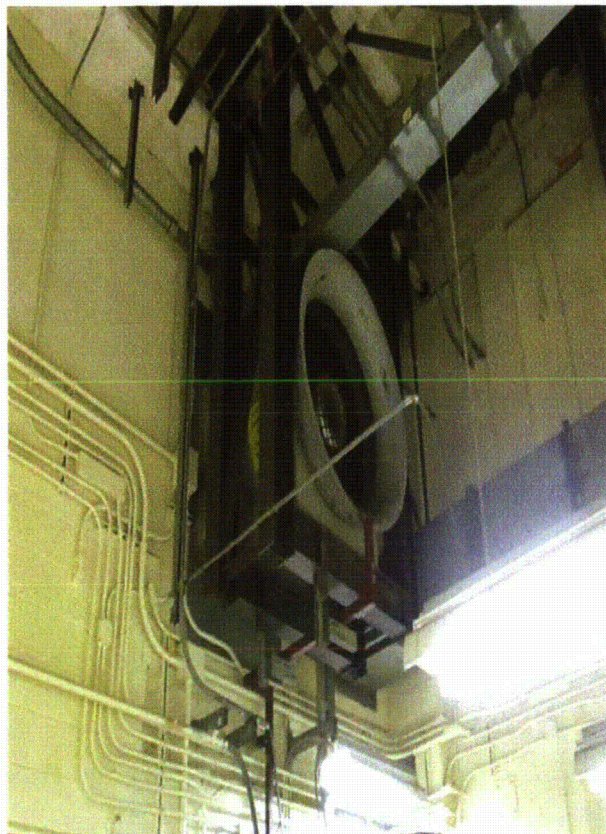
1. Is anchorage configuration verification required (i.e., is the item one of the 50% of SWEL items requiring such verification)? No
2. Is the anchorage free of bent, broken, missing or loose hardware? Yes
3. Is the anchorage free of corrosion that is more than mild surface oxidation? Yes
4. Is the anchorage free of visible cracks in the concrete near the anchors? Yes
5. Is the anchorage configuration consistent with plant documentation? (Note: This question only applies if the item is one of the 50% for which an anchorage configuration verification is required.) Not Applicable
6. Based on the above anchorage evaluations, is the anchorage free of potentially adverse seismic conditions? Yes
Fan is anchored at ceiling, well-supported and acceptable.

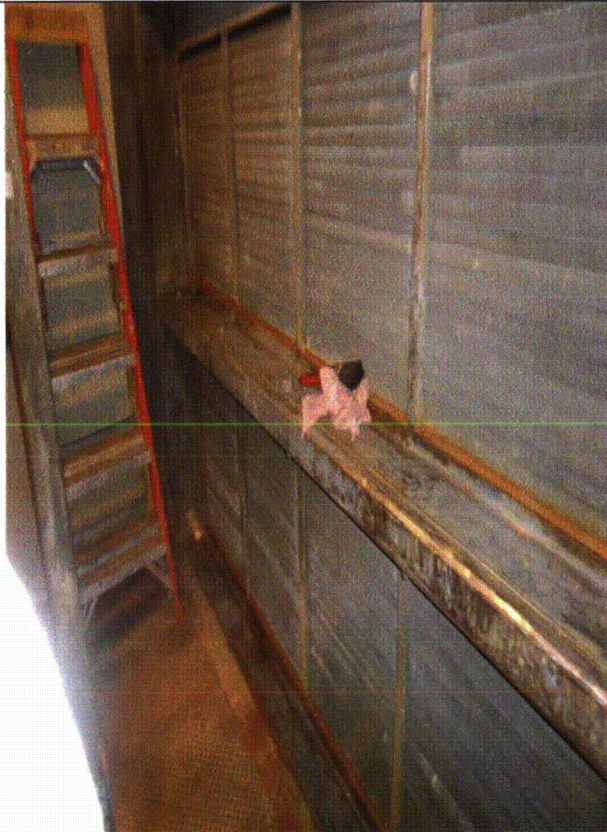
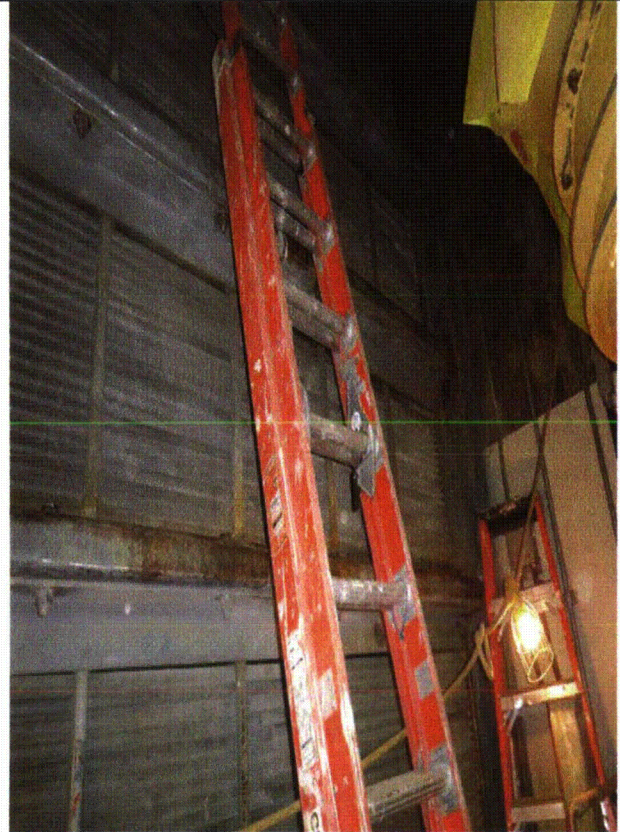
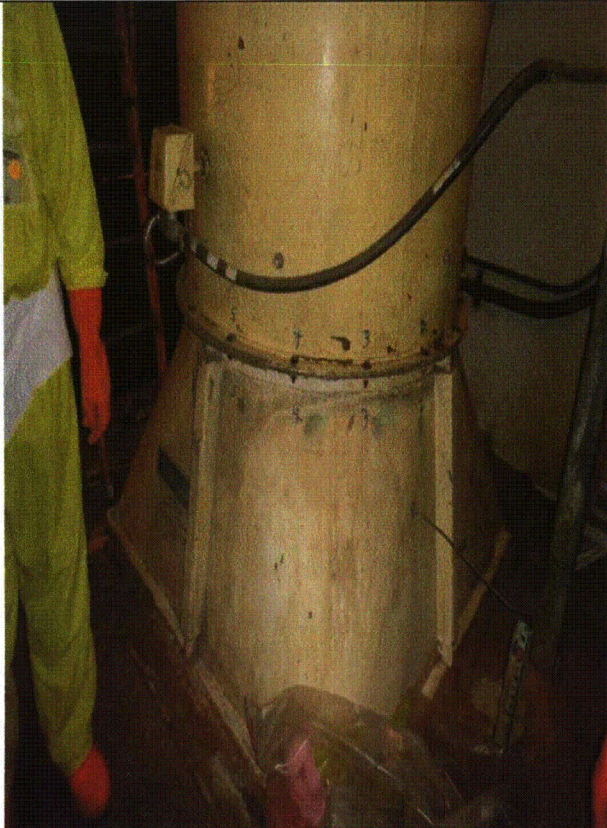
7. Are soft targets free from impact by nearby equipment or structures? Yes
8. Are overhead equipment, distribution systems, ceiling tiles and lighting, and masonry block walls not likely to collapse onto the equipment? Yes
Masonry walls are seismic and would not collapse on equipment
9. Do attached lines have adequate flexibility to avoid damage? Yes
10. Based on the above seismic interaction evaluations, is equipment free of potentially adverse seismic interaction effects? Yes
