ATTACHMENT 9.6

SEISMIC WALKDOWN CHECKLIST FORM

IP3

Seismic Walkdown Checklist (SWC) SWEL1-092

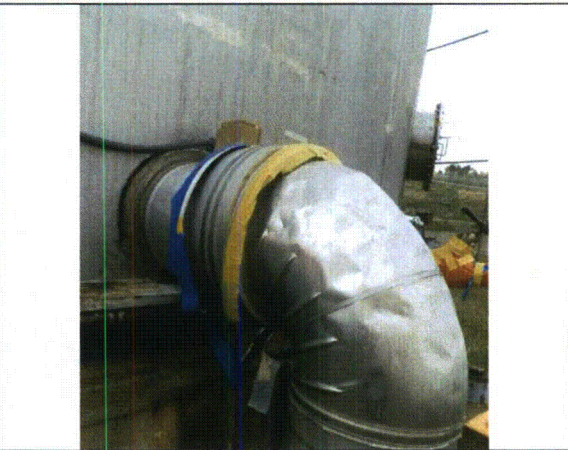
**Note:** Piping insulation connection held with tape.

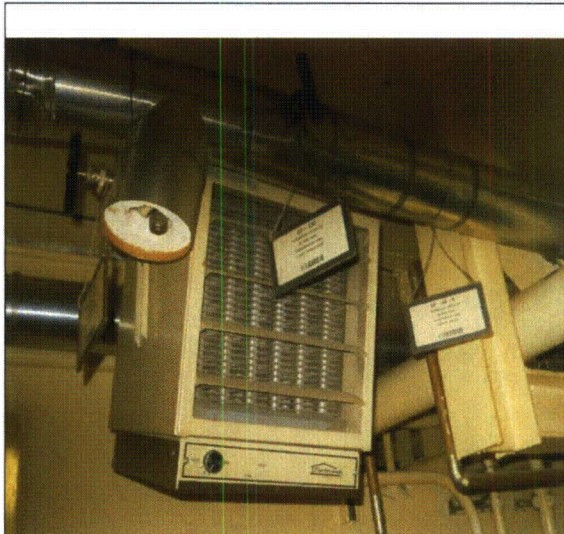
**Note:** Pipe insulation interference with heater.

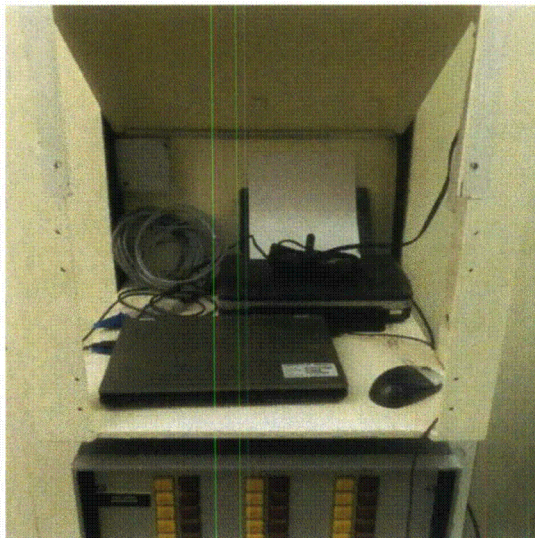
**Note:** Rack adjacent to Instrument Bus 31 has an unrestrained laptop and printer

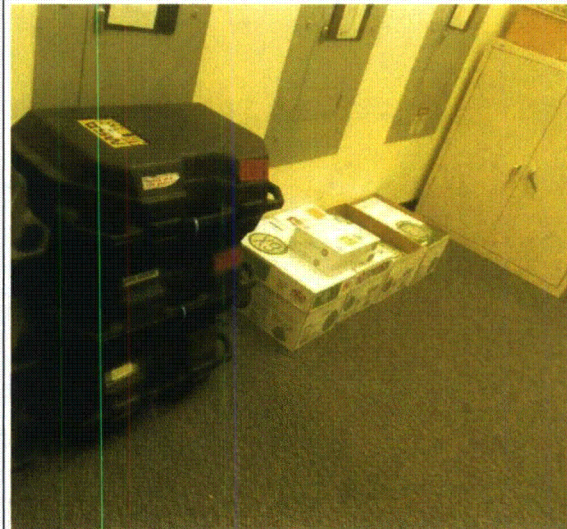
**Note:** Boxes against the west wall on the floor and a box resting on top of a cabinet at the northwest corner of the room

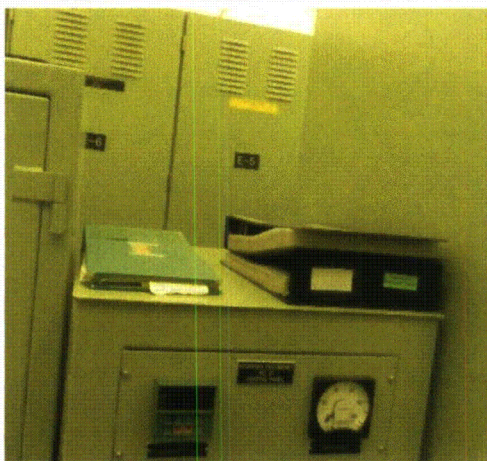
**Note:** unrestrained binders on top of Hydrogen Recombiner No. 31 Control Panel
