**ATTACHMENT 9.7**

**AREA WALK-BY CHECKLIST**

IP3

**Area Walk-By Checklist (AWC)** AWC-020

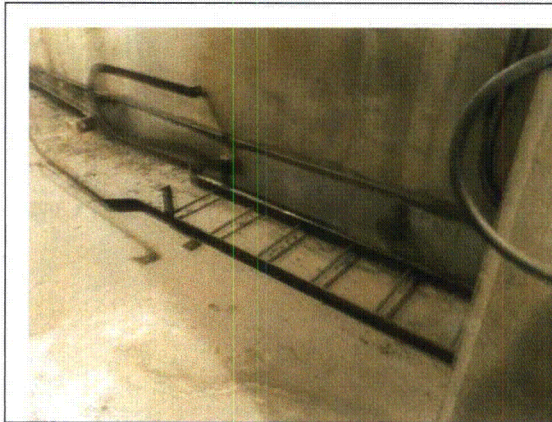
**Note:** unrestrained ladder by the north wall.

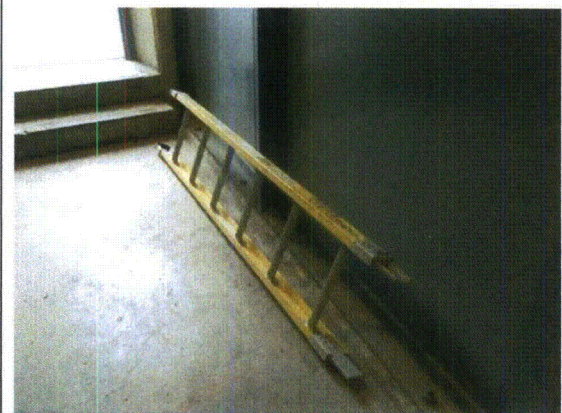
**Note:** unrestrained ladder by the door at the south corner of the room.

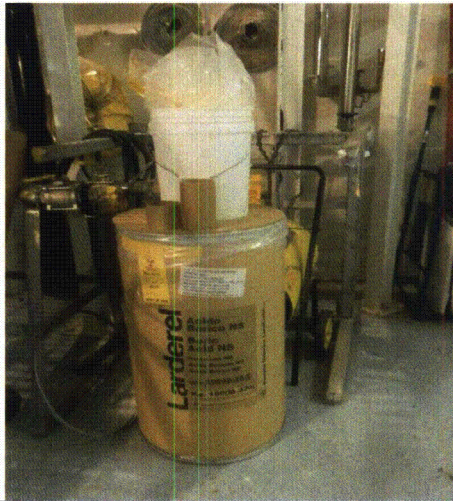
**Note:** Waste bucket on top of a Boric Acid container

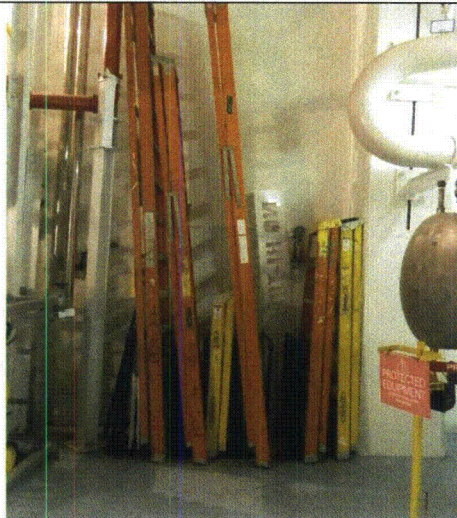
**Note:** Unrestrained ladders in a rack
