Status: Y ☒ N ☐ U ☐**Seismic Walkdown Checklist (SWC)**Equipment ID No. 1P70-A002B Equip. Class¹ 0Equipment Description Emergency N2 BottleLocation: Bldg. REACTOR Floor El. 130 Room, Area RL-R9

Status: Y ☐ N ☒ U ☐**Seismic Walkdown Checklist (SWC)**Equipment ID No. 1Z41-F009B Equip. Class¹ 0,7Equipment Description AIR-ACTUATED DAMPER B003B INLocation: Bldg. CONTROL Floor El. 180 Room, Area _____

Status: Y ☒ N ☐ U ☐**Seismic Walkdown Checklist (SWC)**Equipment ID No. 1E21-C001A Equip. Class¹ 5Equipment Description Core Spray Pump 1ALocation: Bldg. REACTOR Floor El. 87 Room, Area SE Diagonal

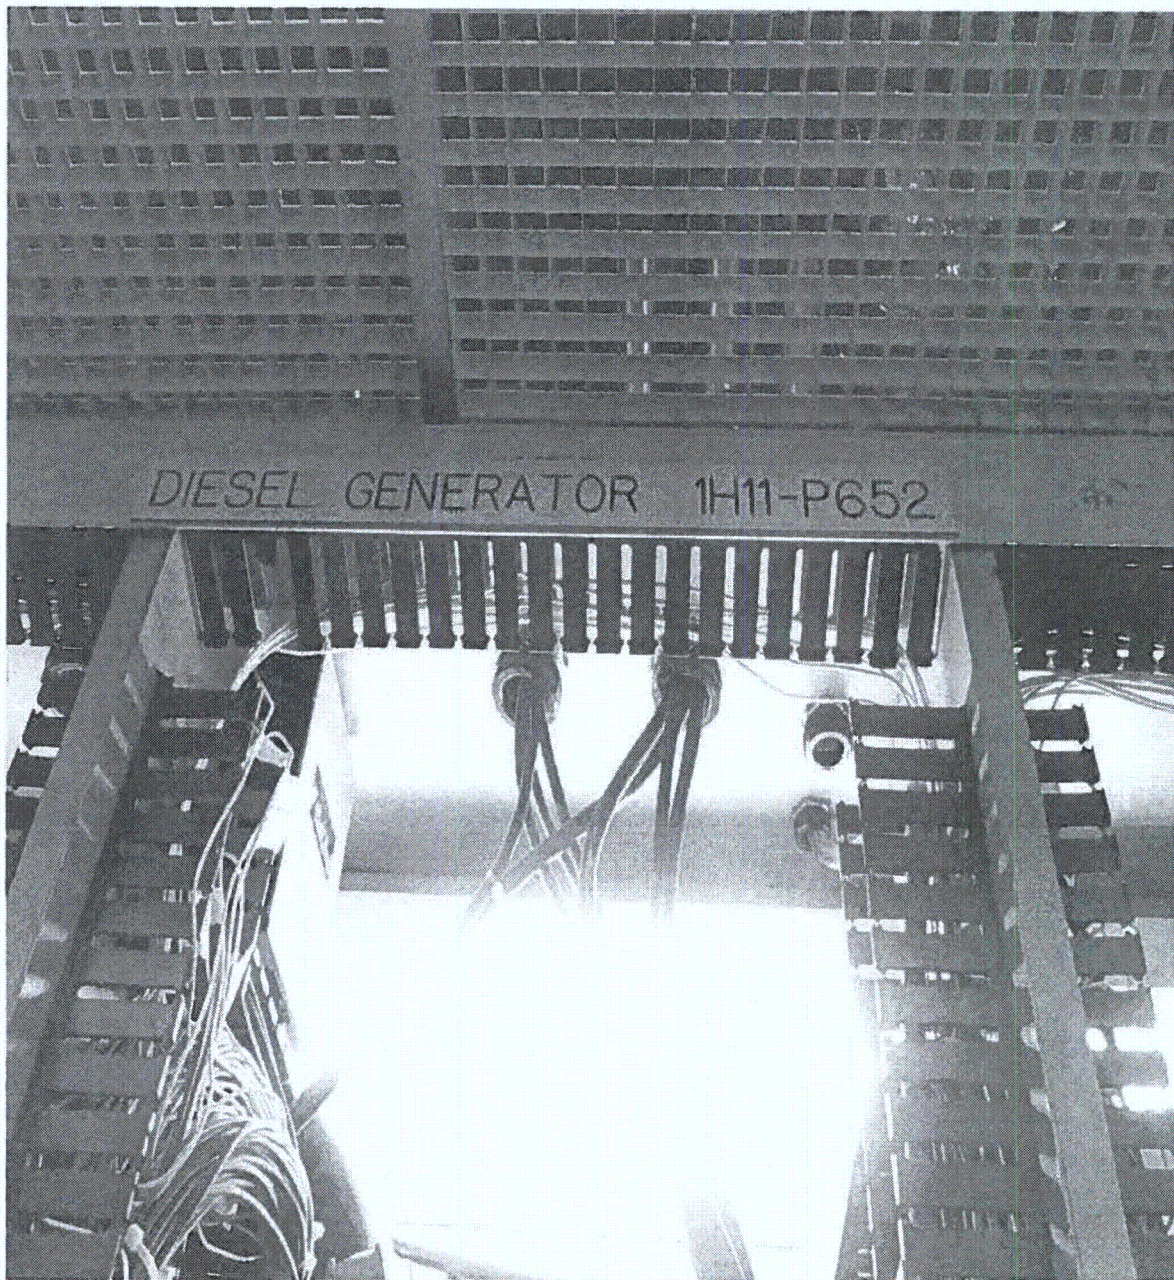
2: Equipment MPL# 1H11-P652 (back)

There were no bolts at rear vertical side connection of Panel 1-H11-P652 to Panel 1-H11-P651. Five bolts were intalled in the middle vertical support member. Also, the bottom bolt on the rear vertical side connection of Panel 1-H11-P652 to Panel 1-H11-P600 does not have full thread engagement. Only approximately 2 threads are engaged in the nut (See Picture #3). All other bolts were properly installed. The details of these connections are not specified in the available design documents. Per review of the SEWS package, the panel weight is conservatively approximated to be 8300lbs. The maximum horizontal acceleration of the panel is 0.75g. The evaluation included in the SEWS package concluded that the floor anchors have sufficient capacity to resist the maximum horizontal acceleration. Therefore, the bolts which connect the panels are required to only restrain the cabinets so that there is no differential movement and consequent banging of the panels.
