Seismic Walkdown Checklist (SWC)

Equipment ID No. Q2R16B006-A, Pkg F2-110 Equip. Class¹ 2

Equipment Description 600V LOAD CENTER 2D

UNIT 2 – AREA WALK-BY CHECKLISTS (AWCs)

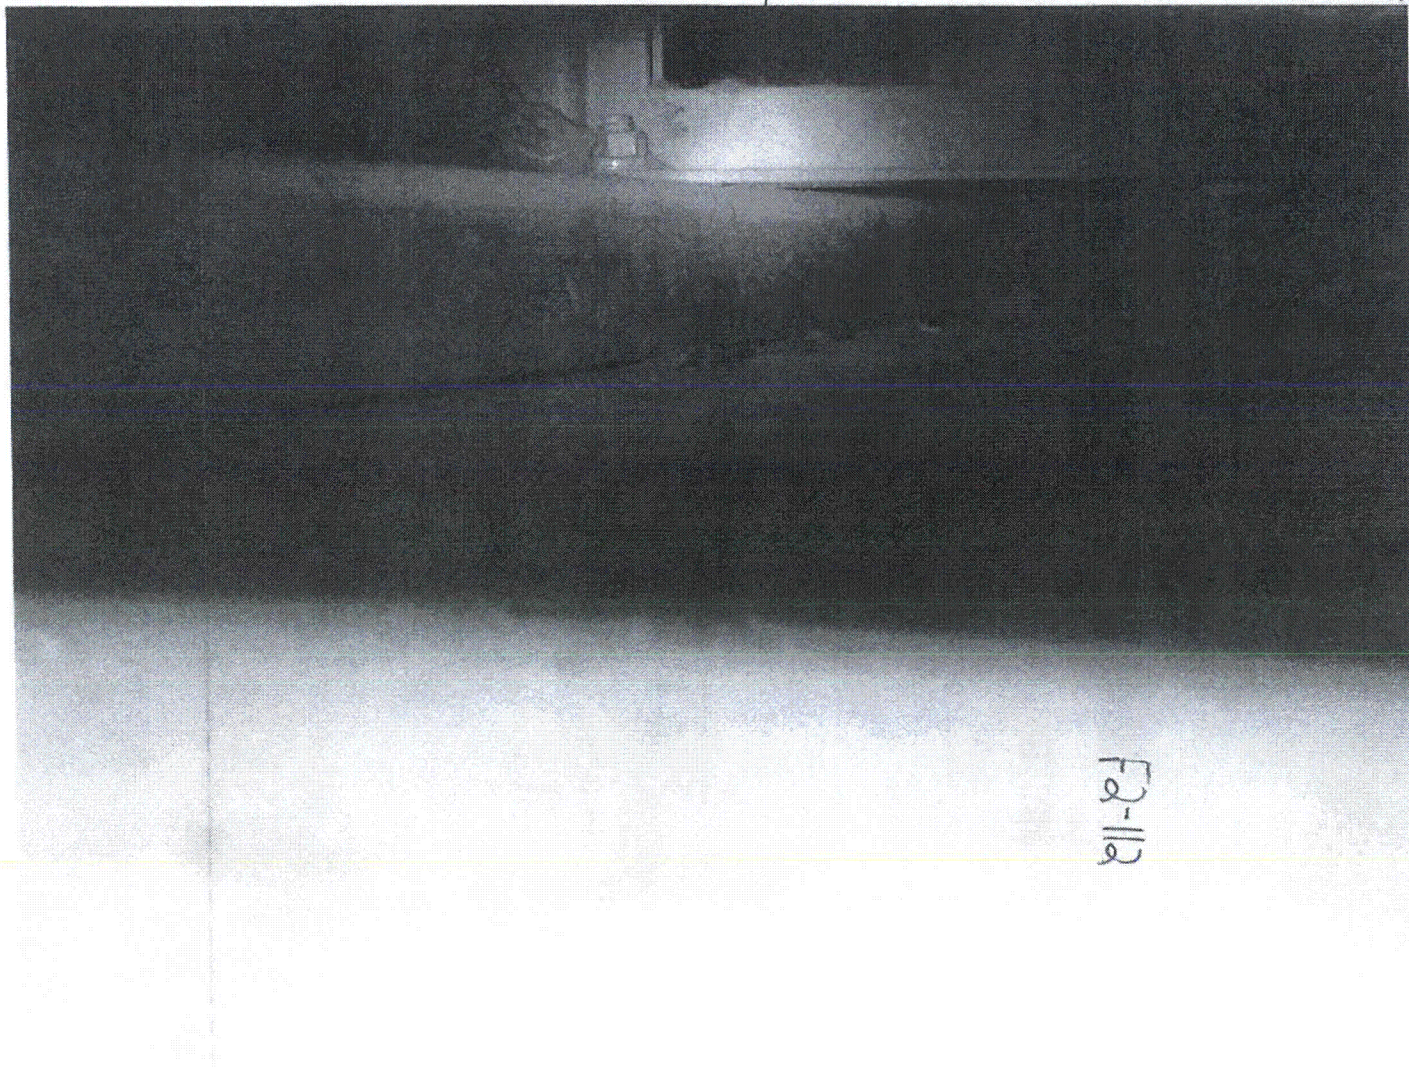
F2-113

2. Is the anchorage free of bent, broken, missing or loose hardware? Y N U N/A
Component welded to channel welded to embedded plate. Welds inspected for cracks, corrosion and other potentially adverse seismic conditions.

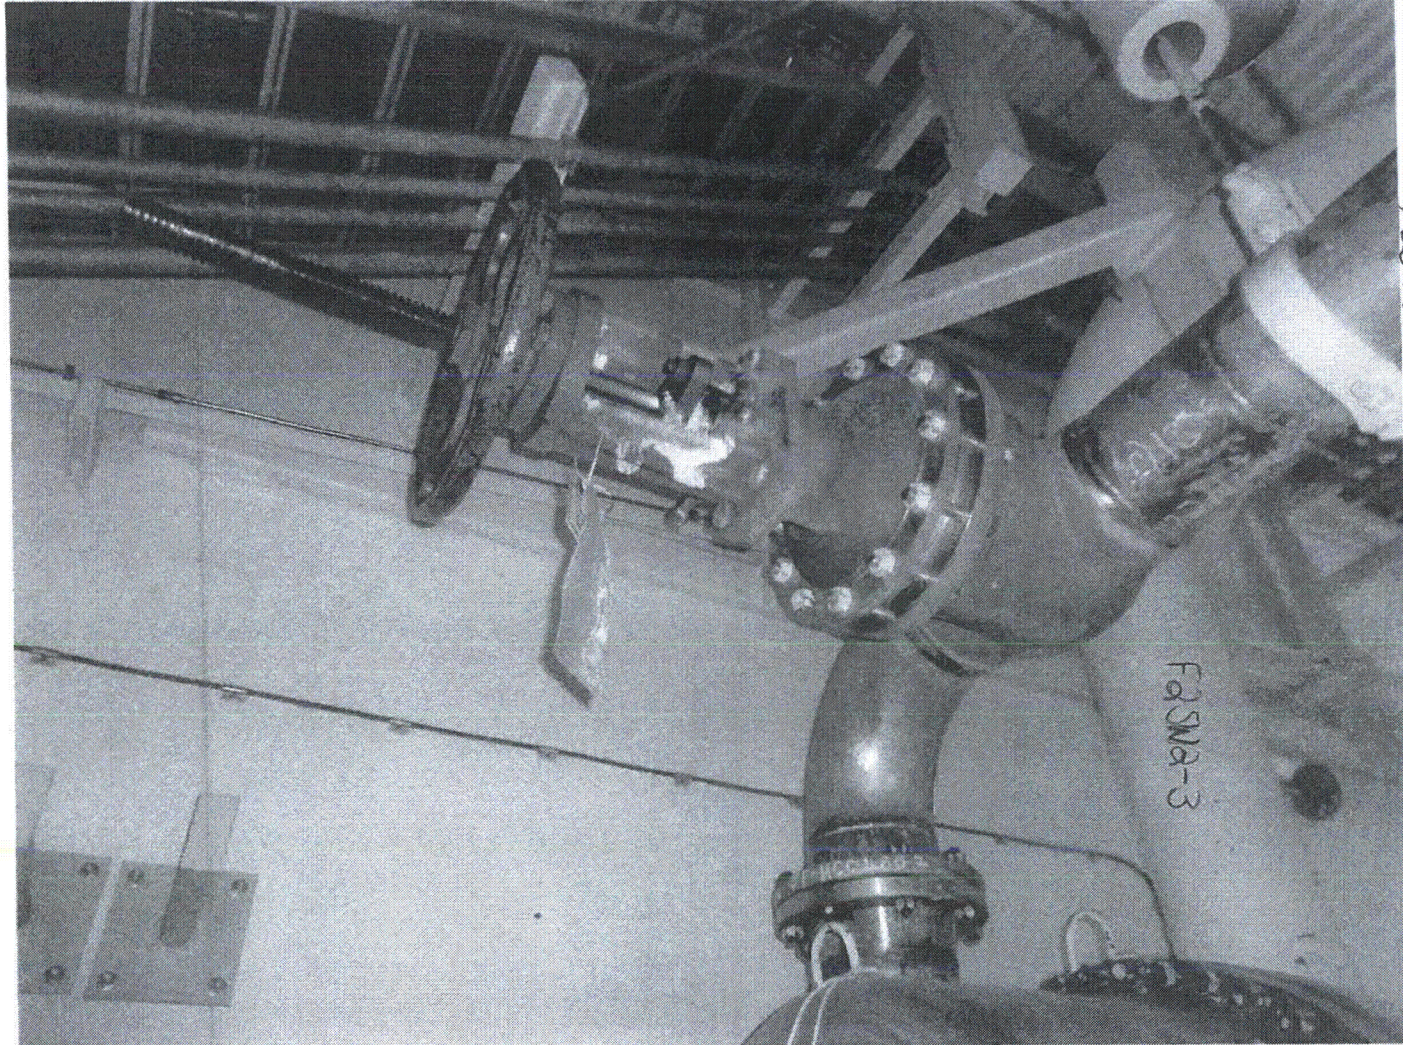
F25W2-A

1. Is the anchorage configuration verification required (i.e., is the item one of the 50% of SWEL items requiring such verification)? Y N
u-line valve, no anchorage.
2. Is the anchorage free of bent, broken, missing or loose hardware? Y N U N/A
3. Is the anchorage free of corrosion that is more than mild surface oxidation? Y N U N/A
4. Is the anchorage free of visible cracks in the concrete near the anchors? Y N U N/A
5. Is the anchorage configuration consistent with plant documentation? (Note: This question only applies if the item is one of the 50% for which an anchorage configuration verification is required.) Y N U N/A
6. Based on the above anchorage evaluations, is the anchorage free of potentially adverse seismic conditions? Y N U
