Area Walk-By Checklist (AWC)

Area 1AB-1g Floor El. 574 Bldg. AX

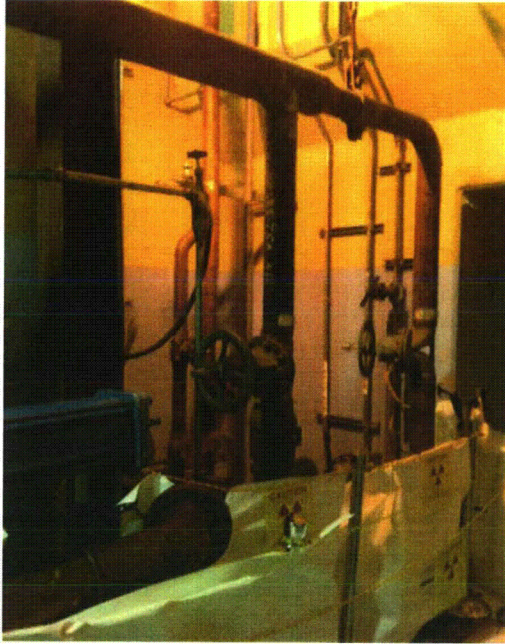
File Name: 1-68-3-1-18.jpeg
Description: Rod Hung Sump Pump Piping

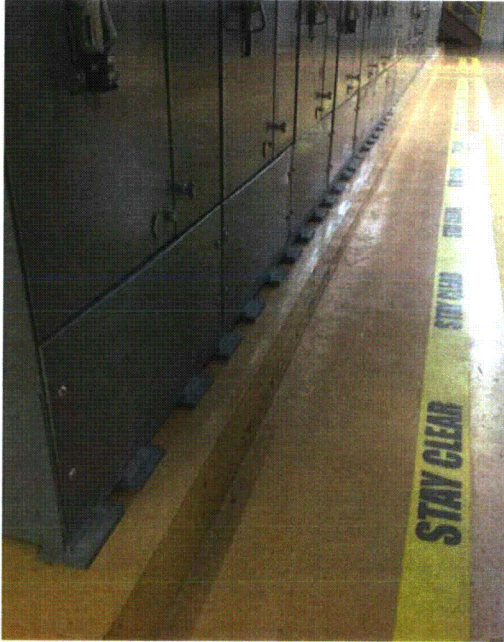
File Name: 1-68-1-1-06.jpeg
Description: View of MCC EF1C07 anchorage (1R24-S0023)

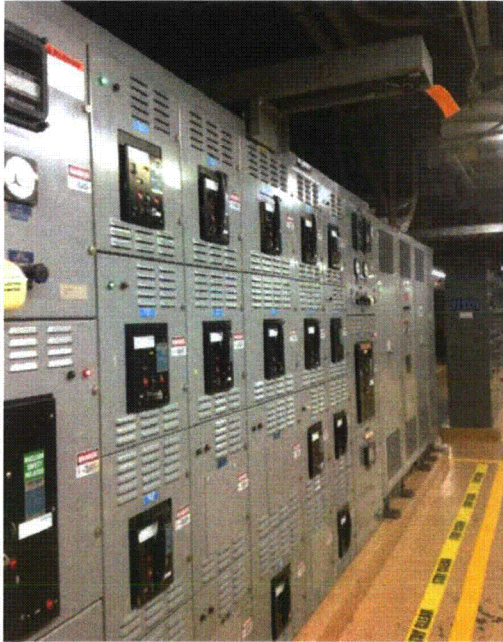
File Name: 1-74-1-1-06.jpeg
Description: View of trolley on top of Cabinet

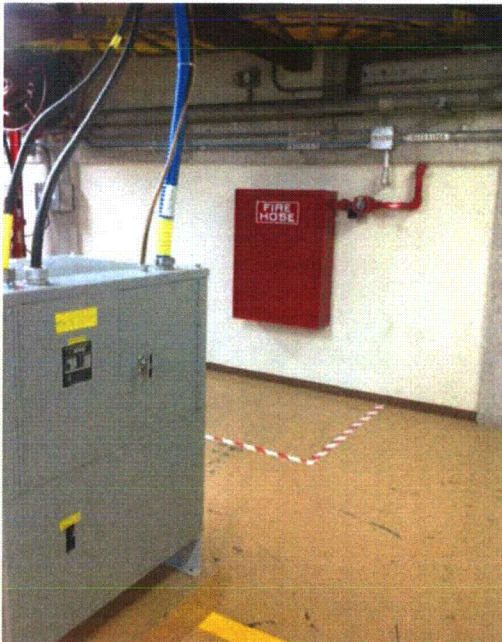
A fire protection valve near components was observed to be adequately supported. Fire protection piping throughout room is CO2. No concerns identified regarding flood sources.

File Name: 1-67-3-1-06.jpeg
Description: Fire protection valve near transformer judged to be adequately supported

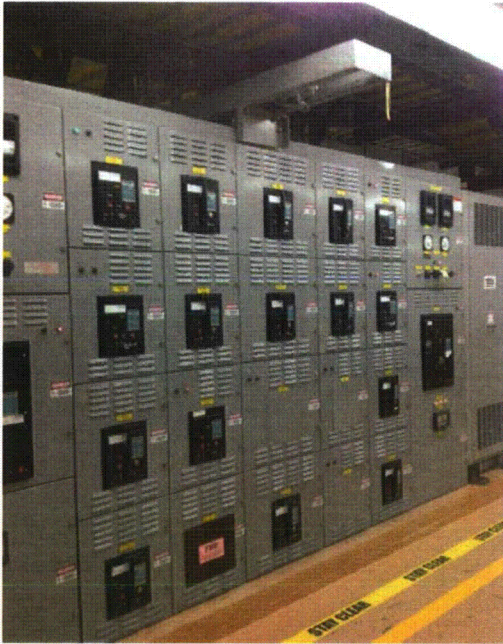
File Name: 1-71-3-1-06.jpeg
Description: View of trolley on top of Cabinet

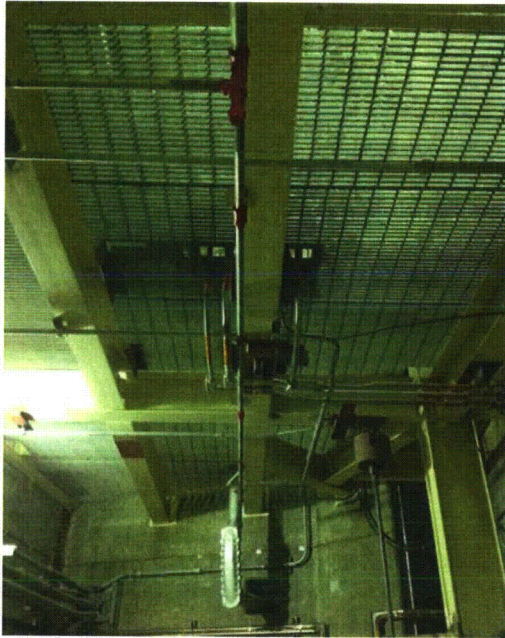
File Name: 1-65-2-1-16.jpeg
Description: View of fire protection piping and overhead grating

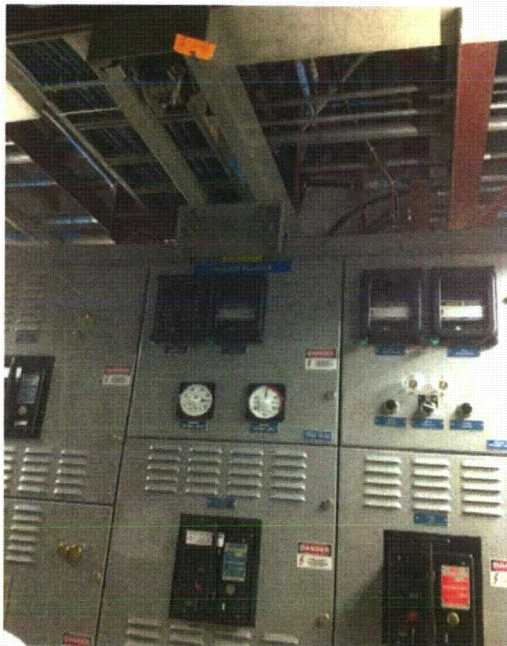
File Name: 1-66-1-1-02.jpeg
Description: View of trolley on top of Cabinet

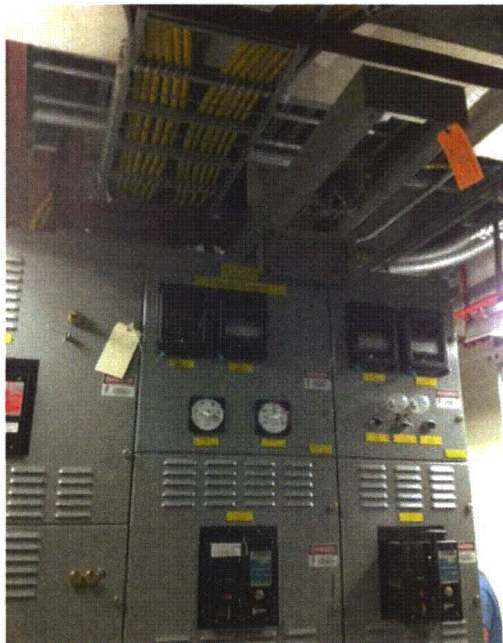
File Name: 1-60-3-1-02.jpeg
Description: View of trolley on top of Cabinet

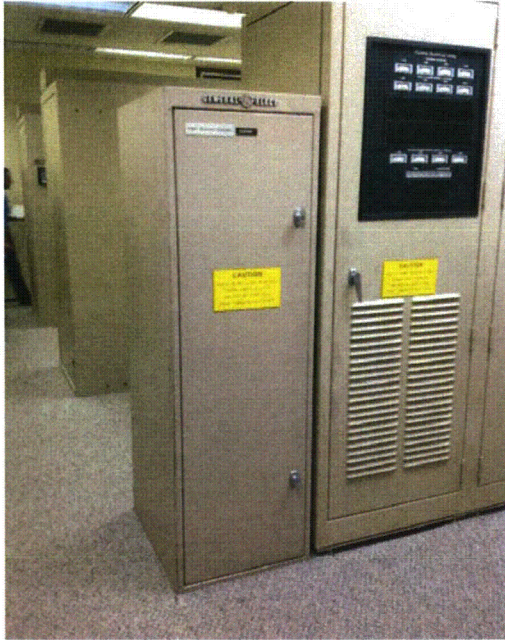
File Name: 1-67-1-1-03.jpeg
Description: Cabinet not anchored

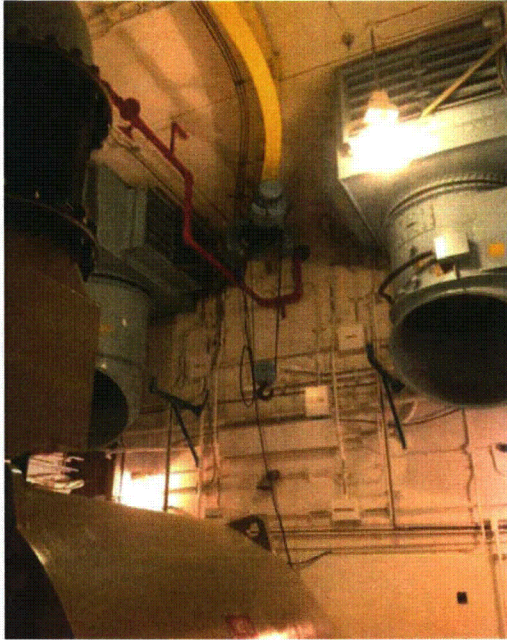
File Name: 1-65-2-1-08.jpeg
Description: Crane away from components

Overhead crane in the area observed to be positioned away from components.
