SUBJECT: MITSUBISHI HEAVY INDUSTRIES – REQUEST FOR WITHHOLDING ROOT CAUSE ANALYSIS AND SUPPLEMENTAL TECHNICAL EVALUATION REPORT INFORMATION FROM PUBLIC DISCLOSURE

San Onofre Nuclear Generating Station, Unit 2 & 3 REPLACEMENT STEAM GENERATORS

Root Cause Analysis Report for tube wear identified in the Unit 2 and Unit 3 Steam Generators of San Onofre Nuclear Generating Station

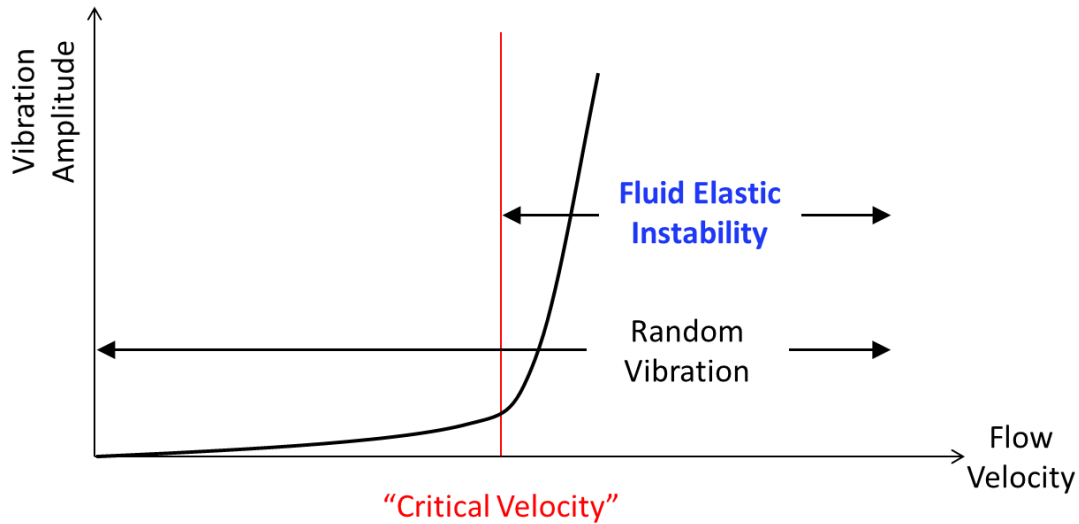
Figure 1

Fluid Elastic Instability (FEI) is a term used to describe a range of tube vibrations that starts at a point on a curve of vibration amplitude versus flow velocity. As depicted in Figure 1, one axis (Y) of that curve is vibration amplitude and the other (X) is flow velocity. The graph shows that as flow velocity increases vibration amplitude increases at a small linear rate until it reaches a point where the slope of the curve increases abruptly. The point in the curve where the slope changes is termed "critical velocity". The critical velocity is a function of several variables. These include tube natural frequency, which is dependent on the tube geometry and support conditions, damping,

As discussed below and in the technical reports referenced above (See Supplemental Technical Evaluation Report), MHI has determined that, due to ineffective support for the tubes in the in-plane direction resulting from the very small and uniform tube-to-AVB gaps, some of the tubes exceeded the fluid elastic critical velocity resulting in in-plane FEI, which in turn produced the large amplitude tube-to-tube wear. This mechanism is influenced by the local thermal hydraulic conditions around the tube. Regions of high void fraction have lower tube damping, which reduces the fluid elastic critical velocity threshold. High void fraction regions also have higher cross flow velocities. Therefore, tubes with low or no contact force in the region of highest void fraction are most susceptible to this mechanism.

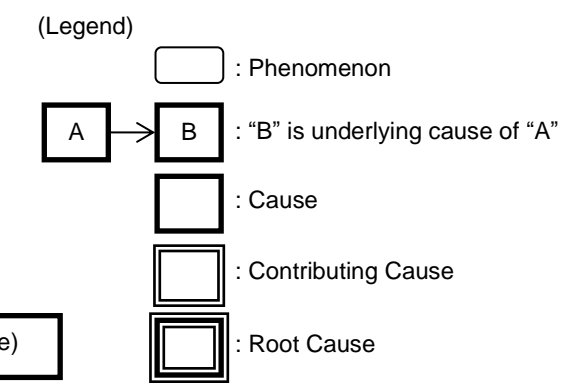
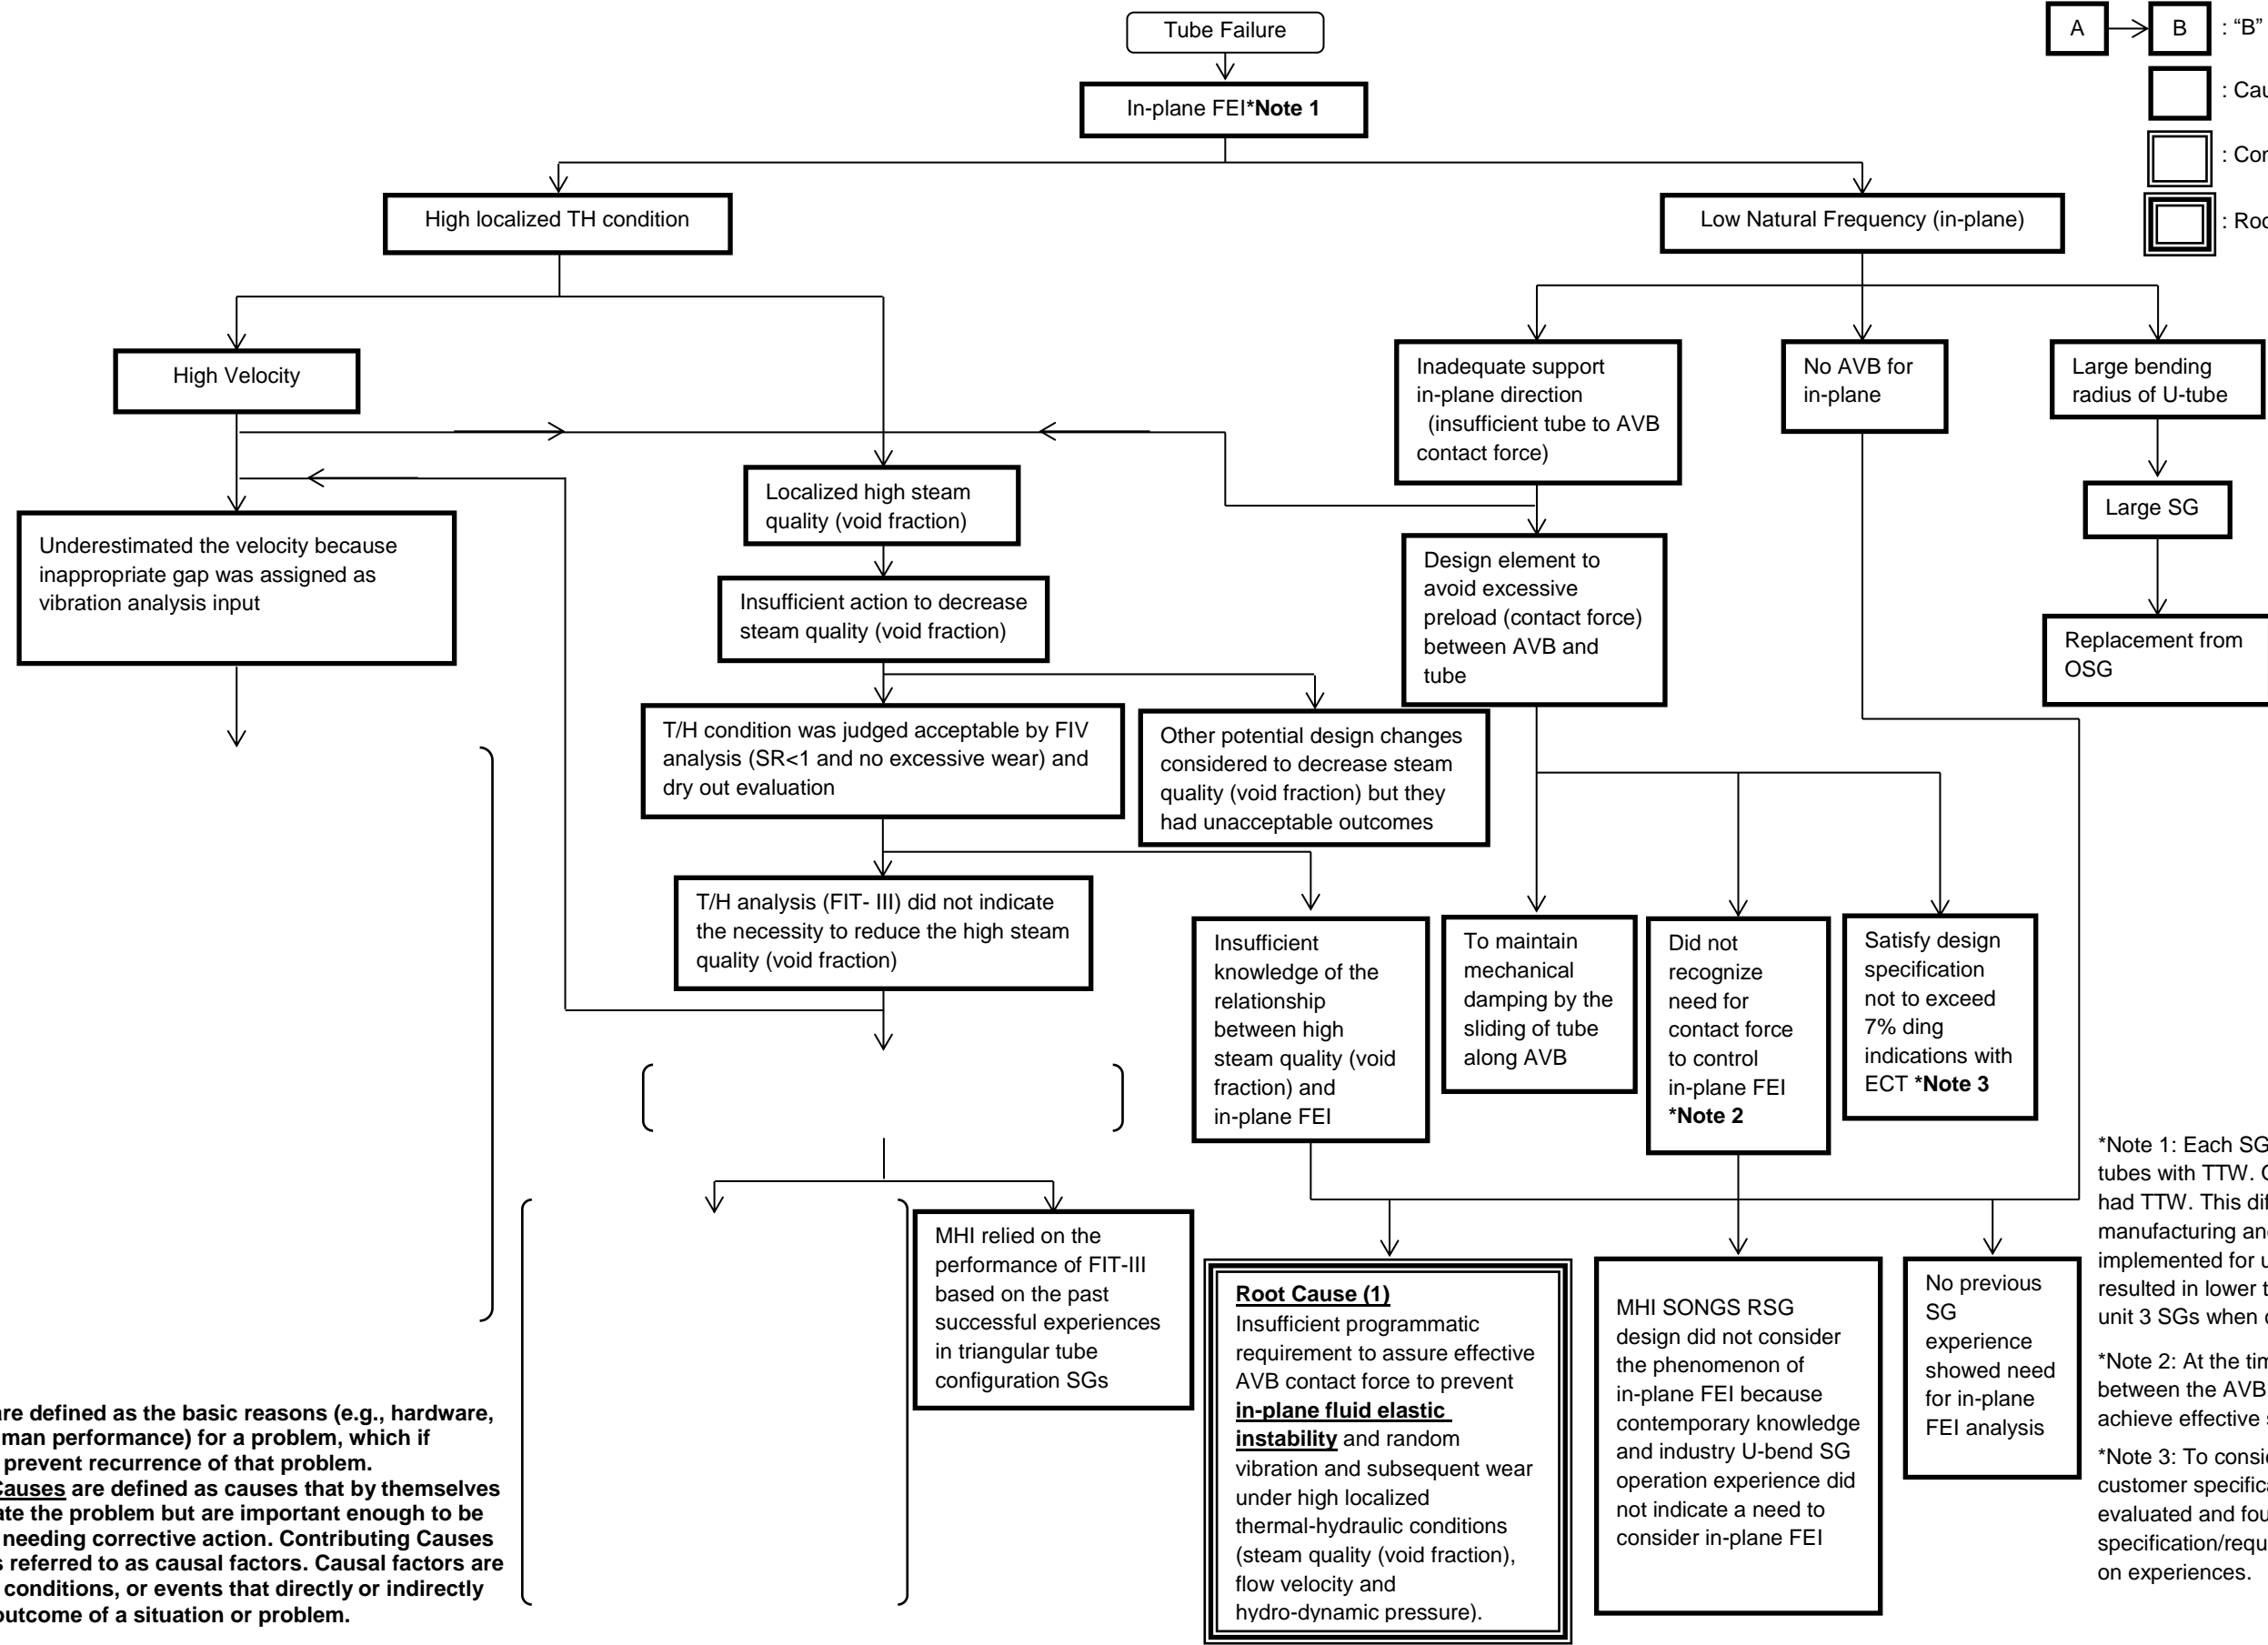
Cause-effect analysis for the tube to tube wear

*Note 1: Each SG on unit 3 had about 160 tubes with TTW. Only 2 tubes in one unit 2 SG had TTW. This difference was caused by manufacturing and fabrication improvements implemented for unit 3. These improvements resulted in lower tube to AVB contact force in unit 3 SGs when compared to unit 2 SGs.
 *Note 2: At the time of design a narrow gap between the AVB and tube was believed to achieve effective support condition.
 *Note 3: To consider identifying specific customer specification but also note that MHI evaluated and found such specification/requirement acceptable based on experiences.

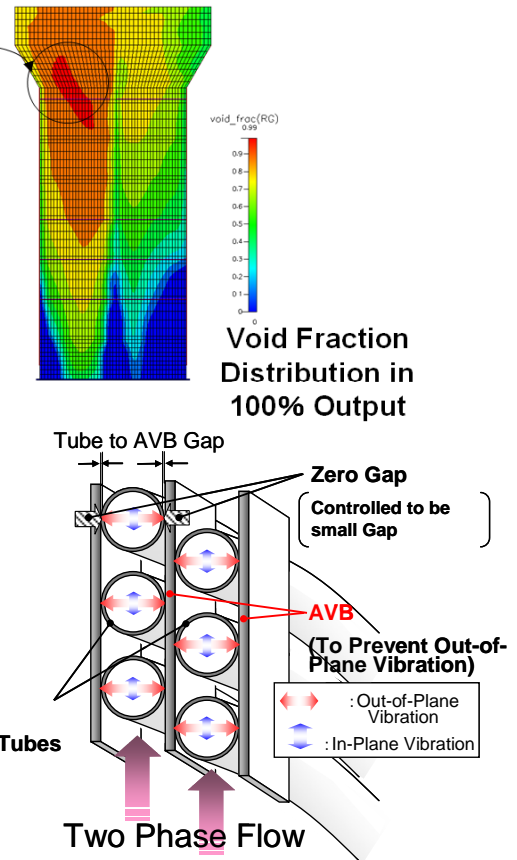
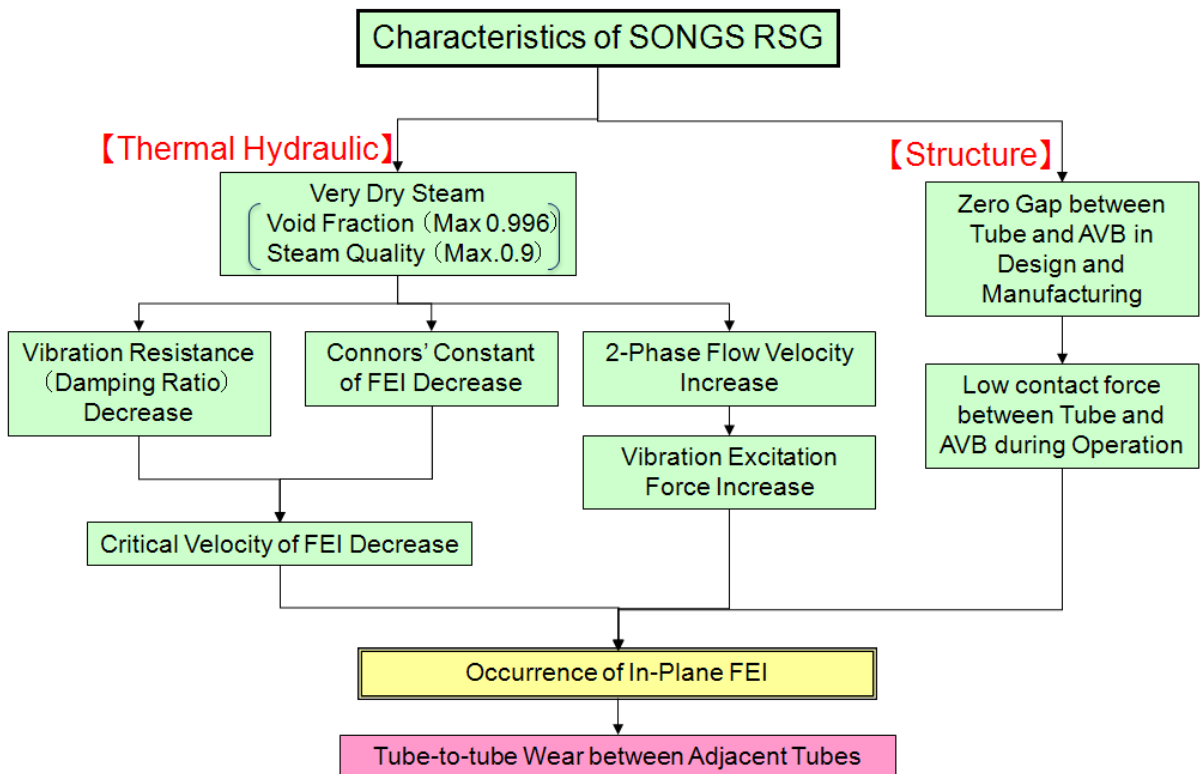
Fig. 2.2-1 Type 1 Wear (TTW) In-Plane Mechanism

As discussed in Sections 5 and 6.1 of the TER, in order for large in-plane displacements to occur two conditions are necessary. First, the tube needs to be unrestrained in the in-plane direction and second the environment must be conducive to FEI (velocity, density, damping, etc.). These causes are summarized in Fig.2.2-1. This figure shows the same mechanism as Fig.6.1-1 in the TER (Ref. 1).

- ✓ Tube between 2 flat AVBs
 - AVB Design Assumes Out-of Plane Vibration
Since out-of-plane FEI is more likely to happen compared to in-plane FEI, AVBs are placed at the sides of tube to prevent out-of-plane vibration
- ✓ 6 V-Shaped AVBs (12 support points)
 - Number of AVB Support Points are confirmed to satisfy ASME FEI Requirements
- ✓ Designed and fabricated for effective "Zero" Gap between Tube and AVB in hot condition

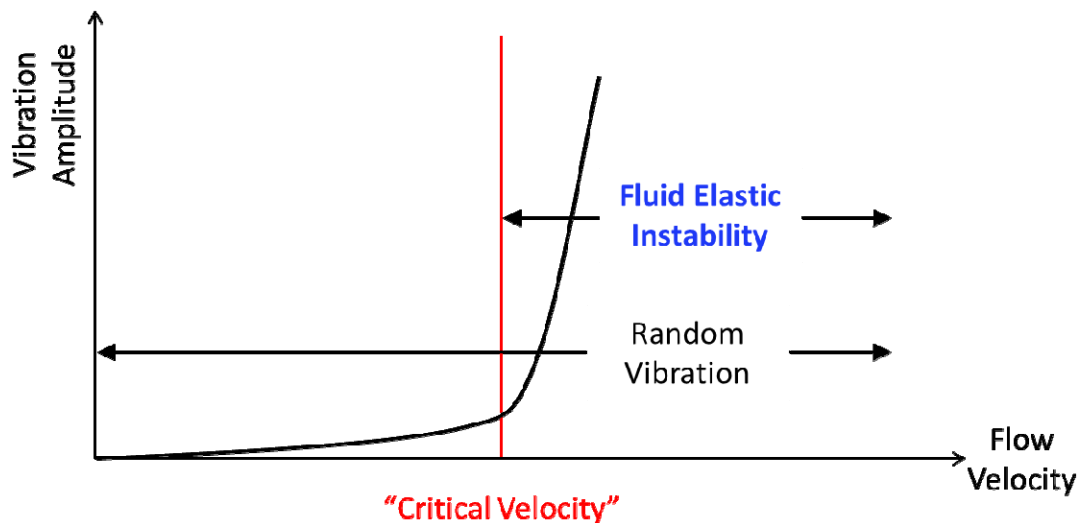
Figure 2.3-1 Relation between Vibration Amplitude and Flow Velocity

In a tube array, a momentary displacement of one tube from its equilibrium position will alter the flow field and change the force balance on the neighboring tubes, causing them to change their positions in a coordinated manner. When the energy extracted from the flow by the tubes exceeds the energy dissipated by damping it produces fluid elastic vibration. The threshold for this instability is shown in Figure 2.3-1 below, where one axis (Y) of the graph is vibration amplitude and the other (X) is flow velocity. The curve shows that as flow velocity increases, vibration initially increases gradually. As velocity continues to increase, it will reach a point where the slope of the vibration line changes abruptly. The point on the curve where the slope changes is termed the "critical velocity".

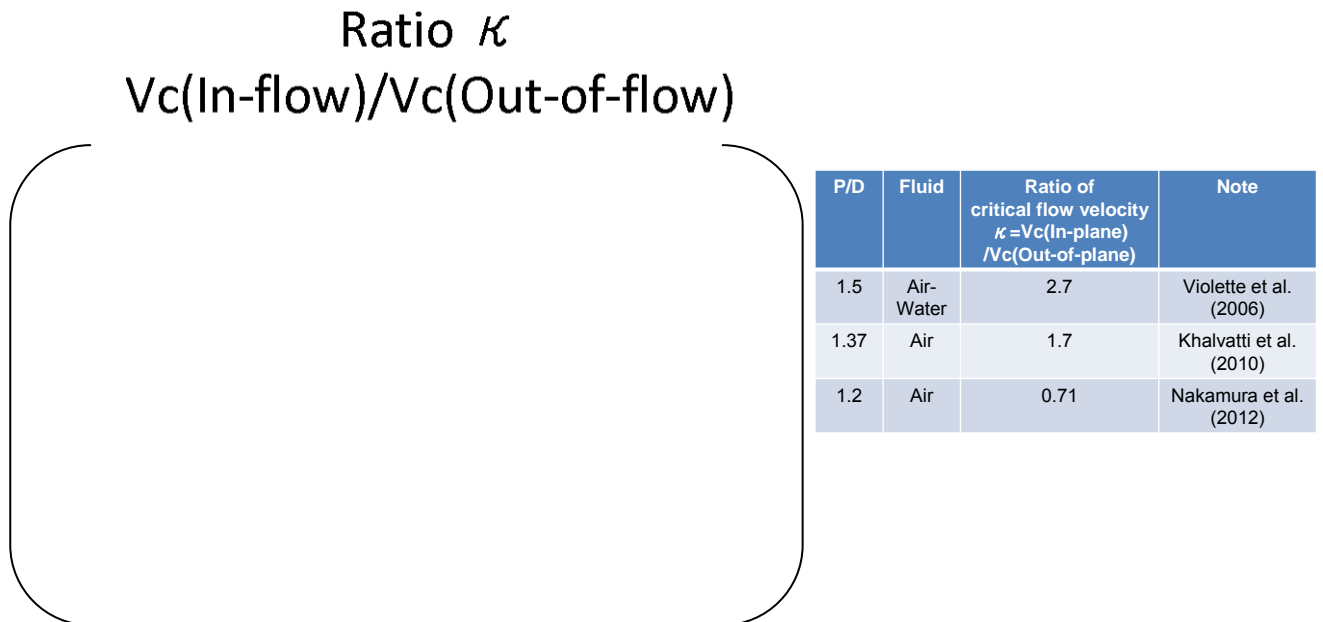
Fig.2.3.2-1 Critical Factor Ratio to P/D Relationship

- k : Ratio of Critical Factor of In-plane FEI and Out-of-plane FEI
- K_i : Best-estimate Critical Factor of In-plane FEI
- K_o : Best-estimate Critical Factor of Out-of-plane FEI

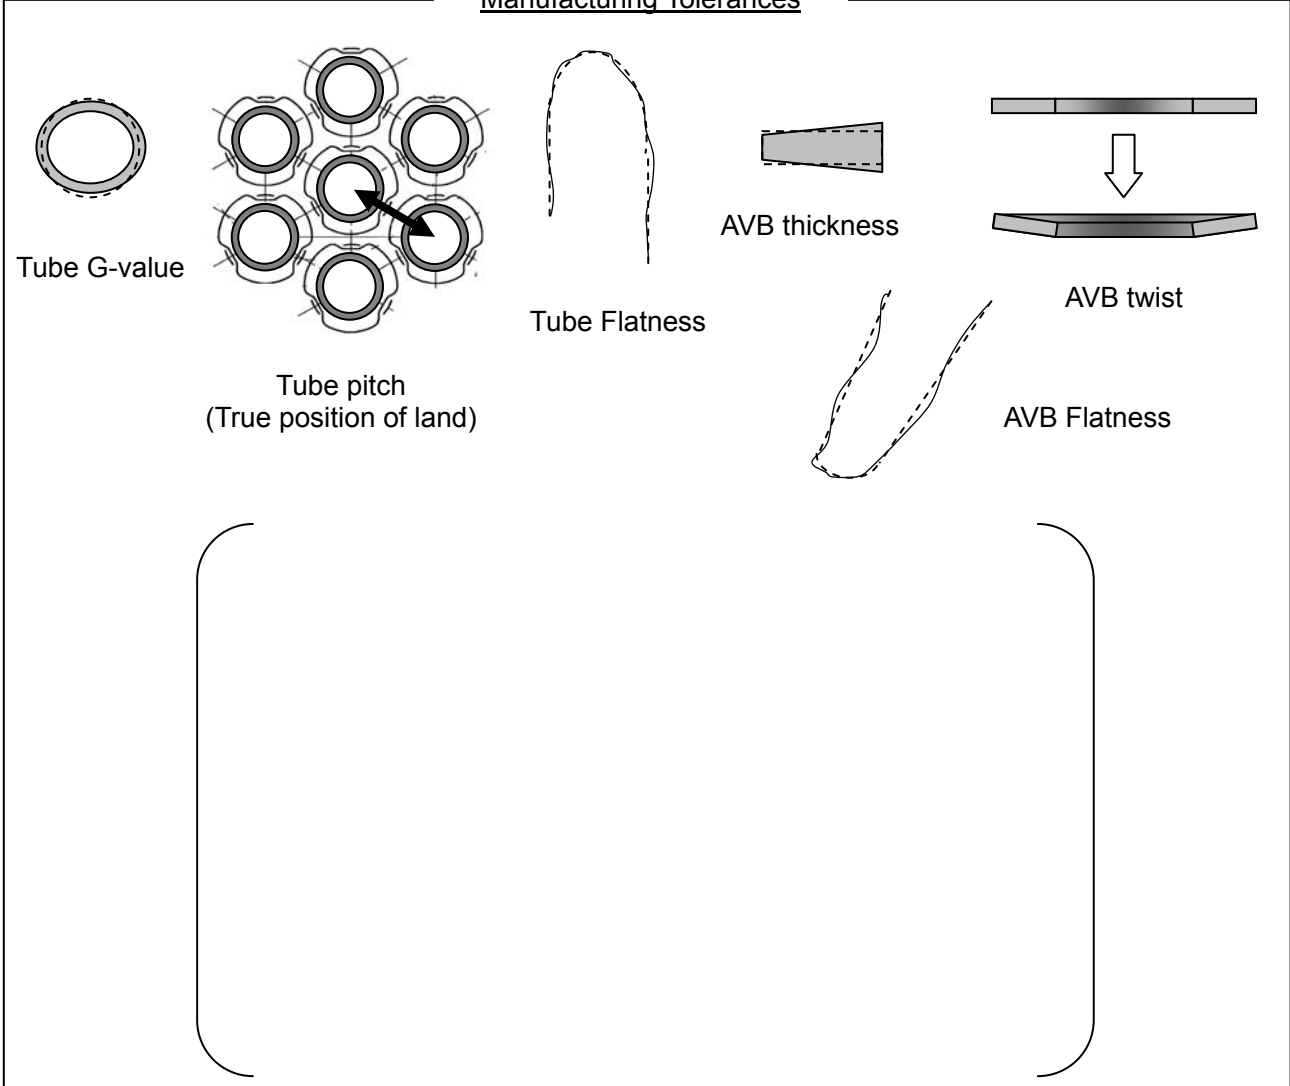
Fig.2.3.3-3 Contact Force Simulation with Manufacturing Tolerances

A comparison of Fig. 2.3.4-3 showing the average void fraction and the figures on the bottom of Fig. 2.3.3-3 showing Unit 2 and Unit 3 contact forces indicates that the tubes in the area of average high void fraction also generally have low contact forces, which generally correspond as well to the Type 2 wear maps in Figs. 3.1-1 and 3.1-2. The turbulence induced (random) tube vibration associated with the small gaps and small contact forces combined with the lower tube damping in the high void fraction regions is sufficient to produce the observed wear.

According to the manufacturing dimensional tolerance analysis, the average contact force in the Unit 3 SGs was found to be smaller than the average contact force in the Unit 2 SGs, as shown in Fig. 2.3.3-3. Therefore, it is concluded that the contact forces of Unit 3 were more likely to be insufficient to prevent turbulence induced (random) vibration of tubes and the Unit 3 SGs were more susceptible to turbulence induced (random) vibration, as shown in Figs. 3.2.1-4 and 3.2.1-5.

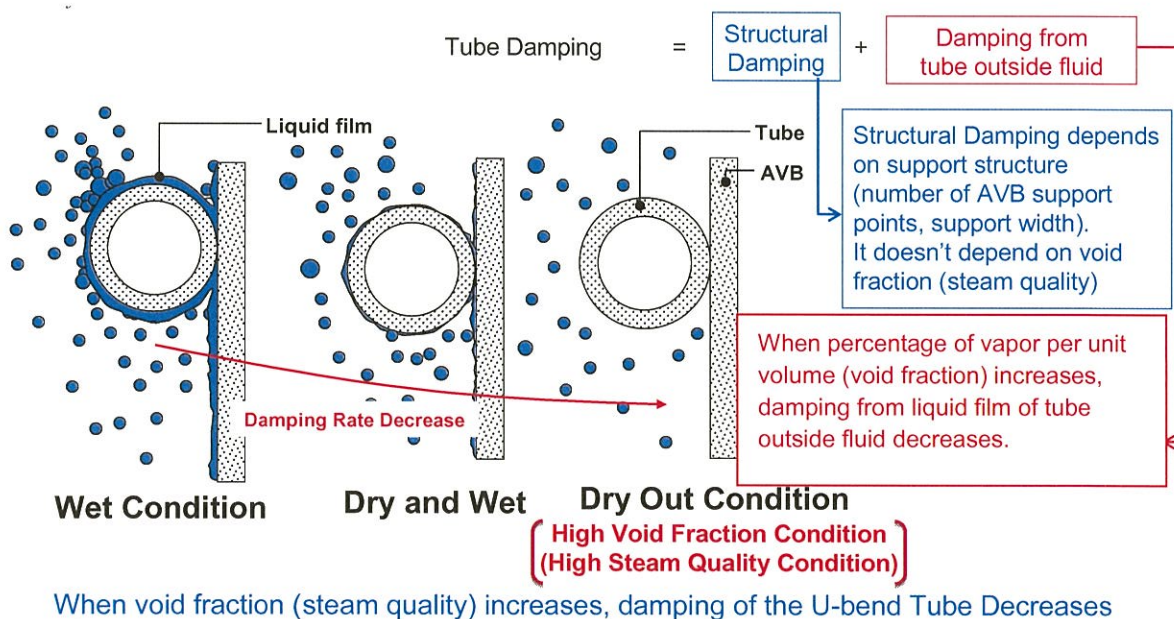
Fig 2.3.4-2 Relation between Steam Quality (Void Fraction) and Damping

Structures in a two-phase flow field have lower resistance to vibration when the steam quality (void fraction) is high. At all but the highest void fraction conditions, a liquid film can form between the tube and the AVB. This film provides liquid film damping (also called squeeze film damping), which “damps” vibration. In the high void fraction region, there is little or no film damping effect. The density and viscosity of the fluid outside the tube also provide damping (called external fluid or two phase damping). When a tube passes through a region of high steam quality (void fraction) the fluid density is low and the associated level of fluid damping is low. The relationship between steam quality (void fraction) and damping is depicted in Fig. 2.3.4-2.

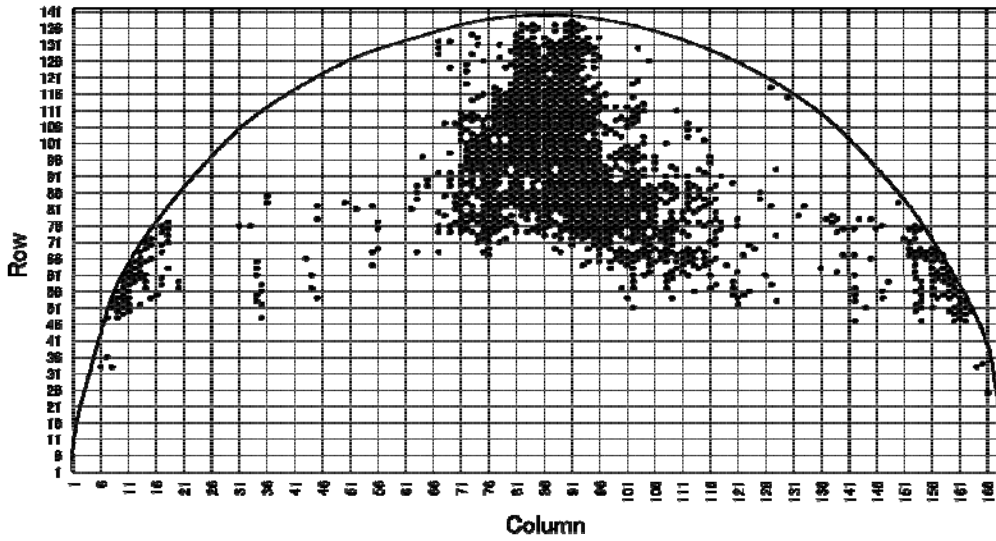
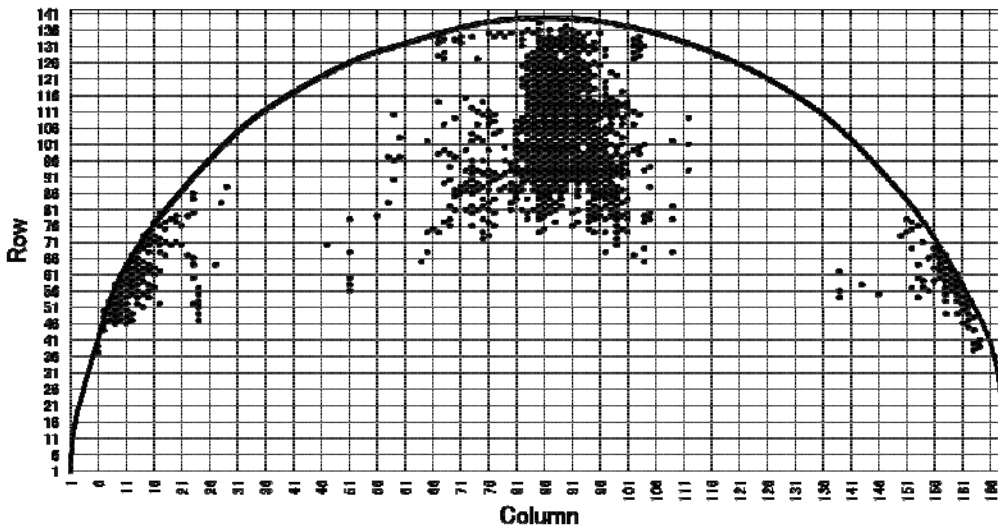
Fig.3.2.1-2 Plant-A Tubes with AVB Indications at first inspection
(based on information from NRC ADAMS ML11270A015 and ML093230226)

The Plant-A inspection results show a wear pattern with many tubes in the center of the U-bend that have tube-to-AVB wear similar to that found in the SONGS steam generators. Figure 3.2.1-2 shows the tubes with tube-to-AVB wear identified at Plant-A during the first inspection following installation of the RSGs and Figure 3.2.1-3 shows the tubes with tube-to-AVB wear identified at Plant-A during the second cycle inspection. Note that the locations of the Plant-A indications are very similar to those for SONGS shown in Figs. 3.1-1 and 3.1-2.

Figure 3.2.1-5 suggests that the tube-to-AVB wear depths at Plant-A have reached a plateau. The reason for such a plateau is unclear. It may be indicative of the type of tube vibration mechanism or an effect of the support condition. But it is clear that the number of tubes with tube-to-AVB wear at Plant-A is growing (refer to Fig. 3.2.1-2 and 3.2.1-3).

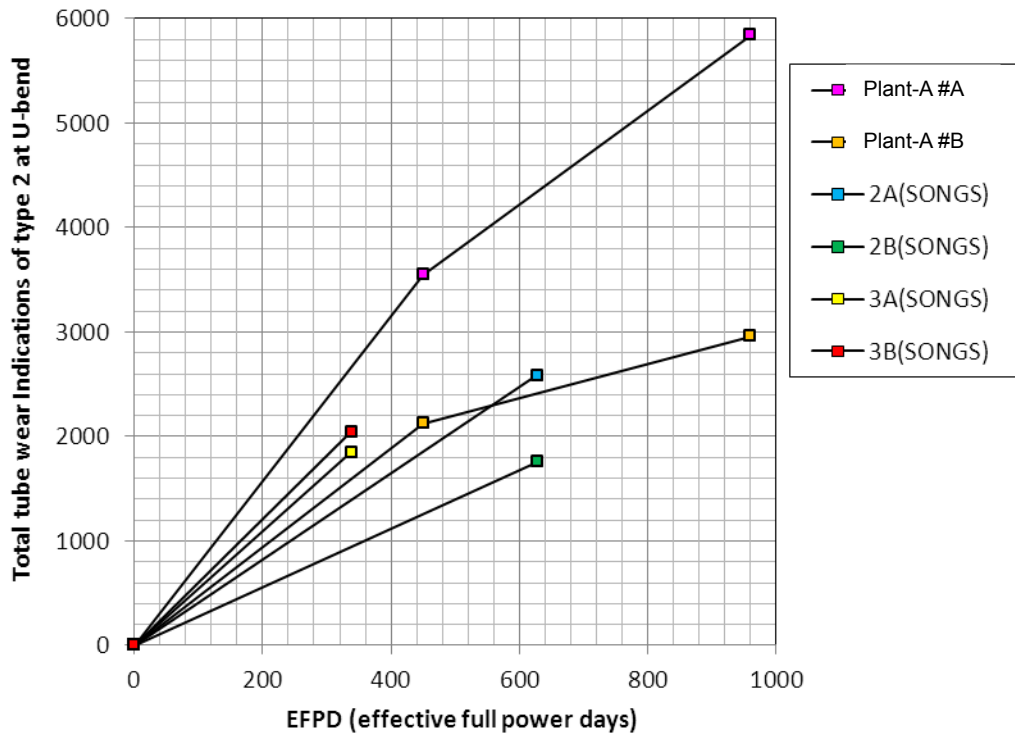
Fig.3.2.1-4 Total Tube-to-AVB Wear Indications

Figure 3.2.1-4 compares the total number of tube-to-AVB wear indications for Plant-A, SONGS Unit 2, and SONGS Unit 3 as a function of time and Figure 3.2.1-5 shows the average wear depths for the three plants (six RSGs) as a function of time. As can be seen from these figures, the total number of indications and average wear depth at Plant-A are comparable to that at SONGS.

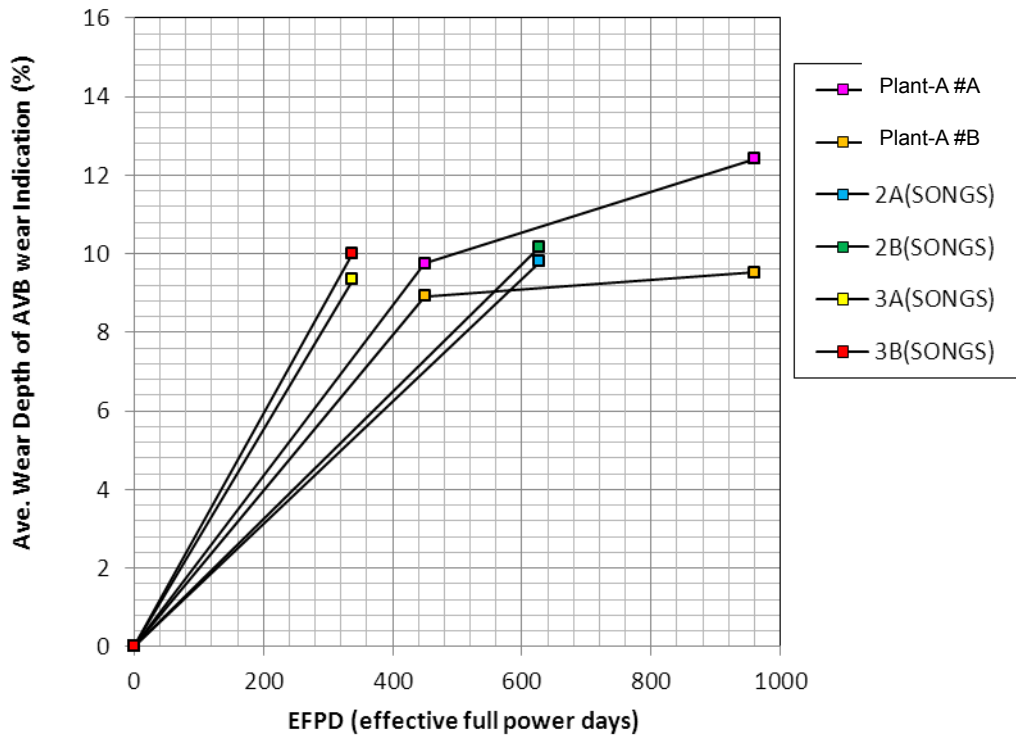
Fig.3.2.1-5 Average Tube-to-AVB Wear Rate

While the number of tubes with Type 2 wear is very similar for Unit 2 and Unit 3 (Compare Table 1-1 and Table 1-2), Unit 2 has operated approximately twice as long as Unit 3. As a result, as shown in Fig. 3.2.1-5, the wear rate in Unit 3 is faster than that for Unit 2. An explanation for this difference is found in the manufacturing assessment which concluded that the tube to AVB contact forces in Unit 3 were less than half than those in Unit 2. (See Section 2.3.3 above.)

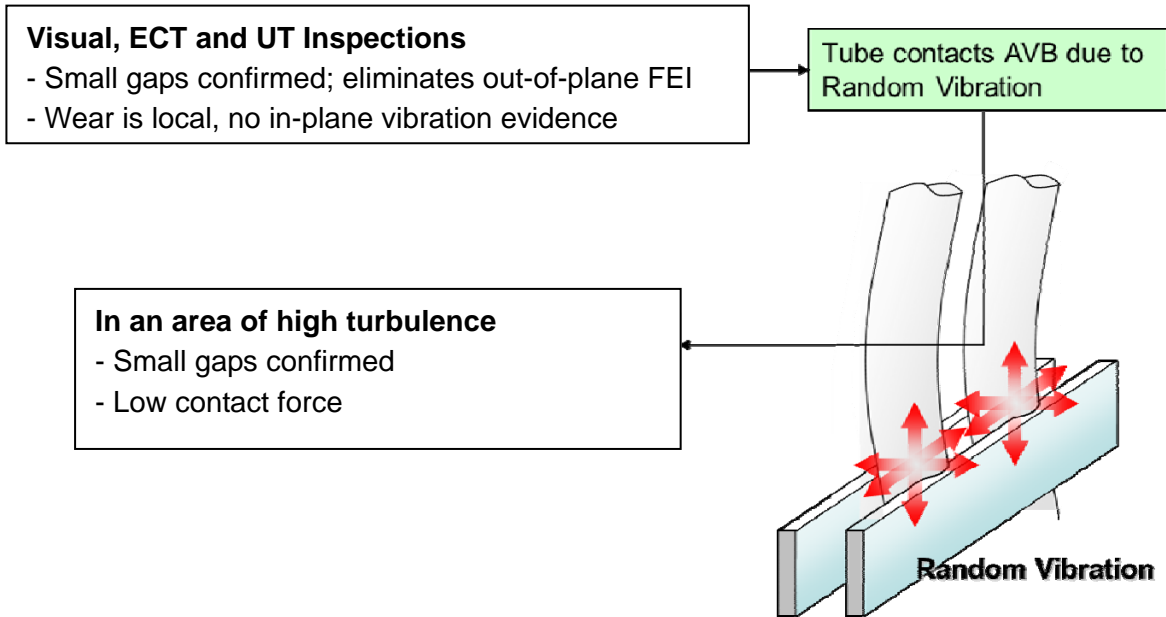
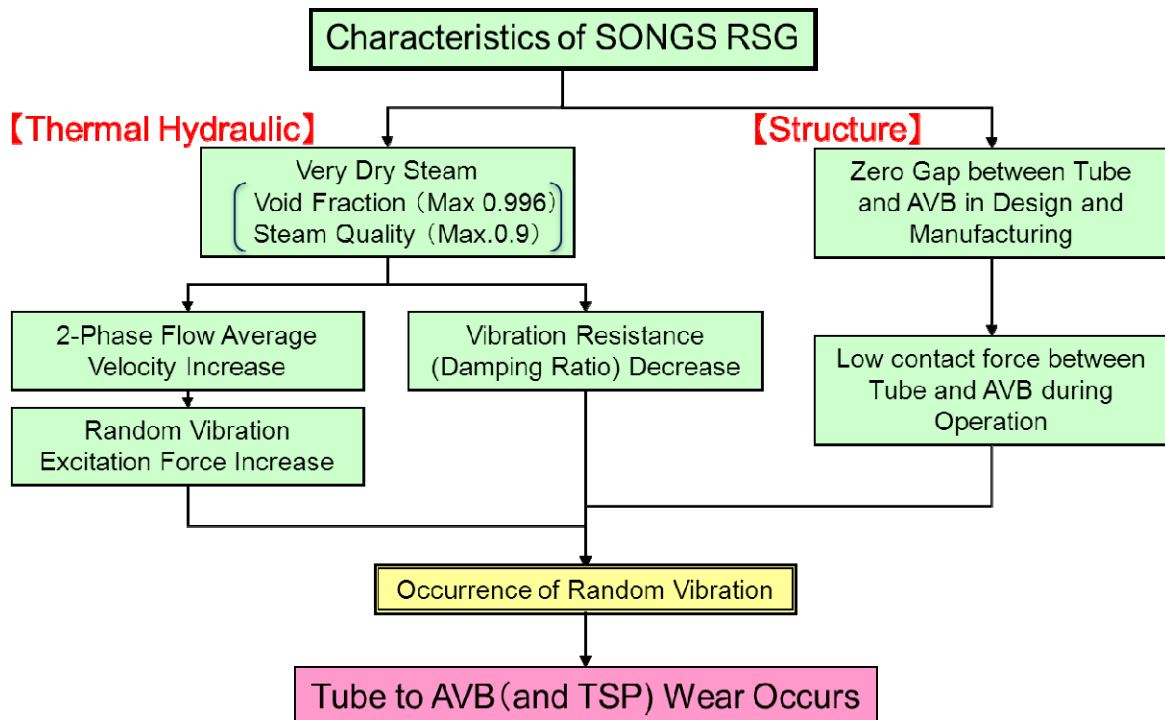
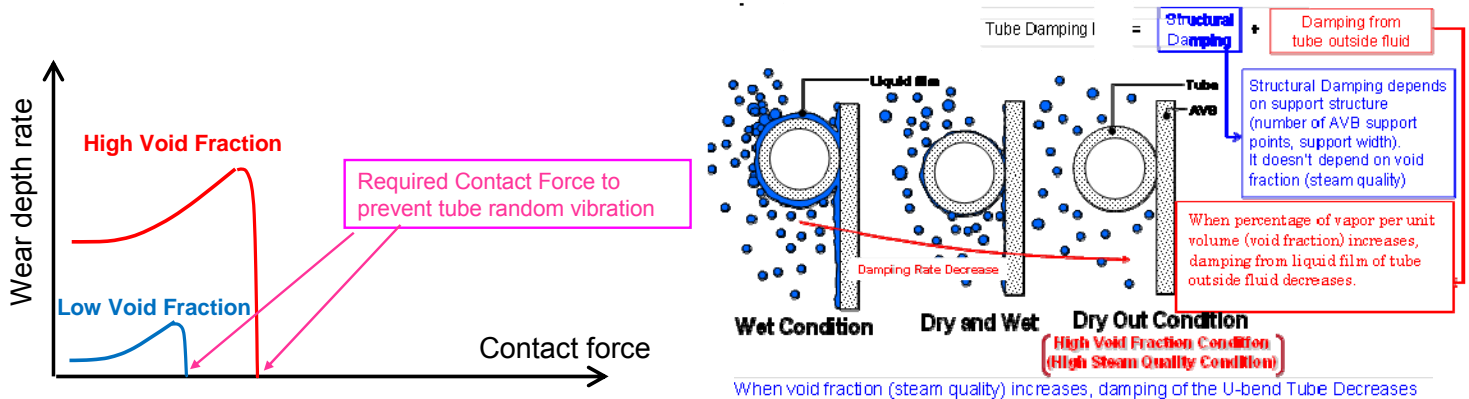
Fig.3.3-1 Type 2 Wear (AVB wear) Mechanism

Fig. 3.3-1 (this figure is similar to Fig. 6.2-1 in the TER (Ref. 1)) provides a summary of the basis for establishing the cause of the Type-2 (tube-to-AVB) wear. Extensive inspections, including visual, eddy current, and ultrasonic methods, indicate that the tube-to-AVB gaps are small at each of the wear sites. This indicates that there are small clearances. Such conditions are sufficient to prevent out-of-plane FEI but not sufficient to prevent turbulence induced (random) vibration and wear.

When void fraction (steam quality) increases, damping of the U-bend Tube Decreases

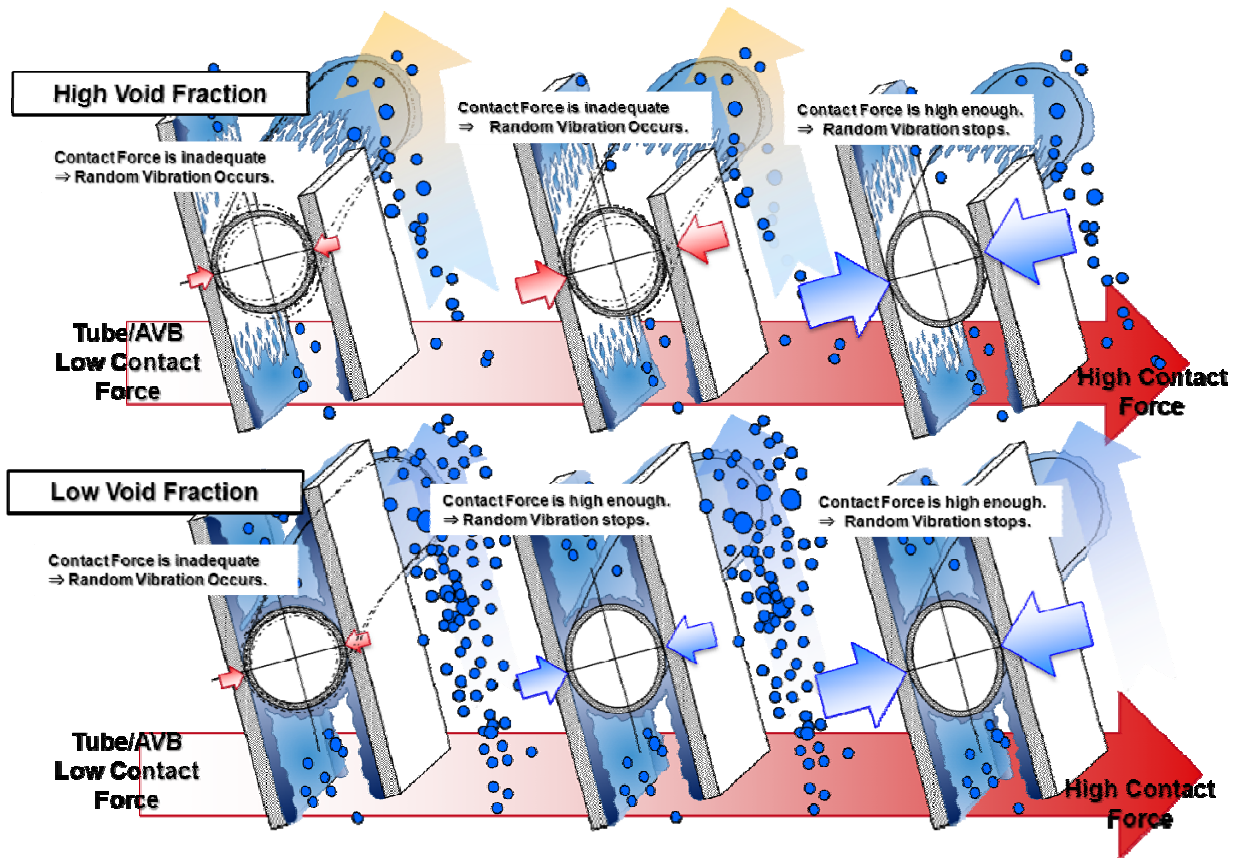
Fig.3.3-2 Contact force sufficient to prevent random tube vibration

As shown in the figure at the upper left corner of Fig.3.3-2, insufficient contact force has an adverse effect on tube wear caused by random tube vibration up to the point where the contact force is sufficient to prevent tube lift-off from (or sliding along) the AVB. The amount of contact force necessary to prevent random vibration is a function of the thermal-hydraulic condition. As the void fraction (steam quality) increases, the amount of contact force necessary to prevent random vibration increases. This is because the higher void fraction (steam quality) results in lower external fluid damping and a reduction in the liquid film damping (squeeze film damping).

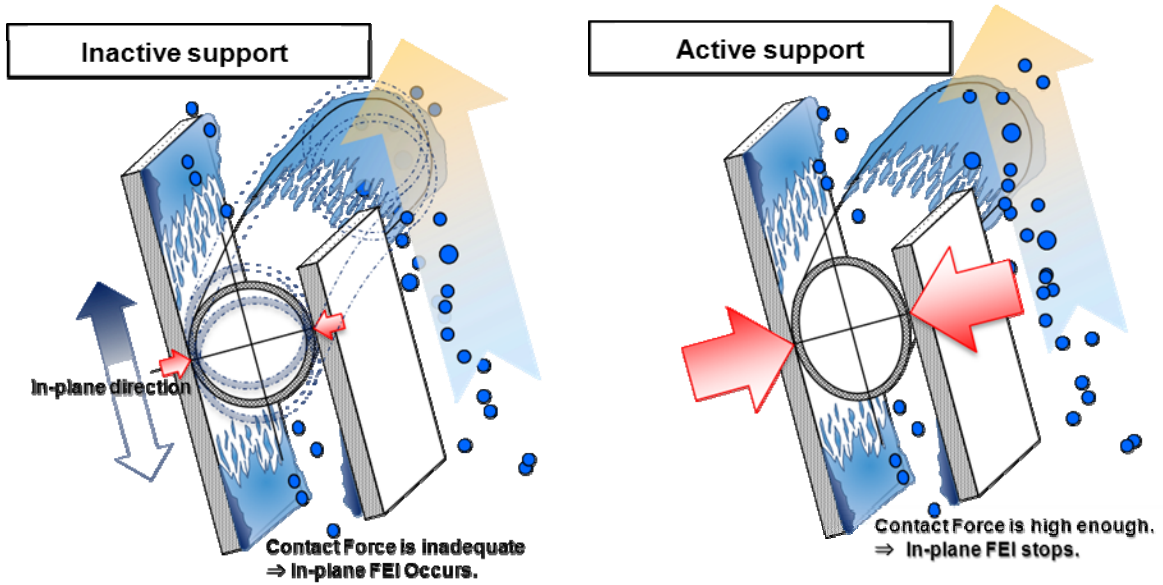
Fig. A2-1 Correlation between Number of inactive supports and Critical velocity

Based on the investigation of the tube wear at SONGS, MHI concludes that the number of active supports against out-of-plane FEI is not identical to the number of active supports against in-plane FEI.

In the case of the SONGS RSGs, the number of active supports against out-of-plane FEI is considered to be the same as designed because narrow or effective zero gaps are confirmed by ECT measurements and visual inspection at tube-to-AVB intersections along representative tubes with wear. On the other hand, for tubes that exhibited tube-to-tube (Type-1) wear, the number of active supports against in-plane FEI is reduced because the contact force is not sufficient.

If the number of active supports that prevent in-plane FEI becomes sufficiently less than the number of supports that prevent out-of-plane FEI, the critical velocity of in-plane FEI becomes lower than that of out-of-plane FEI.
