5.4 Industry Standard Nondestructive Evaluations

6 Destructive Validation of Nozzle 63

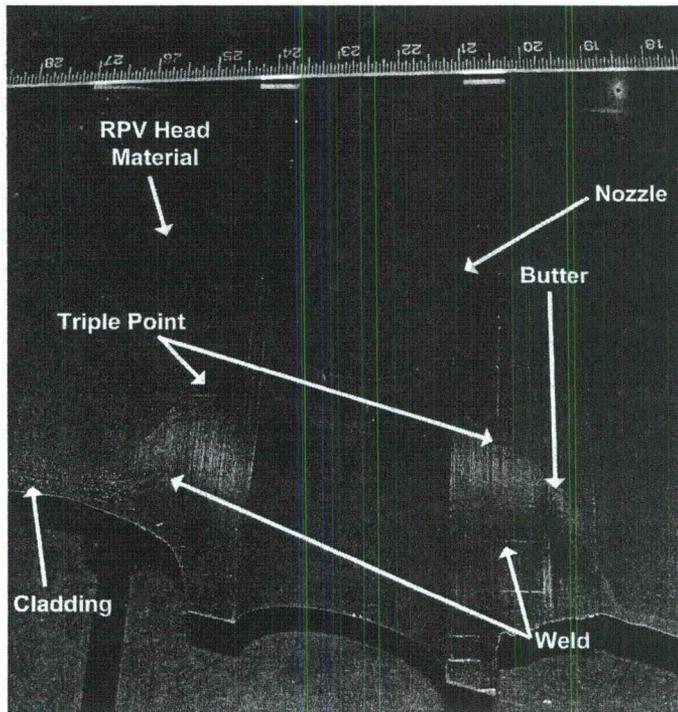
Figure 6.5 Nozzle 63 Assembly Cut in Half by Dissection Cut

After cutting through the first side of the nozzle, the carbide blade was exchanged with the fine-toothed cutting blade and the dissection cutting continued. Another hard spot was incurred in the J-groove weld region. Again, the carbide blade was used to cut through the hard spot with a slow feed rate. Finally, the fine-toothed blade was re-engaged and the dissection cut completed. From the exposed surfaces, the triple point was identified along with the weld and butter regions as shown in Figure 6.5.

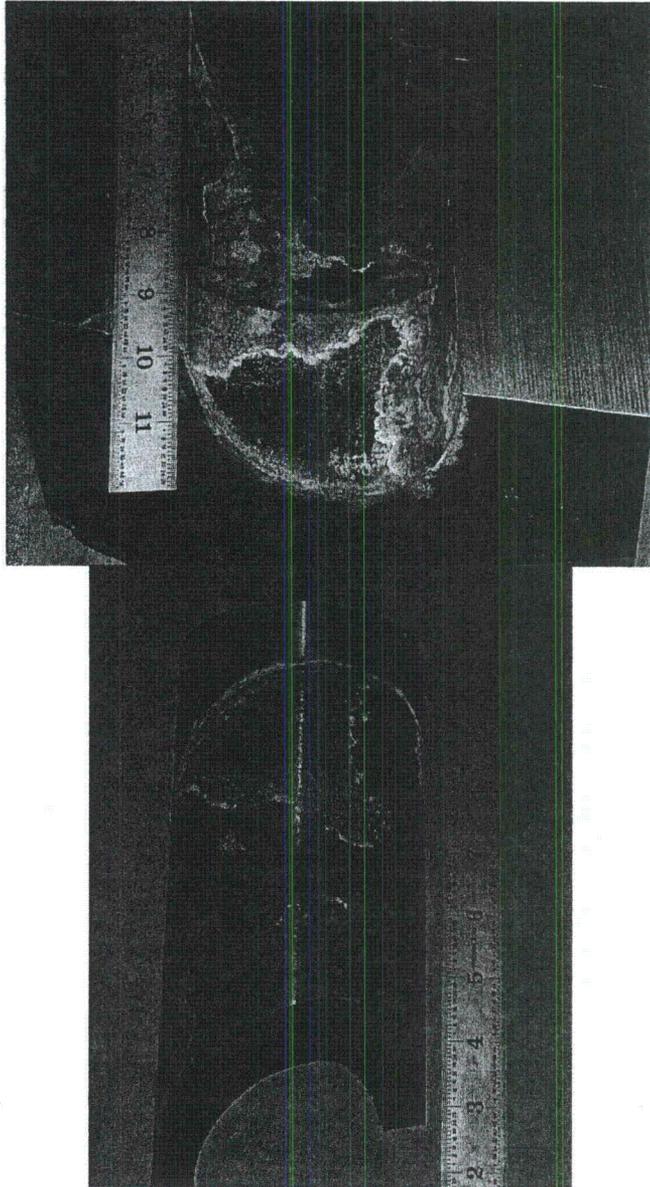
Figure 6.10 Exposed RPV Head and Nozzle from High Side Section

The cutting continued until the entire nozzle was separated from the J-groove weld region as pictured in Figure 6.9. At this point, the nozzle region above the weld was freely released from the RPV head material. Removal of the nozzle exposed the annulus region of the high-side section as shown in Figure 6.10. At this point all available blades were exhausted.

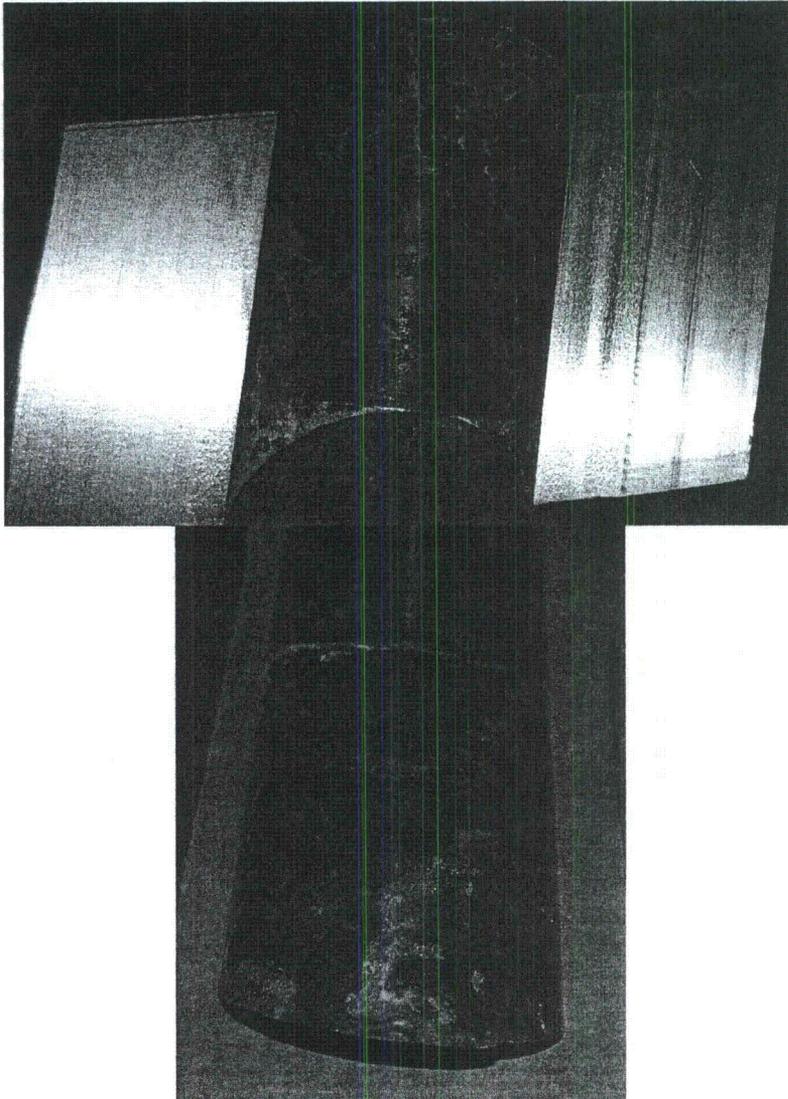
Figure 6.11 Exposed RPV Head and Nozzle from Low-Side Section

Replacement blades were ordered to finish the cut and complete removal of the J-groove weld region. A Nikon D40x camera was used to acquire high-resolution photographic documentation of the annulus region. This activity was provided by B&W. A subsequent cut was conducted on the low-side section to expose its annulus region containing the primary leak path (Figure 6.11). The nozzle freely released from this portion as well.

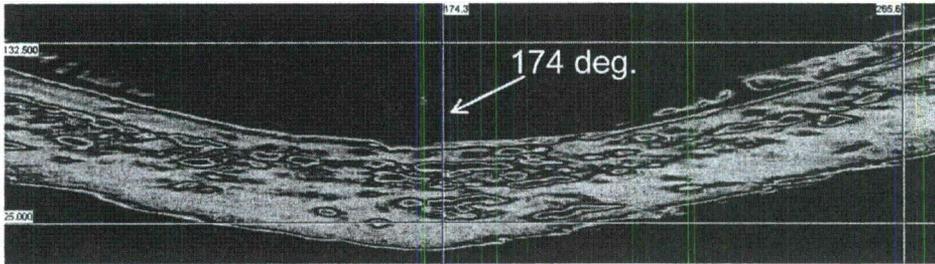
The ultrasonic indications were evaluated for flaw-depth position or distance into the weld material, and all responses appeared to be at or just below the surface with the surface representing the Alloy 600 tube-to-weld or butter interface. Figure 8.4 shows the composite top view of the downhill half of the weld with a vertical line drawn through the 174-degree position. A single plane or slice of data taken at the 174-degree position is displayed in Figure 8.5 and this figure represents a B-scan side view of the data. The horizontal axis in the side-view image represents depth or distance into the material. The first and second ultrasonic echoes are noted and represent reflections from the tube-to-weld interface. The scanner index or nozzle axis is shown in the vertical direction. The profile shape follows the front surface or inside of tube profile displayed in Figure 8.6. The distortion or deviation from vertical is due to the weld heating and subsequent cooling in the material and was measured at approximately 2 mm (0.08 in.). The distortion is magnified in the image due to the velocity difference between water and the Alloy 600 tube. Water velocity is nearly four times slower than the metal, assuming a water velocity of 1483 m/sec (58.4 in./msec) and 5820 m/sec (229.1 in./msec) for the metal. The side-view plots (Figures 8.5, 8.6, and 8.8) display the horizontal axis in units of distance

Figure 8.4 Location of Single Slice Shown in Figure 8.5. The horizontal axis represents 180 degrees approximately and the vertical axis 145 mm (5.7 in.).

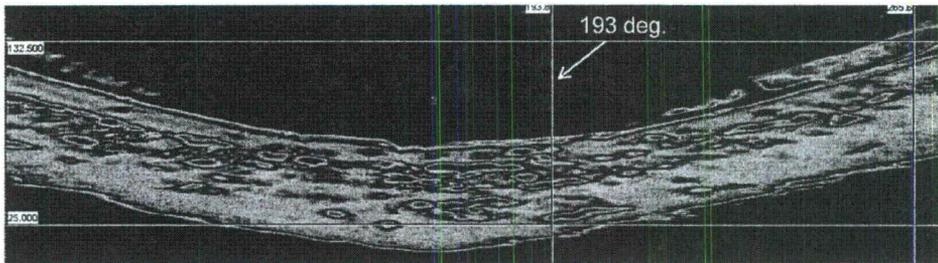
Figure 8.7 Location of Single Slice Shown in Figure 8.8

The weld region was evaluated for anomalies throughout the full 360-degree circumference. The indications fell along the Alloy 600 tube-to-weld interface at all but one circumferential position. At the 193-degrees position as noted in Figure 8.7, an indication appeared earlier in time than the other indications. The corresponding B-scan side view is shown in Figure 8.8 with the early indication circled. This earlier indication would plot into the tube material and could possibly be from a gouge in the tube and improper or no weld fill or repair. The indication displacement is shallow at approximately 1 mm (0.04 in.) in depth. No indications of circumferential cracking across or along weld beads were detected.

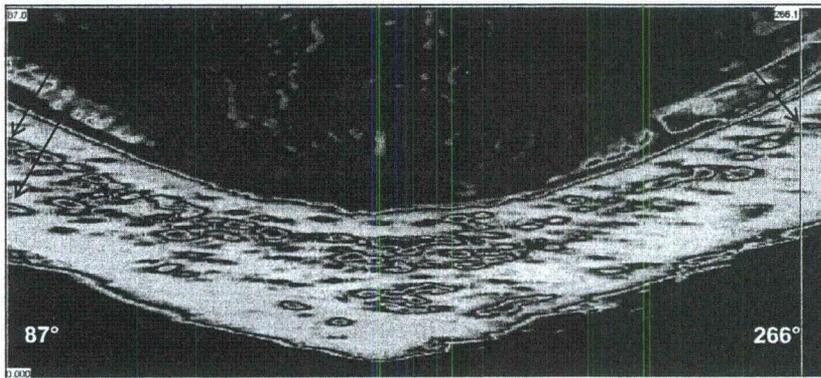
A comparison between the cut surface and ultrasonic data was made. It was observed that the 180-degree or low point on the weld was found to be located at 171 degrees in the ultrasonic image. Therefore, the ultrasonic data was shifted by 9 degrees to account for this offset. By this reasoning, the 95-degree cut surface corresponds to the 86-degree position in the ultrasonic data and the 275 cut surface corresponds to the 266-degree position ultrasonically. Again, note that these positions and the positions of the cut surfaces are estimated. The corresponding ultrasonic positions are noted in the ultrasonic C-scan top view image in Figure 8.11 with the left red vertical line at 87 degrees (on the left edge of the image) and the right blue vertical line at 266 degrees. The image did not extend to the 86-degree position so the 87-degree position is noted instead. The two indications marked by arrows at the 87-degree position in Figure 8.11 correlate to the two indications noted in Figure 8.10. An indication is also marked on the right side at the 266-degree position.

Figure 8.11 C-scan Top View of the Downhill Section of the Weld with the Left Edge Red Line and Right Side Blue Line Slicing through the Image at Locations Corresponding to the Cut Surfaces in Figure 8.9. The horizontal axis represents 180 degrees and the vertical axis 155 mm (6.1 in.) approximately.

B-scan side view images are displayed in Figure 8.12 for the 87- and 266-degree positions from Figure 8.11. The left side view image in Figure 8.12 at the 87-degree circumferential position shows the two defects with anomalous signals in between. The right image at the 266-degree position shows two possible defects with much lower signal amplitude, indicating smaller flaws.

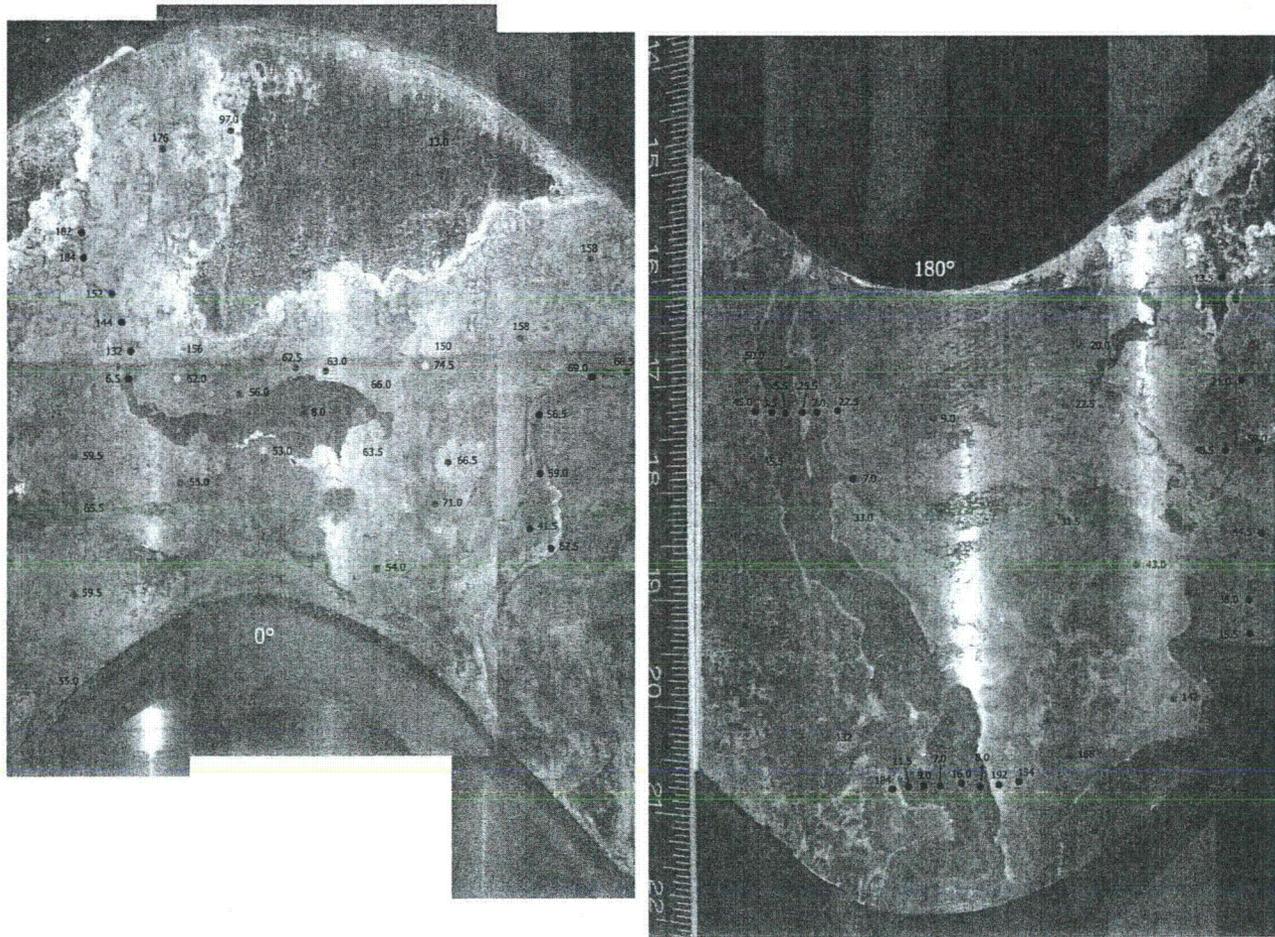
Each of the 70 data points was numbered and the boric acid measurements were entered into a spreadsheet. The thickness measurements in microns are displayed adjacent to the data points in Figure 9.3. Some general observations were:

- 1) Boric acid values above and below the interference fit region outside of leak path and bare metal or nearly bare metal regions are nominally in the 130 to 200 micron (5.1 to 7.9 mils) range.
- 2) The two pairs of data (yellow dots) on either side of the interference fit on the uphill section show boric acid values of 156 and 150 microns (6.1 and 5.9 mils) above the fit region and 62 and 74.5 micron (2.4 and 2.9 mils) in the fit region.
- 3) Leak path and bare metal or nearly bare metal points have a thin surface corrosion layer, not visible boric acid deposits, with deposits at 16 microns (0.63 mils) or less.

Figure 9.3 Boric Acid Thickness Values in Microns

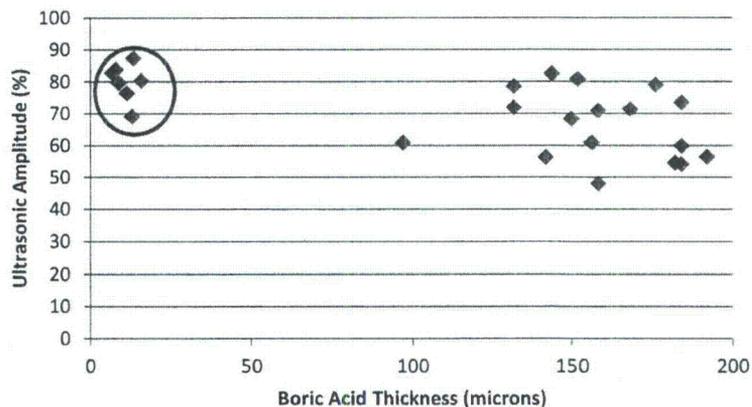
The data above and below the interference fit are displayed in Figure 9.5. The leak path or bare metal points are circled and have ultrasonic values between 69 and 87% and boric acid or corrosion thickness values of 16 microns (0.63 mils) or less. Outside of this circled cluster and the one isolated data point in the middle, the remaining data have boric acid thickness between 132 and 192 microns (5.2 and 7.6 mils) and ultrasonic amplitudes between 48 and 83%. The one outlier point is from the dry side on the uphill half and is towards the edge of a boric acid patch with a center-of-patch (0.7 in. or 17.8 mm to the center) thickness of 176 microns (6.9 mils).

Figure 9.5 Ultrasonic Amplitude as a Function of Boric Acid Thickness from Points Above and Below the Interference Fit Region

If this outlier or transitional point from Figure 9.5 is excluded, all of the boric acid measurements can be segmented into three categories. The leak path or bare metal regions have approximately less than 16 microns (0.63 mils) of boric acid/corrosion products. The interference fit points contain between 16 and 75 microns (0.63 to 3.0 mils) of boric acid, and the annulus region above and below the interference fit contain 132 to 192 microns (5.2 to 7.6 mils) of boric acid. These numbers are assumed to depend on the geometry of the particular control rod drive mechanism (CRDM) assembly and more specifically on the size of the interference fit and counter bore regions outside of the interference fit. It is reasonable to assume that with a leak, any interference fit or counter bore gap could fill with boric acid and corrosion products.

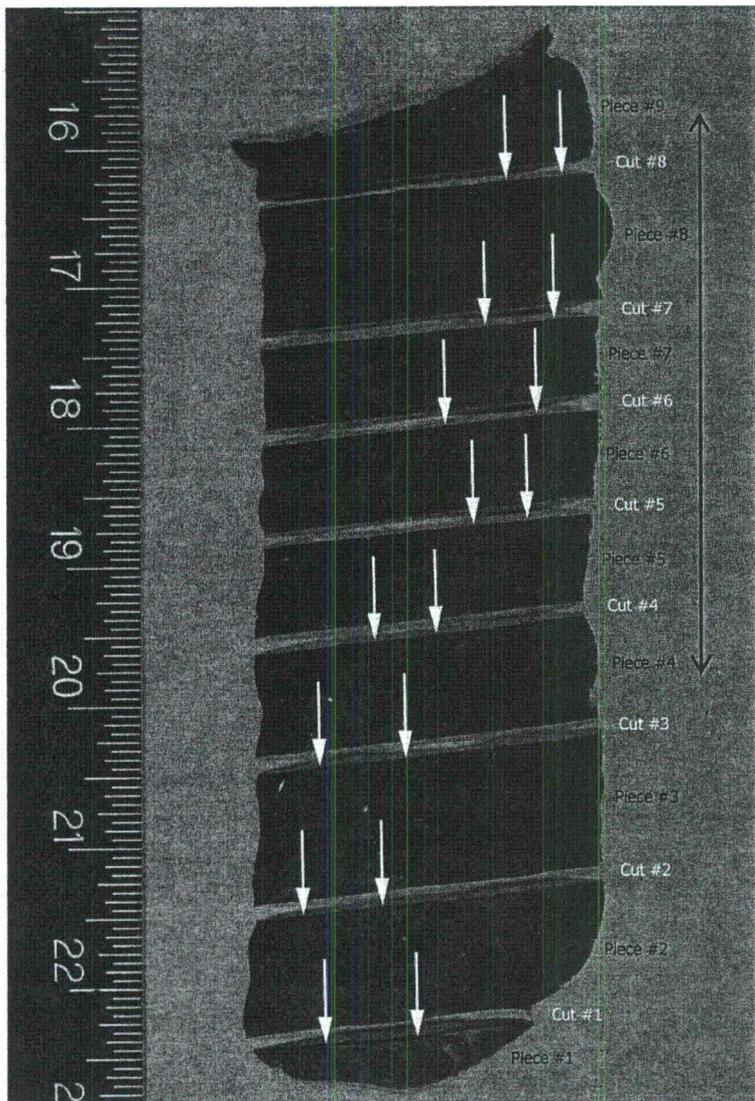
Lastly the replicated surfaces from Figure 9.8 were viewed with a stereomicroscope to better document the surface conditions and to attempt to quantify the corrosion or erosion of the low-alloy steel in the annulus region. Machining marks were observed on the replicated surfaces indicating minimal corrosion, erosion, or wastage throughout the leak path region. Interesting areas are discussed.

Figure 9.8 Leak Path Replica with Cuts and Pieces Identified. The interference fit region is noted with the black line and is contained in pieces 4 through 9.
