AREA WALK-BY CHECKLIST

IP3

Status: Y N U Area Walk-By Checklist (AWC) AWC-010Location: Bldg. IS Floor El. 15'-0" Room, Area¹ _____SWEL Components: SWEL1-030, 031**Instructions for Completing Checklist**

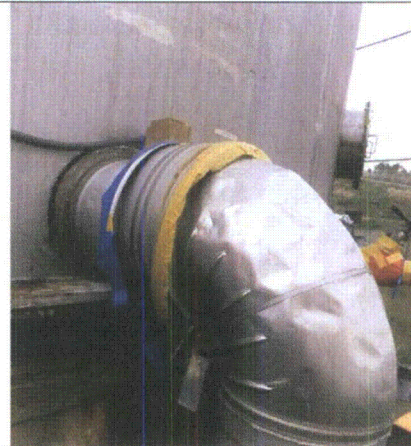
Note: Piping insulation connection held with tape.

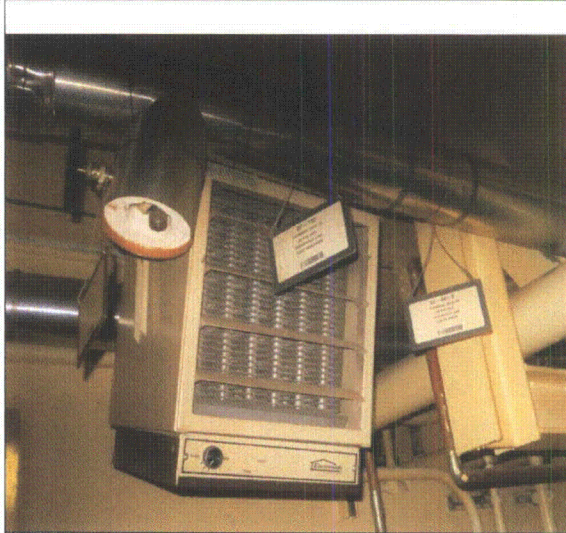
Note: Pipe insulation interference with heater.

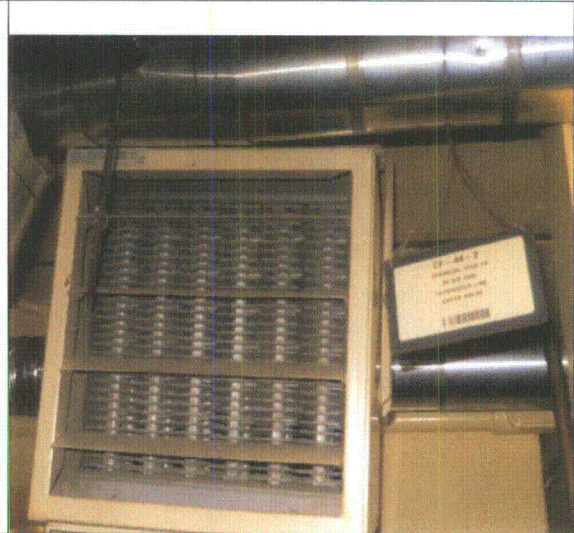
Note: Pipe insulation with heater.

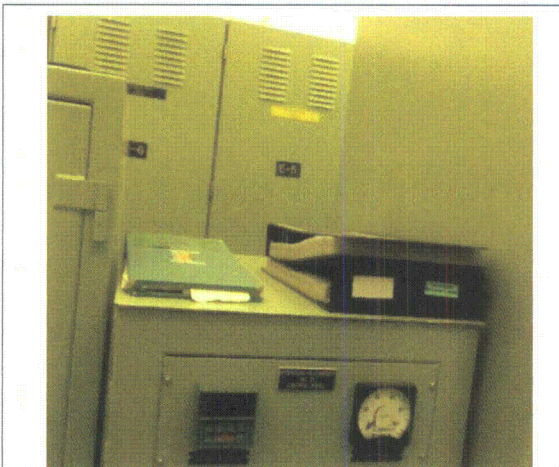
Note: unrestrained binders on top of Hydrogen Recombiner No. 31 Control Panel

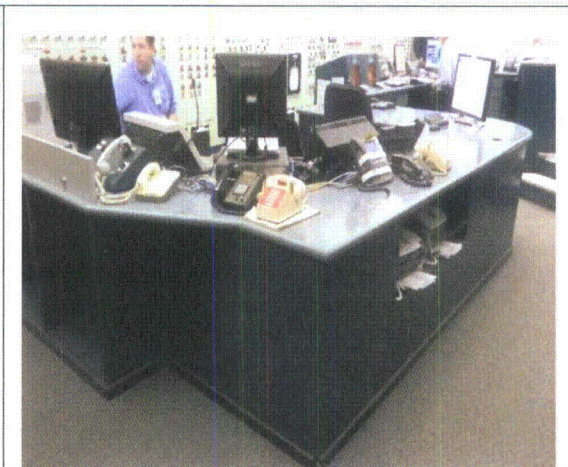
Note: Unrestrained phones, printers and monitors at work stations

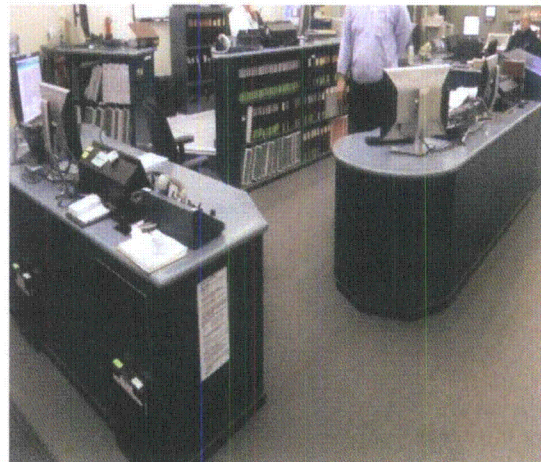
Note: Unrestrained phones, printers and monitors at work stations

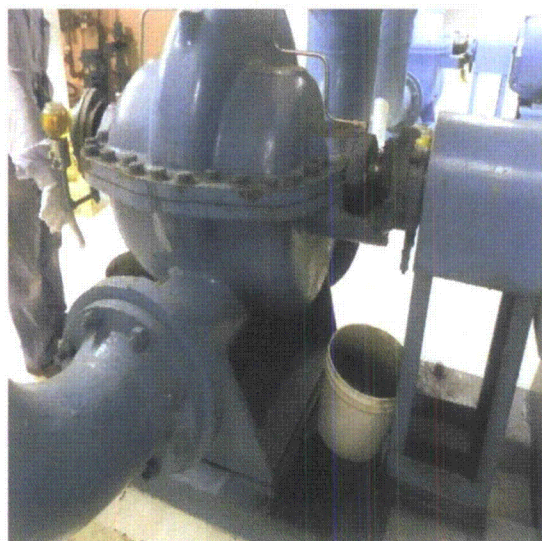
Note: Bucket at 32 CCW pump

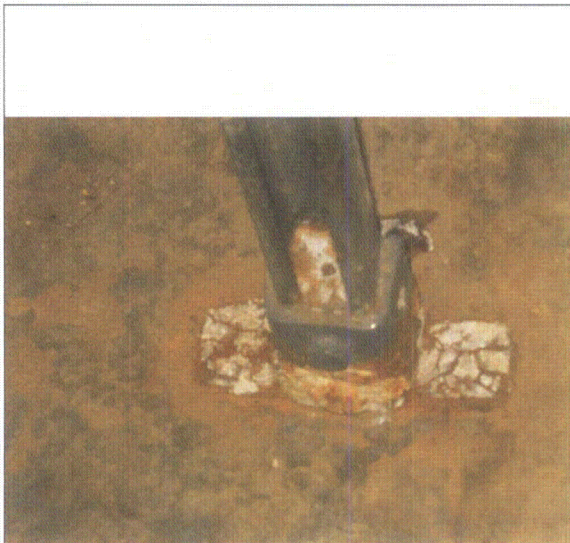
Note: Electric heat tracing cabinet base plate inside of curbed area.

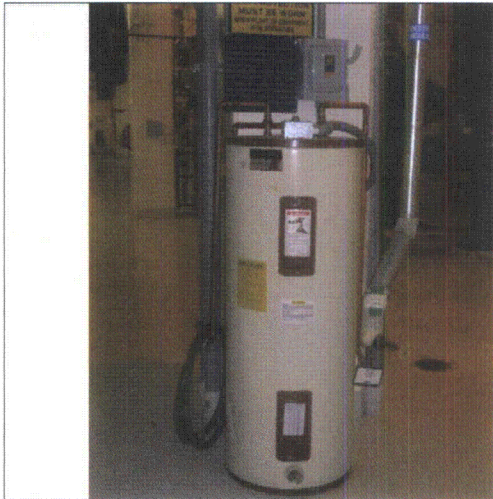
Note: Hot water heater with no apparent restraint

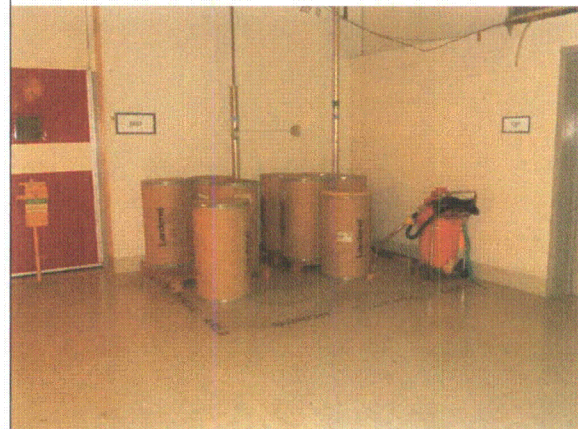
Note: Pallets, drums and vacuum not secured.

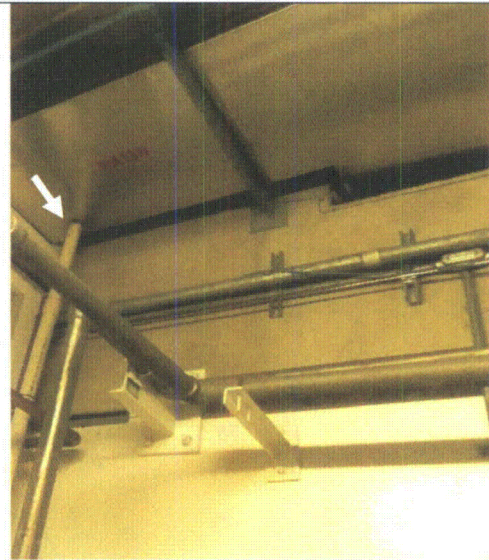
Note: PVC penetrates duct

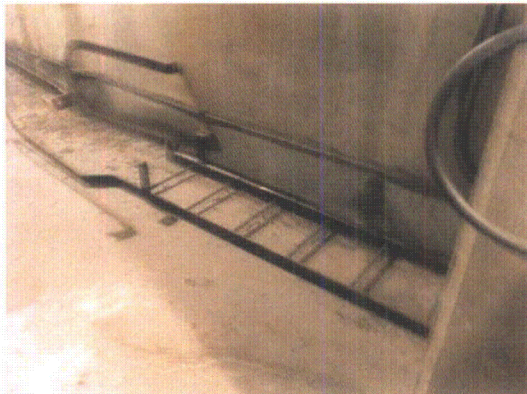
Note: unrestrained ladder by the north wall.

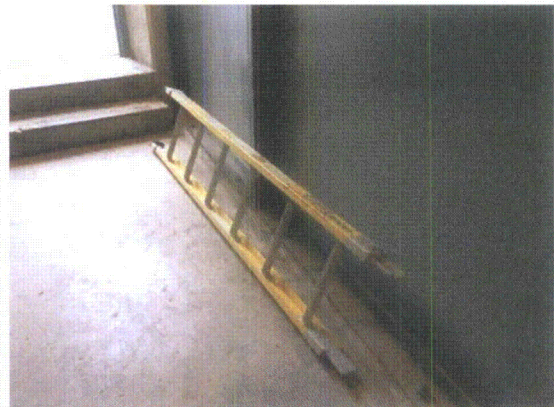
Note: unrestrained ladder by the door at the south corner of the room.

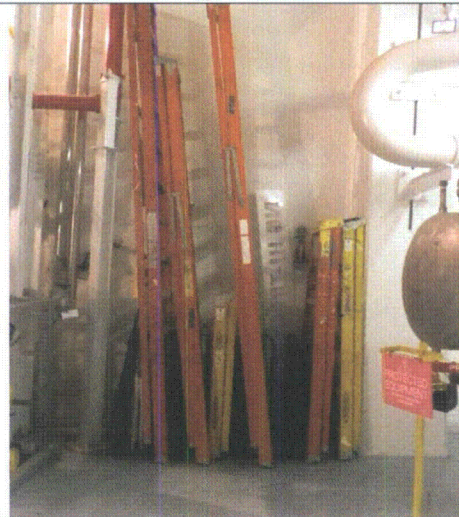
Note: Unrestrained ladders in a rack

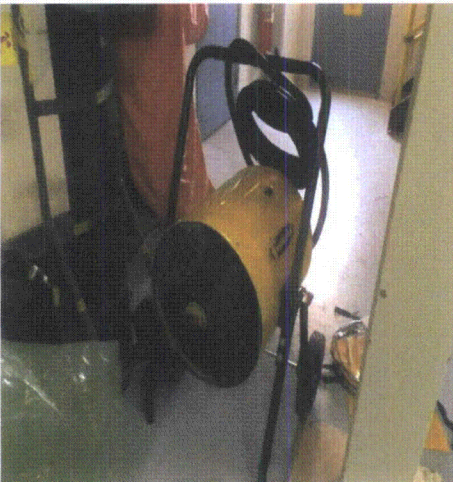
Note: An unrestrained heater and power supplier device on a wheeled cart

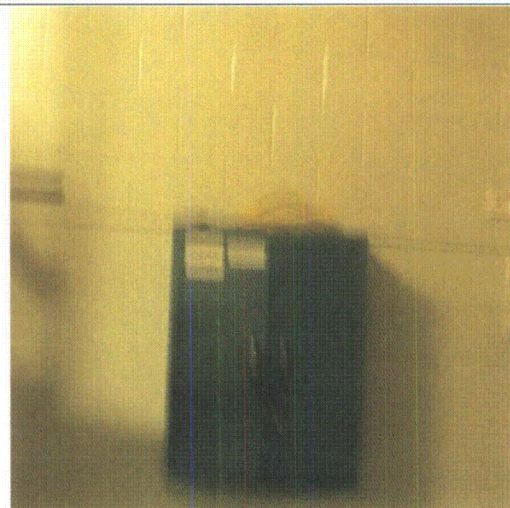
Note: Unrestrained cable and tools on top of the operations equipment cabinet
