NRC Internet Event Briefing

Palisades SIRWT Leak Repair and
Inspections

July 16, 2013

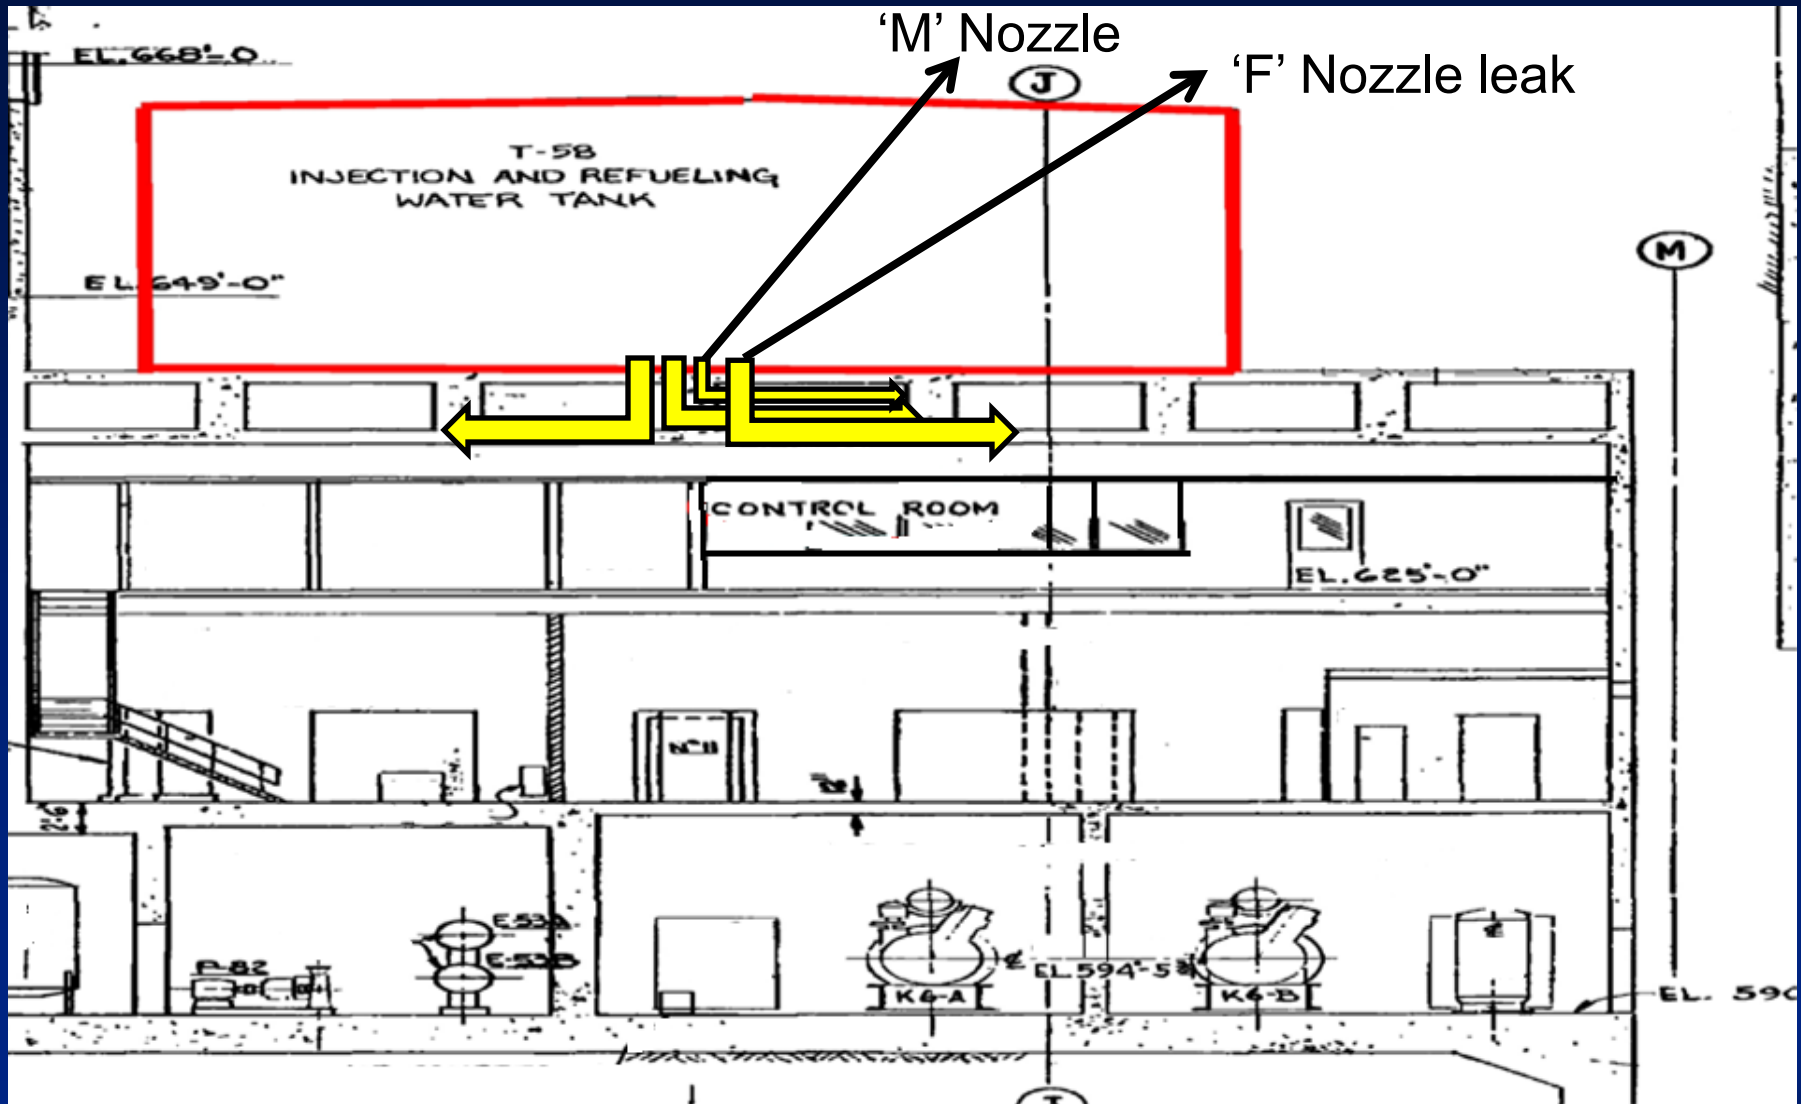
Safety Injection Refueling Water Tank (SIRWT)

Licensee determined the root cause of the SIRWT leak to be a failure of a nozzle weld resulting from an inadequate fusion at the weld root, i.e., a poorly performed weld from 2012

- The NRC reviewed the following actions by the Licensee:
 - Tank bottom replacement
 - Replacement of all welds associated with the floor inside the tank
 - Nozzle replacement
 - Installed a layer of fiber board between the concrete slab and new aluminum plating
