Monticello Nuclear Generating Plant
2807 W County Road 75
Monticello, MN 55362

Supplemental Information Regarding Cycle 25 Inservice Inspection Summary Report –
Core Shroud Support Flaw Evaluation

**SUPPLEMENTAL INFORMATION REGARDING
CYCLE 25 INSERVICE INSPECTION SUMMARY REPORT –
CORE SHROUD SUPPORT FLAW EVALUATION**

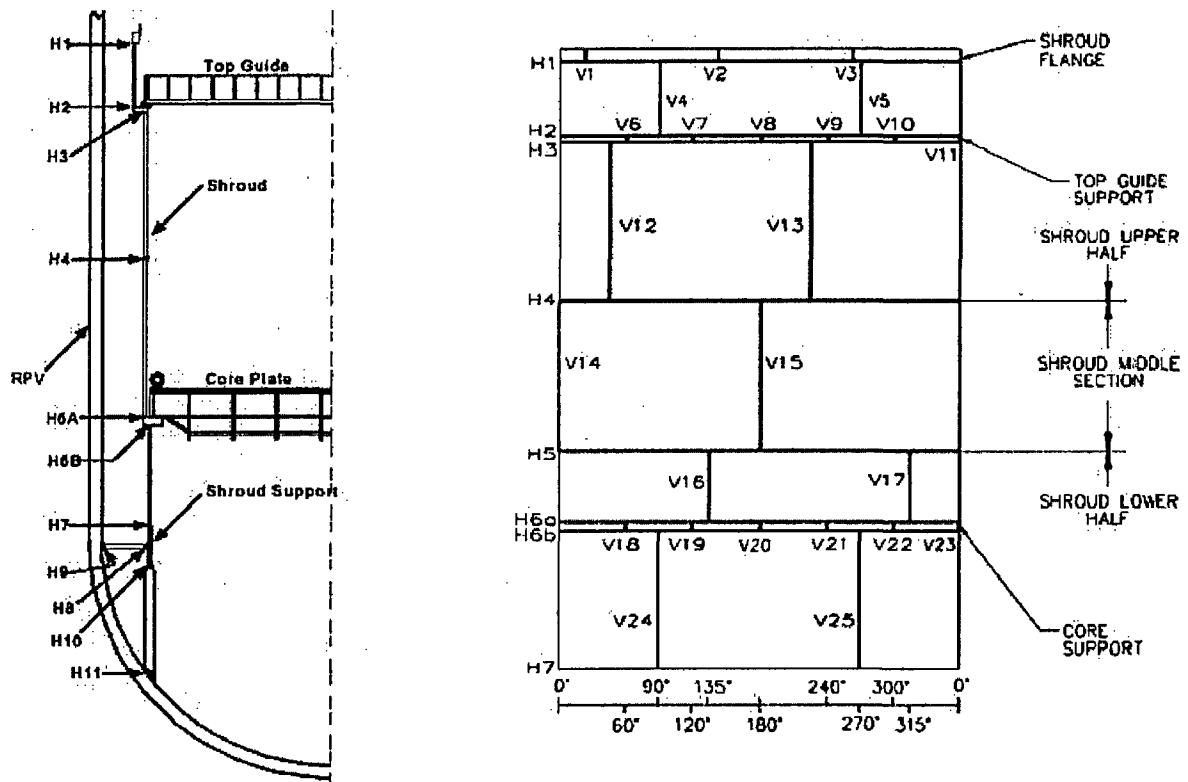
Figure 1. Sketch of Shroud with Typical Weld Locations

During the spring 2011 inspections of the reactor internals at the Monticello BWR, Xcel Energy visually discovered indications at the H8 (shroud support-to-shroud) weld and the H9 (shroud support-to-vessel) weld as shown in Figures 1 and 2. Previously, in spring 2009, indications had been observed in 11 of the 14 shroud support legs. Monticello is a BWR-3 and fabricated by CB&I. For this vessel, the H8 and H9 welds are full penetration double V welds. Figure 2 shows a schematic of the configuration for Monticello [11, Figure 5-59]. The indications observed were located on the bottom side of the shroud support plate thus exposing them to the water environment of the lower plenum.

plate to the bottom of the active fuel (BAF) that includes the underside of the shroud support plate welds H8, H9 and H10, Figures 1 and 2 [8]

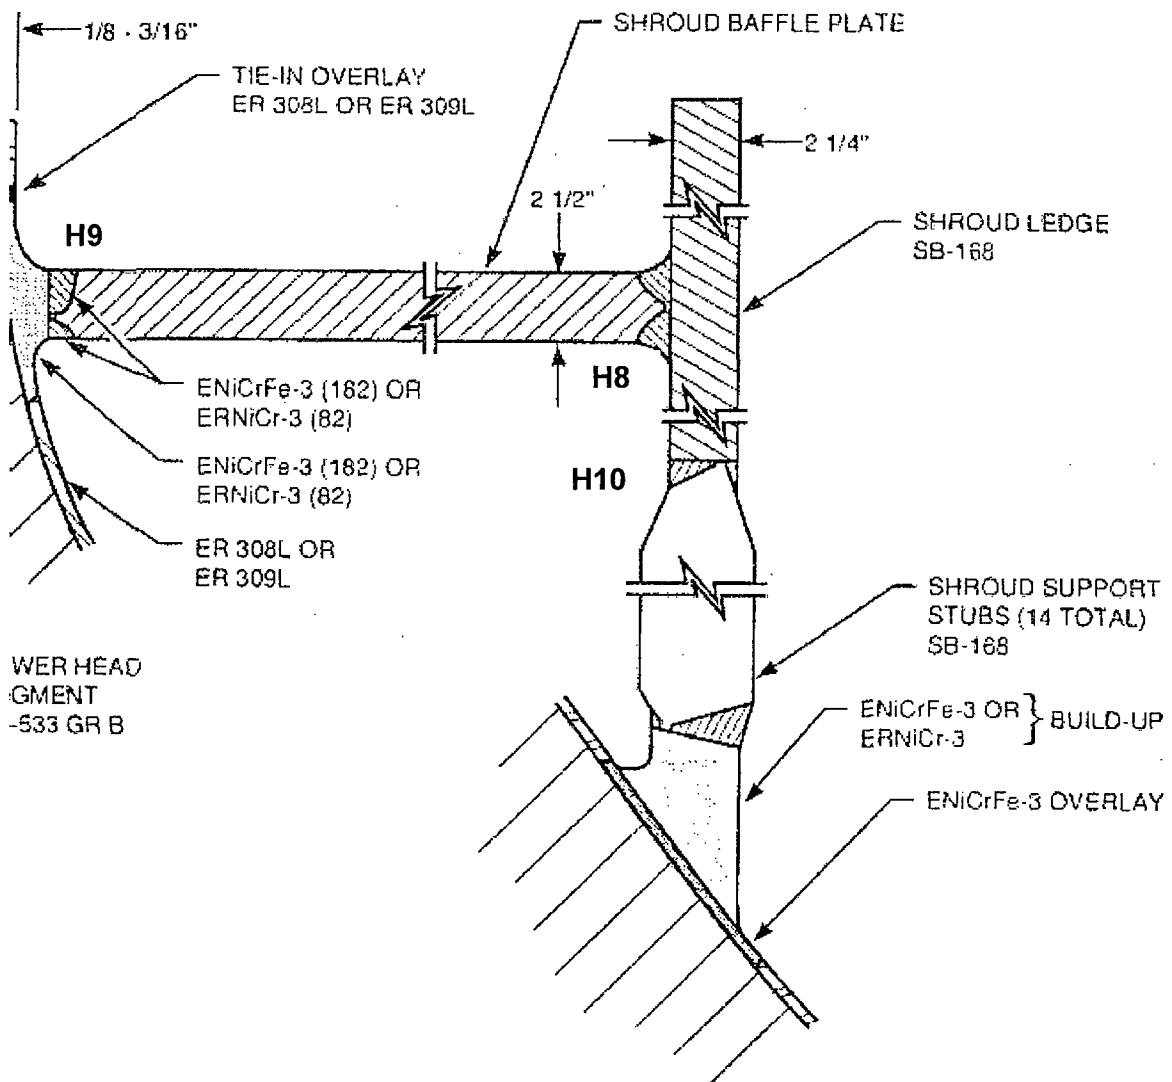
Figure 2: CBIN/CB&I Vessel Shroud Support Structure Attachment Configuration [2]

The observation of the cracking in the Alloy 182 weld metal is consistent based upon the relative susceptibility of the neighboring materials. Since the Alloy 182 is present through the thickness of the shroud support plate (see Figure 2), it is expected that solely based on the susceptibility of the materials involved, that the cracking would be most severe in the most susceptible material, the Alloy 182, and thus continue through the thickness of the shroud support plate.
