SUBJECT: **Calvert Cliffs Nuclear Power Plant, Unit 2**
Renewed Facility Operating License No. DPR-69
Docket No. 50-318

Supplemental Response to 10 CFR 50.54(f) Request for Information,
Recommendation 2.3, Seismic

**IN RESPONSE TO THE 50.54(f) INFORMATION
REQUEST REGARDING
FUKUSHIMA NEAR-TERM TASK FORCE
RECOMMENDATION 2.3: SEISMIC**

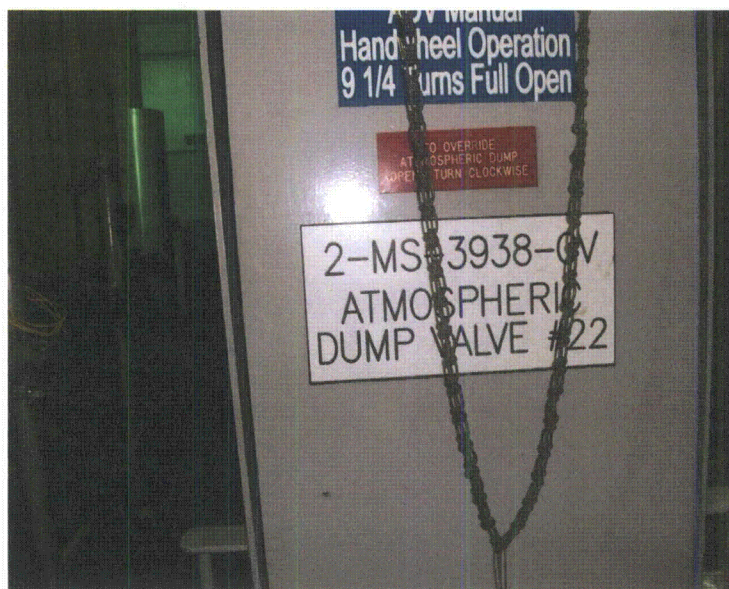
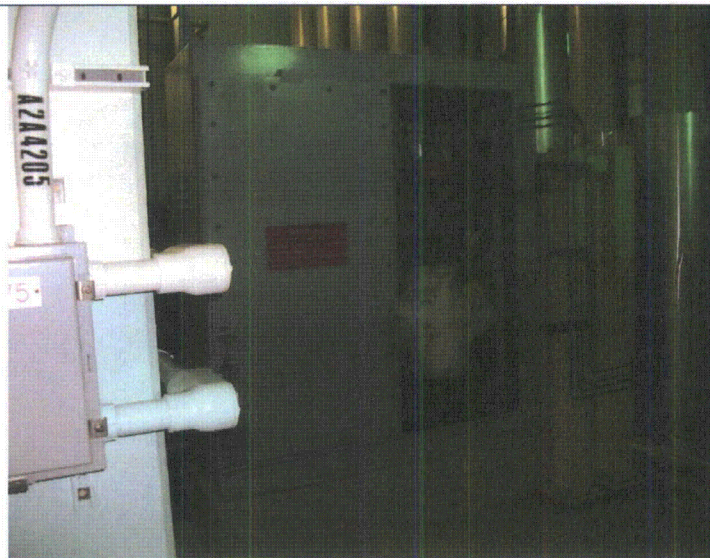
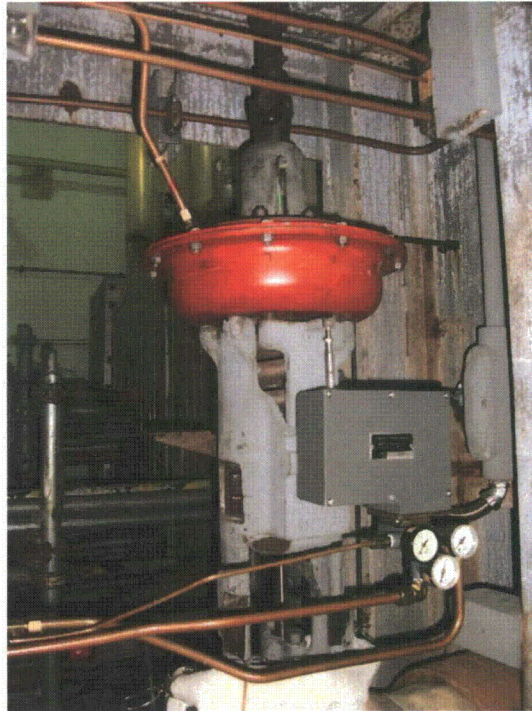
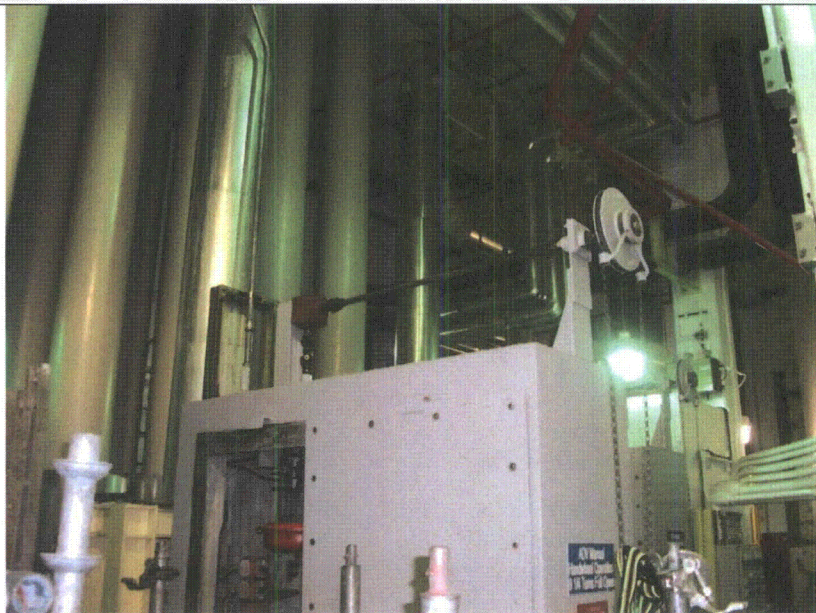
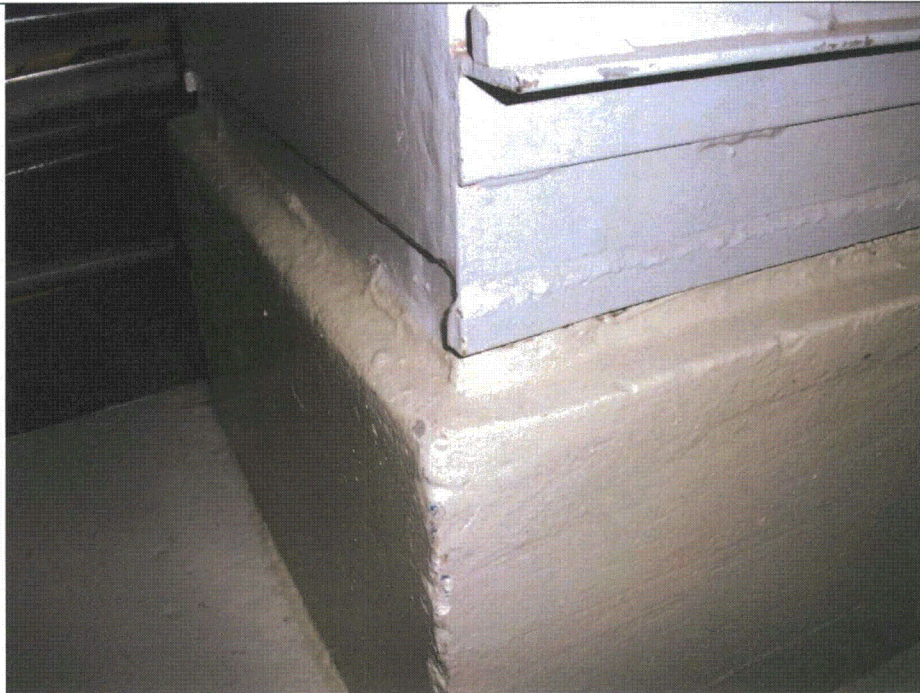
2CV3938 3-4-2013

Cracking in the caulk was noted between the valve enclosure and its concrete pedestal. This is a cosmetic defect which has no adverse affect the enclosure design function.

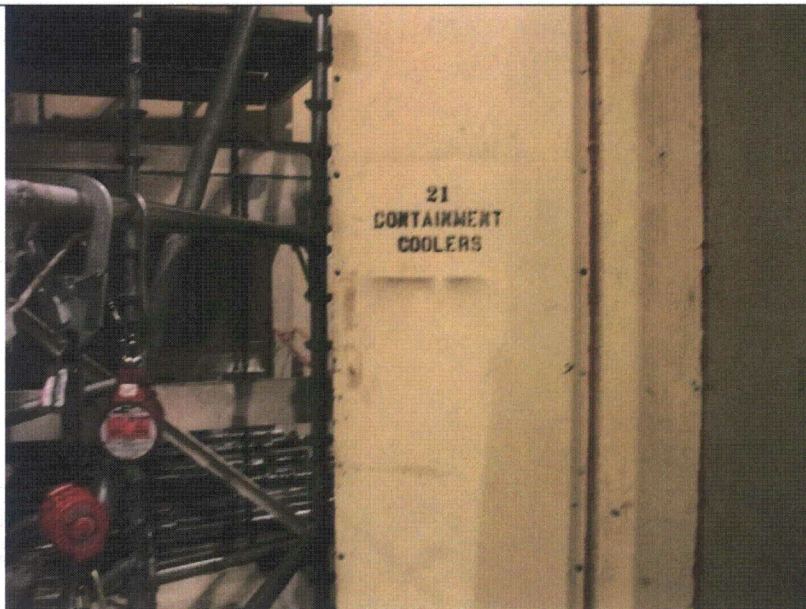
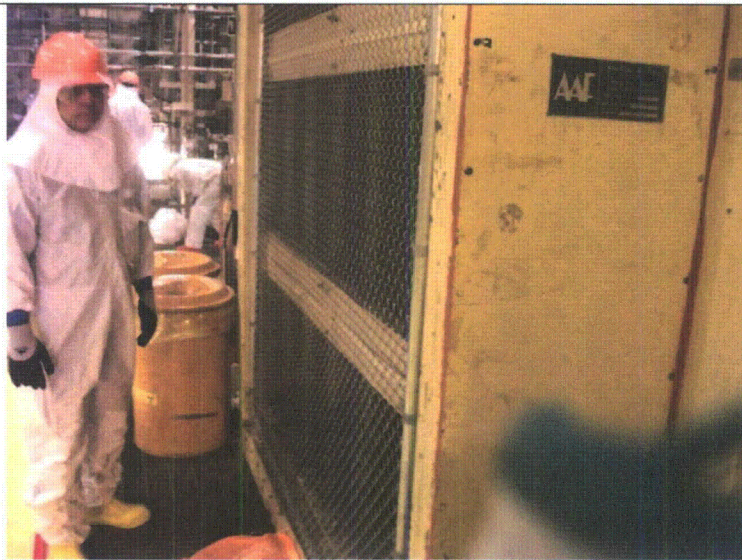
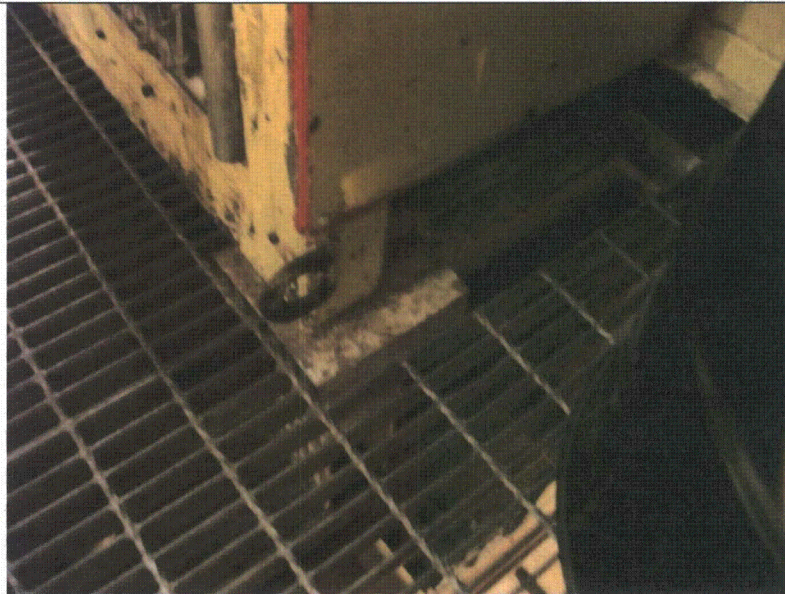
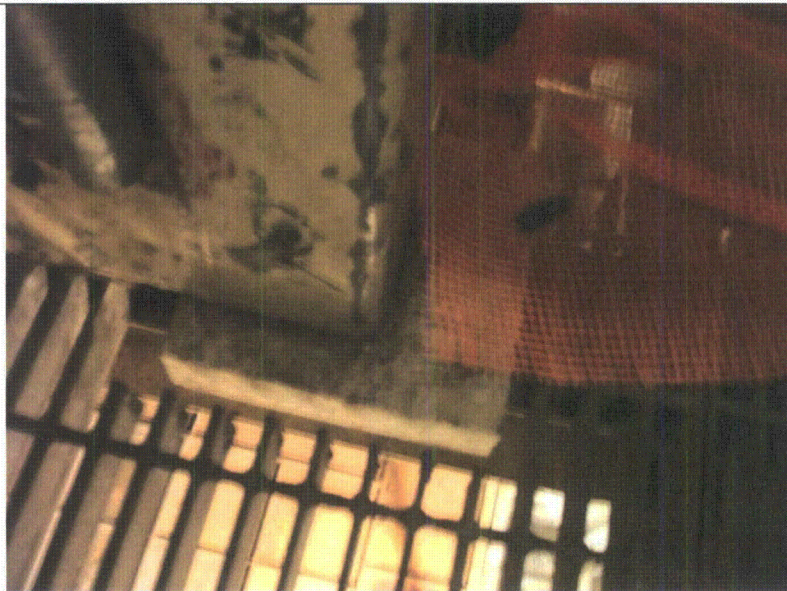
2FANHVACCTCLR21 2-22-2013

| <i>The housing for the Air Cooler was missing welds between corner columns and base plates. CR-2013-001820 captured the issue.</i> | |

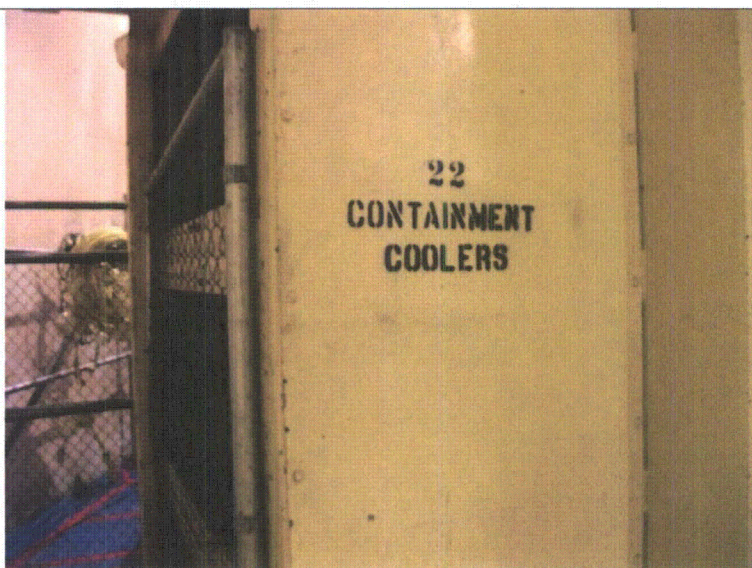
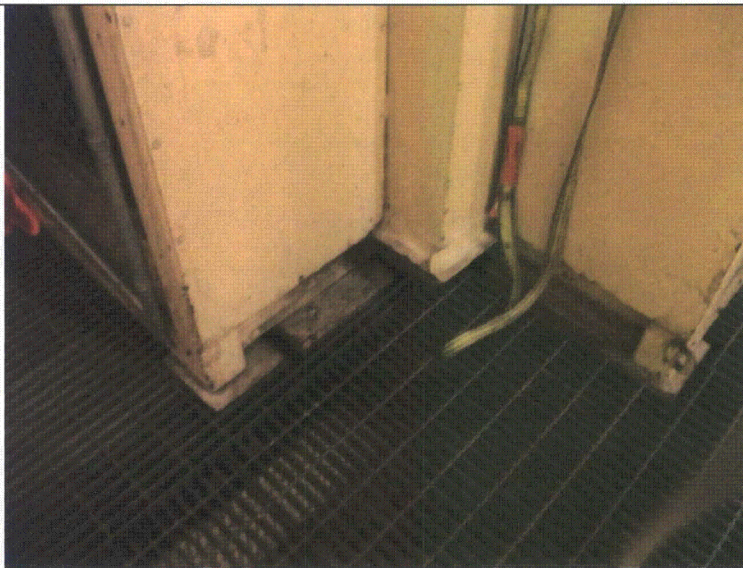
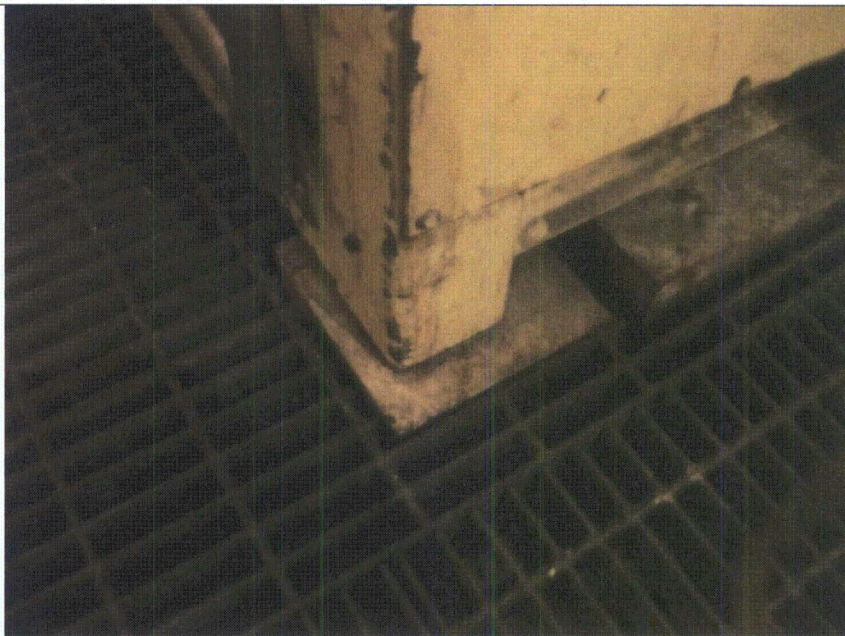
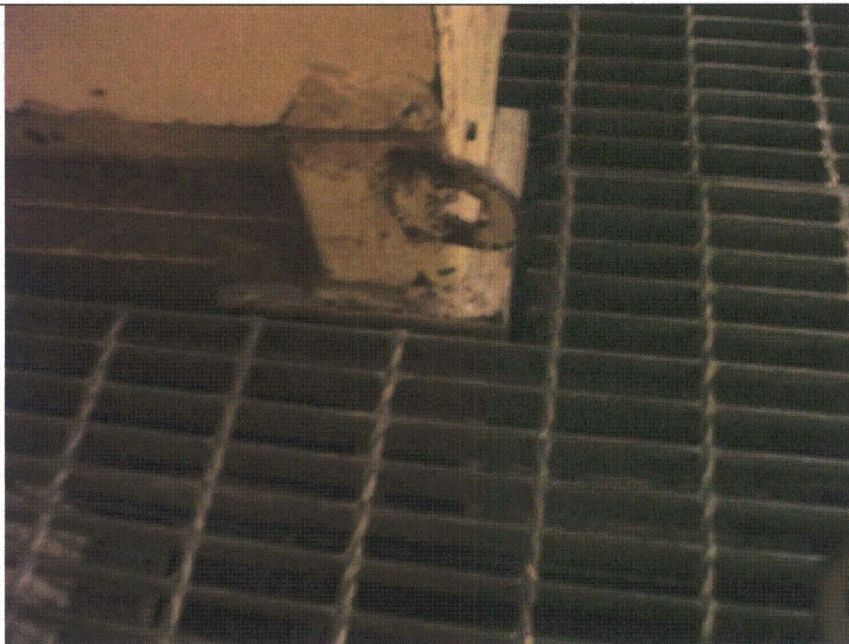
2FANHVACCTCLR22 2-22-2013

| <i>The housing for the Air Cooler was missing welds between corner columns and base plates. CR-2013-001820 captured the issue.</i> | |
