NRC Internet Event Briefing

**Palisades SIRWT Leak Repair and
Inspections**

July 16, 2013

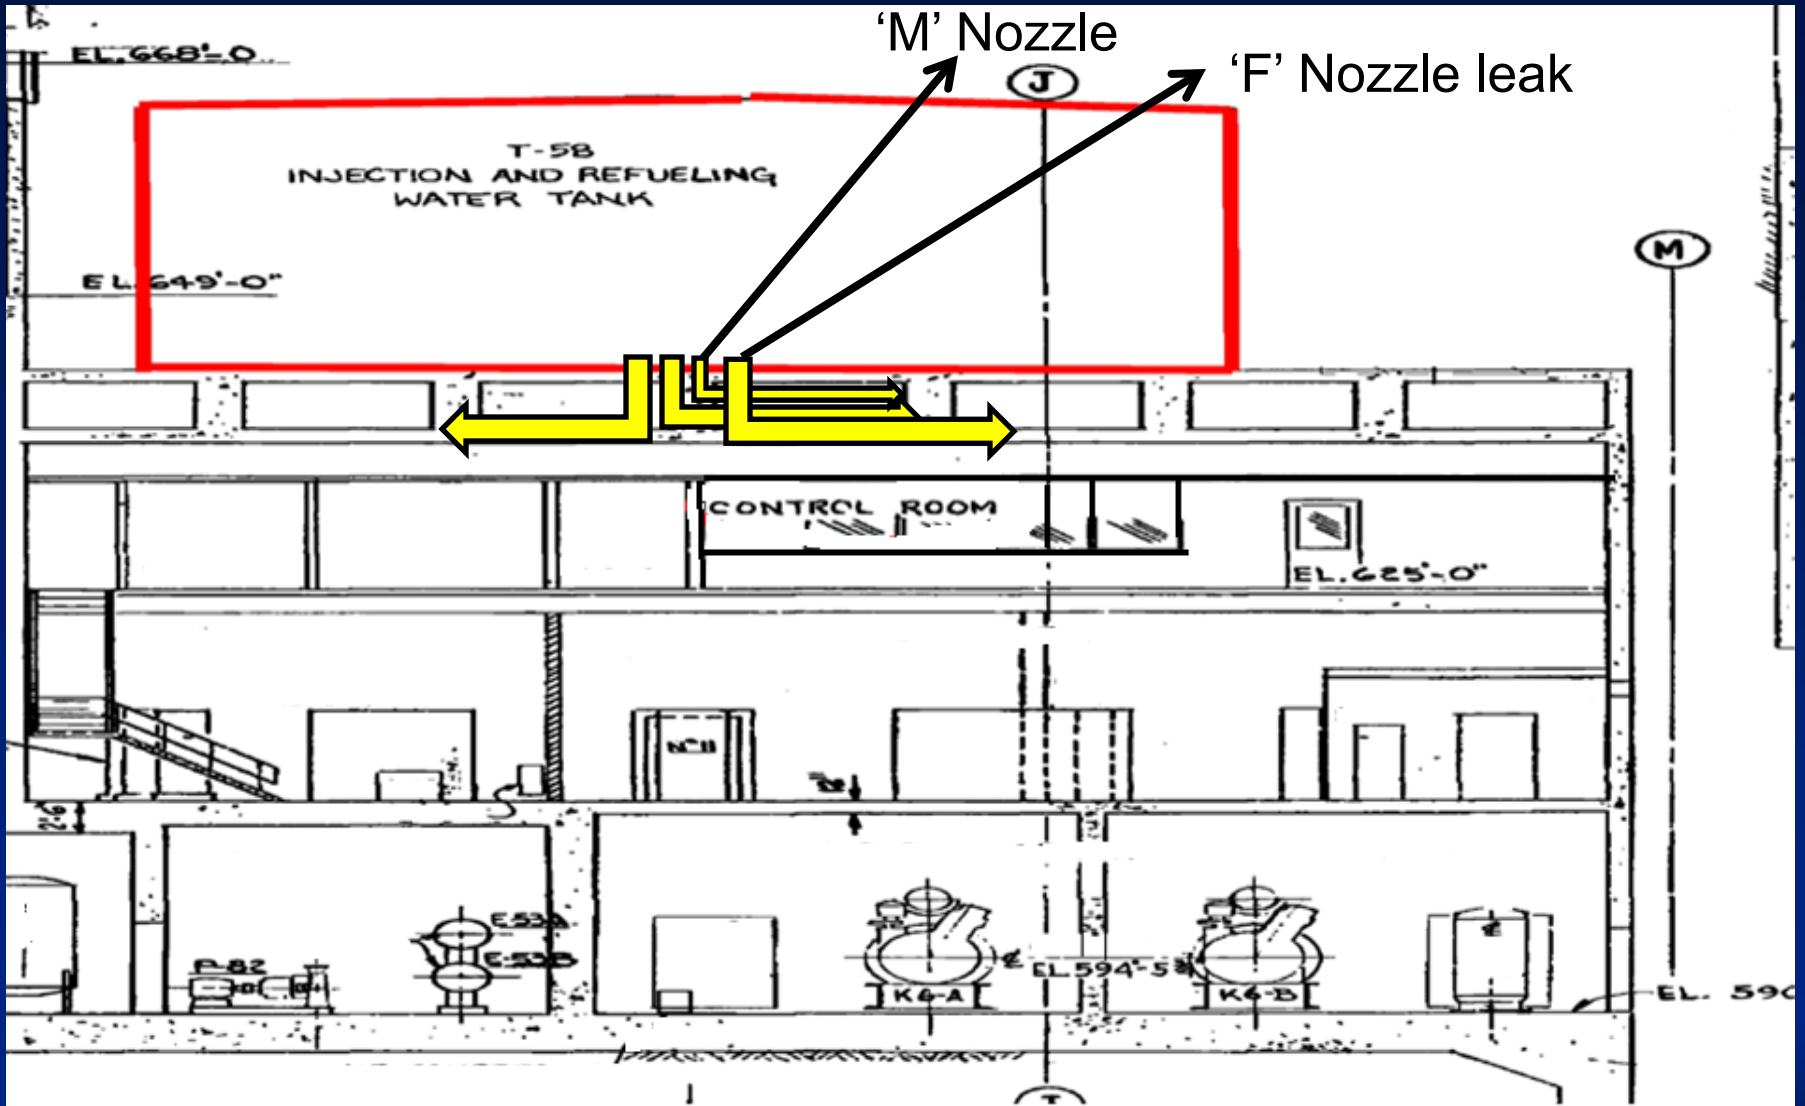
Safety Injection Refueling Water Tank (SIRWT)

- Palisades plant shutdown on May 5, 2013, due to observed SIRWT leakage of ~90 gallons per day (gpd)
- Exceeded the 38 gpd limit to shut down established by NRC's confirmatory action letter (CAL EA 12-155; ML12199A409)
- ~80 gallons of low radioactivity water spread onto the roof, down roof drains, into drains that go to Lake Michigan
- Released radioactivity to Lake Michigan (0.000002 rem) is well below regulatory limits (.1 rem/year) and did not impact the safety of plant workers or the public
- The sand samples taken near the plant discharge indicated no impact to the public – independently verified by NRC

Licensee determined the root cause of the SIRWT leak to be a failure of a nozzle weld resulting from an inadequate fusion at the weld root, i.e., a poorly performed weld from 2012

- The NRC reviewed the following actions by the Licensee:
 - Tank bottom replacement
 - Replacement of all welds associated with the floor inside the tank
 - Nozzle replacement
 - Installed a layer of fiber board between the concrete slab and new aluminum plating
