**NETCO Report NET-30054-01, Revision 0
"Inspection and Testing of Fast Start Surveillance Coupons F22-F11
from the LaSalle County Unit 2 Station"**

**Inspection and Testing of Fast Start
Surveillance Coupons F22-F11 from the
LaSalle County Unit 2 Station**

January 2013

Prepared
for
Exelon Generation

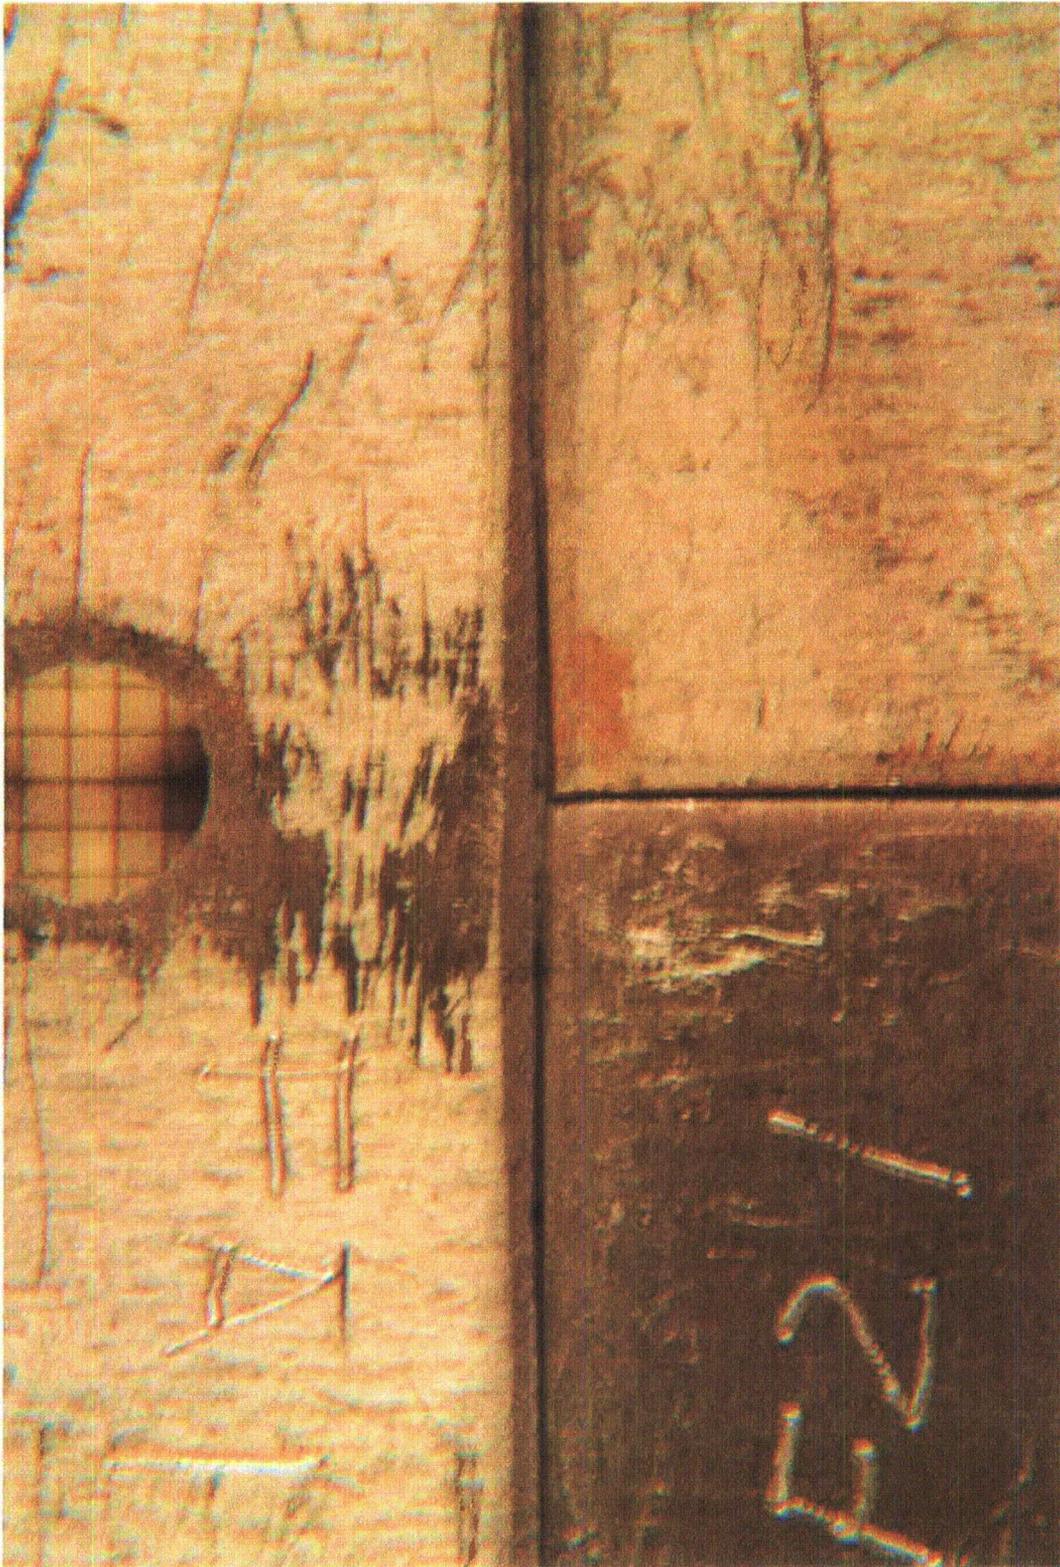
Photo 5- F22 & F21 comparison with archive

F22	<p>General: The ID F22 is inscribed in the upper right corner of the front side. The coupon is fully intact and is in pristine condition. There is no evidence of a light colored oxide film when viewed with the naked eye or under a microscope. Coupon F22 is similar in appearance to coupon F21. Coupon F22 is darker and less reflective than archive coupon FA4.</p> <p>Front side: The background color of this side is a medium grey. Against this background there are some scratches that appear lighter.</p> <p>Back side: The back side appears similar to the front with different scratch patterns.</p>
F21	<p>General: The inscription F21 appears in the upper right corner of the front side. The coupon is intact and is in pristine condition. To the naked eye there is no evidence of a corrosion film. F21 appears slightly darker and reflects less light than archive material not exposed to the pool water. Examination under a microscope showed no evidence of a light colored oxide. Side-by-side microscopic examination indicates the archive coupon is more reflective than F21.</p> <p>Front Side: The color of this side is uniform except where there are scratches where the color is lighter.</p> <p>Back Side: The appearance of the back side is similar to the front side.</p>
