<b>ENTERGY</b>	<b>ENGINEERING STANDARD</b>	<b>EN-EP-S-002-MULTI</b>	<b>REV. 1</b>
	<b>Underground Piping and Tanks General Visual Inspection</b>		<b>PAGE 15 OF 15</b>

**ATTACHMENT 7.3 PIPE/TANK BASE MATERIAL VISUAL INSPECTION CHECKLIST**  
**Sheet 1 of 2**

Line/Tank ID & Name: 3-SI-161-3, 3-SI-161-4 / 3-in SI Line 161 Work Order: 279577-02

Location: IP3 NW WHUT PIT Thickness: 0.216" Inspector: J. Peterson

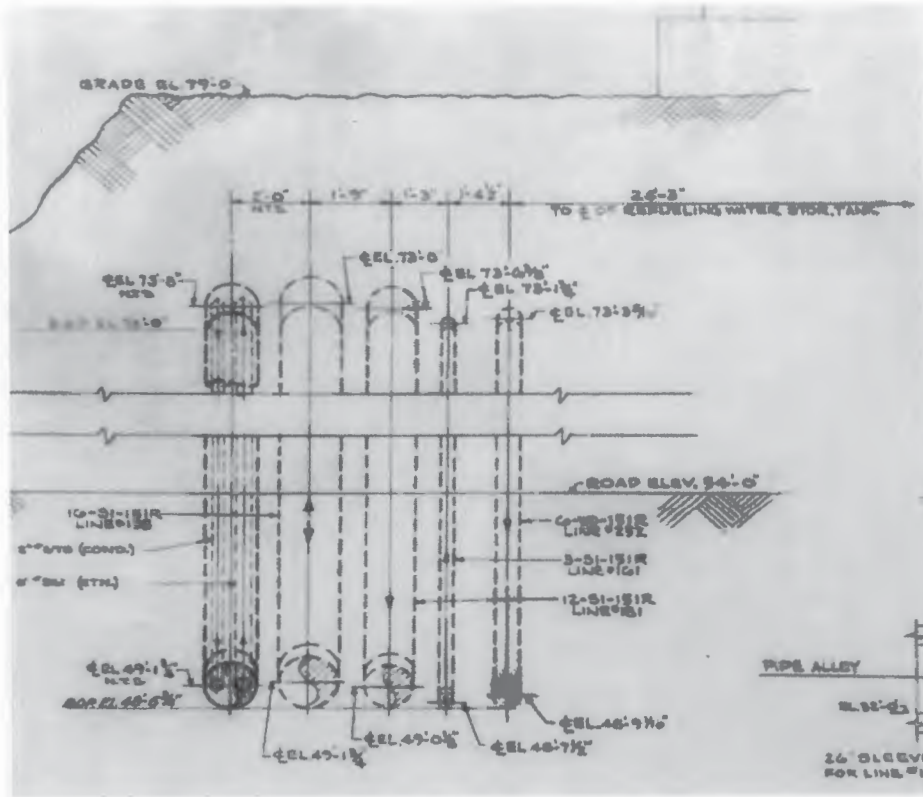
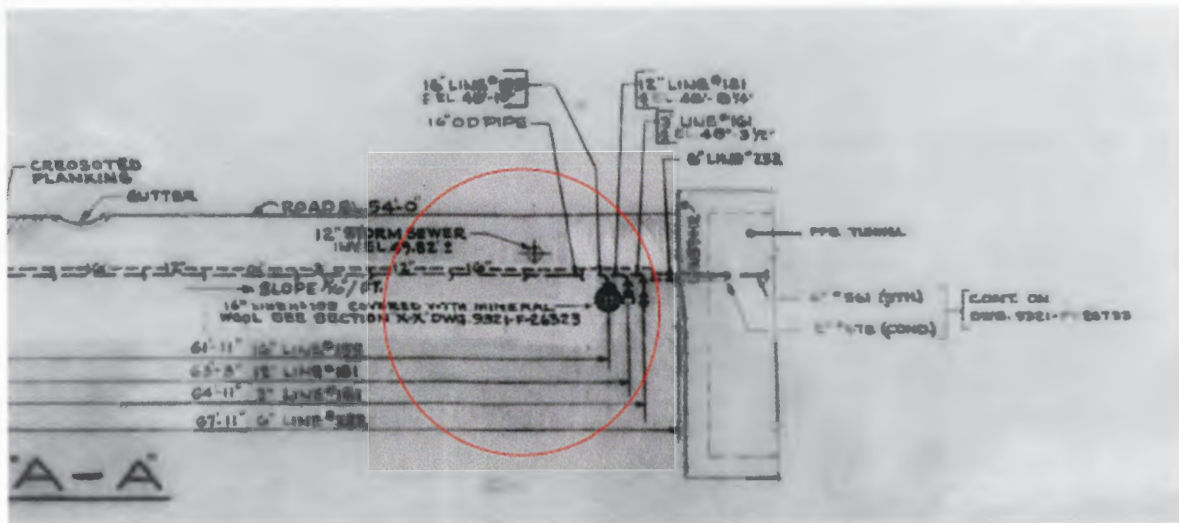
A 15 ft (N-S) x 20 ft (E-W) x 8 ft (deep) excavation (grade is at approx. El. 54 ft) uncover the following lines:

1. 6-inch WD Line 252 (RWST overflow to WHUT)
2. 3-inch SI Line 161 (SIP return to the RWST)
3. 12-inch SI Line 181 (RWST to Cont. Spray Pumps)
4. 16-inch SI Line 155 (RWST to RHR Pumps)
5. 16-inch outer pipe containing 6-inch STM Line 561 and 2-inch COND Line 678

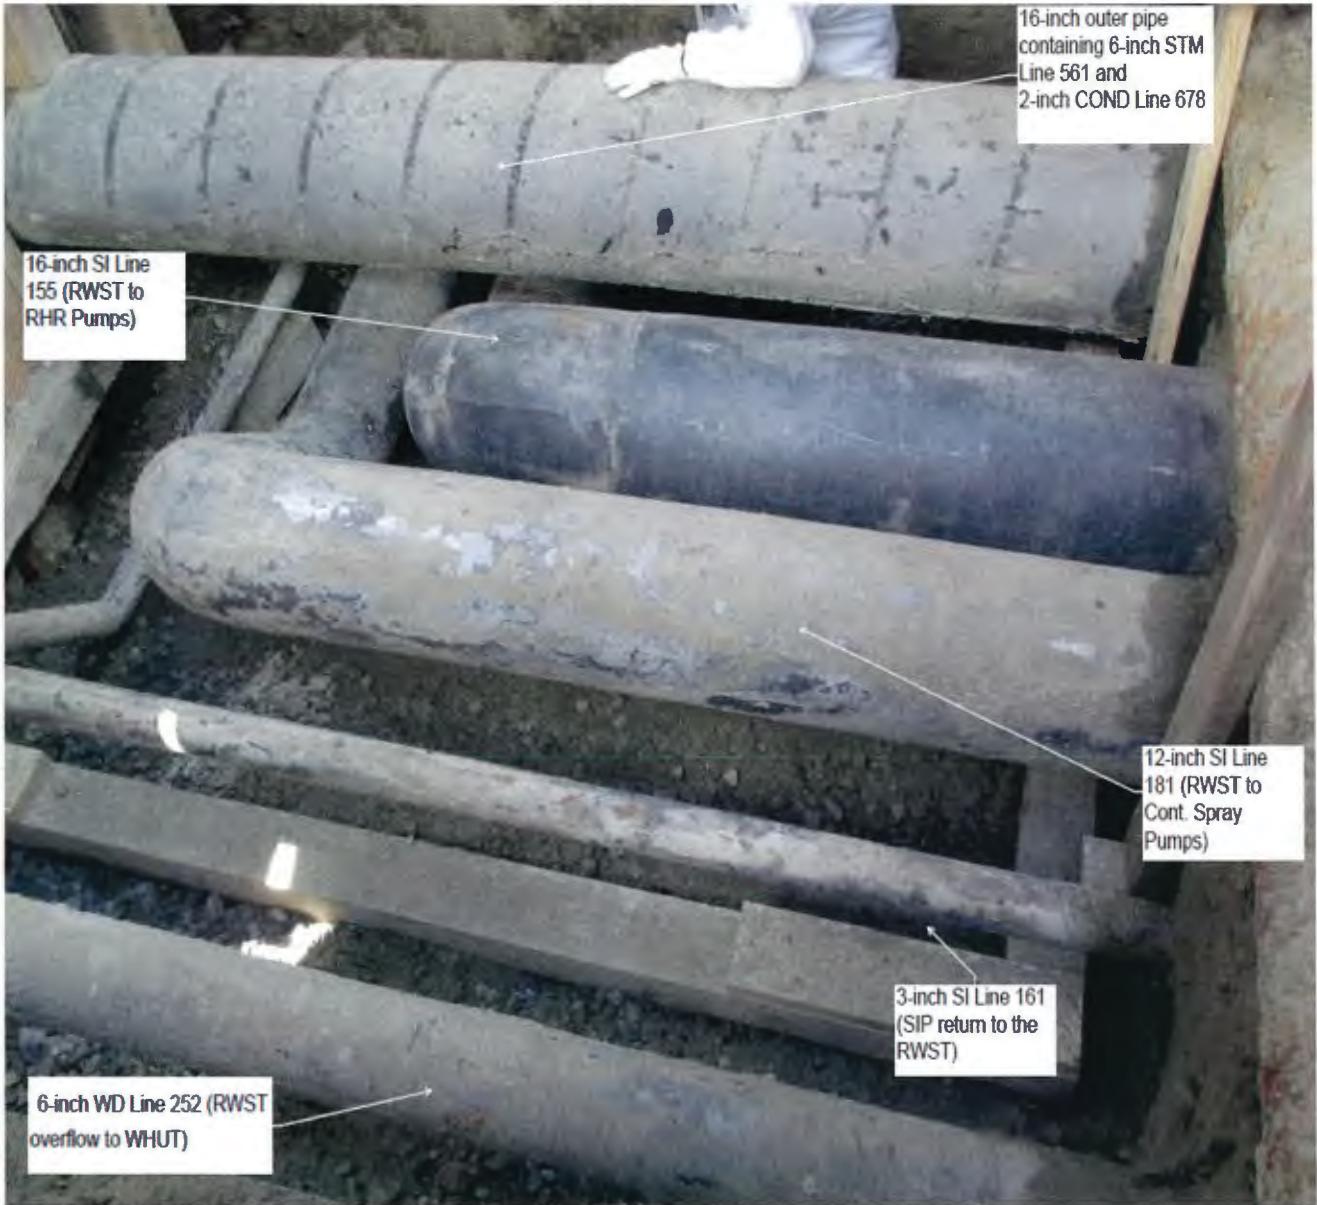
16-inch outer pipe  
containing 6-inch STM  
Line 561 and  
2-inch COND Line 678

16-inch SI Line  
155 (RWST to  
RHR Pumps)

12-inch SI Line  
181 (RWST to  
Cont. Spray  
Pumps)

3-inch SI Line 161  
(SIP return to the  
RWST)

6-inch WD Line 252 (RWST  
overflow to WHUT)

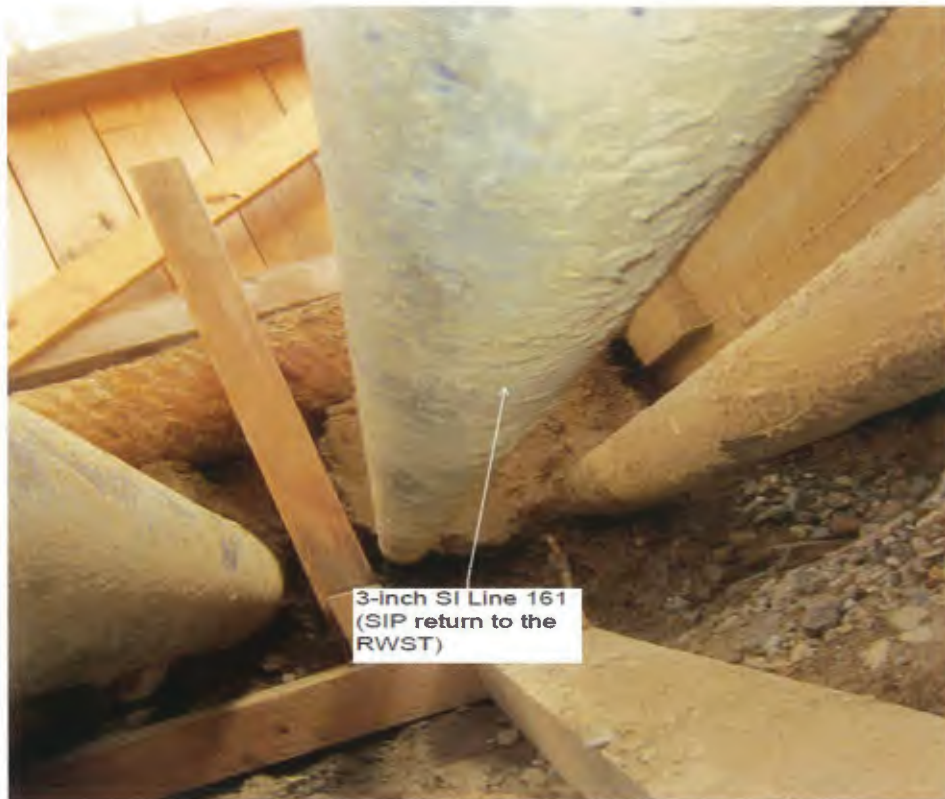
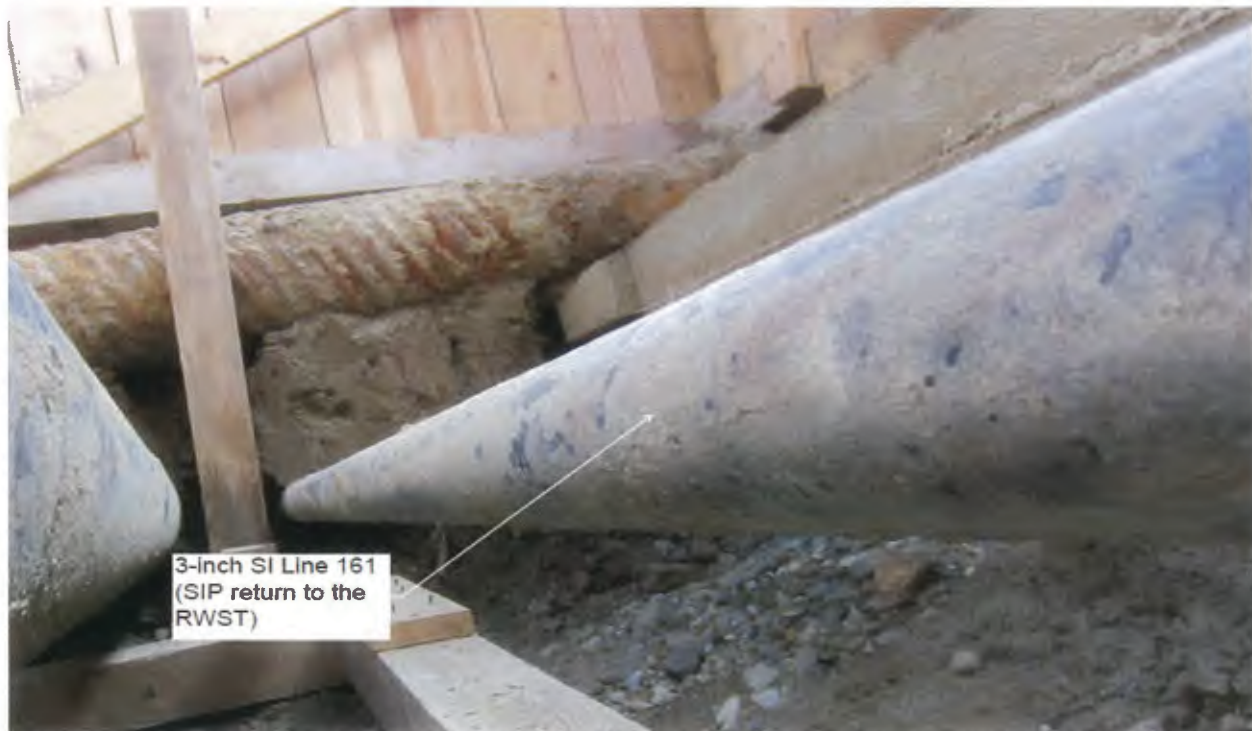
6-inch WD Line 252 (RWST overflow to WHUT)

3-inch SI Line 161 (SIP return to the RWST)
