ENTERGY	ENGINEERING STANDARD	EN-EP-S-002-MULTI	REV. 1
	Underground Piping and Tanks General Visual Inspection	PAGE 14 OF 15

ATTACHMENT 7.2 PIPE/TANK COATING VISUAL INSPECTION CHECKLIST

Line/Tank ID & Name: 8-in Fire Protection Line Work Order: 279577-02
 System: Fire Protection Inspection Date: 5/14/2013
 Location: IP3 NW WHUT PIT Inspector: J.Peterson/S.Guarnaccia
 Coating Material: Koppers Bitumastic with tape wrap Thickness: Original-As found

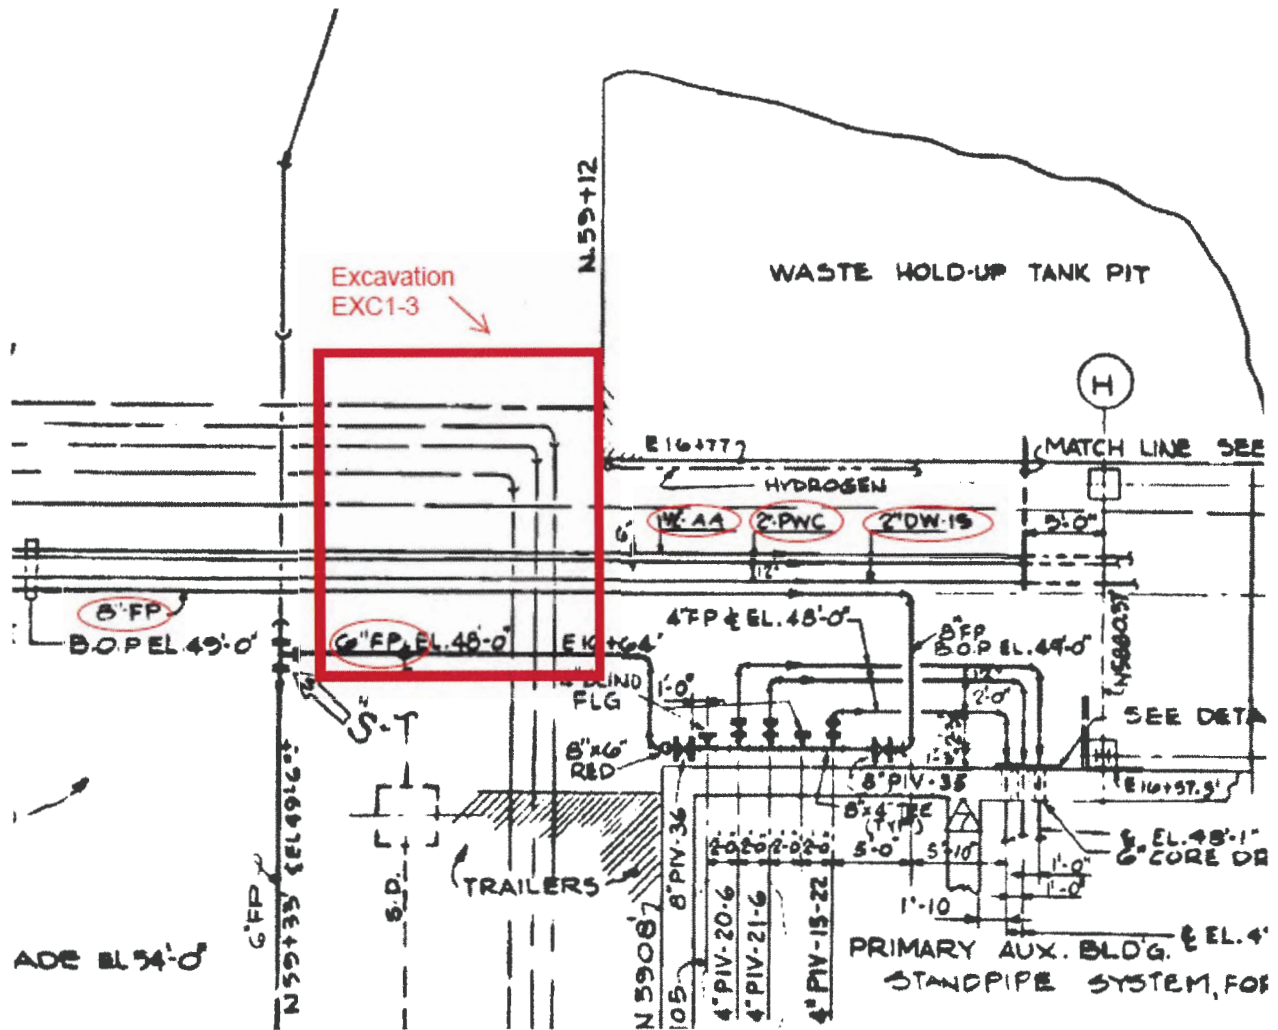
Reference: drawing 9321-F-41823

- Piping Uncovered for inspection:
- 1.5-inch Admin Air Line
 - 2-inch Potable Water (cold) Line
 - 2-inch Demineralized Water Line
 - 8-inch Fire Protection Line
 - 6-inch Fire Protection Line

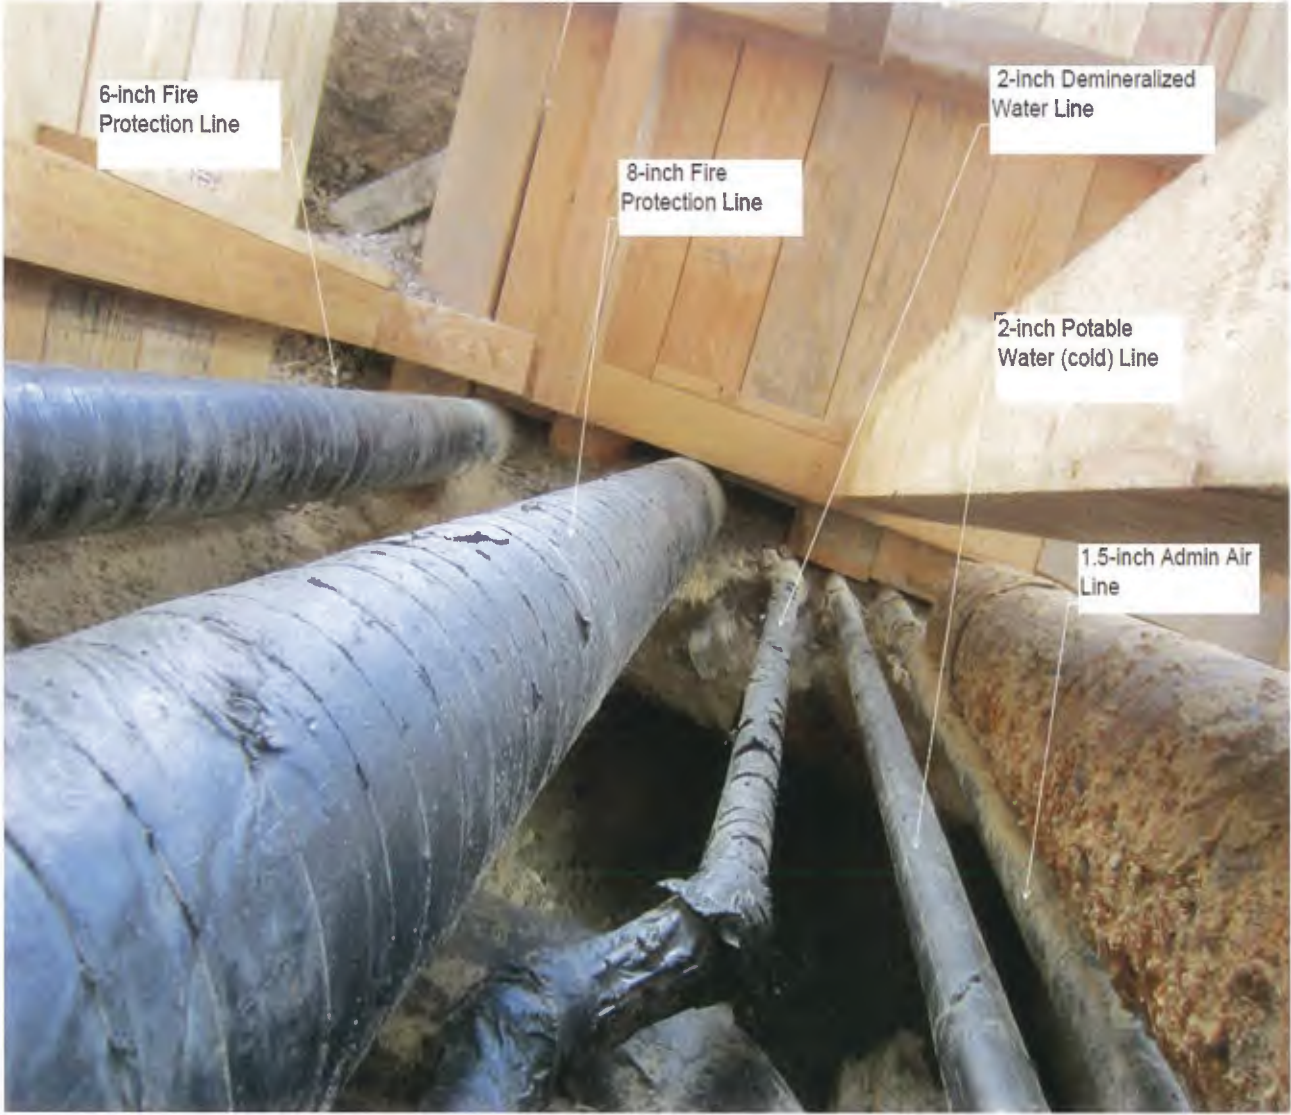
8-inch Fire Protection Line

Comments: Coated piping was wrapped with exterior tape (protective tape). Minor imperfections observed in the exterior tape wrap that did not penetrate down to the coating surface. Damaged could have occurred during excavation. Recommend wrap repair (overlap with new tape). Photos and sketch attached, Ref: Drawing 9321-F-41823.

Recommend that these anomalies be evaluated and repaired as required prior to backfill of the excavation.
