ENTERGY	ENGINEERING STANDARD	EN-EP-S-002-MULTI	REV. 1
	Underground Piping and Tanks General Visual Inspection	PAGE 14 OF 15

ATTACHMENT 7.2 PIPE/TANK COATING VISUAL INSPECTION CHECKLIST

Line/Tank ID & Name: 6-in Fire Protection Line Work Order: 279577-02
 System: Fire Protection Inspection Date: 5/14/2013
 Location: IP3 NW WHUT PIT Inspector: J.Peterson/S.Guarnaccia
 Coating Material: Koppers Bitumastic with tape wrap Thickness: Original-As found

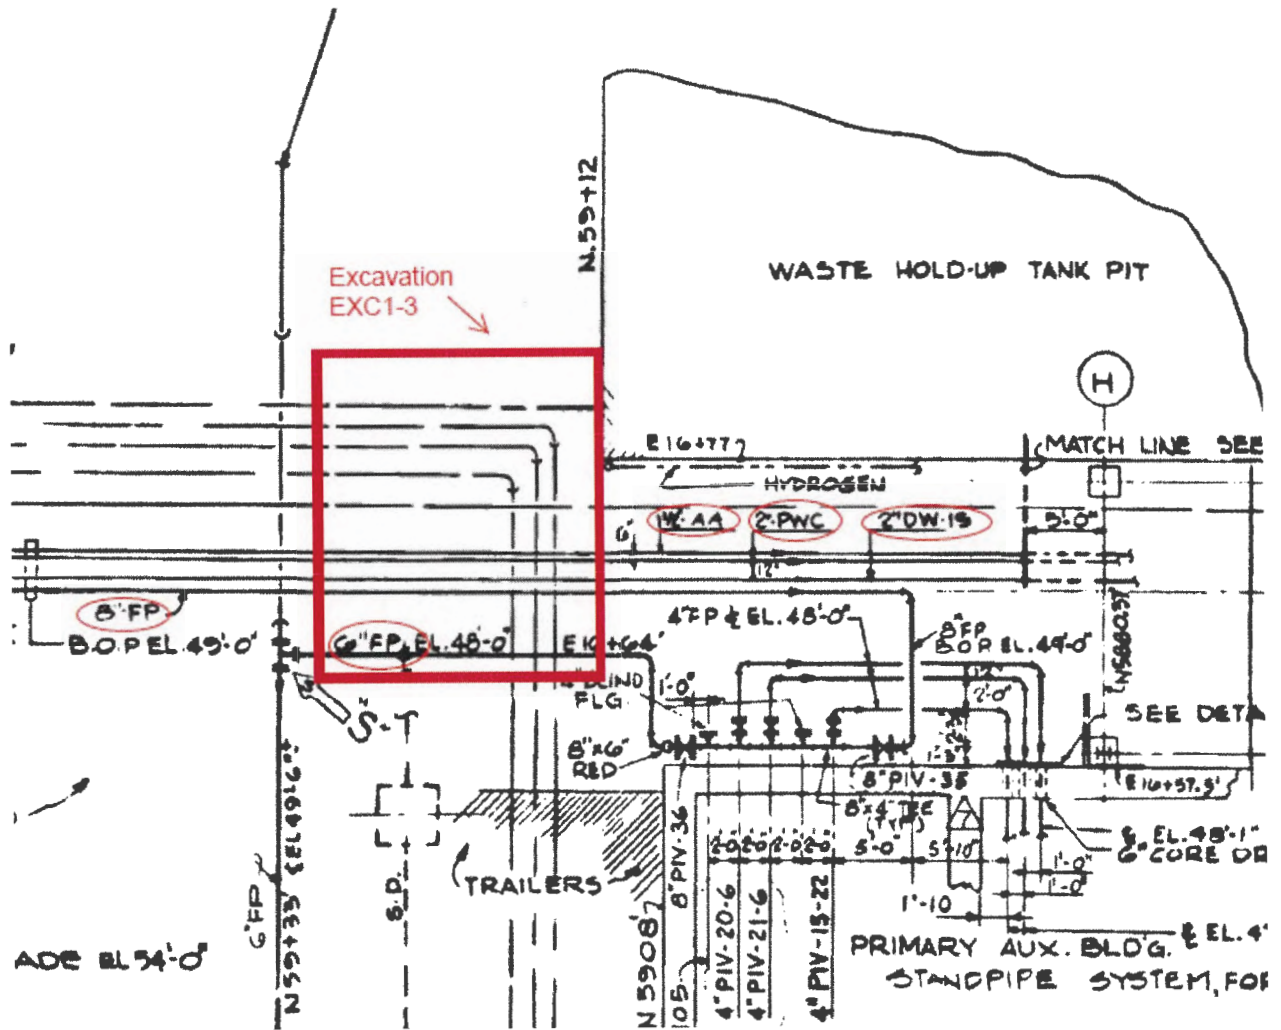
Reference: drawing 9321-F-41823

Piping Uncovered for inspection:

- 1.5-inch Admin Air Line
- 2-inch Potable Water (cold) Line
- 2-inch Demineralized Water Line
- 8-inch Fire Protection Line
- 6-inch Fire Protection Line
