Stator Drop Root Cause Evaluation (Non-Proprietary)

Entergy Operations, Arkansas Nuclear One (ANO)

Root Cause Evaluation Report

Unit 1 Main Turbine Generator Stator

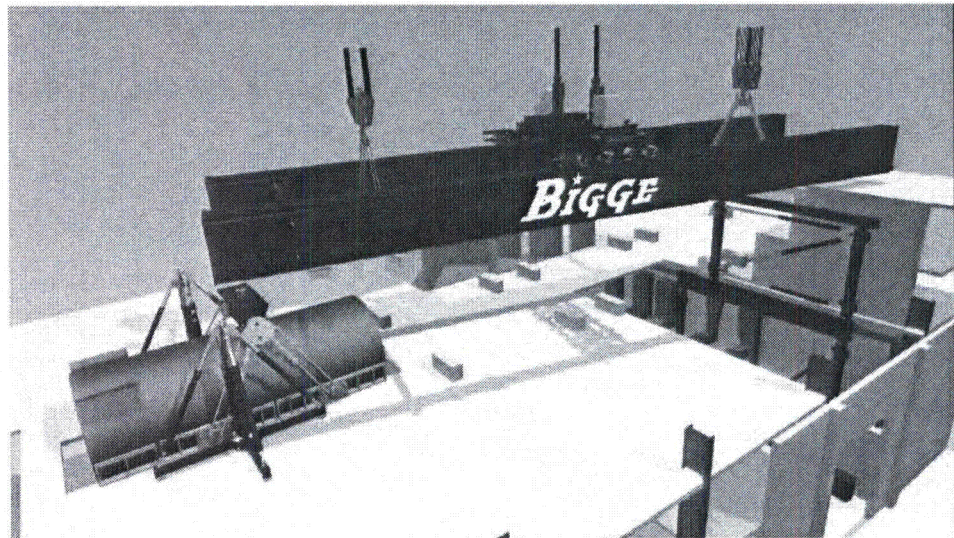
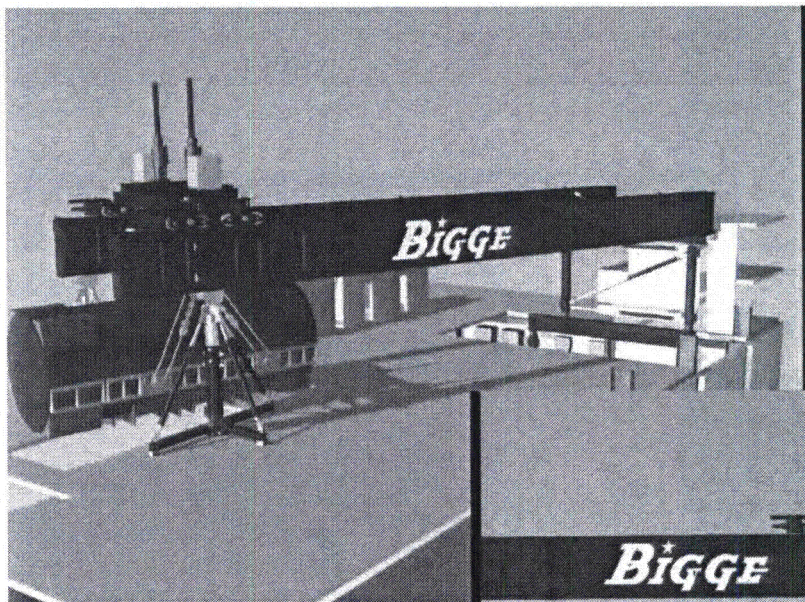
A portable gantry system is assembled between the Unit 1 stator and the train bay. Stations are placed at the south end of the gantry system. A tower is assembled at the north end of the gantry system in the train bay.

The Unit 1 stator is lifted. The procedure requires that the load is monitored to ensure there is not an overload due to binding or unexpected weight. The load is level to within specifications.

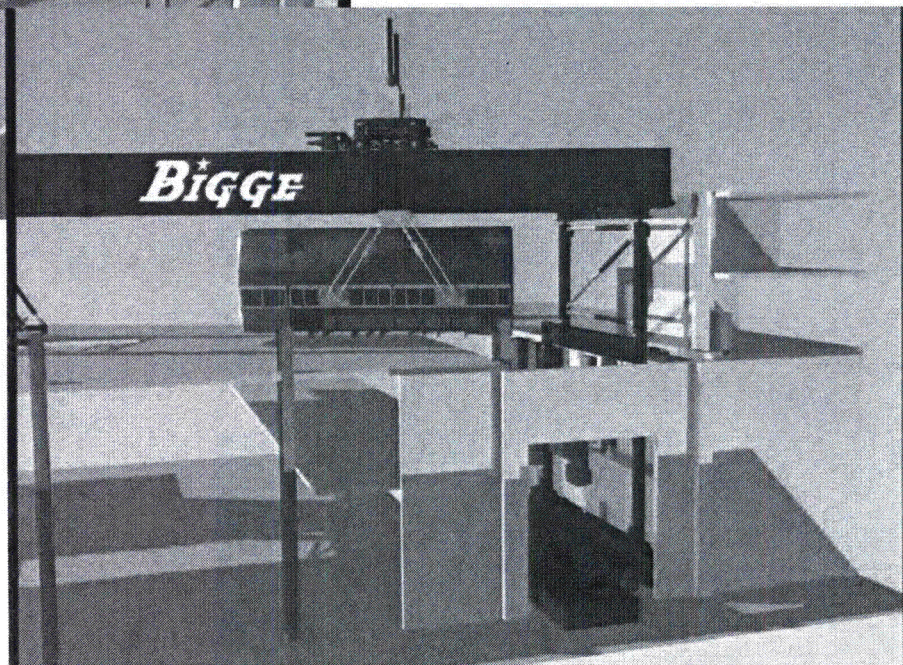
The load is then transported to the train bay and rotated to lower into the bay.

A Goldhofer transport is located in the train bay to receive the stator.

The stator is rotated to align with the train bay.

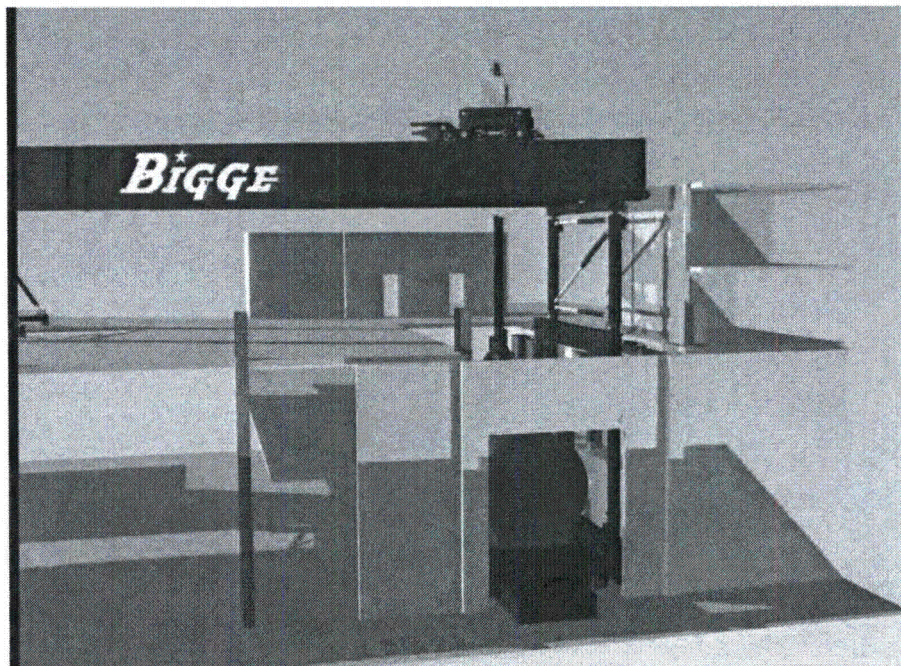
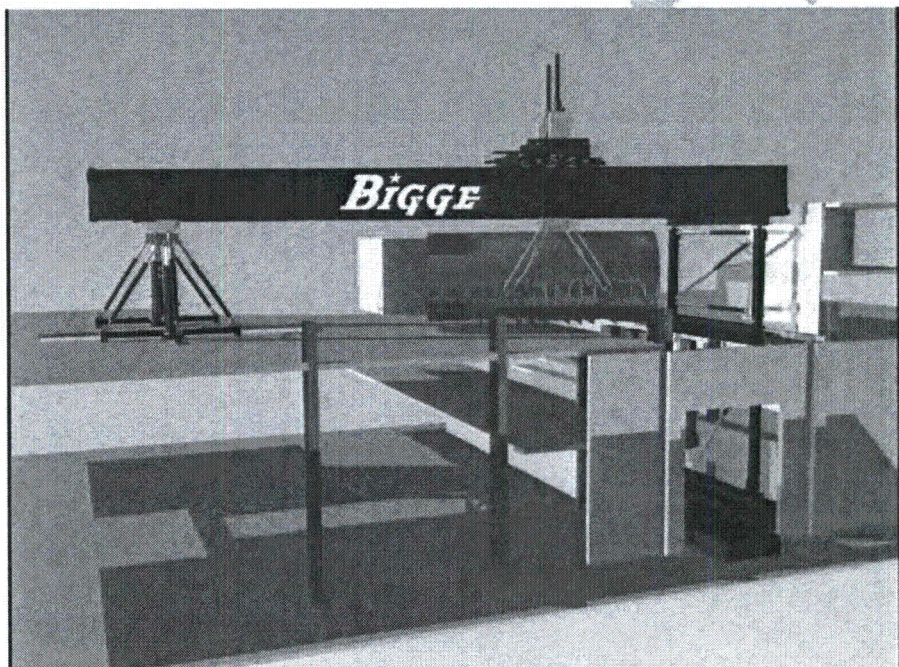
The stator is lowered on to the Goldhofer. Scaffolding is built to gain access to remove the rigging. Once the rigging is removed, the stator is then removed from the train bay. The modernized stator is brought into the train bay and the process is reversed to return the modernized stator to the stator pedestal.
