**Ultrasonic Phased Array
Assessment of the Interference
Fit and Leak Path of the
North Anna Unit 2 Control Rod
Drive Mechanism Nozzle 63 with
Destructive Validation**

Manuscript Completed: January 2012
Date Published:

Prepared by
S. L. Crawford, A. D. Cinson, P. J. MacFarlan, B. D. Hanson,
R. A. Mathews

Pacific Northwest National Laboratory
P.O. Box 999
Richland, WA 99352

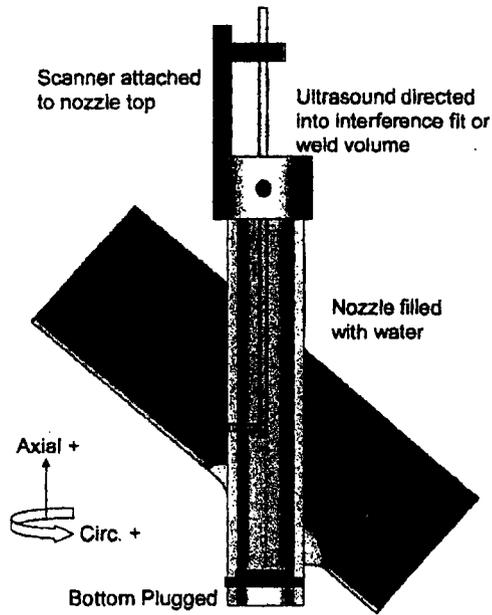
Figure 3.6 Scanning Setup Orientation Schematic

Comment [PG07]: Same as figure 5.3

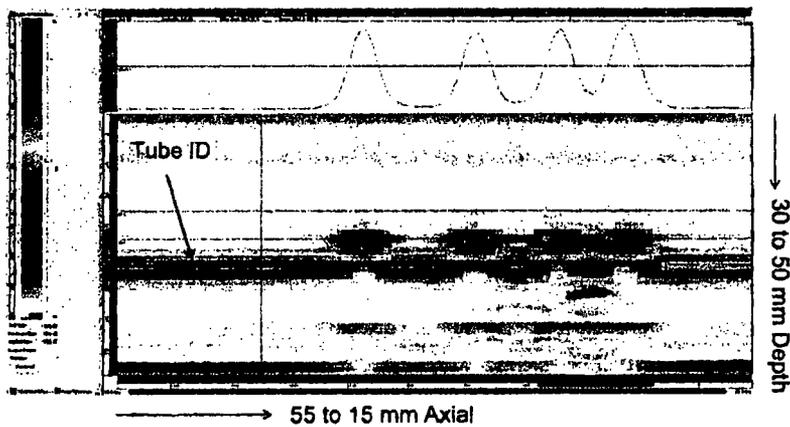
The data analysis software allowed electronic gating of signals in the time or depth dimension as well as positional dimensions Z and theta (axial and circumferential, respectively). The axial resolution notches were first gated or selected for analysis. An enlarged D-scan end view, as depicted in Figure 4.14 was used to measure the center-to-center spacing of the notches. This image was taken as viewed from the left edge of the image in Figure 4.13 and depicts depth into the material (along the sound path) in the vertical axis and the scanner index or nozzle axial

direction in the horizontal axis. From this end view, an "echodynamic" curve or profile was generated along the red horizontal line drawn through the responses from the notches, and was plotted above the image. The measured notch widths, from left to right, as measured at the half-amplitude points, were 2.0, 2.0, 2.5, and 2.5 mm (0.08, 0.08, 0.10, and 0.10 in.), respectively. This represents only 4 or 5 pixels with each pixel equal to 0.5 mm (0.02 in.). The actual notch widths were 2.08, 2.06, 2.16, and 2.11 mm (0.082, 0.081, 0.085, and 0.083 in.), respectively. Notch depths were measured as 2.06, 2.06, 2.03, and 2.03 mm (0.081, 0.081, 0.080, and 0.080 in.), respectively. Actual depths were 2.06, 1.95, 2.00, and 2.00 mm (0.081, 0.077, 0.079, and 0.079 in.), respectively. The data suggested that cracks as small as approximately 1 mm (0.04 in.) in depth could be accurately measured. Also, the notches could be clearly distinguished from each other, providing an indication of lateral probe resolution in the nozzle axial direction. In this set of notches, the actual center-to-center separations were 7.11, 5.08, and 4.06 mm (0.28, 0.20, and 0.16 in.), respectively. The measurements from the ultrasonic data gave separations of 7.0, 5.5, and 4.0 mm (0.28, 0.22, and 0.16 in.), respectively. These highly correlated data values and the data image indicated that an axial resolution of better than 4.0-mm (0.16-in.) was achievable.

Figure 4.14 D-scan End View of the Axial Resolution Notches in the Inconel Tube

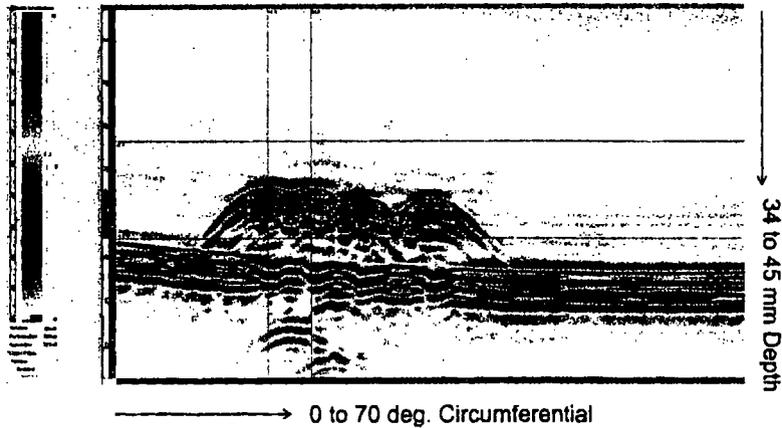
The gated circumferential resolution notch set is shown in Figure 4.15. This image was taken as viewed from the bottom edge in Figure 4.13. Notice that the closely spaced two notches on the left are overlapping but they are still resolvable. Peak-to-peak values gave measured notch separations of 4.36, 5.18, and 6.82 mm (0.17, 0.20, and 0.27 in.), respectively. The actual separations were 4.06, 5.08, and 7.11 mm (0.16, 0.20, and 0.28 in.), respectively. This is greater error than was observed for the axial direction. This test demonstrated a circumferential probe resolution of approximately 4.4 mm (0.17 in.).

Figure 4.15 B-scan Side View of the Circumferential Resolution Notches in the Inconel Tube

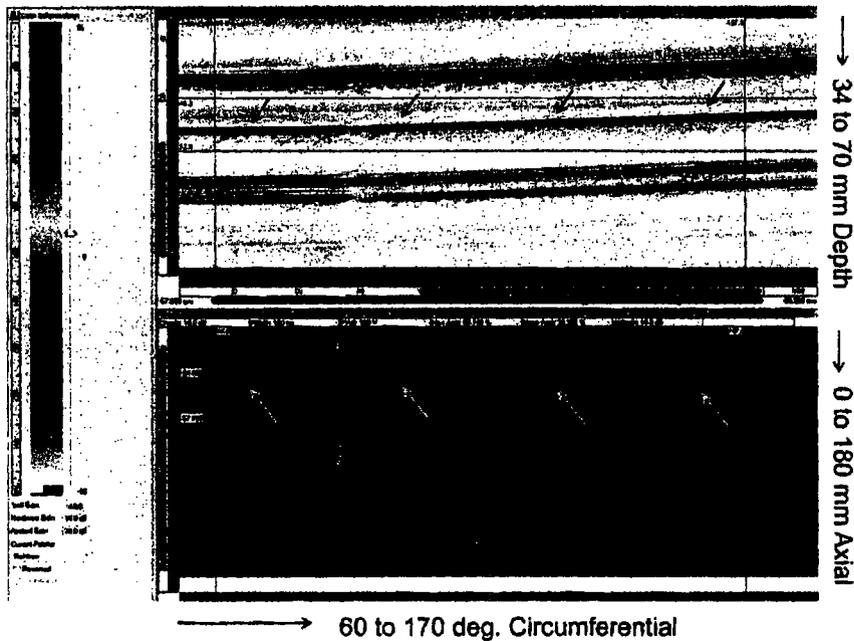
Figure 4.16 The Second Echo is Gated in the Side View Image in the Top of Figure with the Horizontal Lines. The corresponding scan is displayed in the bottom image. This second echo captures a disturbance in the back-wall echo showing some depth information, noted by the red arrows at top.

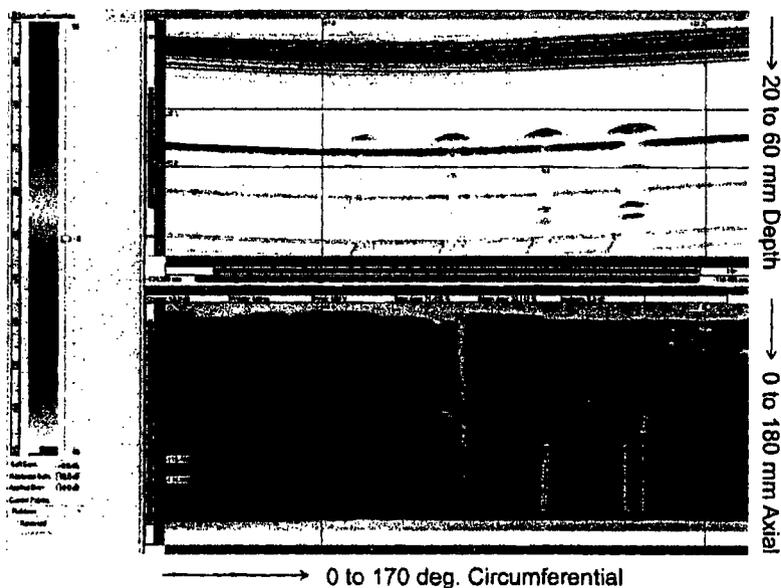
The final set of notches contained width variations and are shown in Figure 4.17. These flaws were ultrasonically measured with depths of 2.2, 2.5, 2.7, and 2.9 mm (0.09, 0.10, 0.11, and 0.11 in.), respectively, left to right in the image, while the actual depth was 2.53 mm (0.10 in.) for all notches. The measured center-to-center spacings were 23.1, 24.8, and 23.8 mm (0.91, 0.98, and 0.94 in.), respectively, while actual spacings were all 24.5 mm (1.00 in.). Finally, the widths of the flaws were measured in two ways. The first method used the width of the upper part of the flaw response, and the second method used the width of the loss of back-wall signal. The loss of back-wall signal technique was more accurate with measured widths of 3.91, 3.36, 5.00, and 8.82 mm (0.099, 0.126, 0.154, and 0.298 in.), respectively. Actual widths were 0.80, 1.61, 3.24, and 6.42 mm (0.031, 0.063, 0.127, and 0.253 in.), respectively. When measured from the second ultrasonic back-wall echo, the loss of signal measurements gave notch widths of 1.36, 2.73, 3.82, and 7.00 mm (0.054, 0.107, 0.150, and 0.276 in.), which were closer to the actual values. The probe spot size when focused at the interference fit, or 15 mm (0.59 in.) into the Alloy 600, was modeled at 1.2 x 1.2 mm (0.047 x 0.047 in.) at the -6 dB points. Flaw width sizing values are typically oversized by the probe spot size so these measured width values were well within the error expected with this probe.

Figure 4.17 B-scan Side View on Top and C-scan Plan View on Bottom of the Width Varying Notches in the Inconel Tube

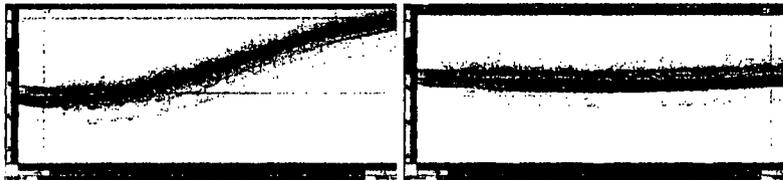
Figure 5.4 Alloy 600 Tube ID Response Before (left) and After (right) Centering the Scanner on the Nozzle. The horizontal axis represents approximately 180 degree and the vertical axis 20 mm (0.79 in.)

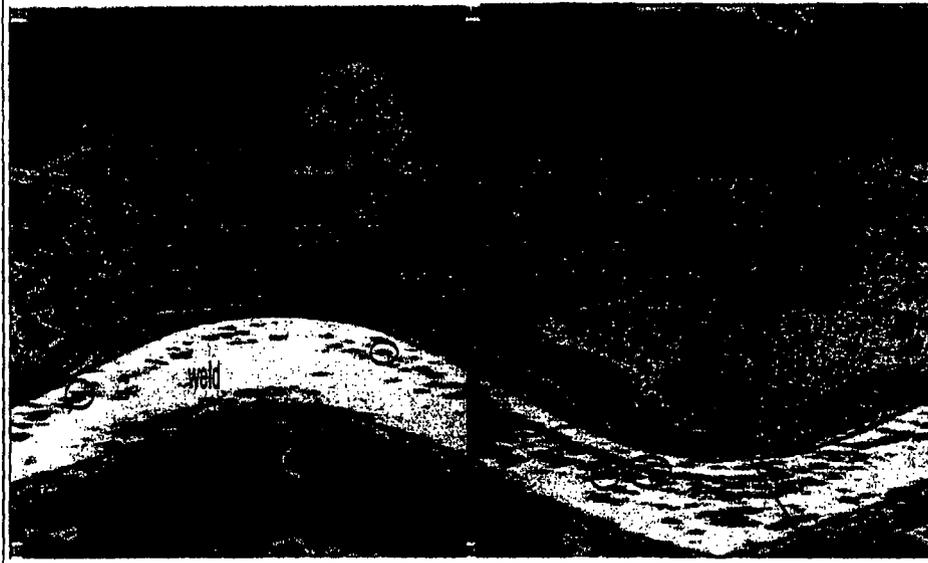
Data acquired after the first brushing from the two scans were pieced together to form the composite image of the interference fit region in Figure 5.11. This image displays a full 360-degree representation of the weld and interference fit region with -90 degrees at the left and 270 degrees at the right. The suspected leakage path at the low point, near 180 degrees, is marked with arrows. Also observed from the weld region response are suspected inclusions or fabrication flaws. Several of these indications are circled in red in the figure.

Figure 5.11 PA Ultrasonic Data from the interference fit in Nozzle 53 Acquired After the First Brushing of the Nozzle ID. The horizontal axis represents the full 360-degree area and the vertical axis represents 360 mm (14.17 in.).

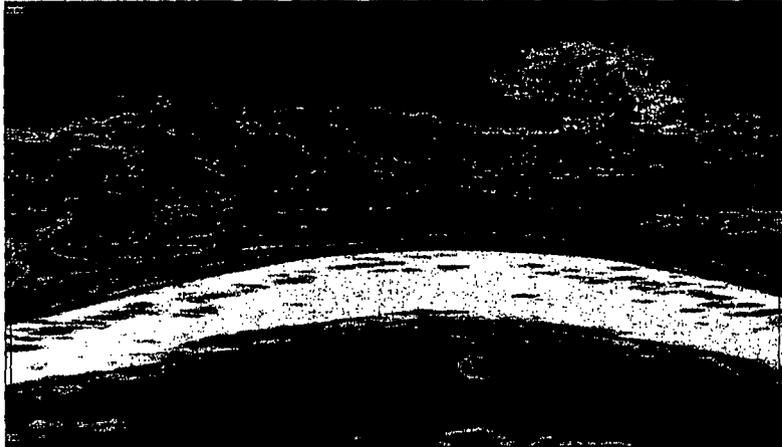
An analysis based on amplitude responses was conducted on the data images. The first such analysis was conducted on the 90 to 270 degree data acquired after the first brushing. The image was segregated into regions as depicted in Figure 5.12. The peak and mean amplitude responses were measured in each boxed region. Regions 1 through 6 are suspected leakage path zones. Regions 7 through 10 represent the interference fit and lower counter bore areas. Regions 11 through 15 represent the tube above the interference fit, and regions 16 through 18 represent the interference fit with suspected boric acid present. The same procedure was used on the 0 to 90 degree data with the boxed regions shown in Figure 5.13. Finally, the mean amplitudes within each boxed region were plotted against the box numbers with results in Figure 5.14. The suspected leakage path and tube responses all were in the range of 60 percent of full screen height and greater. At the other extreme, the regions with suspected boric acid deposits had mean amplitudes 25 percent and below. Finally, the interference fit/counter bore region mean amplitudes were in the 43 to 58 percent range. A proposed segregation of the regions is denoted by the yellow, green, and blue colored zones in the plot. The data suggest that 30 percent mean amplitude or less indicates the presence of boric acid in the interference fit while greater than 60 percent represents an air gap and possible leakage path if connected all the way through (top to bottom) the interference fit. Note that the same analysis

Figure 5.13 [PG036] [See comment above] The horizontal axis represents approximately -90 to +90 degrees. The vertical axis represents 360 mm (14.17 in.).

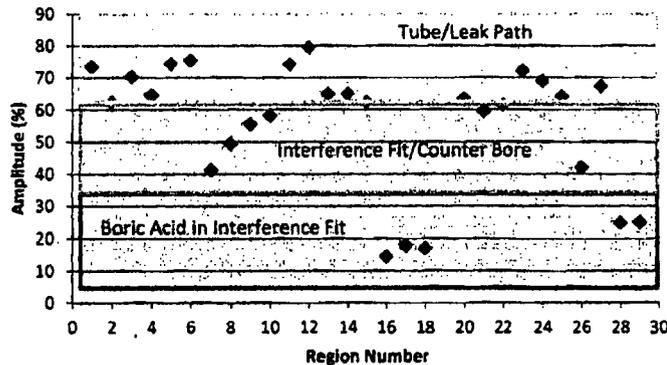
Figure 5.14 Mean Amplitude Responses from the Regions Indicated in Figures 5.12 and 5.13

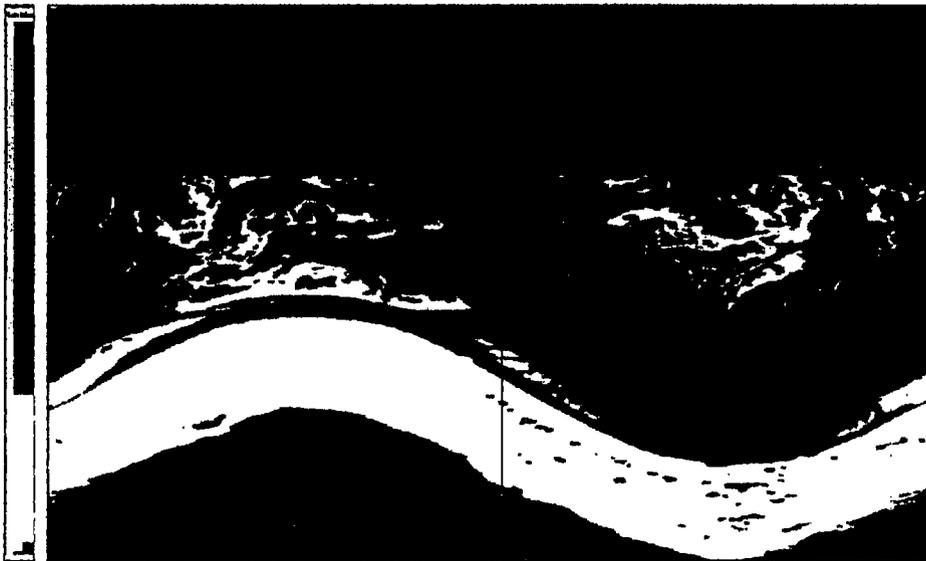
Based on the amplitude analyses conducted, the data were also plotted with a tri-level color bar to represent the three categories previously discussed. The tri-level color bar implementation is shown in Figure 5.16. White represents the less than 30% amplitude range and indicates good transmission such as in the weld or possible boric acid in the interference fit region. Light blue represents the 30 to 60% amplitude range and indicates the interference fit and counter bore regions. Dark blue represents the above 60% amplitude range and indicates poor transmission such as in the tube above the interference fit or an air gap in the interference fit and counter bore regions. A leakage path exists if a gap in the interference fit region extends fully through the interference fit connecting the weld and annulus region immediately above the weld to the dry side of the tube. From this image as well as the rainbow color-coded images, one clear leakage path is visible. The leakage path starts in the vicinity of 180 degrees circumferentially, or the low point of the nozzle, and meanders upwards and toward the right in the image. Other leakage paths are also evident but may not connect all the way through to the dry side of the assembly. Destructive analyses are needed to confirm the cause of these regions of differing reflectivity.

Figure 5.16 Tri-Level Color Representation of the Interference Fit Data

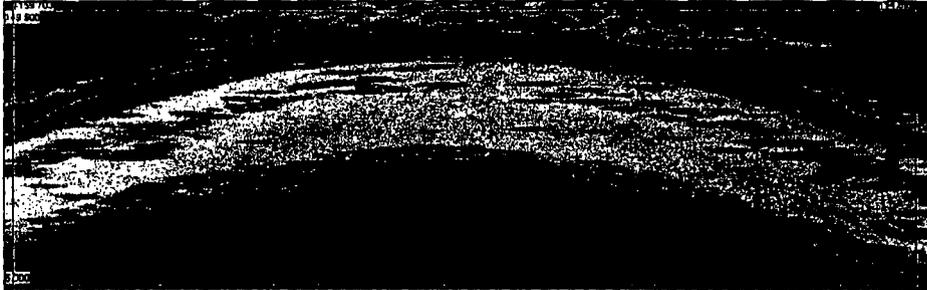
A composite view of the ultrasonic indications in the weld are presented in the C-scan top view or plan view images in Figures 8.2 and 8.3 for the uphill and downhill halves of the weld, respectively. Each figure represents approximately 150 mm (5.91 in.) in the vertical or axial direction and 180 degrees in the horizontal or circumferential direction. The indications were generally all located at the Alloy 600 tube-to-weld interface, or near surface, as will be discussed in more detail below. These indications appear to be volumetric in shape, indicative of fabrication flaws and assumed to be welding anomalies. The types of fabrication flaws expected would include incomplete or lack of fusion between individual weld beads, inclusions, voids, etc. Notice that the downhill image contains more indications. This is not unexpected due to the more difficult configuration at this position in the nozzle assembly. One would be welding upside down, in a deeper cavity, and with limited access at this location; and therefore more likely to introduce imperfections in the weld. A connected string of indications following the curvature of the weld are observed in Figure 8.3—likely a lack of fusion between weld bead passes. These indications are noted by the red arrow in the figure.

Figure 8.2 Uphill Half of the Weld. The horizontal axis represents approximately 180 degrees and the vertical axis represents approximately 150 mm (5.9 in.).

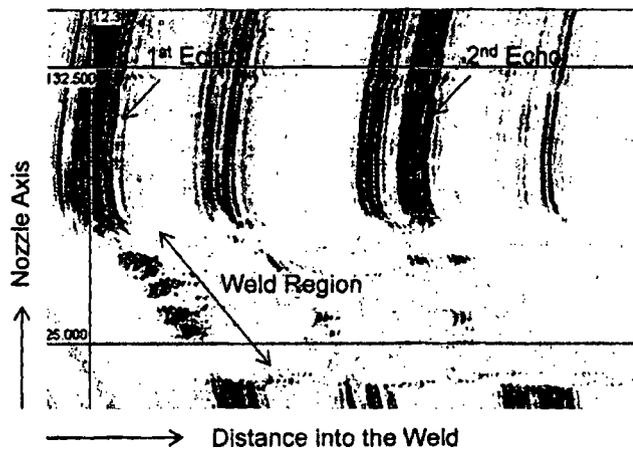
Figure 8.5 B-scan Side View at the 174-Degree Circumferential Position. Near-surface indications are visible in the weld material. The horizontal axis represents approximately 40 mm (1.6 in.) in metal and the vertical axis 155 mm (6.1 in.).

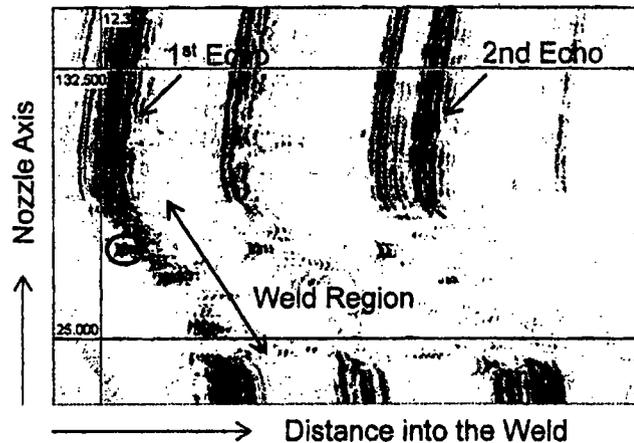
The weld region was evaluated for anomalies throughout the full 360-degree circumference. The indications fell along the Alloy 600 tube-to-weld interface at all but one circumferential position. At the 193-degree position as noted in Figure 8.7, an indication appeared earlier in time than the other indications. The corresponding B-scan side view is shown in Figure 8.8 with the early indication circled. This earlier indication would plot into the tube material and could possibly be from a gouge in the tube and improper or no weld fill or repair. The indication displacement is shallow at approximately 1 mm (0.04 in.) in depth. No indications of circumferential cracking across or along weld beads were detected.

Figure 8.8 B-scan Side View at the 193-Degree Circumferential Position. Near-surface indications and one indication, circled in red, occurring earlier in time are visible. The horizontal axis represents approximately 40 mm (1.6 in.) in metal and the vertical axis 155 mm (6.1 in.).

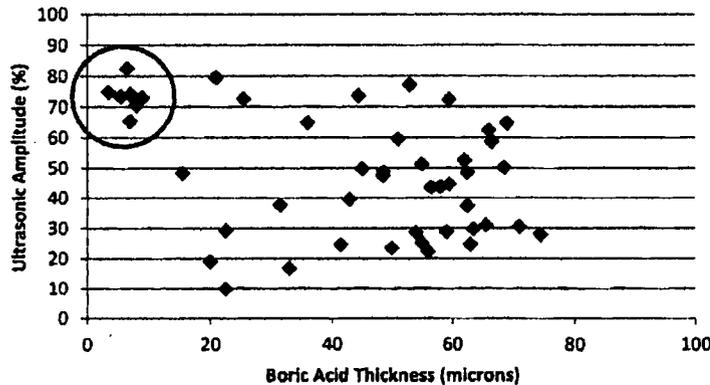
The relationship, if any, between the ultrasonic response values and boric acid values are displayed in graphical form in Figures 9.4 and 9.5. In the first graph, shown in Figure 9.4, the ultrasonic data are displayed as a function of the boric acid values for measurement points in the interference fit region. The points circled in the upper left corner represent bare metal or nearly bare metal points and point from the leak path. These points cluster separately from the remaining data and have ultrasonic values greater than 65% of full screen height and coating layer values less than or equal to 9 microns (0.35 mils). Furthermore, these points represent a strong ultrasonic response such as one associated with a reflection from a gap or void in the interference fit region. There was not close contact between the Alloy 600 tube outer diameter (OD) and the RPV head inner diameter (ID) materials at these locations and minimal or no boric acid or corrosion products were present. The points outside of the circled region represent the rest of the data and show no correlation between the ultrasonic response and the boric acid or coating thickness. The region is, however, bounded by boric acid deposits in the 16 to 75 micron (0.63 to 3.0 mils) range, while the ultrasonic responses almost cover the full range, spanning from 10 to 80% of full screen height.

Figure 9.4 Ultrasonic Amplitude as a function of Boric Acid Thickness from Points in the Interference Fit Region

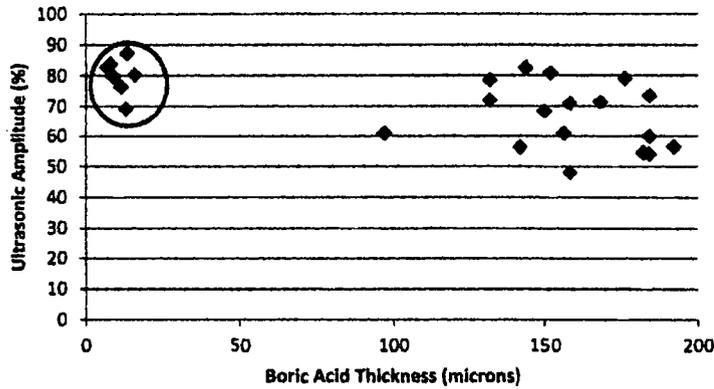
The data above and below the interference fit are displayed in Figure 9.5. The leak path or bare metal points are circled and have ultrasonic values between 69 and 87% and boric acid or corrosion thickness values of 16 microns (0.63 mils) or less. Outside of this circled cluster and the one isolated data point in the middle, the remaining data have boric acid thickness between 132 and 192 microns (5.2 and 7.6 mils) and ultrasonic amplitudes between 48 and 83%. The one outlier point is from the dry side on the uphill half and is towards the edge of a boric acid patch with a center-of-patch (0.7 in. or 17.8 mm to the center) thickness of 176 microns (6.9 mils).

Figure 9.5 Ultrasonic Amplitude as a Function of Boric Acid Thickness from Points Above and Below the Interference Fit Region
