March 13, 2012

SUBJECT: Review of Draft NUREG/CR – XXXX Entitled, "Ultrasonic Phased Array Assessment of the Interference Fit and Leak Path of the North Anna Unit 2 Control Rod Drive Mechanism Nozzle 63 with Destructive Validation"

**Ultrasonic Phased Array
Assessment of the Interference
Fit and Leak Path of the
North Anna Unit 2 Control Rod
Drive Mechanism Nozzle 63 with
Destructive Validation**

Manuscript Completed: February 2012

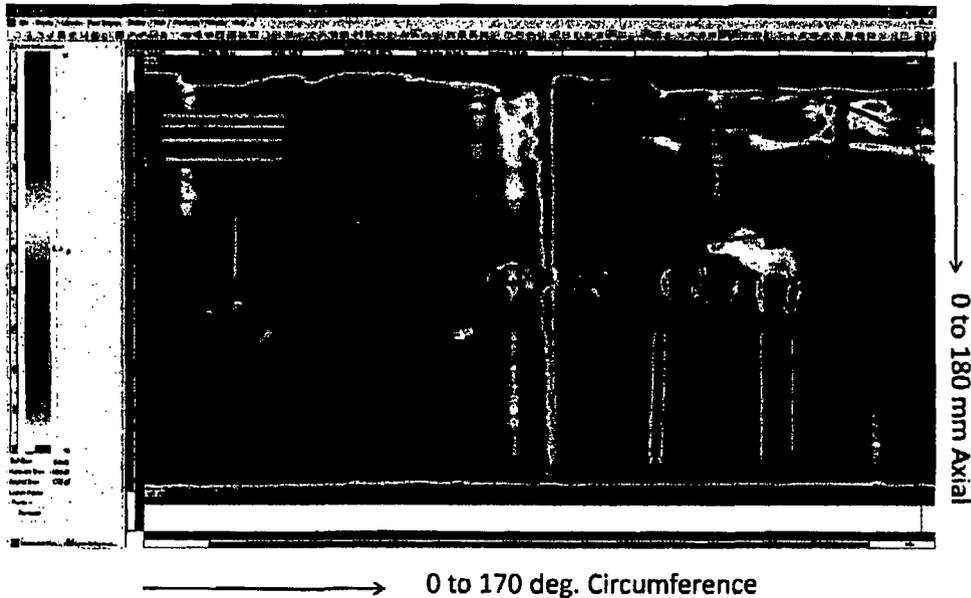
The machined notches in the Alloy 600 tube of the CRDM nozzle mockup simulated potential cracks or degradation of the nozzle penetration. The notched area shown in Figure 4.4 was scanned over approximately a 0 to 170 degree range in the circumferential direction (horizontal axis) and 0 to 180 mm (7.1 in.) in the axial direction (vertical axis) with the data image shown in Figure 4.10. This top view, plan view, or C-scan image shows the resolution notches in the upper-left portion of the image. The variable depth and width notches are also seen as well as the letters "PNNL." The color scale is displayed on the left with lowest amplitudes at the bottom represented by white and the highest amplitude at the top of the color bar represented by red. In this pulse-echo data, the low amplitude signals (blue and green) indicate good transmission or low reflection of the ultrasonic energy at the interface of the tube to the carbon steel. Conversely, the high-amplitude signals (yellow and red) represent poor transmission or large

reflection at the interface. A large reflected signal would be generated at a tube-to-air interface as would be seen above and below the interference fit region or in the presence of a notch with large enough dimensions.

Figure 4.10 Top View, Plan View, or C-scan Ultrasonic Image of the Upper Interference Fit Region Containing Calibration Notches in the Alloy 600 Tube. Calibration notches are circled.

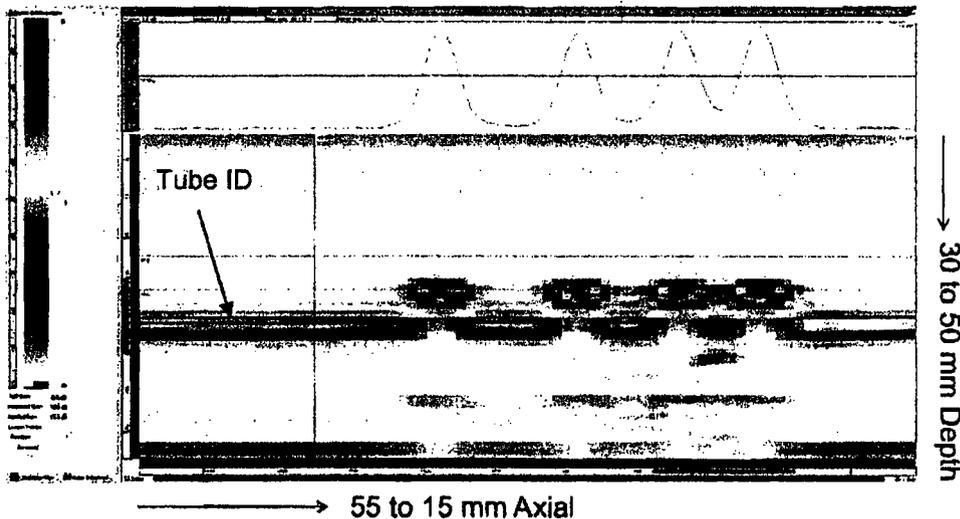
The data analysis software allowed electronic gating of signals in the time or depth dimension as well as positional dimensions Z and theta (axial and circumferential, respectively). The axial resolution notches were first gated or selected for analysis. An enlarged D-scan end view, as depicted in Figure 4.11 was used to measure the center-to-center spacing of the notches. This image was taken as viewed from the left edge of the image in Figure 4.10 and depicts depth into the material (along the sound path) in the vertical axis and the scanner index or nozzle axial direction in the horizontal axis. From this end view, an "echodynamic" curve or profile was generated along the red horizontal line drawn through the responses from the notches, and was plotted above the image. The measured notch widths, from left to right, as measured at the half-amplitude points, were 2.0, 2.0, 2.5, and 2.5 mm (0.08, 0.08, 0.10, and 0.10 in.), respectively. This represents only 4 or 5 pixels with each pixel equal to 0.5 mm (0.02 in.). The actual notch widths were 2.08, 2.06, 2.16, and 2.11 mm (0.082, 0.081, 0.085, and 0.083 in.), respectively. Notch depths were measured as 2.06, 2.06, 2.03, and 2.03 mm (0.081, 0.081, 0.080, and 0.080 in.), respectively. Actual depths were 2.06, 1.95, 2.00, and 2.00 mm (0.081, 0.077, 0.079, and 0.079 in.), respectively. The data suggested that cracks as small as approximately 1 mm (0.04 in.) in depth could be accurately measured. Also, the notches could be clearly distinguished from each other, providing an indication of lateral probe resolution in the nozzle axial direction. In this set of notches, the actual center-to-center separations were 7.11,

5.08, and 4.06 mm (0.28, 0.20, and 0.16 in.), respectively. The measurements from the ultrasonic data gave separations of 7.0, 5.5, and 4.0 mm (0.28, 0.22, and 0.16 in.), respectively. These highly correlated data values and the data image indicated that an axial resolution of better than 4.0-mm (0.16-in.) was achievable.

Figure 4.11 D-scan End View of the Axial Resolution Notches in the Inconel Tube

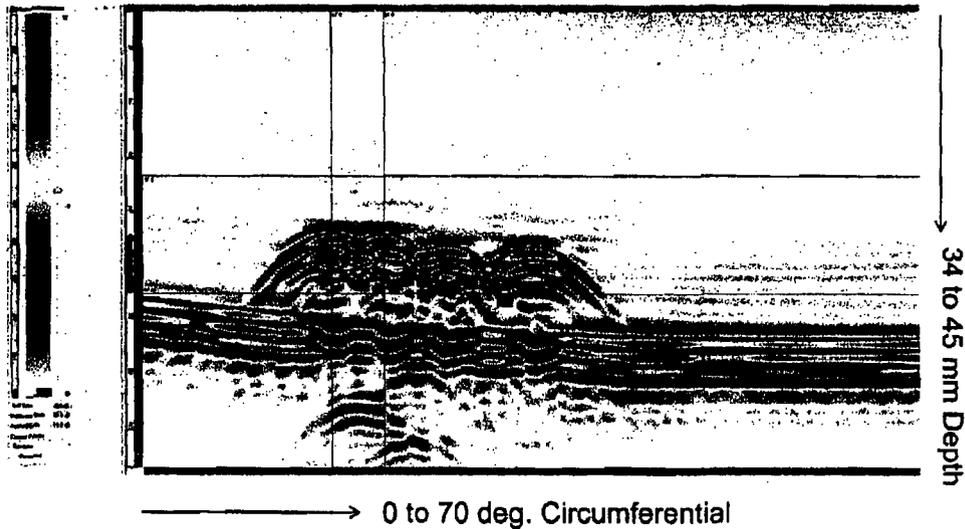
The gated circumferential resolution notch set is shown in Figure 4.12. This image was taken as viewed from the bottom edge in Figure 4.10. Notice that the closely spaced two notches on the left are overlapping but they are still resolvable. Peak-to-peak values gave measured notch separations of 4.36, 5.18, and 6.82 mm (0.17, 0.20, and 0.27 in.), respectively. The actual separations were 4.06, 5.08, and 7.11 mm (0.16, 0.20, and 0.28 in.), respectively. This is greater error than was observed for the axial direction. This test demonstrated a circumferential probe resolution of approximately 4.4 mm (0.17 in.).

Figure 4.12 B-scan Side View of the Circumferential Resolution Notches in the Inconel Tube

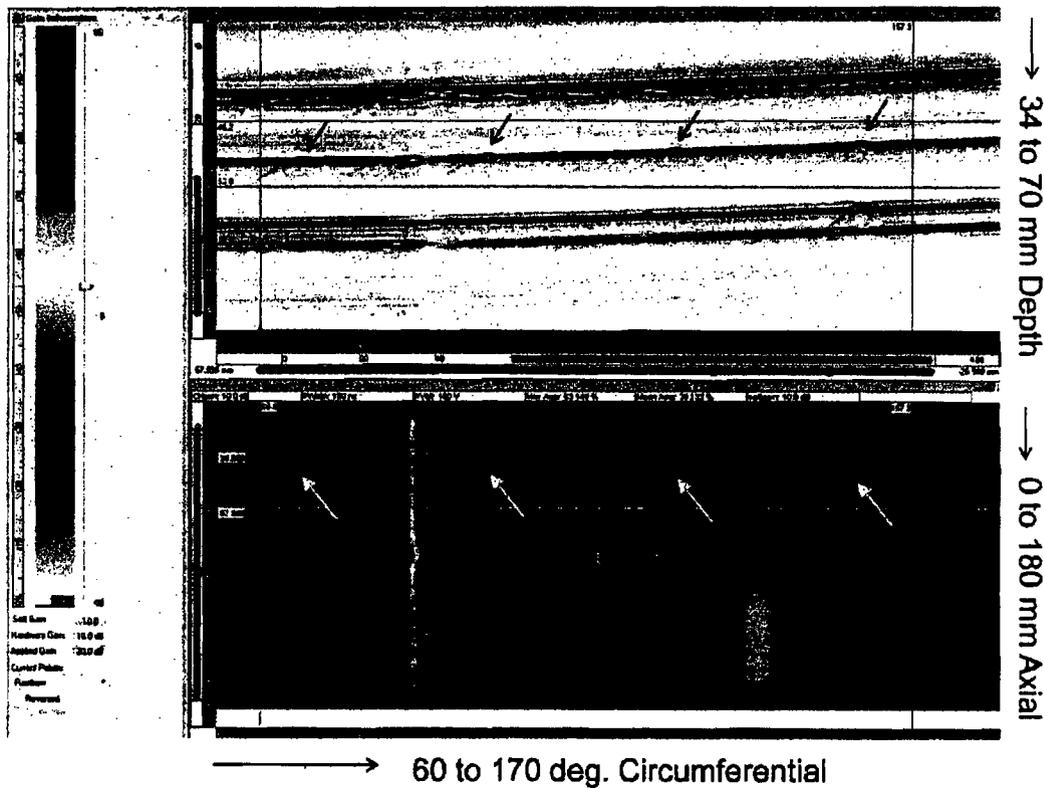
The set of notches in the upper right portion of the scanned image in Figure 4.10 varied in depth but had constant width. These very shallow notches were recognized because their shape and location were known, but they could have been missed based on amplitude response alone. Machining marks on the tube as well as variations in the interference fit produced a non-uniform background response for the fit region, complicating the detection. The center-to-center separations of these notches as ultrasonically measured were 23.84, 24.29, and 23.61 mm (0.939, 0.956, and 0.930 in.), respectively, whereas the actual spacing was 25.4 mm (1.0 in.) between each notch. Flaw depth information was not discernible in the first interference fit echo, but the second echo gave some indication of a flaw tip as noted by the red arrows in the upper part of Figure 4.13. This image represents the B-scan side view of the data while the lower image is a C-scan top view. A higher inspection frequency could have better resolved the small depth variations in these notches. The current second-echo ultrasonic data showed an approximate depth of 0.15 mm (0.006 in.) for all four notches, whereas the actual depths were 0.028, 0.051, 0.76, and 0.13 mm (0.001, 0.002, 0.003, and 0.005 in.), respectively. While these very shallow notches each presented a discontinuity that was ultrasonically detected, their depths were below the system depth or range resolution. For a greater than 50% bandwidth probe, the range resolution is on the order of one wavelength, which in Alloy 600 is approximately 1.1 mm (0.043 in.) at a 5-MHz inspection frequency.

Figure 4.13 The Second Echo is Gated in the Side View Image in the Top of Figure with the Horizontal Lines. The corresponding C-scan top view is displayed in the bottom image. This second echo captures a disturbance in the back-wall echo showing some depth information, noted by the red arrows at top. The yellow arrows note the depth-varying notches.

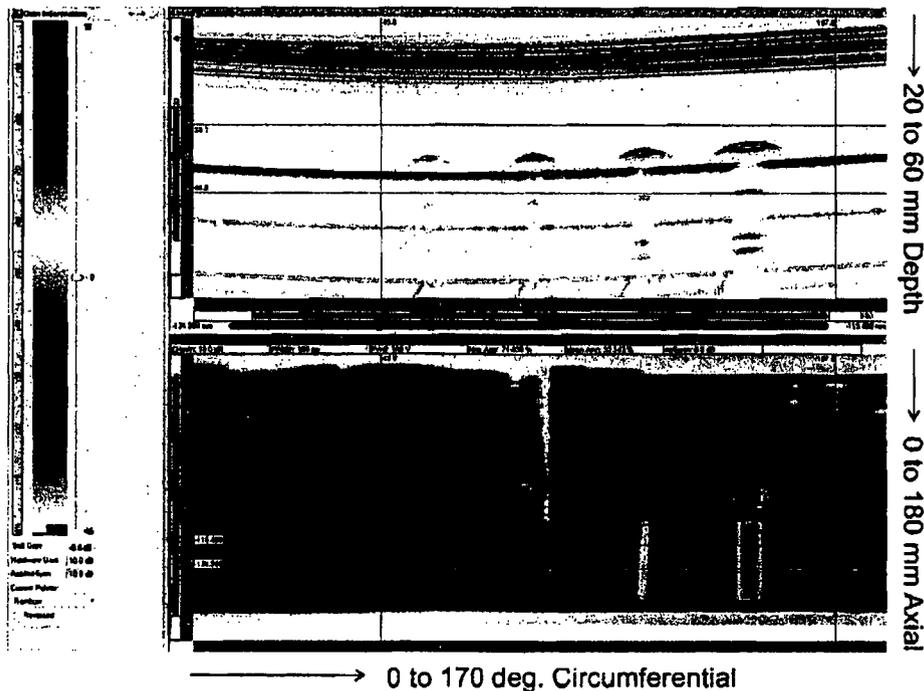
The final set of notches contained width variations and are shown in Figure 4.14. These flaws were ultrasonically measured with depths of 2.2, 2.5, 2.7, and 2.9 mm (0.09, 0.10, 0.11, and 0.11 in.), respectively, left to right in the image, while the actual depth was 2.53 mm (0.10 in.) for all notches. The measured center-to-center spacings were 23.1, 24.8, and 23.8 mm (0.91, 0.98, and 0.94 in.), respectively, while actual spacings were all 24.5 mm (1.00 in.). Finally, the widths of the flaws were measured in two ways. The first method used the width of the upper part of the flaw response, and the second method used the width of the loss of back-wall signal. The loss of back-wall signal technique was more accurate with measured widths of 3.91, 3.36, 5.00, and 8.82 mm (0.099, 0.126, 0.154, and 0.298 in.), respectively. Actual widths were 0.80, 1.61, 3.24, and 6.42 mm (0.031, 0.063, 0.127, and 0.253 in.), respectively. When measured from the second ultrasonic back-wall echo, the loss of signal measurements gave notch widths of 1.36, 2.73, 3.82, and 7.00 mm (0.054, 0.107, 0.150, and 0.276 in.), which were closer to the actual values. The probe spot size when focused at the interference fit, or 15 mm (0.59 in.) into the Alloy 600, was modeled at 1.2 x 1.2 mm (0.047 x 0.047 in.) at the -6 dB points. Flaw width

sizing values are typically oversized by the probe spot size so these measured width values were well within the error expected with this probe.

Figure 4.14 B-scan Side View on Top and C-scan Plan View on Bottom of the Width Varying Notches in the Inconel Tube

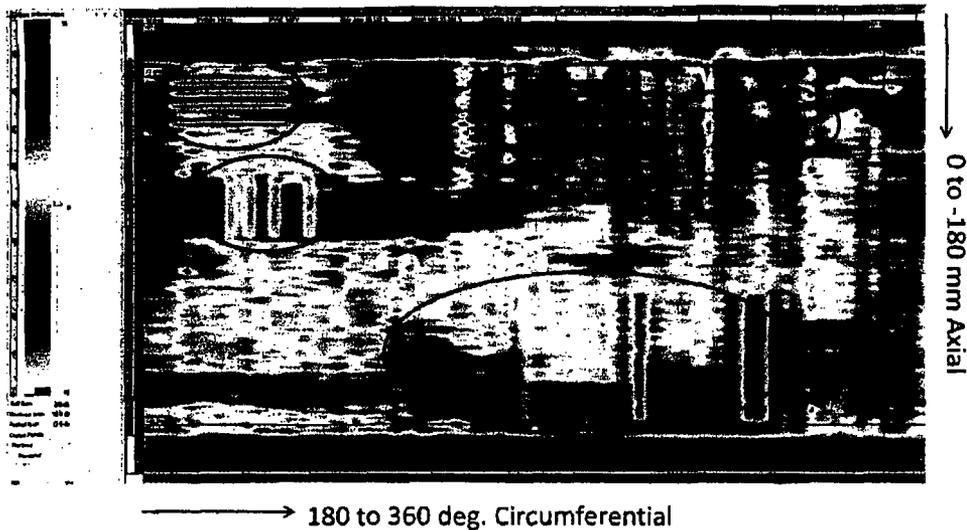
The 180–360 degree portion of the upper fit region in the CRDM mockup contained notches in the carbon steel block to simulate degradation or wastage of the RPV head material. These notches were on the far side of the interference fit relative to the location of the probe. Because the interference fit was not uniform, the notch responses were not as clear as those for notches in the tube, as evident in Figure 4.15.

Figure 4.15 C-scan Plan View of the Notches in the Carbon Steel from the First Ultrasonic Echo. The calibration notches are circled.

The axial resolution notches in the top left of the figure were resolved, but the lower notch was on the edge of a high-amplitude region. The measured center-to-center spacings were 3.90, 4.58, and 6.88 mm (0.15, 0.18, and 0.27 in.), respectively, while actual spacings were 4.06, 5.08, and 7.11 mm (0.16, 0.20, and 0.28 in.), respectively. Axial resolution was therefore approximately 4 mm (0.16 in.) or better.

Measurements from the circumferential resolution notch pattern showed center-to-center spacings of 3.82, 5.00, and 7.54 mm (0.15, 0.20, and 0.30 in.), respectively, with actual spacings of 4.06, 5.08, and 7.11 mm (0.16, 0.20, and 0.28 in.). Circumferential resolution was also approximately 4 mm (0.16 in.) or better.

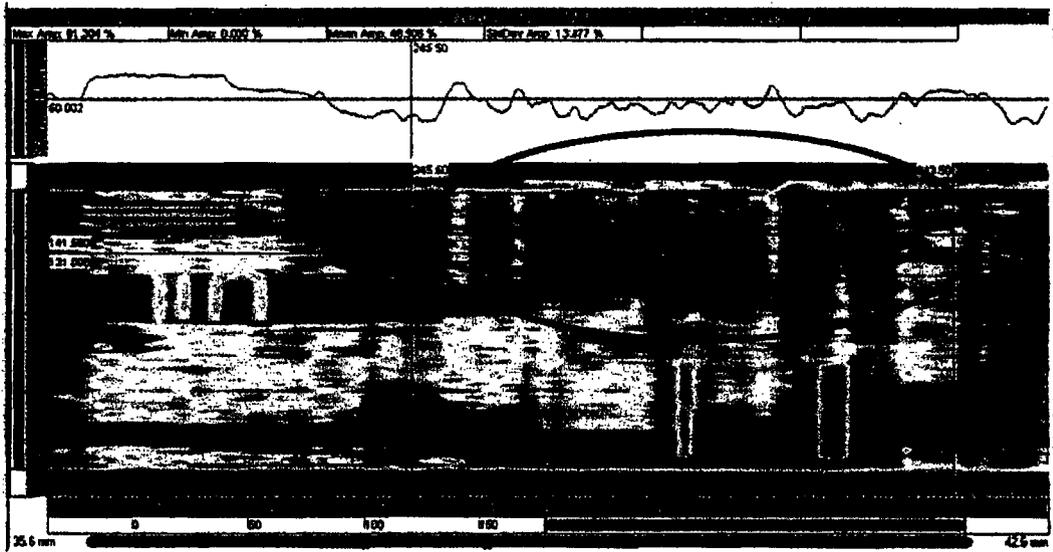
The variable depth notches in the top right of Figure 4.15 were detected but depths could not be measured. First and second echo images are shown in Figures 4.16 and 4.17, respectively. Center-to-center spacing was ultrasonically measured at 23.9, 22.4, and 24.4 mm (0.94, 0.88, and 0.96 in.), respectively, with an actual spacing of 25.4 mm (1.00 in.) for all notches.

Figure 4.16 C-scan Plan View of the Depth Notches in Carbon Steel, Circled on the Upper Right. This image was acquired from the first ultrasonic echo.

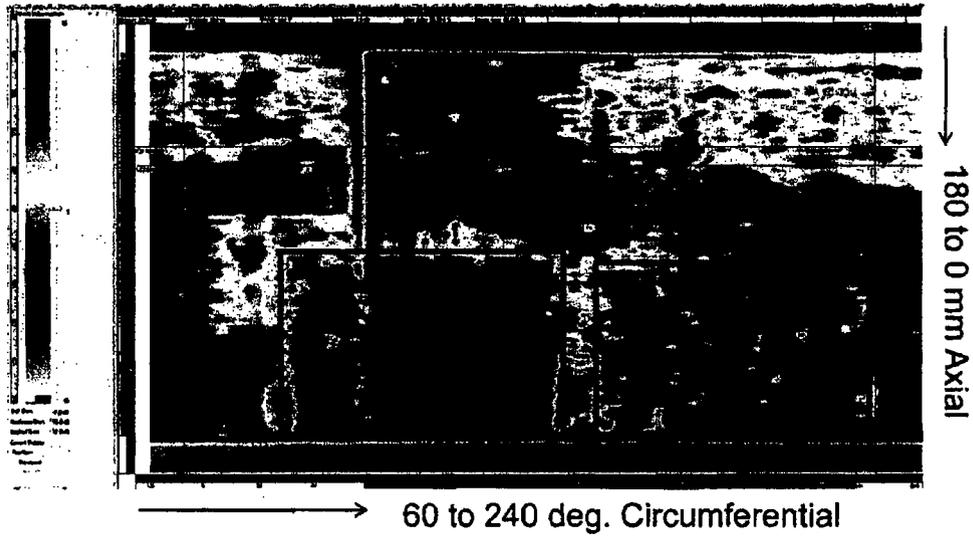
The top view, C-scan images from the mockup with boric acid deposits in the interference fit region are displayed in Figures 4.19 and 4.20. The first image represents the 60 to 240 degree circumferential region and the second image represents the 240 to 60 degree circumferential region, both as captured by the first echo. The boric acid regions were readily detected as lower amplitude response and are outlined with red boxes. Again, notice machining marks and non-uniformity in the interference fit response. The amplitude relevance is discussed in the next section.

Figure 4.19 C-scan Plan View of the Boric Acid Deposits, Boxed in Red, in the Lower Interference Fit Region. The horizontal axis represents the circumferential range of 60–240 degrees. This image is from the first ultrasonic echo.

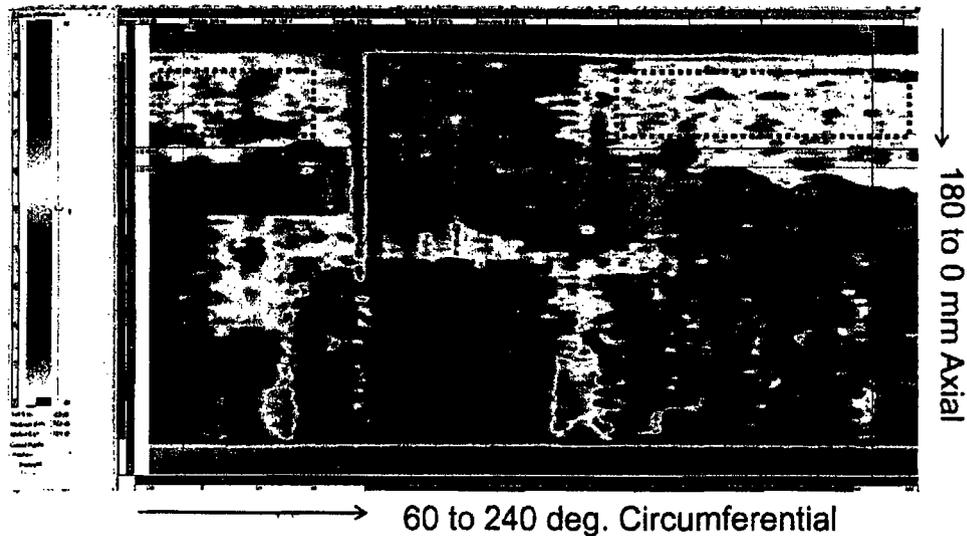
In addition to characterizing the notch response data for probe spatial and range resolution and flaw detection capability, an analysis of the acoustic response from the different regions was performed based on the reflected signal strength in the lower boric acid mockup section. The three categories represented in the data were the interference fit region where no boric acid was present, the interference fit region where boric acid was present, and the tube region outside of the interference fit area. These areas are represented in Figure 4.21 for the 60 to 240 degree boric acid image. The portion of the image outlined with the red box represents the interference fit region where boric acid deposits were present, the black dashed boxes represent the tube regions above and below the interference fit, and the black dotted boxes represent regions in the interference fit without boric acid deposits. The mean and peak amplitudes were measured in each of these boxed areas from the C-scan image. Similar measurements were also acquired for the 240 to 60 degree boric acid image.

Figure 4.21 The Interference Fit Region Containing Boric Acid is Subdivided into Three Regions. The red box represents the presence of boric acid in the interference fit region, the black dashed boxes represent the tube region, and the black dotted boxes represent the interference fit region.

The data images were analyzed with a total image gain of 12 dB. This represented 10 dB of hard gain applied during acquisition and 2 dB of soft gain applied during analysis. The mean responses from the interference fit regions without boric acid deposits were in the range of 40 to 55 percent of full-screen amplitude. This range of values was due to the variability in the fit itself. Some regions of the fit were tight, giving lower reflected amplitude and more transmitted energy. This condition is represented by the green color in the image. Other regions of the fit showed higher reflected energy (not tight), thus less transmitted energy, and this state is represented by the yellow-to-orange colors. Machining marks were evident and also lead to

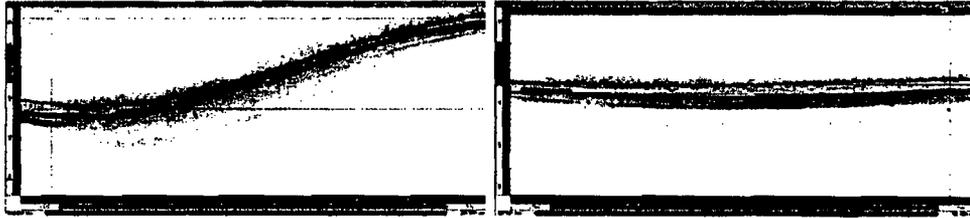
Figure 5.1 Alloy 600 Tube ID Response Before (left) and After (right) Centering the Scanner on the Nozzle. The horizontal axis represents approximately 180 degree and the vertical axis 20 mm (0.79 in.).

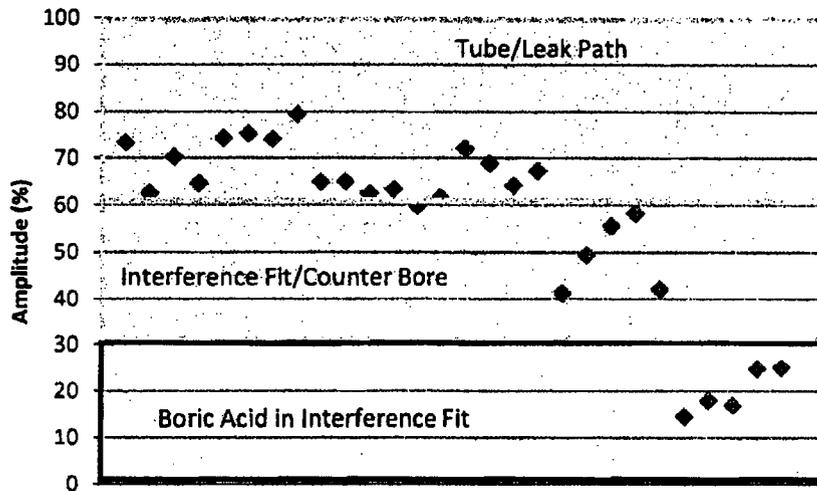
Figure 5.6 Mean Amplitude Response from the Regions Indicated in Figures 5.4 and 5.5

In summary, the mean amplitude responses from the different regions in the data image were measured. Based on this analysis, the regions are separable and compare favorably to the responses measured previously on the calibration mockup specimen. A comparison of the responses is presented in Table 5.1. Note that the Nozzle 63 data were acquired with 1 dB

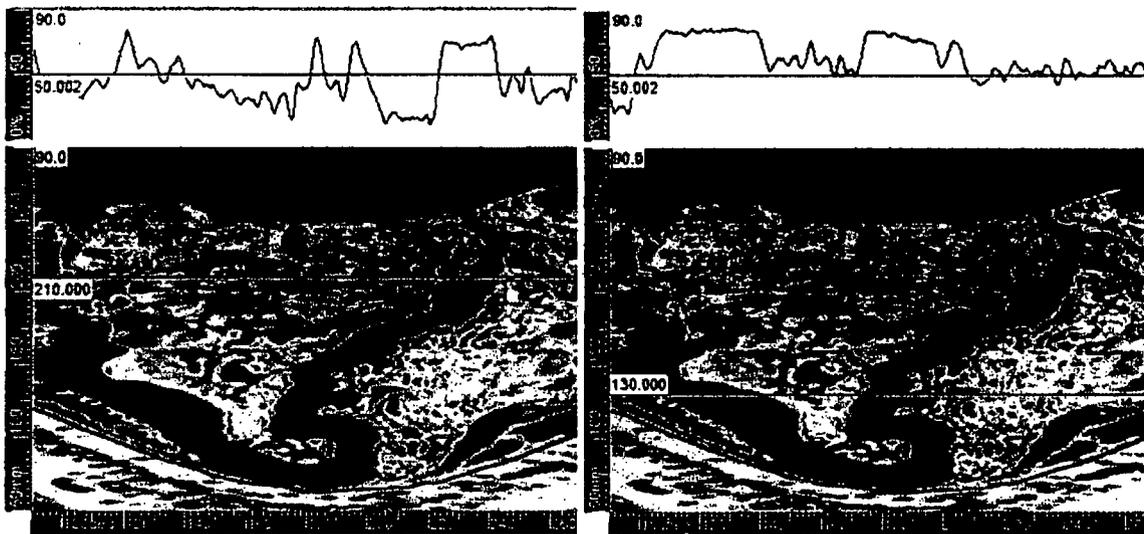
The relationship between the ultrasonic response values and eddy current (EC) thickness values was explored in more detail. As was previously demonstrated in the mockup evaluation, the large-amplitude ultrasonic data represent a gap in the interference fit. These data regions are represented by the color orange in the rainbow color bar previously shown in Figure 5.3, for example. Two horizontal profiles that display ultrasonic amplitude variations along the selected measurement line in the image are shown in Figure 8.3. The left image displays a profile taken along the red horizontal line located in the interference fit region. Clearly the high ultrasonic response is evident across the main leak path and then the response falls off on either side, of the leak path. The left side drop off is more severe in the profile and is associated with the blue color in the image, while the right side drop off is moderate and is associated with the yellow color in the image. The right image displays a profile taken along the red horizontal line in the image below the interference fit. The profile as well as the data image, again, shows a high-amplitude ultrasonic response for the leak path regions with signal drop off on both sides of the leak paths. At this axial position in the annulus, the drop off is smaller than that observed in the data from within the interference fit on the left.

Figure 8.3 Ultrasonic Response Profile at Top, Acquired Along the Red Horizontal Line in the Image Below. The left image profile is in the interference fit and the right image profile is outside of the interference fit.

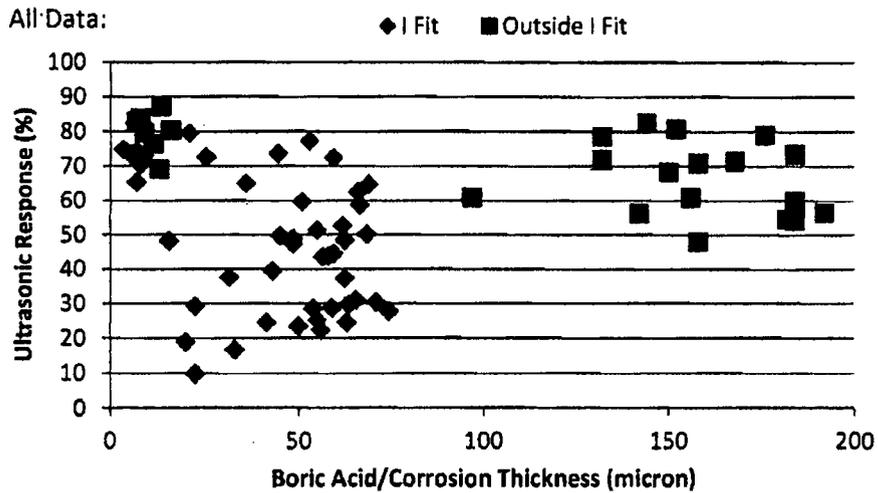
Figure 8.6 Comparison of Ultrasonic Response and Boric Acid/Corrosion Layer Thickness at all 70 Acquired Data Points

Lastly, an attempt was made to correlate the ultrasonic and eddy current measurements at all 70 data points. In this analysis, the data points were segregated as the interference fit region and outside of the interference fit region. Initially, all of the points were plotted with results shown in Figure 8.6. Points with high ultrasonic response and BA/corrosion thickness, upper left, are primarily associated with the main leak path region and represent areas where any potential deposits are flushed out and not allowed to remain. In addition to the primary leak path, other partial leak paths and regions with possible bare metal, lacking deposits, were identified. All of these leak path and bare metal points are plotted in Figure 8.7. These points represent a gap in the annulus, noted by the high ultrasonic response. Deposits as measured with the EC probe could be present but are not compacted throughout the annulus thickness. The remaining points (70 original points minus the leak path and bare metal points) represent the nominal annulus condition and are plotted in Figure 8.8. An ultrasonic amplitude level of approximately 50% divides the data between an interference fit response and one outside the interference fit region. For this nozzle, the BA/corrosion layer thickness values in the interference fit are less than 75 microns (3.0 mils), and outside the interference fit are greater than 130 microns (5.12 mils). The center point, with a layer thickness of 97 microns (3.82 mils) in Figure 8.8, can be excluded as it was obtained at a location where there is a noticeable boric acid deposit on the nozzle side. This additional deposit, though not quantitatively known, would increase the layer thickness value moving the point to the right and likely in the range of the other "Outside I Fit" data points. The other outlier point (EC value of 9 microns [0.35 mils] and UT value of 73%) is from the interference fit data and was obtained at a rust-colored region so it was not included in the bare metal points. This outlier is possibly explained by positional registration error of the data points. For example, ultrasonic data in a narrow secondary leak path varied from a value of 83 to 44% within and outside the leak path, respectively. Also the accuracy in acquiring EC data at the exact points specified on the photograph varied as definitive local boundary markers on the component were not always present. This is to say that these measurements have some positional error that cannot be eliminated. Nevertheless,

a clustering of the data is evident. These results are specific to this nozzle, Nozzle 63, as the fabrication of each nozzle represents a unique geometrical condition; however, these data likely show expected trends for nozzles in general. A summary of the Nozzle 63 results is listed.

- Leak paths
 - a. High UT response, >60%
 - b. Minimal boric acid/corrosion layer EC measurement, <16 microns (0.63 mils)
- Outside the leak path
 - a. Inside the interference fit region
 - i. UT response <50%
 - ii. EC measurement low, 15–75 microns (0.59–3.0 mils)
 - b. Outside the interference fit region
 - i. UT response >50%
 - ii. EC measurement larger, 130–190 microns (5.12–7.48 mils)
