An Ultrasonic Leak Path Assessment of a Pressurized Water Reactor Control Rod Drive Mechanism Nozzle

P.G. Oberson,^a D.S. Dunn,^a A.D. Cinson,^b S.L. Crawford,^b P.J. MacFarlan,^b B.D. Hanson^b

^aU.S. Nuclear Regulatory Commission, Washington, DC, 20555, USA

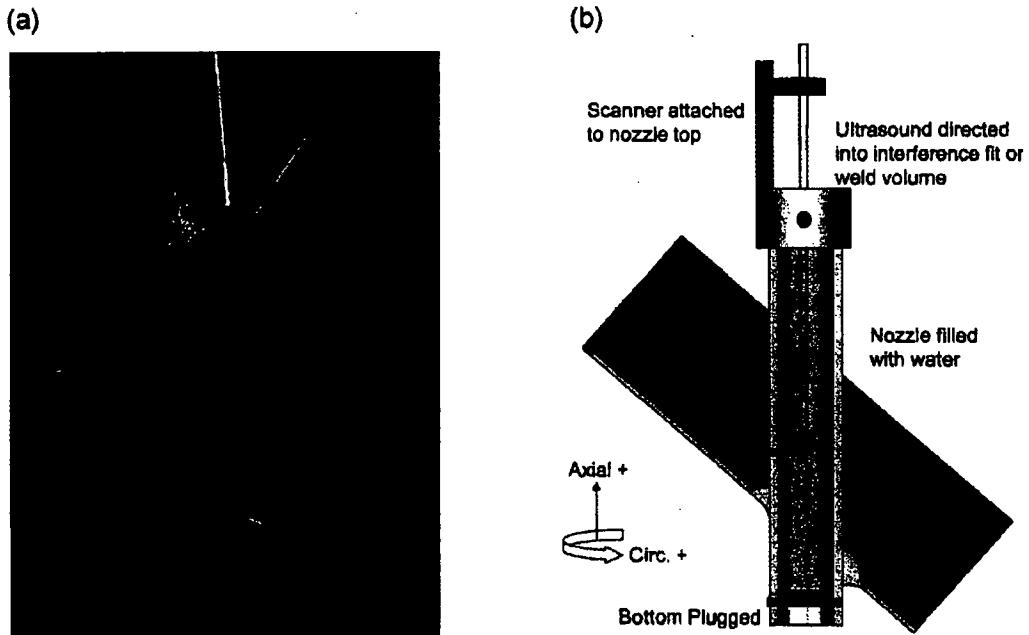
Nozzle 63, shown in Figure 2(a), was a peripheral CRDM nozzle in the upper head of North Anna Unit 2, a Westinghouse PWR that entered service in 1980. The materials of construction for Nozzle 63 were Alloy 600 base metal and Alloy 182 J-groove weld metal. Following indications of leakage of reactor coolant onto the upper head during an outage in 2001, the J-groove weld was overlaid with Alloys 52 and 152 in 2001 [7]. Subsequent visual examination during the fall 2002 outage revealed six CRDM nozzles that were suspected of leaking and 21 that were masked to the extent that their status could not be determined, including Nozzle 63. Given the level of degradation of the RPV head, the decision was made to replace the head. The Electric Power Research Institute took possession of a number of the nozzles, including number 63, which were transferred to PNNL and made available for NRC research.

Figure 2. (a) CRDM nozzle 63 used for this investigation, (b) Schematic illustration of ultrasonic scanning setup for Nozzle 63.
