Post-Test Examination Results from Integral, High-Burnup, Fueled LOCA Tests at Studsvik Nuclear Laboratory

This report presents and discusses the results of the U.S. Nuclear Regulatory Commission's integral loss-of-coolant accident (LOCA) testing program conducted at Studsvik Nuclear AB in Sweden. In this program, refabricated, high burnup irradiated fuel rodlets were subjected to LOCA conditions. In total, six single-rod LOCA tests were conducted in the Hot Cell Laboratory at Studsvik Nuclear AB. This report documents the test conditions, rodlet response, and post-test examinations for all six tests. The purpose of this document is to make this information available for comparison to related or complementary experimental programs. The observations of fuel fragmentation, relocation, and dispersal in this experimental program may be of particular interest for comparison to related or complementary experimental programs.

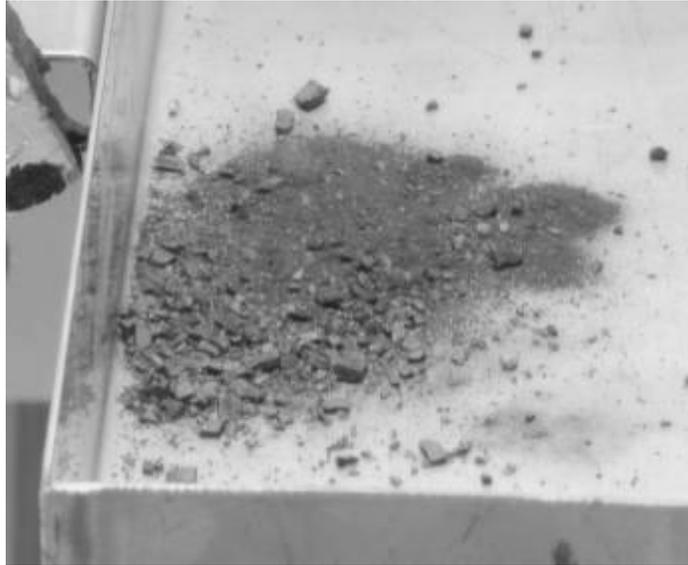
In total, it appears that about half of the fuel fell out of this rod during the simulated LOCA transient test and during shaking. The collected fuel in LOCA test chamber totalled 41 grams. Fuel which was lost during the four-point bend test and after minor shaking was also collected and weighed. The mass of fuel that was collected after the bend test and after shaking was 20 grams. In total, 61 grams of fuel were collected. Figure 2-7 provides an image of the collected fuel fragments.

Figure 2-7 Images of fuel collected from Test 189

The fuel dispersed and collected from Test 189 was sent to disposal before sieve analysis; therefore, there is no quantitative information regarding fragment size distribution for this rodlet.

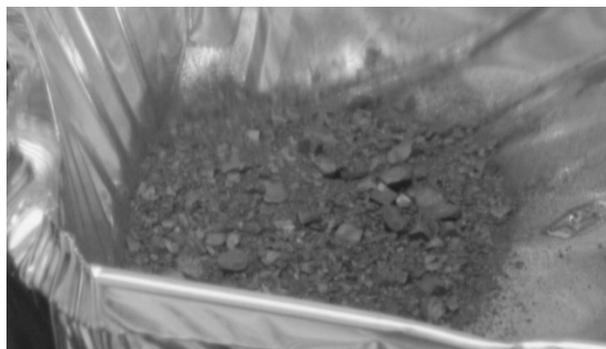
In total, it appears that about half of the fuel fell out of this rod during the simulated LOCA transient test and during shaking. During the wire probe measurement, completed after all experimental steps (LOCA transient, bending and shaking), the probe traveled unobstructed approximately 55 millimeters above and approximately 70 millimeters below the rupture center. The mass loss measured following the LOCA test was 52 grams. The mass loss measured following the bend test and after shaking was 7 grams. In total, 59 grams of fuel was lost. Figure 2-13 provides an image of the collected fuel fragments.

Figure 2-13 Images of fuel collected from Test 191

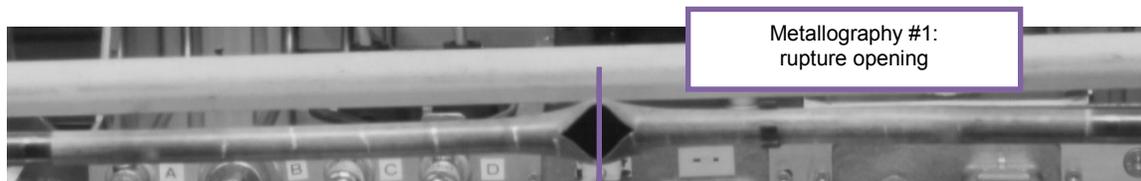
Figure 2-14 Photo of test segment from Test 191, indicating the location of metallography and hydrogen measurements

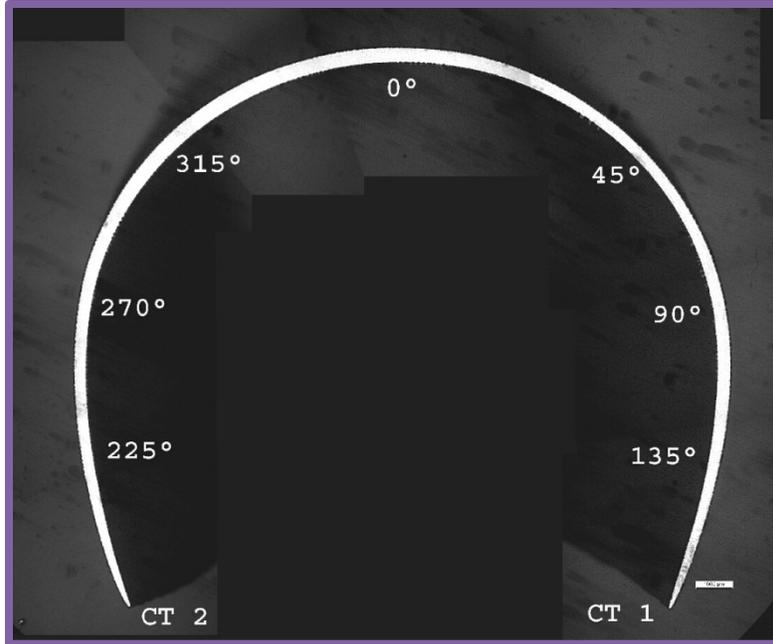
Figure 2-15 Macrograph of cross section from the rupture region of rodlet tested in LOCA Test 191

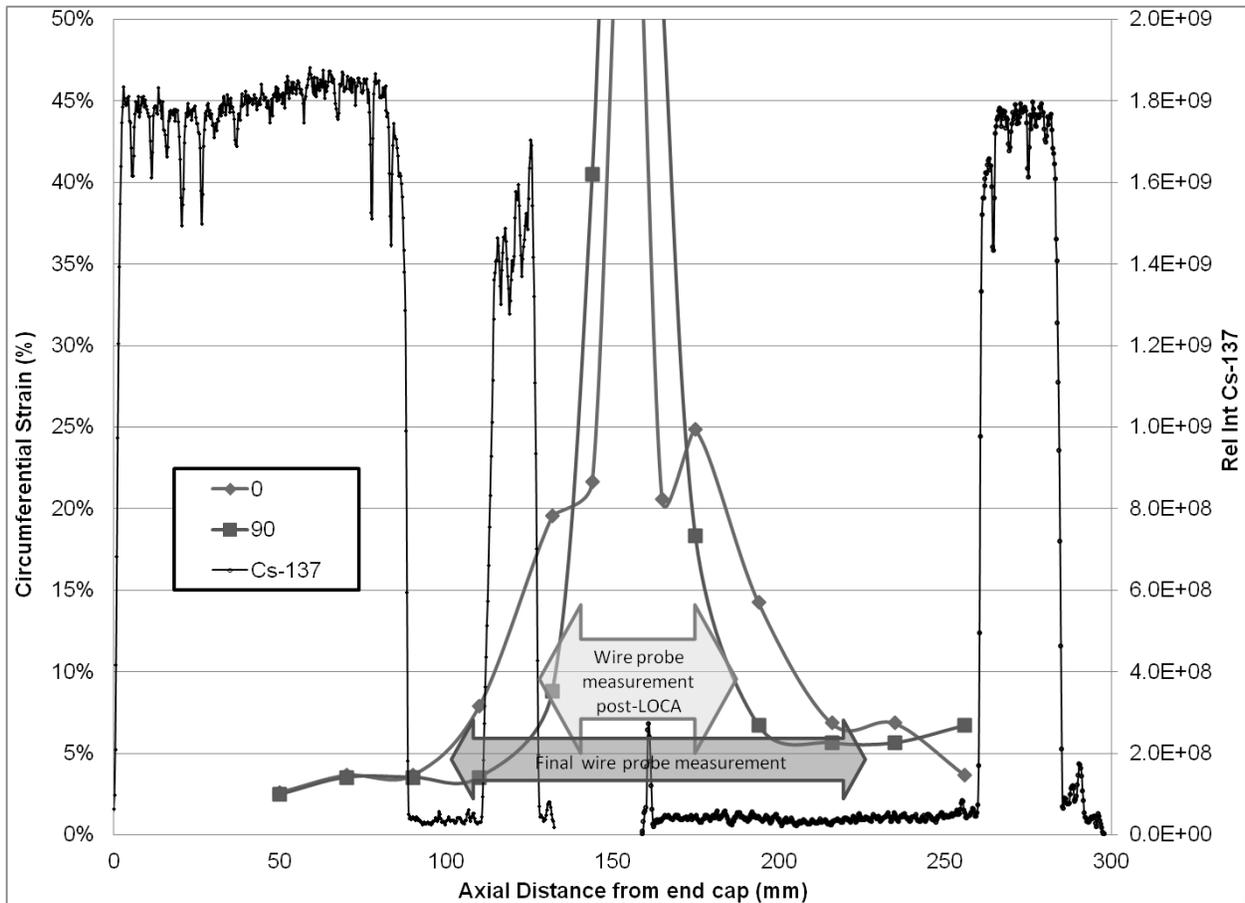
In Figure 2-19, the gamma scan results were plotted together with the profilometry results and the wire probe measurements performed just after the LOCA test (indicated as “post-LOCA” in the figure below) and just after the shaking test (indicated as “final wire probe measurement” in the figure below).

Figure 2-19 Gamma scan results for Test 191 with comparison to profilometry and initial wire probe measurements

As indicated earlier, these gamma scan results were obtained over 1 year after the LOCA test was performed. In the time between the LOCA test and these gamma scans, the rodlet portions were stored in metal cans in the hot-cell. It is important to note that the gamma scan was performed with the balloon end down and that the bottom end of the rodlet portion was filled with epoxy because of the preparation work for making the metallography sample in the balloon node. The gamma scan indicates fuel material in the 110-120 millimeter range and a gradual decline of the fuel column in the 75-90 millimeter range in Figure 2-19. The fuel material in the 110-120 millimeter range is probably loose material that is trapped by the epoxy filling. However, the balloon end of the top rodlet portion was open during storage and some fuel material was found in the metal can once this rodlet portion was removed for gamma scanning. The mass of fuel material found in the can was 16.7 grams. It is important to note that this fuel had fallen out of the rod before the gamma scan. This additional fuel loss during storage approximately accounts for the difference between the final wire probe measurement and the indication on the gamma scan results of the start of the remaining fuel column on the top rodlet portion.

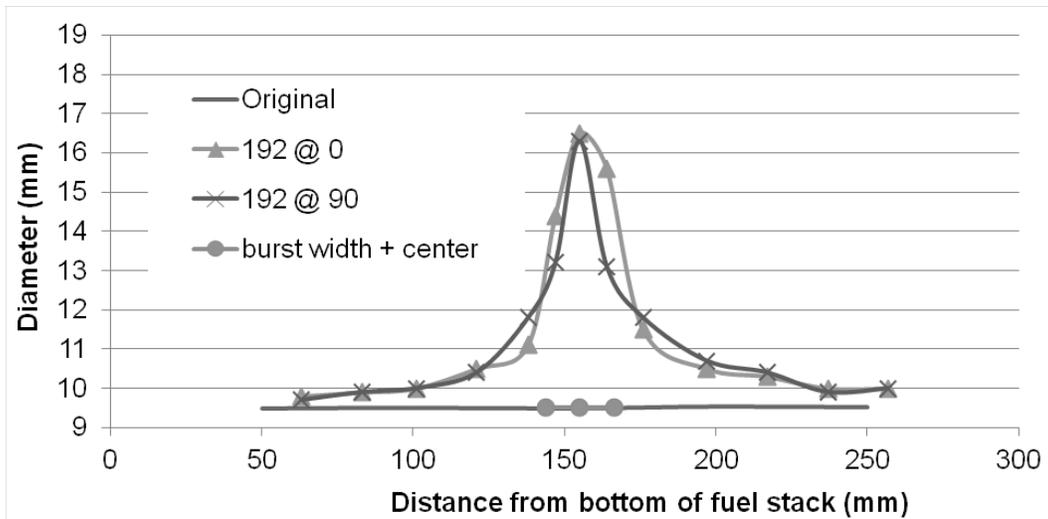
The rod did not experience significant distortion (or bending) during the LOCA transient, which can be seen in Figure 2-23. Profilometry measurements were made and they are shown in Figure 2-24. In Figure 2-24, the initial diameter and rupture length are also indicated. The mid-wall rupture strain value for Test 192 was calculated to be 56 percent.

Figure 2-24 Profilometry measurements of segment 192 post-transient. The rupture length is also indicated.

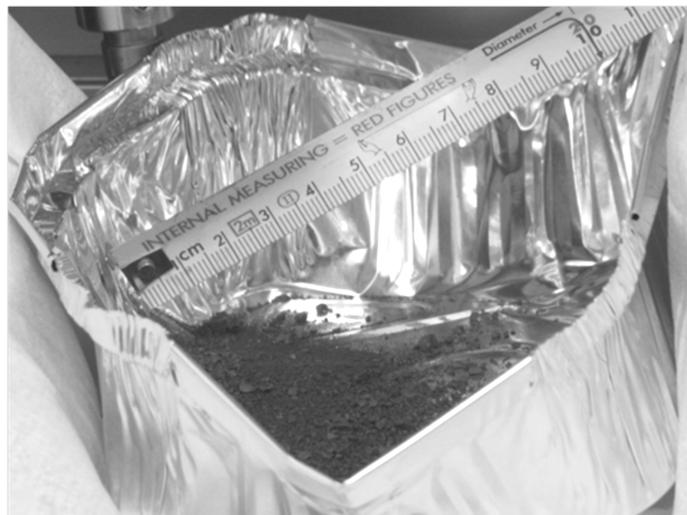
In total, it appears that about half of the fuel fell out of this rod during the simulated LOCA transient test and during shaking. During the wire probe measurement, completed after all experimental steps (LOCA transient, bending and shaking), the probe traveled unobstructed approximately 73 millimeters above and approximately 85 millimeters below the rupture center. The mass loss measured following the LOCA test was 68 grams. The mass loss measured following the bend test and after shaking was 16 grams. In total, 84 grams of fuel was lost. Figure 2-25 provides an image of the collected fuel fragments.

Figure 2-25 Images of fuel collected from Test 192

Considering the initial wire probe measurements, the fuel fragments collected after the LOCA test and initial shake test (shown in Figure 2-25 and quantified in Table 2-6) likely originated from the middle 150 millimeter region of the fuel rod that was measured to be empty following the LOCA test. However, the fuel fragments shown in Figure 2-36 collected 1 year later, after gentle shaking just before the gamma scan, likely originated from some span beyond the middle 150 millimeters, possibly in the axial length between the wire probe measurement and the indication of fuel in the gamma scan (approximately 230-255 millimeters in Figure 2-35). Additional sieve analysis was performed to characterize the fragment size distribution of the fragments shown in Figure 2-36. The measured mass of each sieve group is provided in Table 2-8, along with the mass percentage of each group relative to the total fuel analyzed. Figure 2-37 provides a comparison of the fuel fragment size distribution from these two regions of segment 192. The comparison suggests that fragmentation may be less pronounced in regions near the rodlet ends and further from rupture.

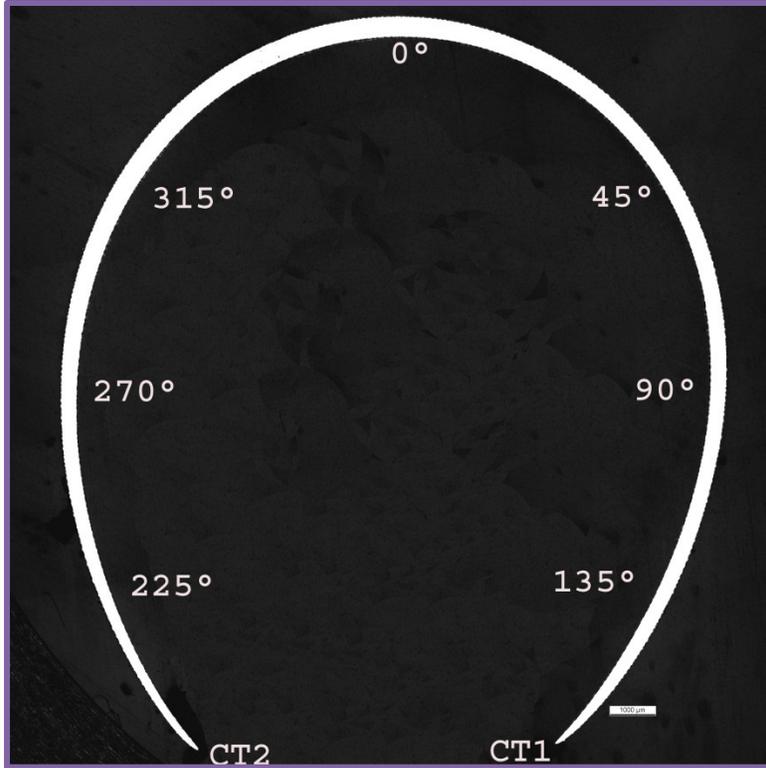
Figure 2-27 Macrograph of cross section from the rupture region of rodlet tested in LOCA Test 192

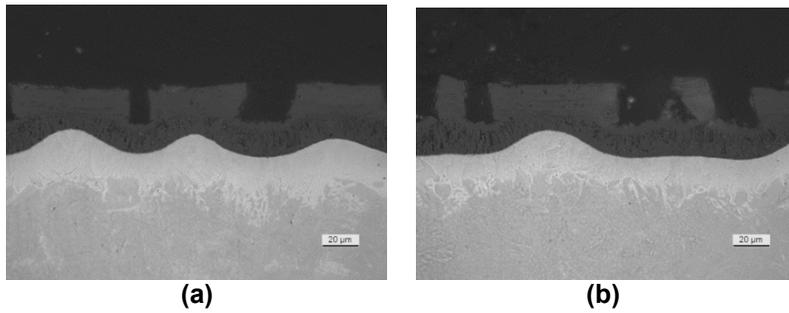
Figure 2-28 Two high-resolution images of the cladding outer diameter from the metallography examination in the rupture region of the rodlet tested in LOCA Test 192 at (a) 45° and (b) 135°

Here, it is useful to recall that the calculated CP-ECR was 11 percent, with a hold time at 1,185 degrees C of 5 seconds. In Figure 2-28, the initial oxide thickness can be seen to have cracked and separated in this high strain (56 percent) area, and the transient oxidation layer is seen beneath this damaged initial oxide layer. The noticeable scalloping of the oxide layer was often seen in the outer diameter of the LOCA test samples. In Figure 2-29, it appears that some fuel fragments remain on the inner diameter and that the initial fuel-cladding bonding layer has also cracked and separated. An inner diameter transient oxidation layer is seen, which appears to be approximately the same thickness at the outer transient oxidation layer. These observations are expected at this location because it is in the rupture node and therefore exposed to a steam environment after rupture.

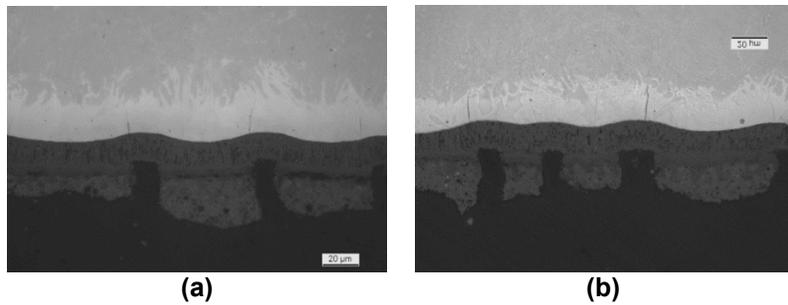
Figure 2-29 Two high-resolution images of the cladding inner diameter from the metallography examination in the rupture region of the rodlet tested in LOCA Test 192 at (a) 0° and (b) 315°

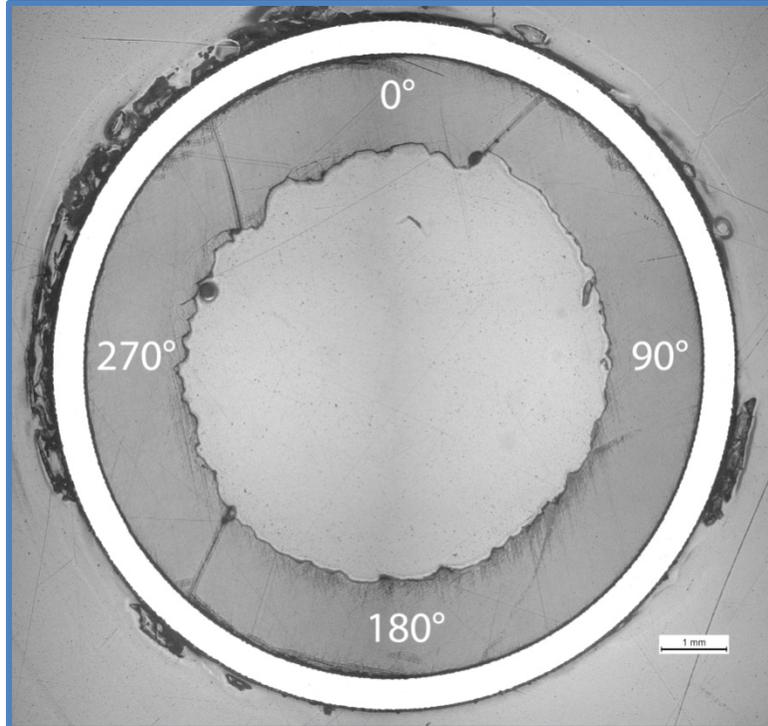
In Figure 2-30, the interior of the cladding contains a large feature in the middle of the cross section. This feature is an artifact of the epoxy casting. This rod was cast with epoxy in two stages and the features in the interior of the cladding reveal the boundary between the two stages of epoxy casting.

Figure 2-30 Macrograph of cross section from 50 mm below the rupture region of rodlet tested in LOCA Test 192

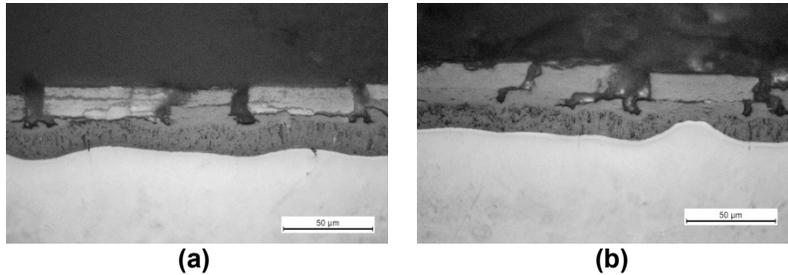
Figure 2-31 Two high-resolution images of the cladding outer diameter from the metallography examination 50 mm below the rupture region of the rodlet tested in LOCA Test 192 at (a) 90° and (b) 315°

In Figure 2-31, the initial oxide thickness can be seen to have slightly cracked and separated in this area, although much less than in the images taken from the rupture node. The strain in this region was approximately 5-7 percent. As in the rupture node, the transient oxidation layer is seen beneath this damaged initial oxide layer. In Figure 2-32, it appears that some fuel fragments remain on the inner diameter and that the initial fuel-cladding bonding layer has also cracked and separated. An inner diameter transient oxidation layer is seen, which appears to approximately the same thickness at the outer transient oxidation layer.

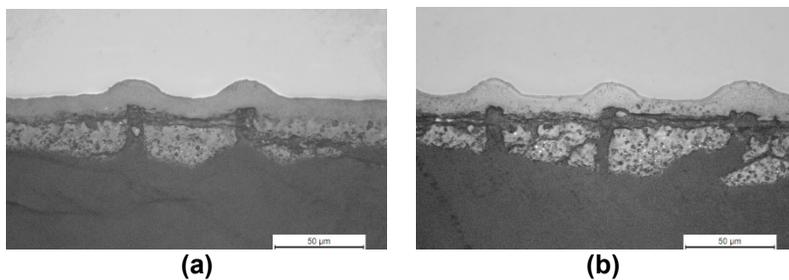
Figure 2-32 Two high-resolution images of the cladding inner diameter from the metallography examination 50 mm below the rupture region of the rodlet tested in LOCA Test 192 at (a) 45° and (b) 225°

In Figure 2-41 (a and b), fuel fragments remain on the inner diameter and the fuel-clad bond layer appears more intact than in the M/C images in Figure 2-29 and Figure 2-32 taken within and 50 millimeter below the rupture node, respectively. Also, an alpha layer microstructure can be seen on the inner diameter. This region of the test segment remained fueled and was far (approximately 100 millimeters) from the rupture location; therefore, the inner diameter was not exposed to a steam environment during the transient. The oxygen necessary for the inner diameter alpha layer is proposed to have originated from the fuel-cladding bond layer. In Figure 2-41 (c and d), the initial oxide layer, transient oxide layer, and an alpha layer can be seen.

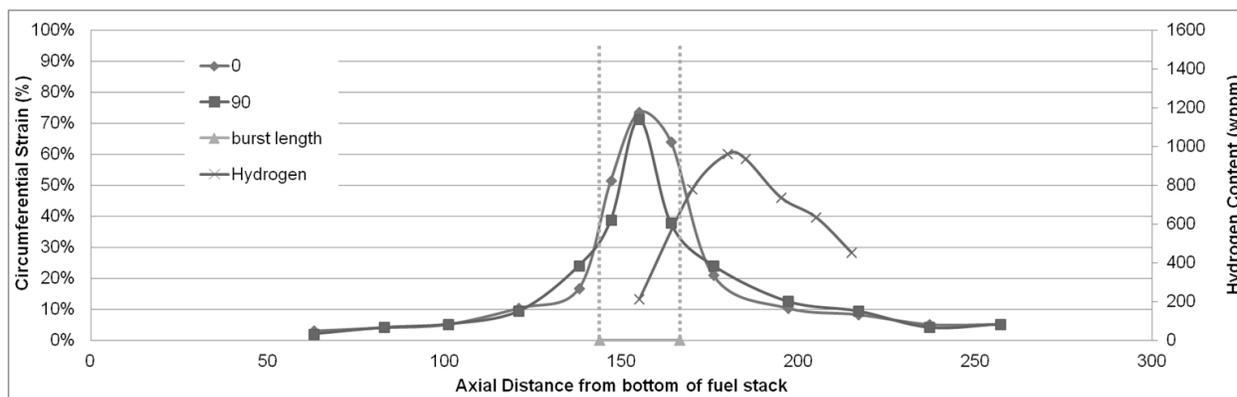
The location and values of hydrogen content, measured by hot vacuum extraction, are provided in Table 2-7 and illustrated, relative to the segment post-LOCA strain profile and rupture length measurements, in Figure 2-33.

Distance above rupture opening (mm)	0	15	25	30	40	50	60
Hydrogen Content (wppm)	212	781	963	938	738	635	453

Figure 2-33 Hydrogen measurements from 192 relative to segment strain profile and rupture length

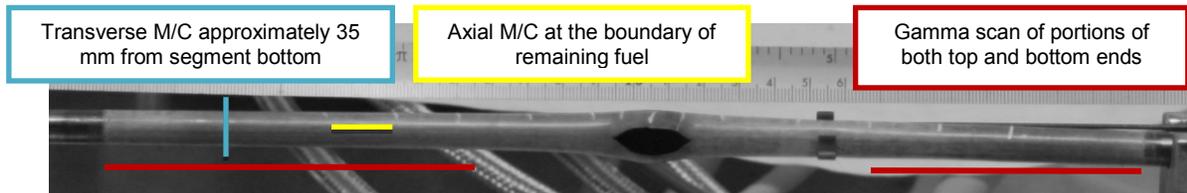
regions of the test segments. To investigate the length and condition of the remaining fueled regions, gamma scans and additional metallography and ceramography (M/C) examinations were performed. Recall that the rodlet used in Test 192 fractured in the rupture node during the four-point bend test, and multiple cladding segments were removed for metallography and hydrogen analysis. The remaining portions of the rodlet were gamma scanned separately and the scans in combination covered about two-thirds of length of the rodlet, as shown in Figure 2-34. The locations of additional M/C examinations are also shown in Figure 2-34.

Figure 2-34 Photo of test segment from Test 192, indicating the relative length of gamma scan results and location of additional M/C examinations in the remaining fueled regions

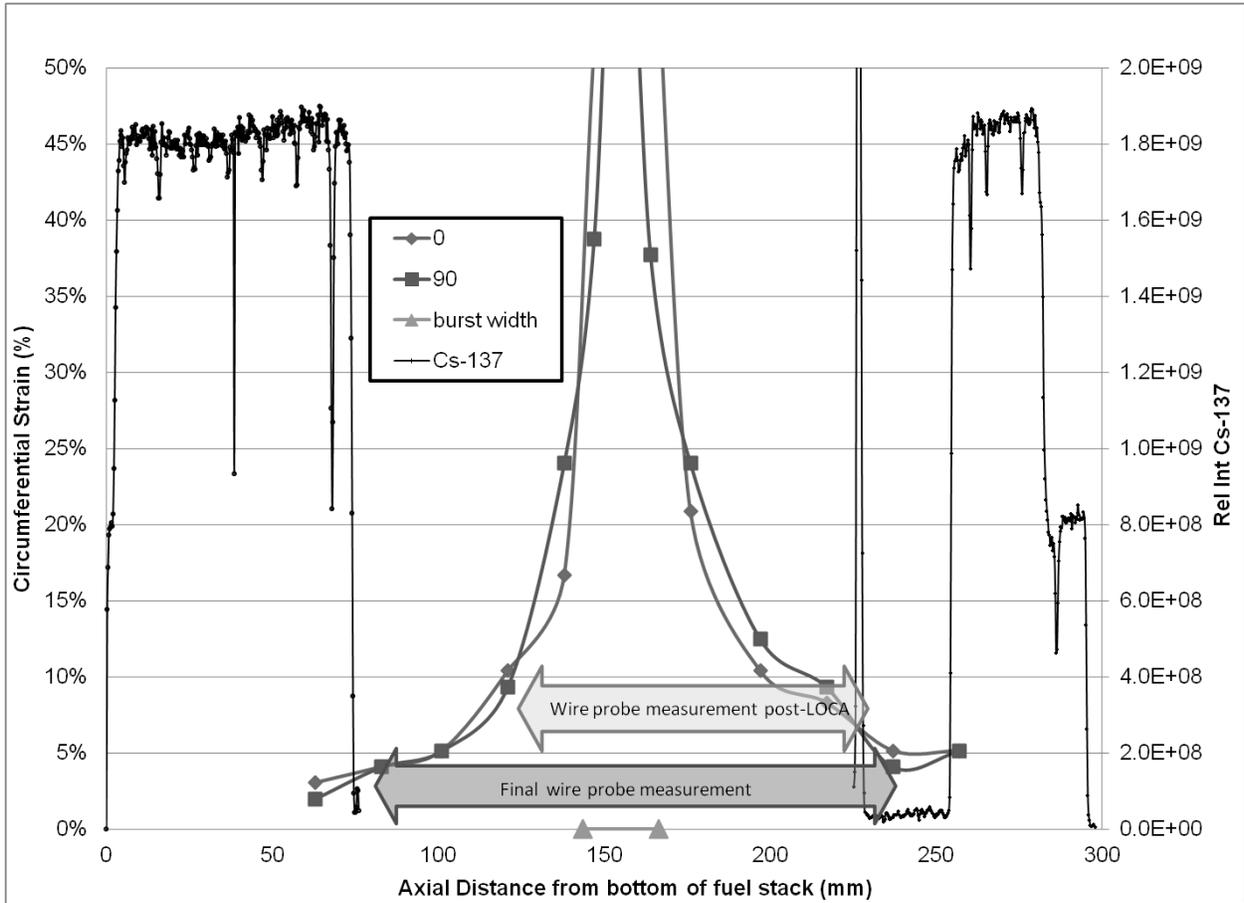
In Figure 2-35, the gamma scan results were plotted together with the profilometry results and the wire probe measurements performed just after the LOCA test (indicated as “post-LOCA” in the figure below) and just after the shaking test (indicated as “final wire probe measurement” in the figure below).

Figure 2-35 Gamma scan results for Test 192 with comparison to profilometry and initial wire probe measurements

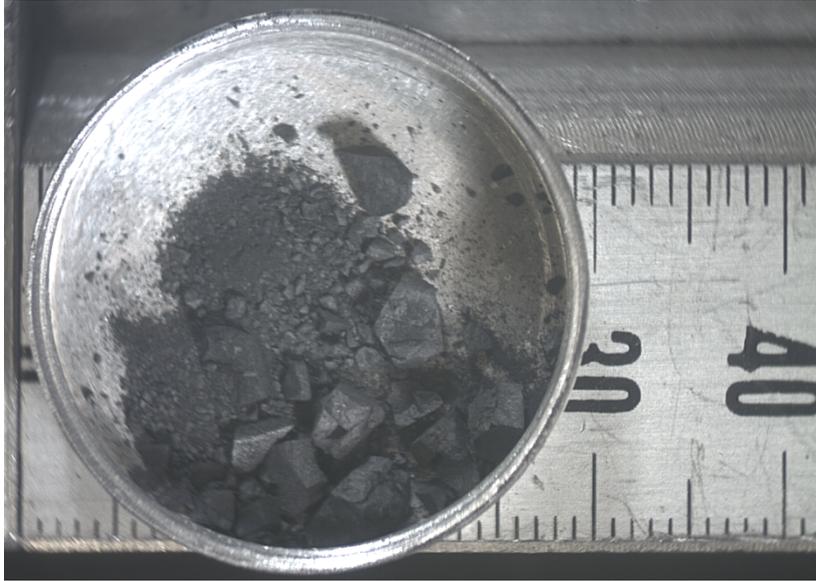
As indicated earlier, these gamma scan results were obtained over 1 year after the LOCA test was performed. In the time between the LOCA test and these gamma scans, the rodlet portions were stored in metal cans in the hot-cell. Some fuel material was found in the metal cans once the rodlet portions were removed for gamma scanning and some additional material fell out after minor shaking. The mass of fuel material found in the can storing the top portion of the rodlet was 5.4 grams (no additional fuel loss was noticed in the can storing the bottom portion of the rodlet). It is important to note that this fuel had fallen out of the rod before the gamma scan. This additional fuel loss during storage approximately accounts for the difference between the final wire probe measurement and the indication on the gamma scan results of the start of the remaining fuel column on the top rodlet portion. An image of the fuel material collected from the top end of rodlet 192 is shown in Figure 2-36.

Figure 2-36 Fuel fragments collected from the top end of rod 192 after gentle shaking just before gamma scan

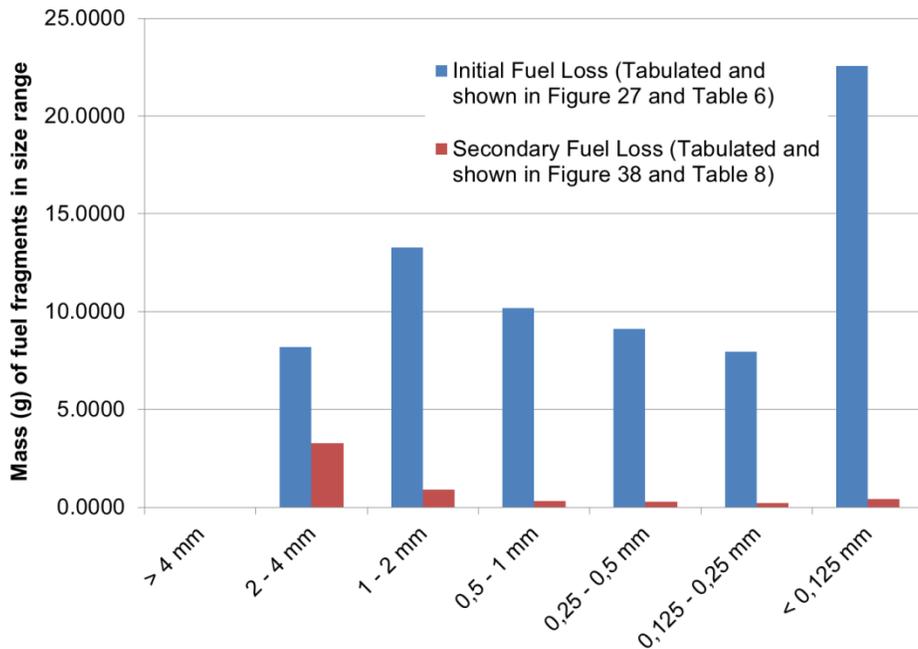
Figure 2-37 Comparison of fuel fragment size distribution from two regions of segment 192

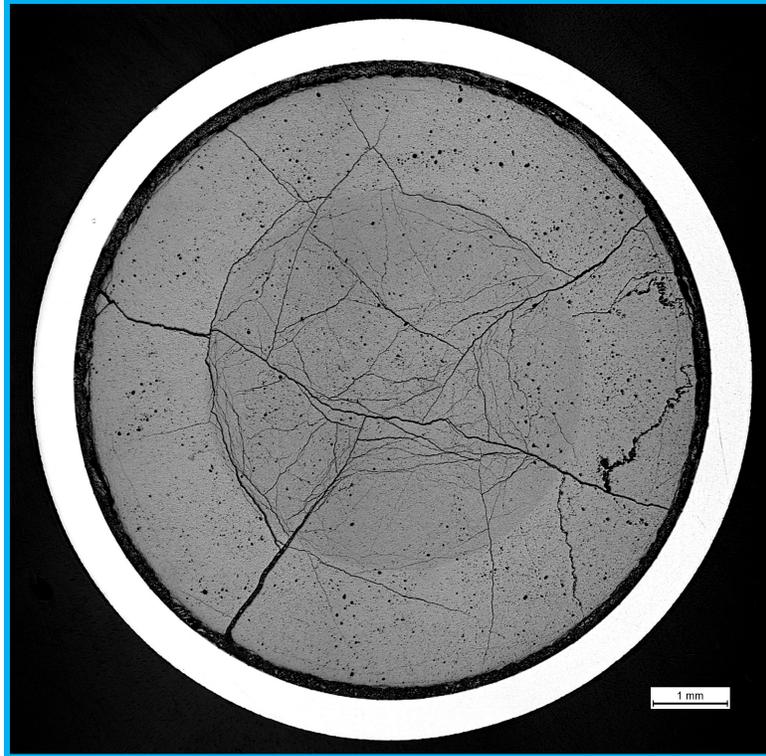
Additional M/C examinations provide an even more detailed characterization of the remaining fueled region than the gamma scan results. The transverse M/C sample shown in Figure 2-38 was taken approximately 35 millimeters from the segment bottom. The image reveals a largely intact pellet cross section. A high-resolution image, shown in Figure 2-39, reveals that some amount of fuel remains attached to the inner cladding wall. Many small fuel fragments can be seen in the space between the cladding and the relatively intact remaining fuel material.

Figure 2-38 Macrograph of transverse cross section 35 mm from the bottom of the rodlet tested in LOCA Test 192

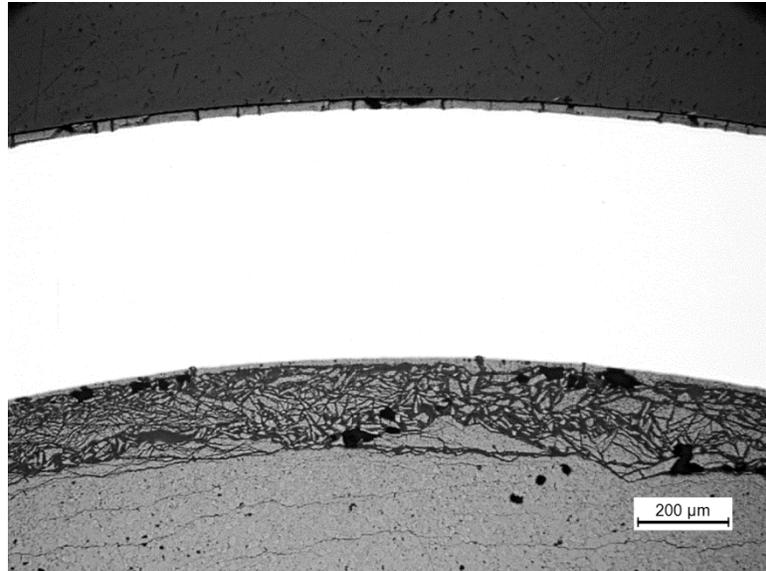
Figure 2-39 A high-resolution image of the fuel cladding gap from the M/C examination 35 mm from the bottom of the rodlet tested in LOCA Test 192

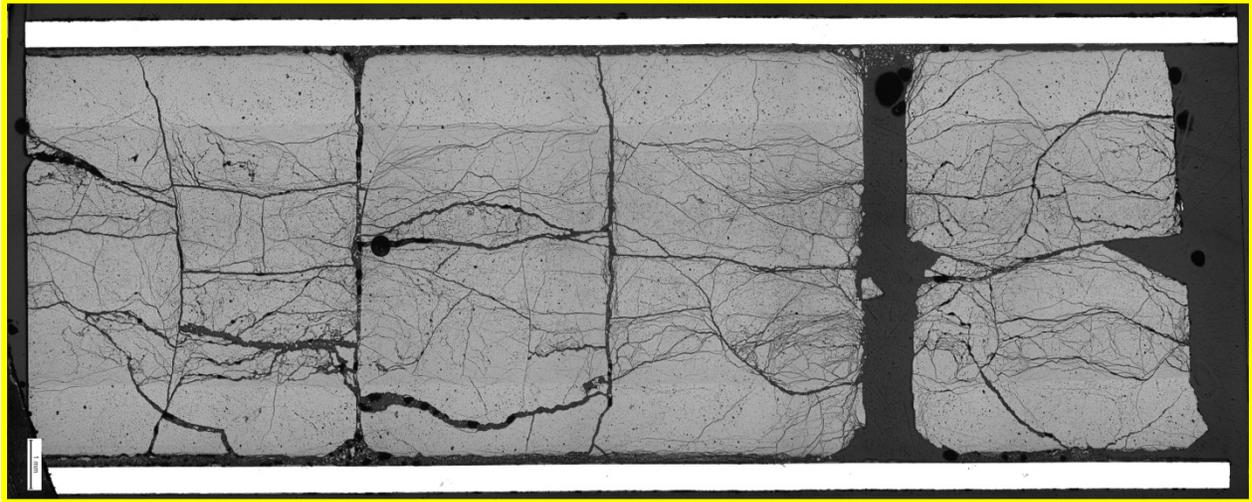
The axial M/C sample shown in Figure 2-40 was taken at the boundary of remaining fuel and empty cladding, covering a span approximately 50-75 millimeters from the segment bottom.

The image reveals that the boundary between fueled and empty cladding is abrupt, and that the fueled region contains cracked, but largely complete, pellet cross sections.

Figure 2-40 Macrograph of axial cross section covering a span approximately 50–75 mm from the segment bottom of the rodlet tested in LOCA Test 192

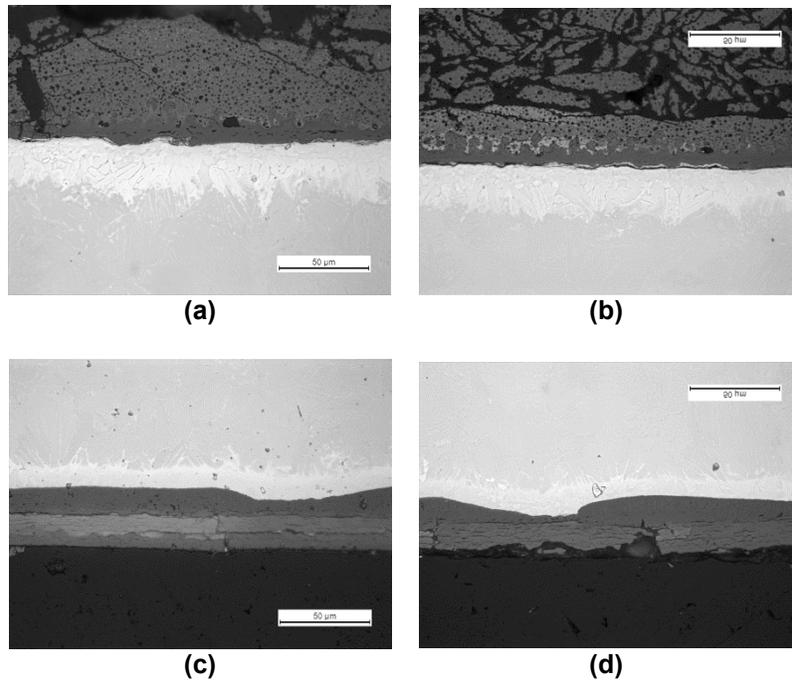
Select, high-resolution images are included in Figure 2-41 from the inner (a and b) and outer (c and d) cladding diameter. These images were near the bottom (left) of the axial M/C, approximately 55 millimeters from the original segment bottom of the rodlet tested in LOCA Test 192. Again, here it is useful to recall that for Test 192 the calculated CP-ECR was 11 percent, with a hold time at 1,185 degrees C of 5 seconds.

Figure 2-41 High-resolution images of the cladding (a and b) inner and (c and d) outer diameter taken from the axial M/C shown above. These images were near the bottom (left) of the axial M/C, approximately 55 mm from the original segment bottom and approximately 100 mm below the rupture opening of the rodlet tested in LOCA Test 192.

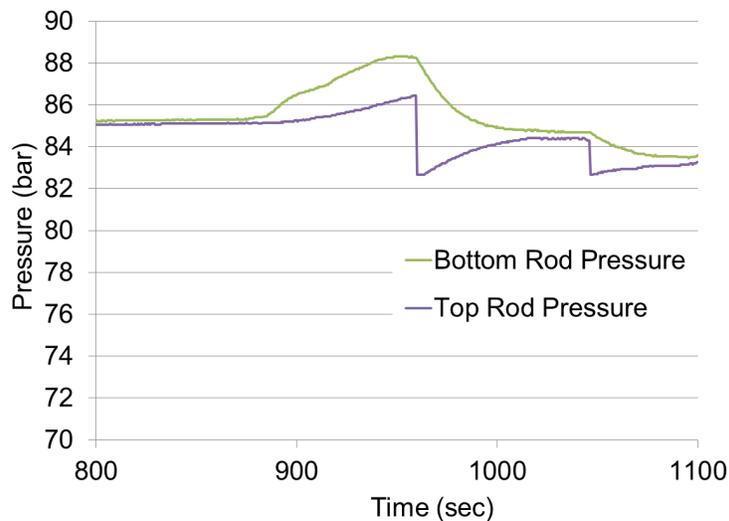
To begin the transient, the rodlet was heated and maintained at 300 degrees C for approximately 15 minutes to achieve thermal equilibrium. Before initiating the temperature ramp, the desired fill pressure was established at 300 degrees C. For Test 193, the rodlet was pressurized to 82 bar (at 300 degrees C). The pressure adjustment procedure provides an indication of gas communication by observing the response time of the lower pressure transducer, as shown in Figure 2-42. Recall that while the gas line is open, the top pressure transducer indicates the gas line pressure and the bottom should reflect the ability of gas to move the 300 millimeter to equilibrate pressure. Once the desired fill pressure was established, the gas line was closed and the rodlet was heated at 5 degrees C/s until the rodlet temperature reached 1,160 degrees C. The rodlet was held at 1,160°C for 85 seconds. The calculated CP-ECR (based on measured rupture strain reported below) was approximately 17 percent.

Figure 2-42 Fill pressure adjustment at 300 °C for Test 193, which provides an indication of gas communication

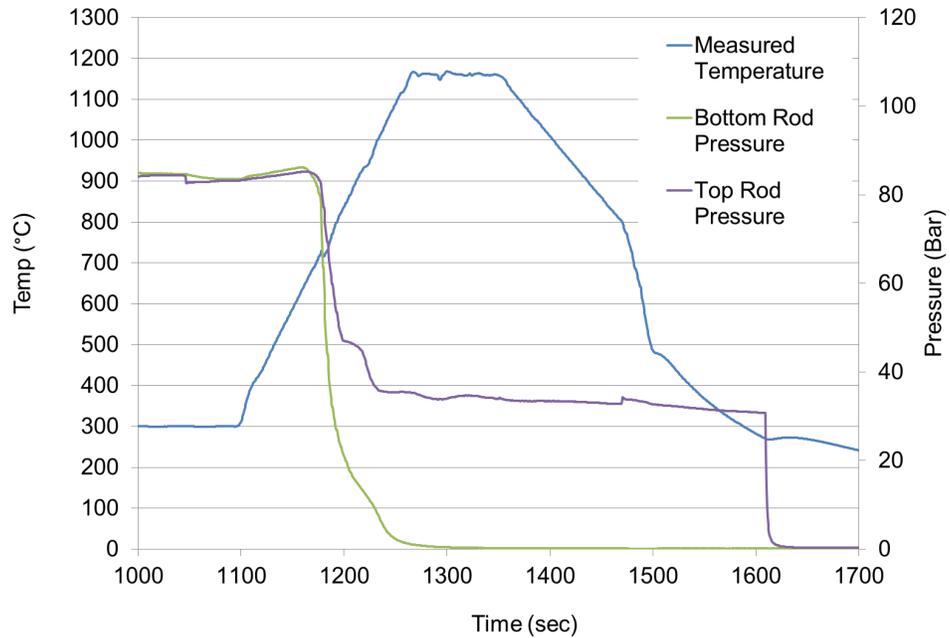
Rupture is estimated to have taken place when the rod internal pressure reached 81 bar and the cladding temperature reached 728 degrees C. The depressurization rate was relatively slow for Test 193; the top pressure gauge recorded a 50 percent reduction in pressure (relative to

81 bar) after 45 seconds and the bottom pressure gauge recorded a 50 percent reduction in pressure after 8 seconds. The temperature and pressure history for Test 193 is shown in Figure 2-43.

Figure 2-43 Temperature and pressure history for Test 193

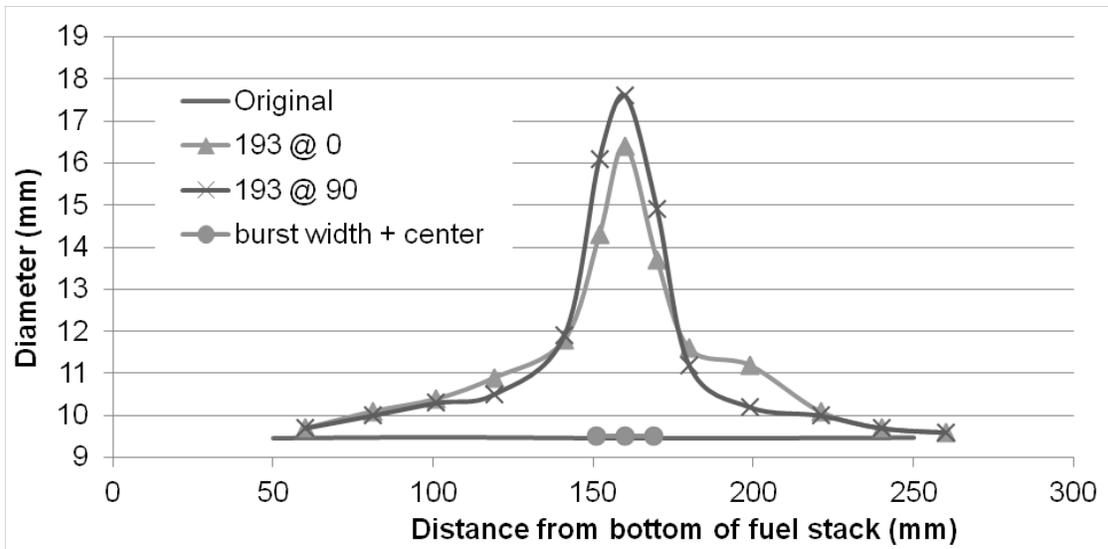
The rod experienced minor distortion (or bending) during the LOCA transient, which can be seen in Figure 2-45. Profilometry measurements were made and they are shown in Figure 2-46. In Figure 2-46, the initial diameter and rupture length are also indicated. The mid-wall rupture strain value for Test 193 was calculated to be 50 percent.

Figure 2-46 Profilometry measurements of segment 193 post-transient. The rupture length is also indicated.

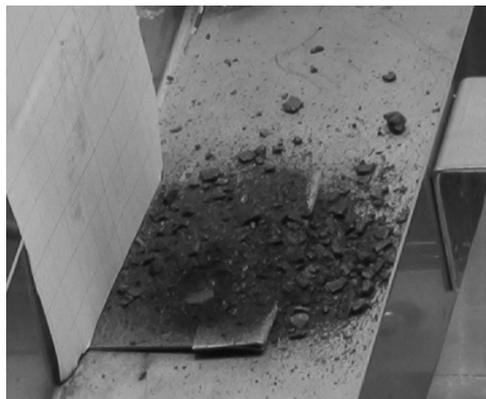
In total, it appears that about half of the fuel fell out of this rod during the simulated LOCA transient test and during shaking. During the wire probe measurement, completed after all experimental steps (LOCA transient, bending and shaking), the probe traveled unobstructed approximately 92 millimeters above and approximately 113 millimeters below the rupture center. The mass loss measured following the LOCA test was 105 grams. The mass loss measured following the bend test and after shaking was 41 grams. In total, 146 grams of fuel was lost. Figure 2-47 provides an image of the collected fuel fragments.

Figure 2-47 Images of fuel collected from Test 193

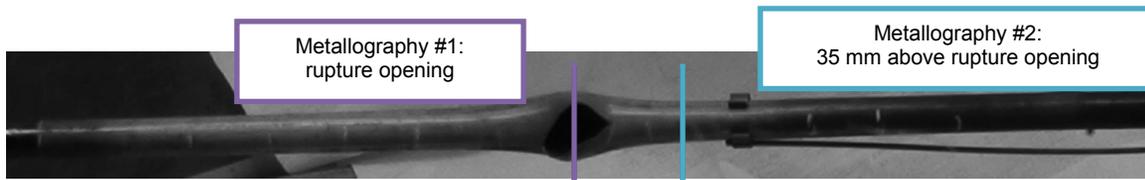
Figure 2-48 Photo of test segment from Test 193, indicating the location of metallography

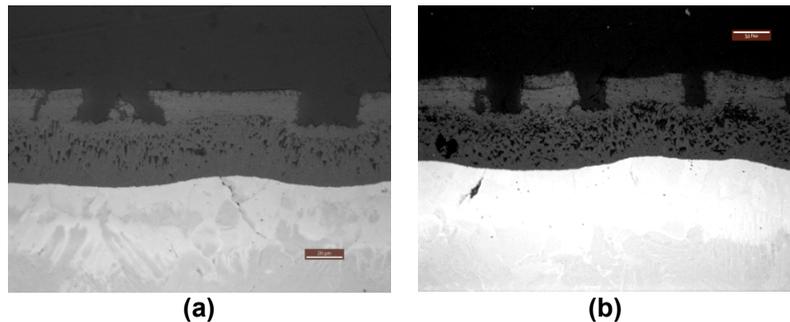
Figure 2-50 Two high-resolution images of the cladding outer diameter from the metallography examination in the rupture region of the rodlet tested in LOCA Test 193 at (a) 90° and (b) 270°

Here, it is useful to recall that for Test 193 the calculated CP-ECR was 17 percent, with a hold time at 1,185°C of 85 seconds. In Figure 2-50, the initial oxide thickness can be seen to have cracked and separated in this high strain (50 percent) area, and the transient oxidation layer is seen beneath this damaged initial oxide layer. In Figure 2-51, it appears that some fuel fragments remain on the inner diameter and that the initial fuel-cladding bonding layer has also cracked and separated. An inner diameter transient oxidation layer is not apparent in these images, although the micrographs indicate some unique microstructure layer that may be an alpha zirconium layer. The absence of an inner diameter transient oxidation layer is somewhat surprising at this location because it is in the rupture node and was held for 85 seconds at high temperature.

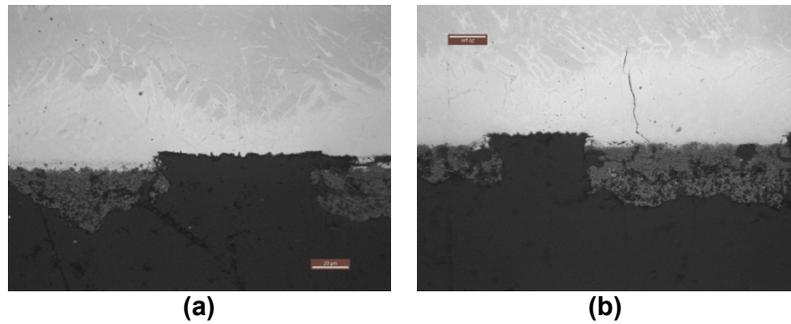
Figure 2-51 Two high-resolution images of the cladding inner diameter from the metallography examination in the rupture region of the rodlet tested in LOCA Test 193 at (a) 135° and (b) 270°

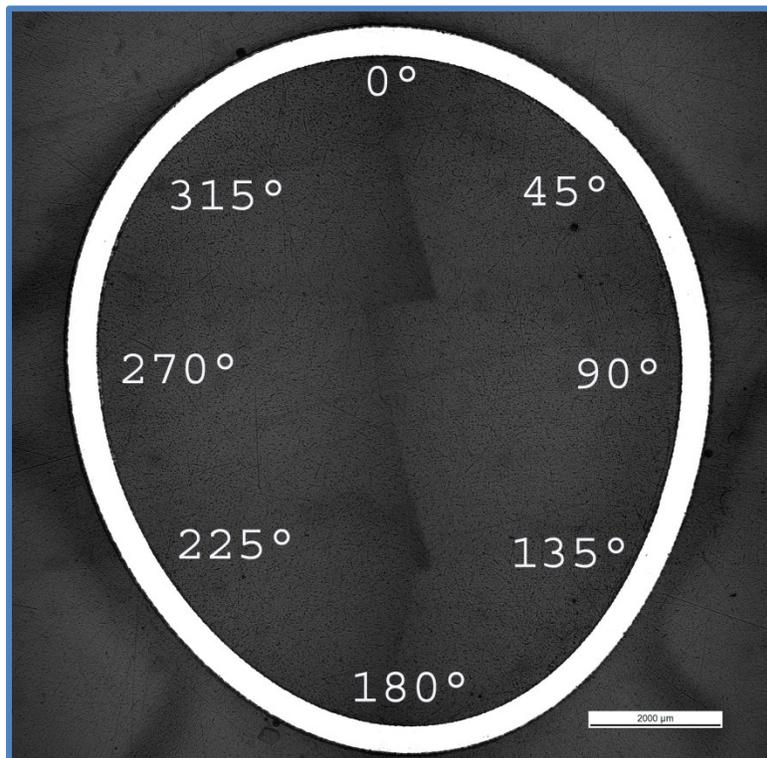
The metallography sample shown in Figure 2-52 was taken from a section 35 millimeters above the rupture opening. Select, high-resolution images from the outer cladding diameter and inner cladding diameter are included in Figure 2-53 and Figure 2-54, respectively.

Figure 2-52 Macrograph of cross section from 35 mm above the rupture region of rodlet tested in LOCA Test 193

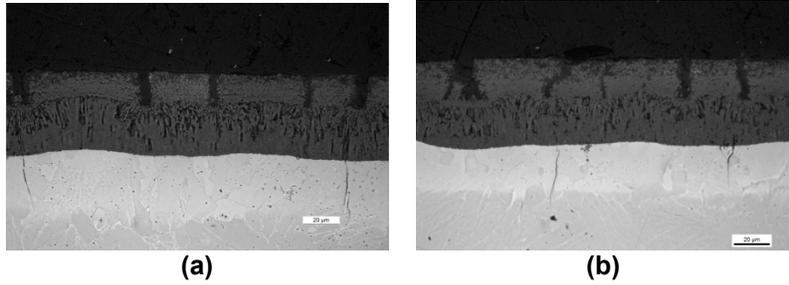
Figure 2-53 Two high-resolution images of the cladding outer diameter from the metallography examination 35 mm above the rupture region of the rodlet tested in LOCA Test 193 at (a) 45° and (b) 270°

In Figure 2-53, the initial oxide thickness can be seen to have cracked and separated at this location 35 millimeters above the rupture node, and the transient oxidation layer is seen beneath this damaged initial oxide layer. The local strain in this region is approximately 15 to 20 percent. In Figure 2-54, it appears that some fuel fragments remain on the inner diameter and that the initial fuel-cladding bonding layer has also cracked and separated. An inner diameter transient oxidation layer is not apparent in these images, although the micrographs indicate some unique microstructure layer that may be an alpha zirconium layer.

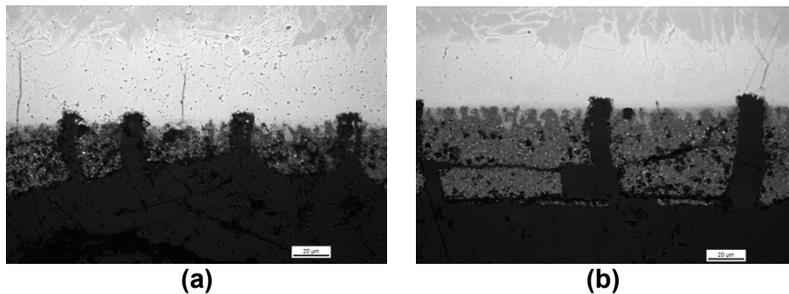
Figure 2-54 Two high-resolution images of the cladding inner diameter from the metallography examination 35 mm above the rupture region of the rodlet tested in LOCA Test 193 at (a) 135° and (b) 270°

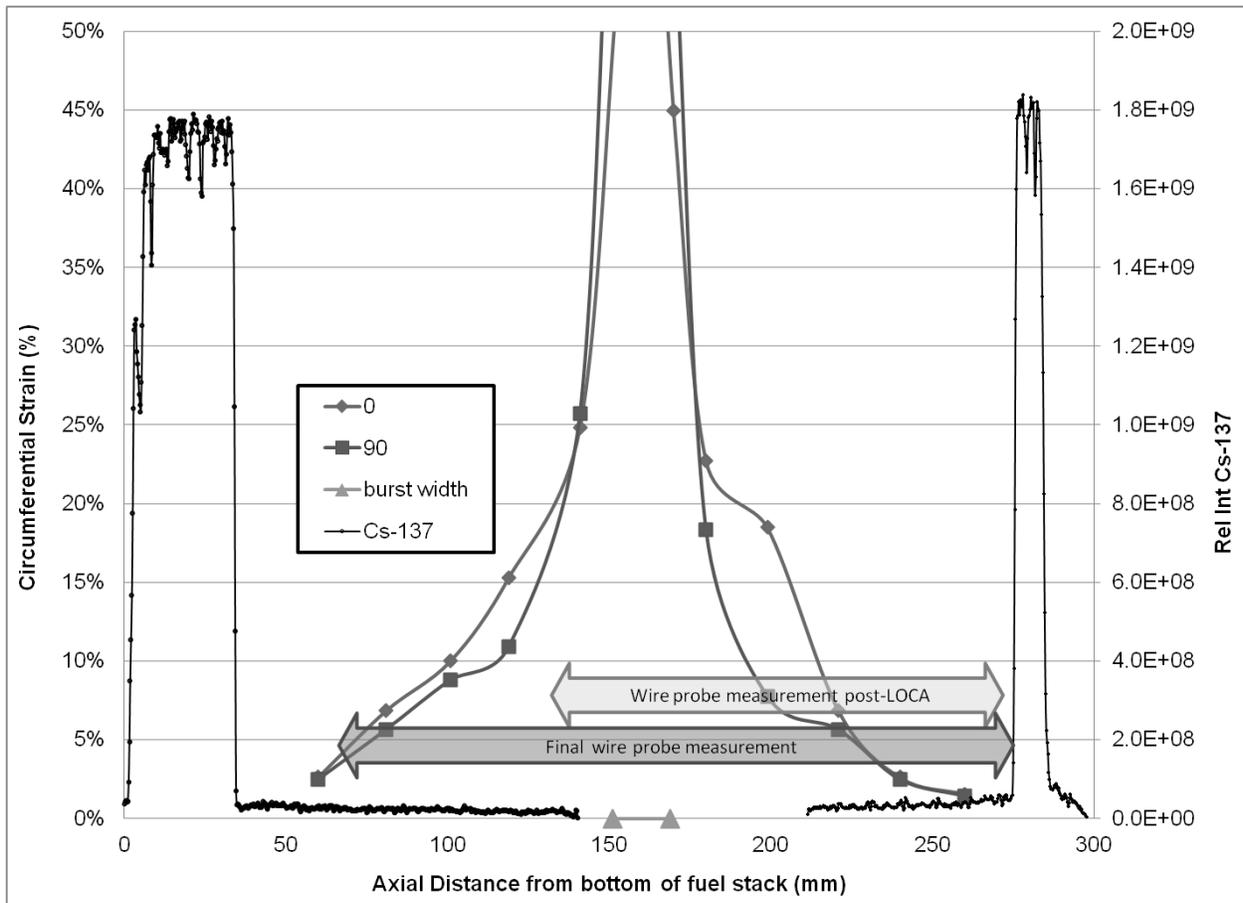
In Figure 2-57, the gamma scan results were plotted together with the profilometry results and the wire probe measurements performed just after the LOCA test (indicated as “post-LOCA” in the figure below) and just after the shaking test (indicated as “final wire probe measurement” in the figure below).

Figure 2-57 Gamma scan results for Test 193 with comparison to profilometry and initial wire probe measurements

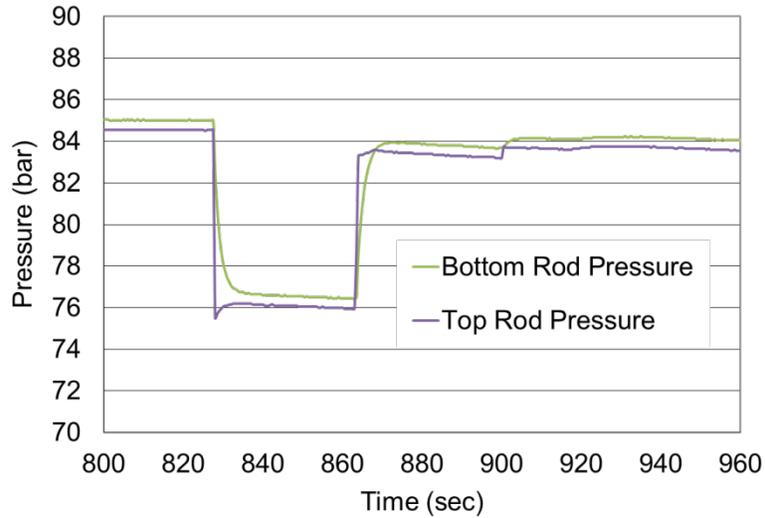
To begin the transient, the rodlet was heated and maintained at 300 degrees C for approximately 15 minutes to achieve thermal equilibrium. Before initiating the temperature ramp, the desired fill pressure was established at 300 degrees C. For test 196, the rodlet was pressurized to 82 bar (at 300 degrees C). The pressure adjustment procedure provides an indication of gas communication by observing the response time of the lower pressure transducer, as shown in Figure 2-58. While the gas line is open, the top pressure transducer indicates the gas line pressure and the bottom should reflect the ability of gas to move the 300 millimeter segment length to equilibrate pressure. Once the desired fill pressure was established, the gas line was closed and the rodlet was heated at 5 degrees C/s through ballooning and rupture. This was a “ramp-to-rupture” test and therefore the furnace was shut off to terminate the test at 950 degrees C and there was no quench. No significant oxidation was accumulated during this test.

Figure 2-58 Fill pressure adjustment at 300 °C for Test 196, which provides an indication of gas communication

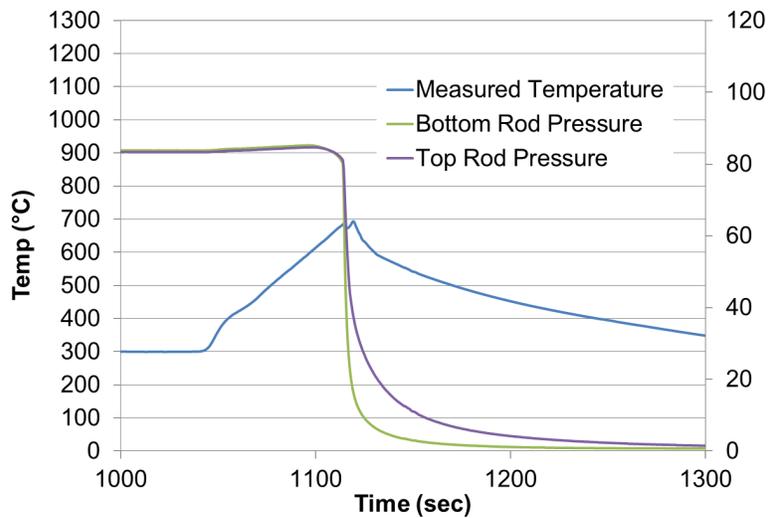
Figure 2-59 Temperature and pressure history for Test 196

Rupture is estimated to have taken place when the rod internal pressure reached 81 bar and the cladding temperature reached 686 °C (1267 degrees F). The depressurization rate was relatively fast for test 196; the top pressure gauge recorded a 50 percent reduction in pressure (relative to 81 bar) after 5 seconds and the bottom pressure gauge recorded a 50 percent reduction in pressure after 2 seconds. The temperature and pressure history for Test 196 is shown in Figure 2-59.
