Post-Test Examination Results from Integral, High-Burnup, Fueled LOCA Tests at Studsvik Nuclear Laboratory

This report presents and discusses the results of the U.S. Nuclear Regulatory Commission's integral loss-of-coolant accident (LOCA) testing program conducted at Studsvik Nuclear AB in Sweden. In this program, refabricated, high burnup irradiated fuel rodlets were subjected to LOCA conditions. In total, six single-rod LOCA tests were conducted in the Hot Cell Laboratory at Studsvik Nuclear AB. This report documents the test conditions, rodlet response, and post-test examinations for all six tests. The purpose of this document is to make this information available for comparison to related or complementary experimental programs. The observations of fuel fragmentation, relocation, and dispersal in this experimental program may be of particular interest for comparison to related or complementary experimental programs.

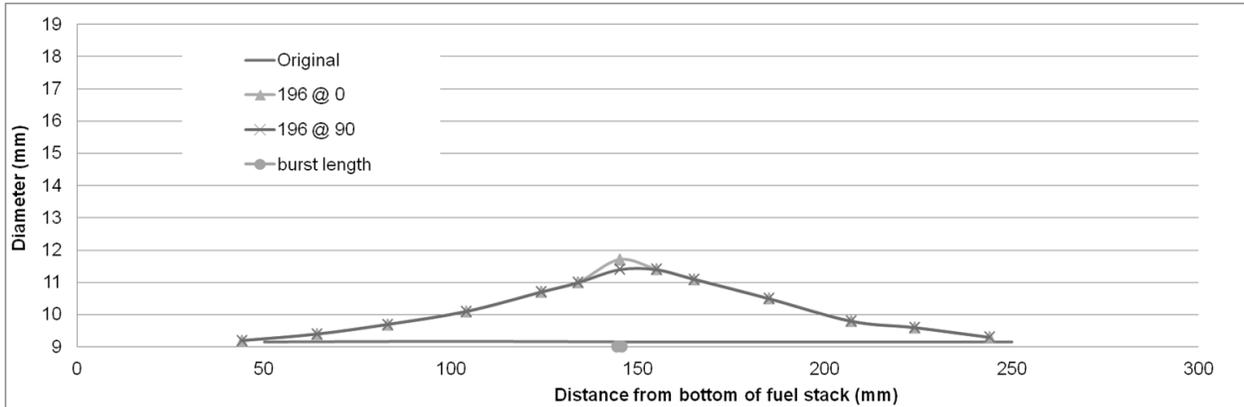
Figure 2-62 Profilometry measurements of segment 196 post-transient. The rupture length is also indicated.

The rod did not experience distortion (or bending) during the LOCA transient, which can be seen in Figure 2-61. Profilometry measurements were made and they are shown in Figure 2-62. In Figure 2-62, the initial diameter and rupture length are also indicated. The mid-wall rupture strain value for Test 196 was calculated to be 25 percent.

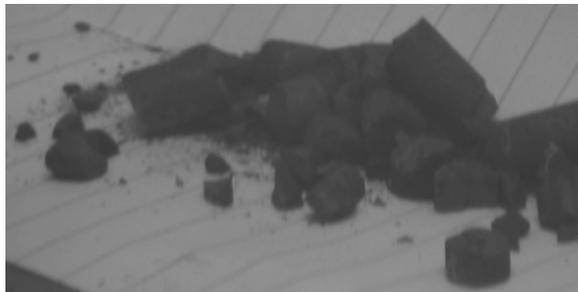
Figure 2-63 Images of fuel collected from Test 196

Because this rodlet did not experience significant oxidation and therefore was expected to be highly ductile, there was no bend test performed on this rod. Instead, the rod was manually cut into two pieces, through the rupture node. The two pieces were then shaken and fuel loss was observed. There was no fuel loss measured following the LOCA test; however, it appears that about half of the fuel fell out of this rod during shaking. During the wire probe measurement, completed after shaking, the probe traveled unobstructed approximately 90 millimeters above and approximately 66 millimeters below the rupture center. The mass loss measured following the bend test and after shaking was 77 grams. Figure 2-63 provides an image of the collected fuel fragments.

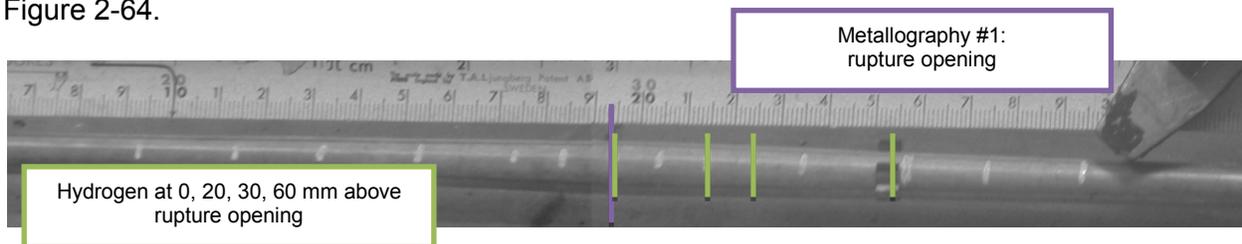
Figure 2-64 Photo of test segment from Test 196, indicating the location of metallography and hydrogen measurements

One metallography examination and four hydrogen measurements were made of the rodlet used in Test 196. The locations of metallography and hydrogen measurements are shown in Figure 2-64.

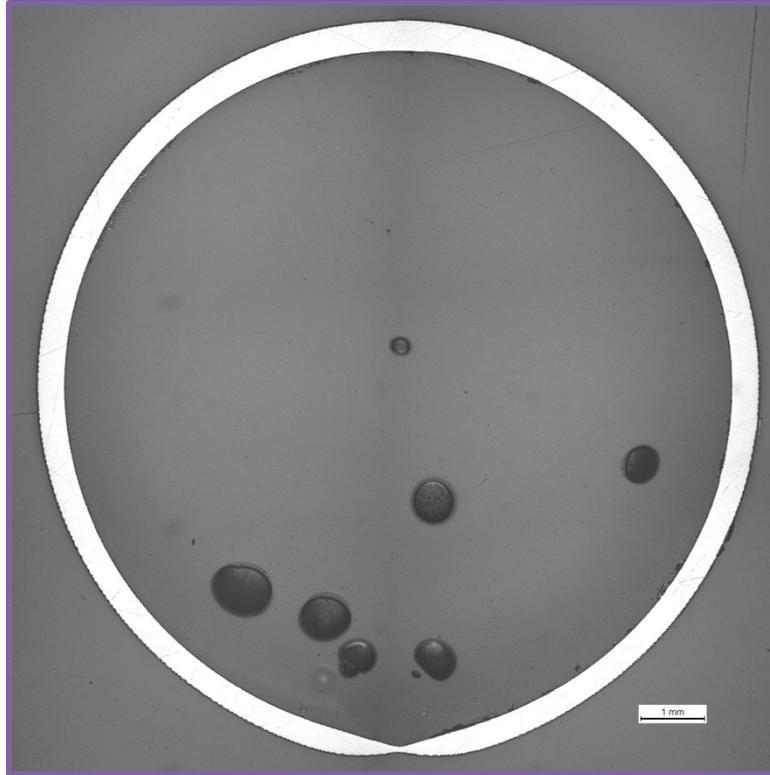
Figure 2-65 Macrograph of cross section from the rupture region of rodlet tested in LOCA Test 196

The metallography sample shown in Figure 2-65 was taken from the rupture opening. Select, high-resolution images from the outer cladding diameter and inner cladding diameter are included in Figure 2-66 and Figure 2-67, respectively.

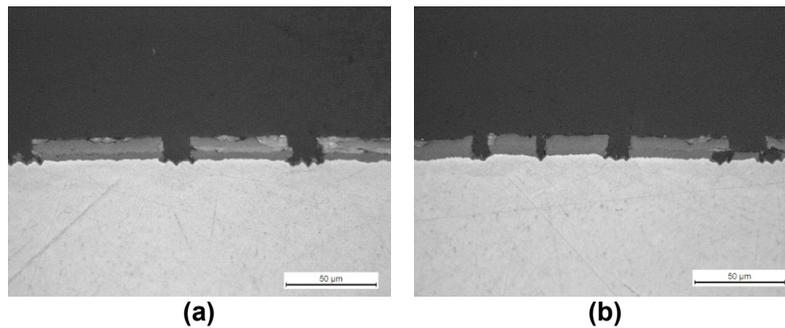
In Figure 2-66, the initial oxide thickness can be seen to have cracked and separated with the strain of the cladding. The strain at this location was approximately 25 percent. No transient oxidation layer can be observed in these images, which is expected for this test because it was a “ramp-to-rupture” test and did not accumulate significant oxidation. In Figure 2-67, some remnants of a fuel-clad bonding layer can be observed. This layer can be seen to have cracked and separated with the strain of the cladding. Again, this is expected because the test was terminated just after rupture and before significant transient oxidation could accumulate.

Figure 2-66 Two high-resolution images of the cladding outer diameter from the metallography examination in the rupture region of the rodlet tested in LOCA Test 196 at (a) 90° and (b) 270°

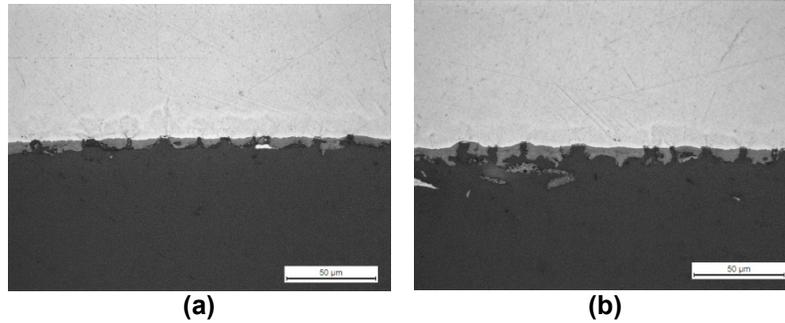
Figure 2-67 Two high-resolution images of the cladding inner diameter from the metallography examination in the rupture region of the rodlet tested in LOCA Test 196 at (a) 45° and (b) 270°

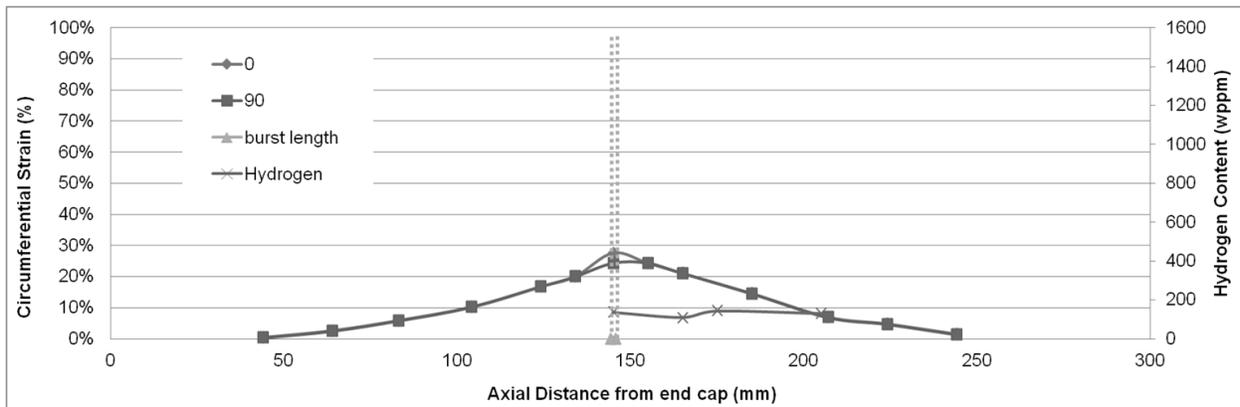
Figure 2-68 Hydrogen measurements from 196 relative to segment strain profile and rupture length

The location and values of hydrogen content, measured by hot vacuum extraction, are provided in Table 2-13, and illustrated, relative to the segment post-LOCA strain profile and rupture length measurements, in Figure 2-68.

Distance above rupture opening (mm)	0	20	30	60
Hydrogen Content (wppm)	137	110	144	131

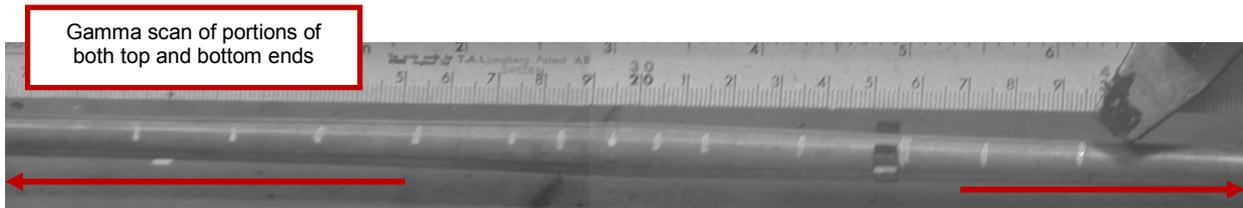
Figure 2-69 Photo of test segment from Test 196, indicating the relative length of gamma scan results

the scans in combination covered a little over half of the length of the rodlet, as shown in Figure 2-69.

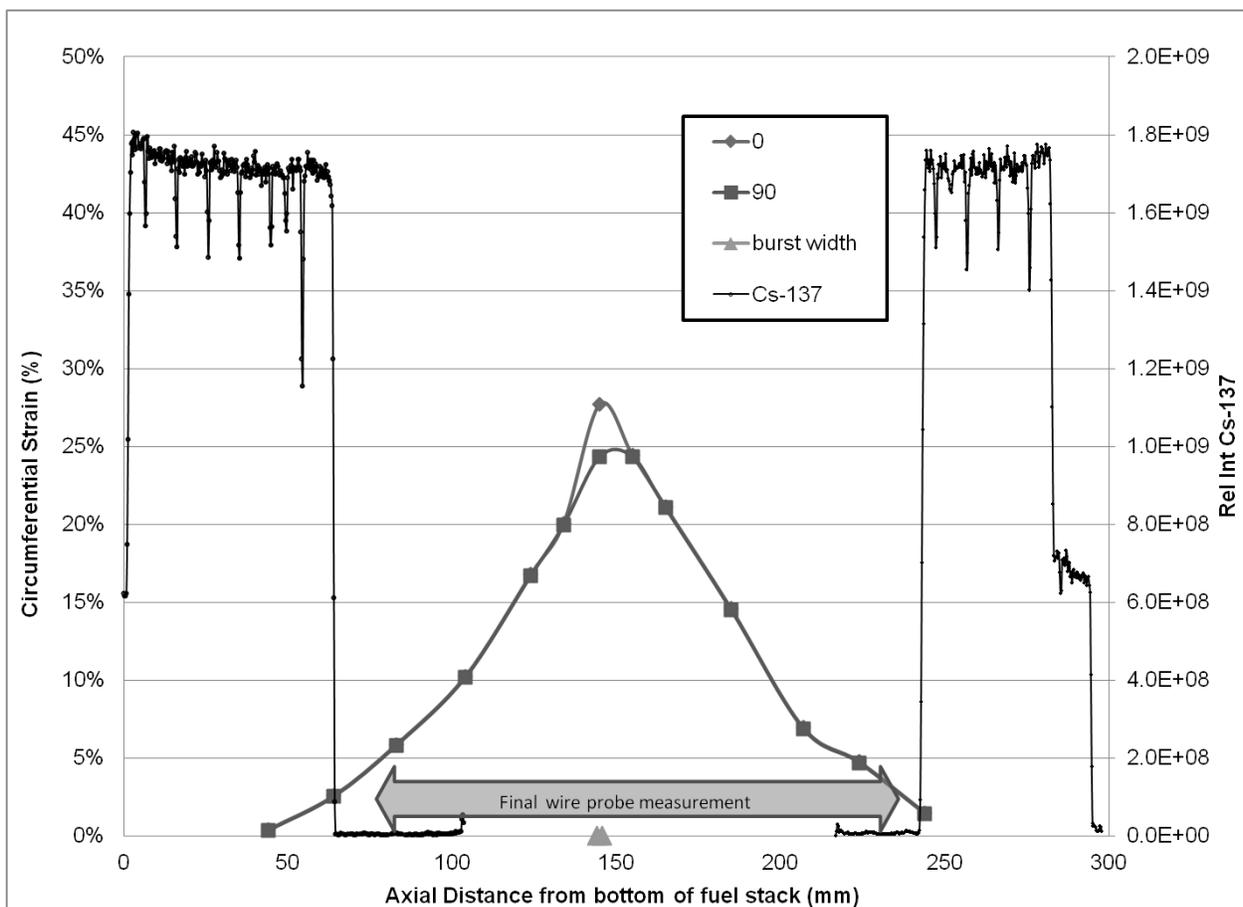
Figure 2-70 Gamma scan results for Test 196 with comparison to profilometry and initial wire probe measurements

In Figure 2-70, the gamma scan results were plotted together with the profilometry results and the wire probe measurements performed after the shake test (indicated as “final wire probe measurement” in the figure below).

As indicated earlier, these gamma scan results were obtained over 1 year after the LOCA test was performed. In the time between the LOCA test and these gamma scans, the rodlet portions were stored in metal cans in the hot-cell. Some fuel material was found in the metal cans once the rodlet portions were removed for gamma scanning and some additional material fell out after minor shaking. The mass of fuel material found in the can storing the bottom portion of the rodlet was 8.3 grams. A few milligrams of fuel material was found in the can storing the top portion of the rodlet. An image of the fuel material collected from the bottom end of rodlet 196 is shown in Figure 2-71. It is important to note that this fuel had fallen out of the rod before the gamma scan. This additional fuel loss during storage approximately accounts for the difference between the final wire probe measurement and the indication on the gamma scan results of the start of the remaining fuel column on the top rodlet portion.

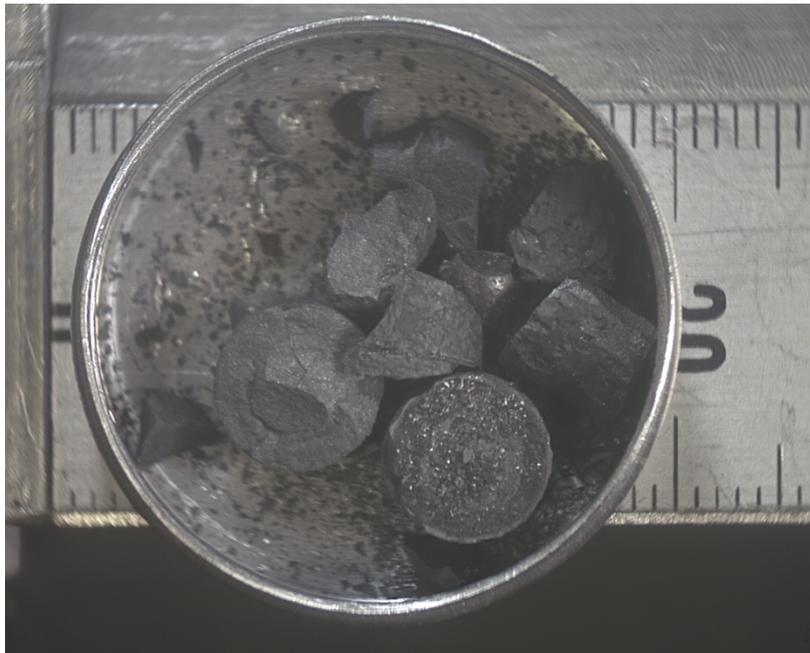
Figure 2-71 Fuel fragments collected from the bottom of rod 196 after gentle shaking just before gamma scan

Considering the initial wire probe measurements, the fuel fragments collected after the LOCA test and initial shake test (shown in Figure 2-63 and quantified in Table 2-12) likely originated from the middle 150 millimeter region of the fuel rod that was measured to be empty following the LOCA test. However, the fuel fragments shown in Figure 2-71 collected 1 year later after gentle shaking just before the gamma scan likely originated from some span beyond the middle 150 millimeter, possibly in the axial length between the wire probe measurement and the indication of fuel in the gamma scan (approximately 70 to 75 millimeter in Figure 2-70). Additional sieve analysis was performed to characterize the fragment size distribution of the fragments collected and shown in Figure 2-71. The measured mass of each sieve group is provided in Table 2-14, along with the mass percentage of each group relative to the total fuel analyzed. Figure 2-72 provides a comparison of the fuel fragment size distribution from these two regions of segment 196. The comparison suggests that fragmentation size distribution is comparable in these two regions.

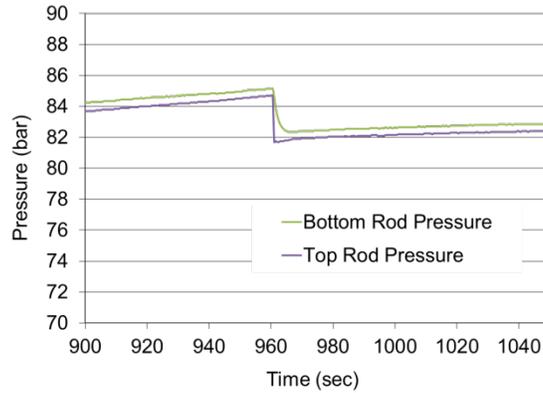
Figure 2-73 Fill pressure adjustment at 300 °C for Test 198, which provides an indication of gas communication

To begin the transient, the rodlet was heated and maintained at 300 degrees C for approximately 15 minutes to achieve thermal equilibrium. Before initiating the temperature ramp, the desired fill pressure was established at 300 degrees C. For Test 198, the rodlet was pressurized to 82 bar (at 300 degrees C). The pressure adjustment procedure provides an indication of gas communication by observing the response time of the lower pressure transducer, as shown in Figure 2-73. Recall that while the gas line is open, the top pressure transducer indicates the gas line pressure and the bottom should reflect the ability of gas to move the 300 millimeter segment length to equilibrate pressure. Once the desired fill pressure was established, the gas line was closed and the rodlet was heated at 5 degrees C/s until the rodlet temperature reached 1,185 degrees C. The rodlet was held at 1,185 degrees C for 85 seconds. The calculated CP-ECR (based on measured rupture strain reported below) was approximately 15 percent.

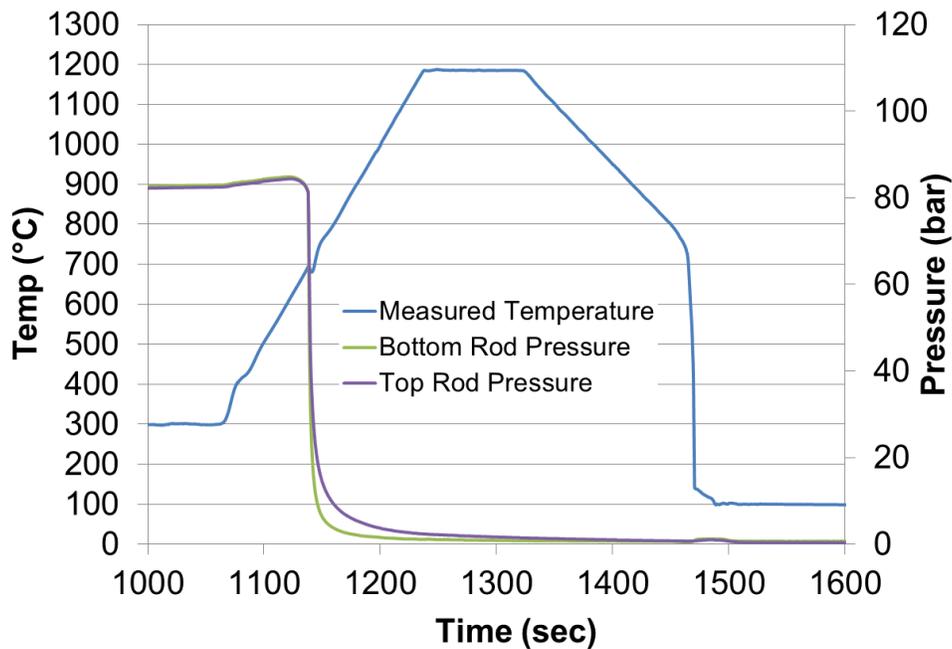
Figure 2-74 Temperature and pressure history for Test 198

Rupture is estimated to have taken place when the rod internal pressure reached 81 bar and the cladding temperature reached 693 degrees C (1279 degrees F). The depressurization rate was relatively fast for Test 198; the top pressure gauge recorded a 50 percent reduction in pressure (relative to 81 bar) after 3 seconds and the bottom pressure gauge recorded a 50 percent reduction in pressure after 2 seconds. The temperature and pressure history for Test 198 is shown in Figure 2-74.

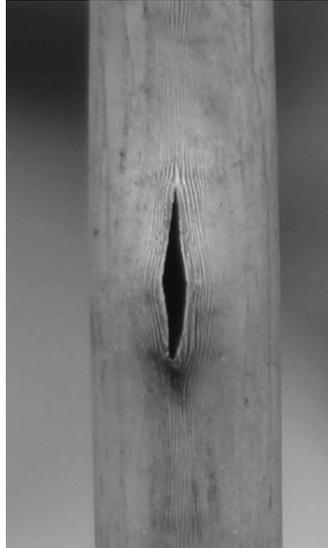
After the simulated LOCA transient was complete, the fuel rod was examined. Figure 2-75 provides a photo of the fuel rod after the transient. The rupture opening was measured to be 1.6 millimeters wide and 11 millimeters in length.

Figure 2-75 Rupture opening after the transient simulation for Test 198

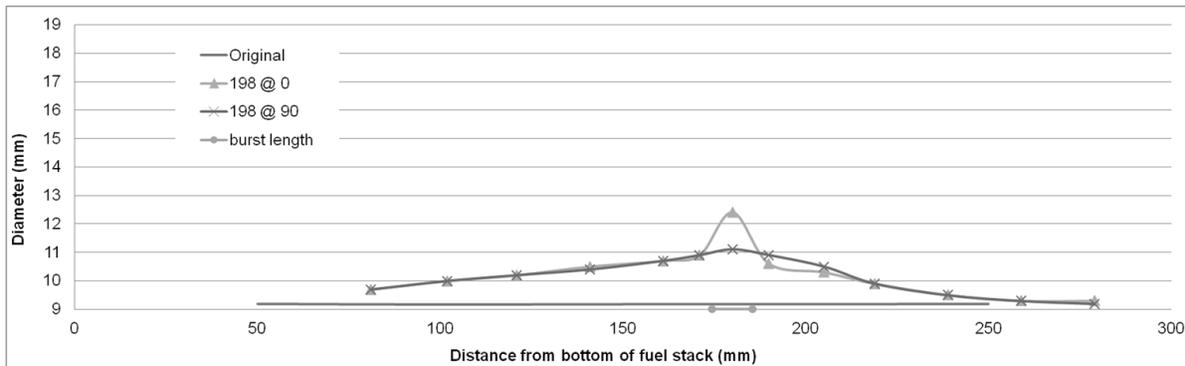
Figure 2-77 Profilometry measurements of segment 198 post-transient. The rupture length is also indicated.

The rod did not experience distortion (or bending) during the LOCA transient, which can be seen in Figure 2-76. Profilometry measurements were made and they are shown in Figure 2-77. In Figure 2-77, the initial diameter and rupture length are also indicated. The mid-wall rupture strain value for Test 198 was calculated to be 25 percent.

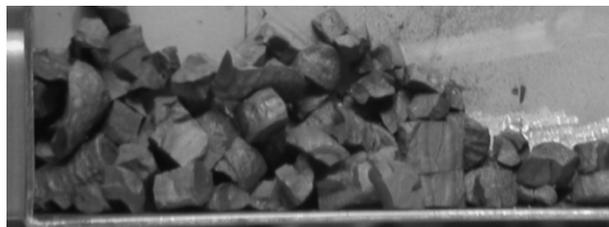
Figure 2-78 Images of fuel collected from Test 198

There was no fuel loss measured following the LOCA test, however, it appears that about half of the fuel fell out of this rod during shaking. During the wire probe measurement, completed after shaking, the probe traveled unobstructed approximately 55 millimeters above and approximately 76 millimeters below the rupture center. There was no measured mass loss following the LOCA test. The mass loss measured after shaking was 62 grams. Figure 2-78 provides an image of the collected fuel fragments.

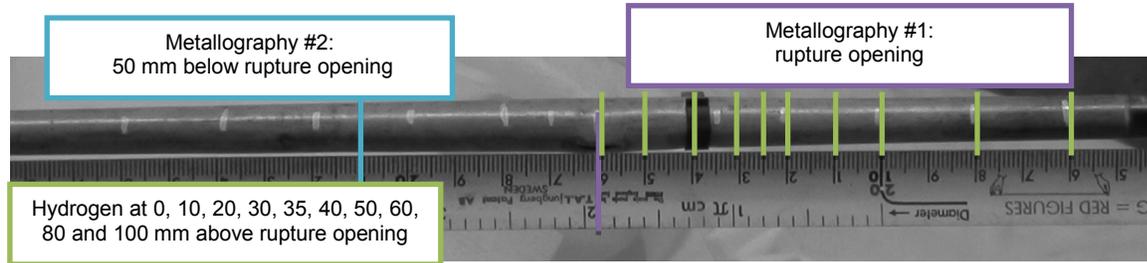
Figure 2-79 Photo of test segment from Test 198, indicating the location of metallography and hydrogen measurements

Two metallography examinations and ten hydrogen measurements were made of the rodlet used in Test 198. The locations of metallography and hydrogen measurements are shown in Figure 2-79.

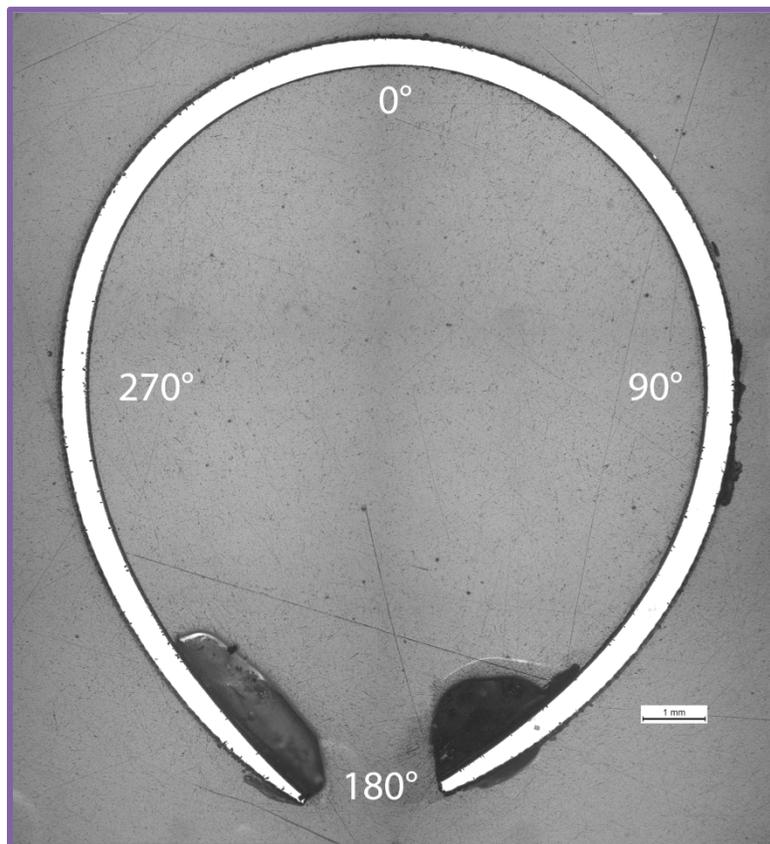
Figure 2-80 Macrograph of cross section from the rupture region of rodlet tested in LOCA Test 198

The metallography sample shown in Figure 2-80 was taken in the rupture opening. Select, high-resolution images from the outer cladding diameter and inner cladding diameter are included in Figure 2-81 and Figure 2-82, respectively.

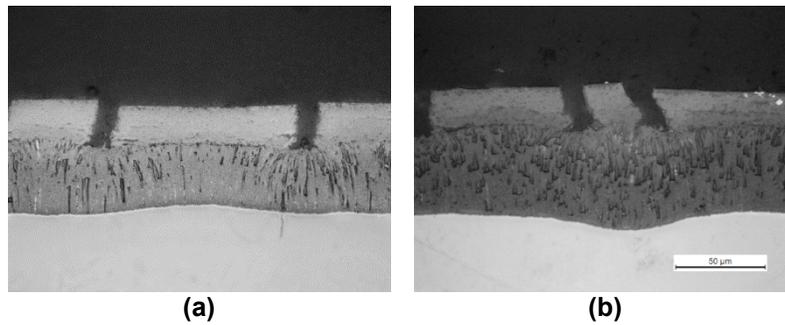
Figure 2-81 Two high-resolution images of the cladding outer diameter from the metallography examination in the rupture region of the rodlet tested in LOCA Test 198 at (a) 90° and (b) 270°

Here, it is useful to recall that for Test 198 the calculated CP-ECR was 15 percent, with a hold time at 1,185 degrees C of 85 seconds. In Figure 2-81, the initial oxide thickness can be seen to have cracked and separated, and the transient oxidation layer is seen beneath this damaged initial oxide layer. In Figure 2-82, it appears that some fuel fragments remain on the inner diameter and that the initial fuel-cladding bonding layer is somewhat cracked and separated. An inner diameter transient oxidation layer is seen, which appears to be approximately the same thickness at the outer transient oxidation layer. These observations are expected at this location because it is in the rupture node.

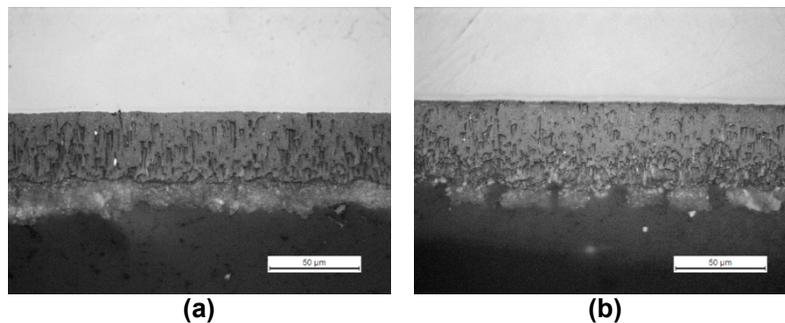
Figure 2-82 Two high-resolution images of the cladding inner diameter from the metallography examination in the rupture region of the rodlet tested in LOCA Test 198 at (a) 90° and (b) 225°

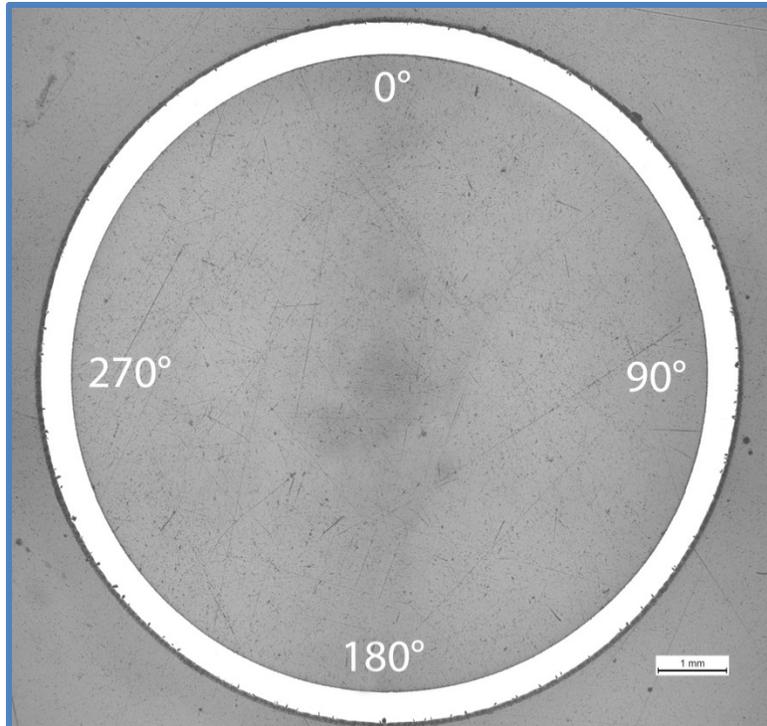
Figure 2-83 Macrograph of cross section from 50 mm below the rupture region of rodlet tested in LOCA test 198

The metallography sample shown in Figure 2-83 was taken from a section 50 millimeters below the rupture opening. Select, high-resolution images from the outer cladding diameter and inner cladding diameter are included in Figure 2-84 and Figure 2-85, respectively.

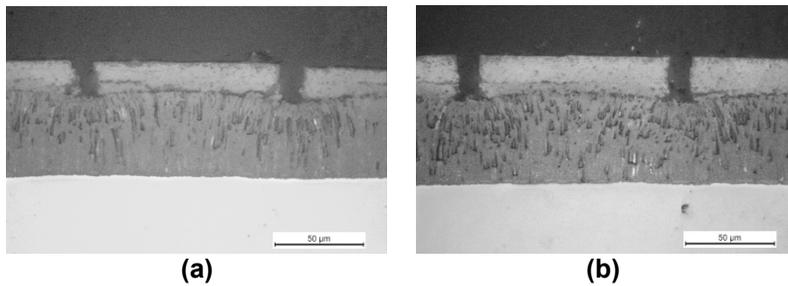
Figure 2-84 Two high-resolution images of the cladding outer diameter from the metallography examination 50 mm below the rupture region of the rodlet tested in LOCA Test 198 at (a) 90° and (b) 180°

In Figure 2-84, the initial oxide thickness can be seen to have cracked and separated, and the transient oxidation layer is seen beneath this damaged initial oxide layer. In Figure 2-85, a few small fuel fragments remain on the inner diameter. An inner diameter transient oxidation layer is not observed at this location 50 millimeters below the rupture opening. These observations are interesting because they suggest this region, 50 millimeters below the rupture node, was not exposed to a steam environment during the transient. The metallography samples were not prepared in such a way to reveal the presence and thickness of an alpha layer and the extent of fuel cladding bonding on this sample has not been characterized.

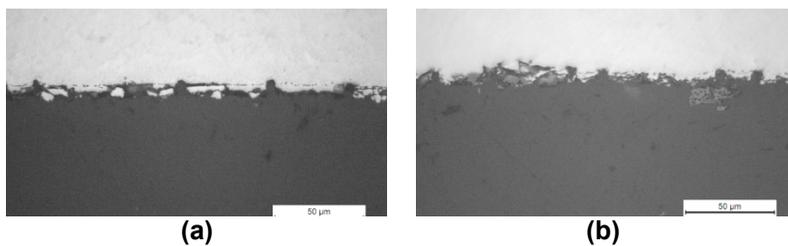
Figure 2-85 Two high-resolution images of the cladding inner diameter from the metallography examination 50 mm below the rupture region of the rodlet tested in LOCA Test 198 at (a) 90° and (b) 225°

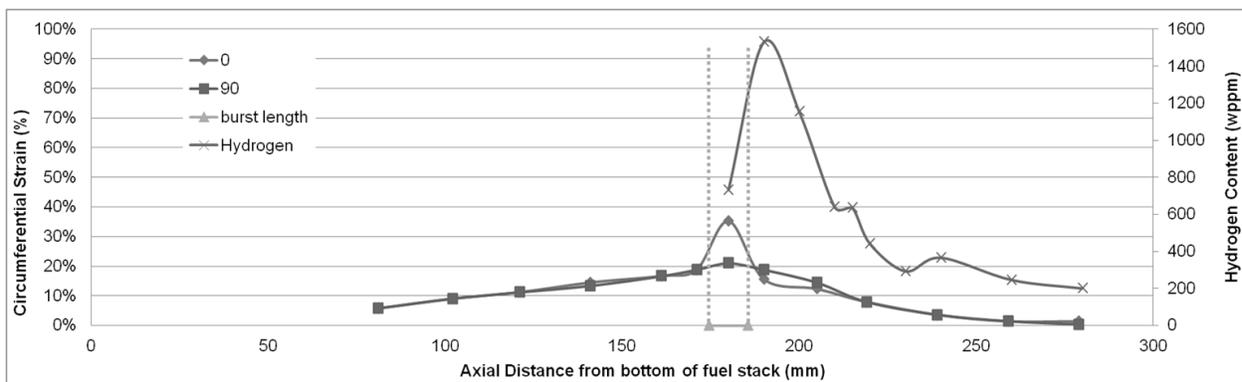
Figure 2-86 Hydrogen measurements from Test 198 relative to segment strain profile and rupture length

The location and values of hydrogen content, measured by hot vacuum extraction, are provided in Table 2-17, and illustrated, relative to the segment post-LOCA strain profile and rupture length measurements, in Figure 2-86.

Distance above rupture opening (mm)	0	10	20	30	35	40	50	60	80	100
Hydrogen Content (wppm)	733	1531	1155	641	636	442	294	367	247	201

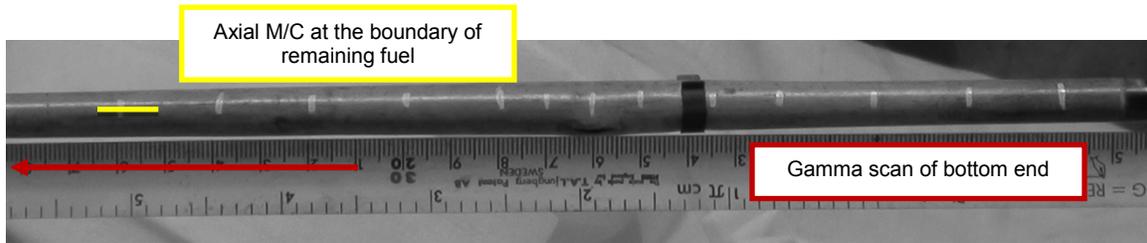
Figure 2-87 Photo of test segment from Test 198, indicating the relative length of gamma scan results and location of an additional M/C examination in the remaining fueled region

portions of cladding material were removed for metallography and hydrogen analysis. The remaining length of the lower portion was gamma scanned, as shown in Figure 2-87. The location of the additional M/C examination is also shown in Figure 2-87.

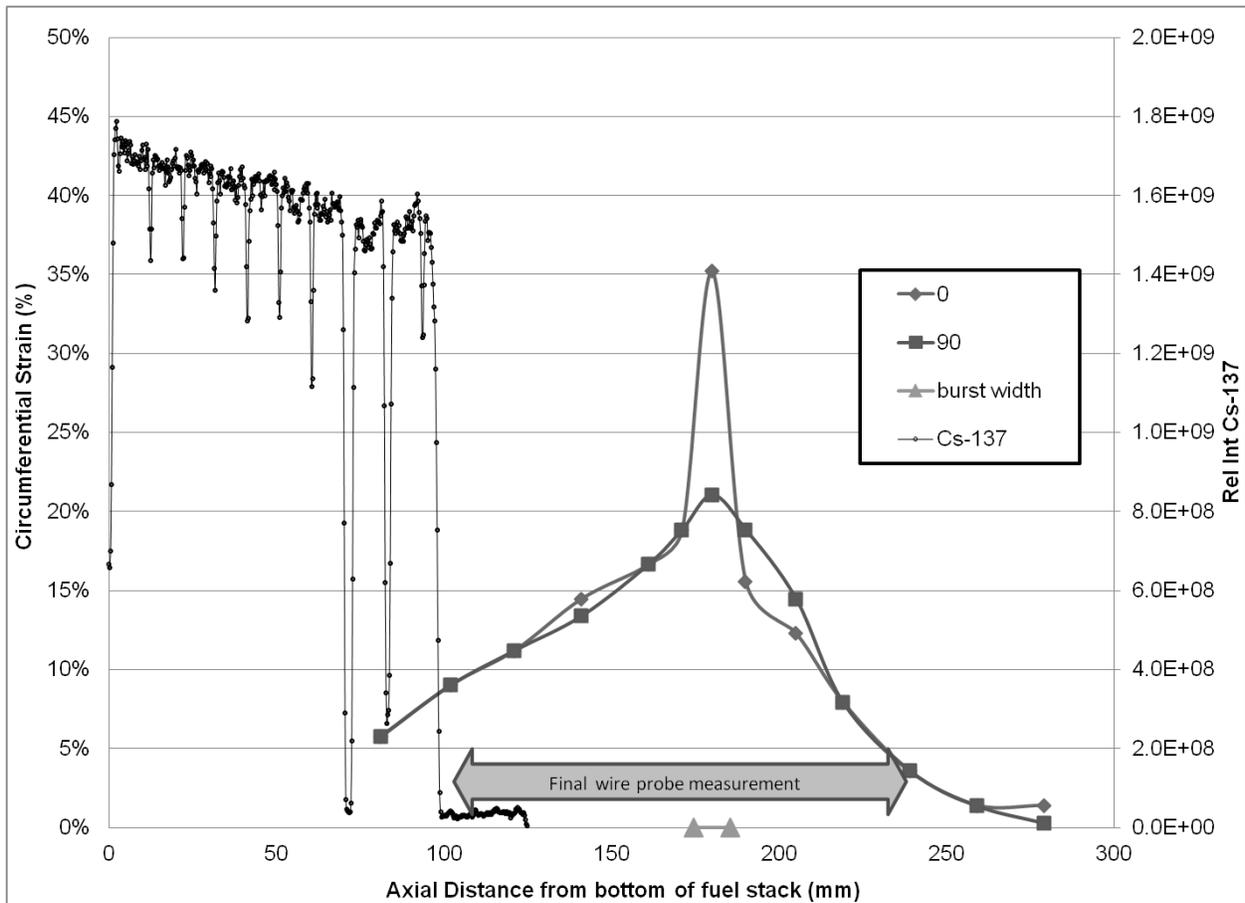
Figure 2-88 Gamma scan results for Test 198 with comparison to profilometry and initial wire probe measurements

In Figure 2-88, the gamma scan results were plotted together with the profilometry results and the wire probe measurements performed after the shaking test (indicated as “final wire probe measurement” in the figure below).

As indicated earlier, these gamma scan results were obtained over 1 year after the LOCA test was performed. In the time between the LOCA test and these gamma scans, the rodlet portions were stored in metal cans in the hot-cell. Some fuel material was found in the metal cans once the rodlet portions were removed for gamma scanning. The mass of fuel material found in the can storing the bottom portion of the rodlet was 6.6 grams. It is important to note that this fuel had fallen out of the rod before the gamma scan. This additional fuel loss during storage approximately accounts for the difference between the final wire probe measurement and the indication on the gamma scan results of the start of the remaining fuel column on the bottom rodlet portion.

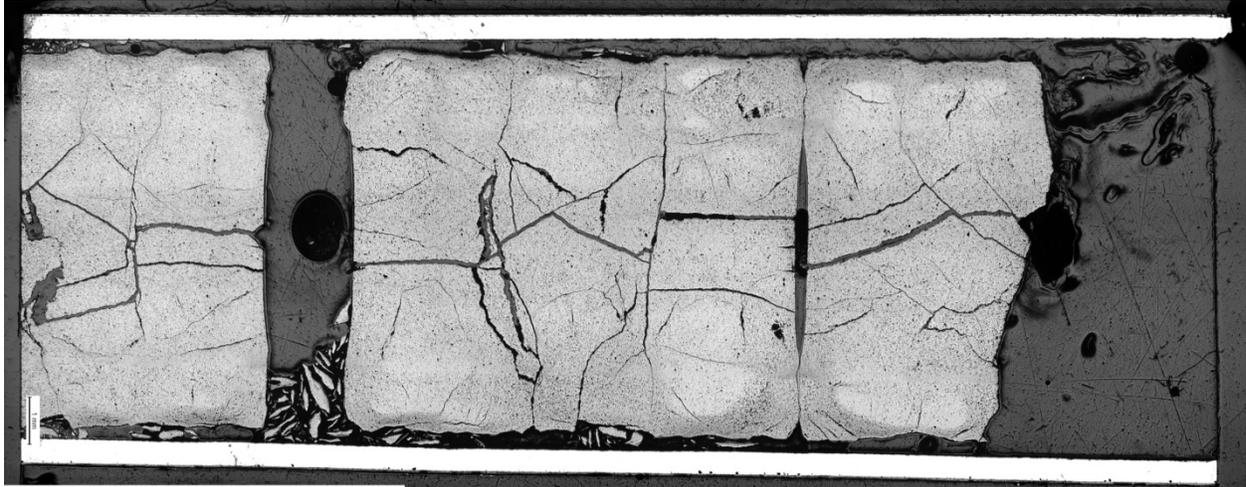
Figure 2-89 Macrograph of axial cross section covering a span approximately 80–105 mm from the segment bottom of the rodlet tested in LOCA Test 198

An additional M/C examination provides an even more detailed characterization of the remaining fueled region than the gamma scan results. The axial M/C sample shown in Figure 2-89 was taken at the boundary of remaining fuel and empty cladding, covering a span approximately 80-105 millimeters from the segment bottom. The image reveals that the boundary between fueled and empty cladding is rather abrupt, and that the residual fuel is relatively intact. The fuel-clad gap in this image appears rather large and it is somewhat surprising that these fuel pellets did not relocate even after the agitation of the shake test.

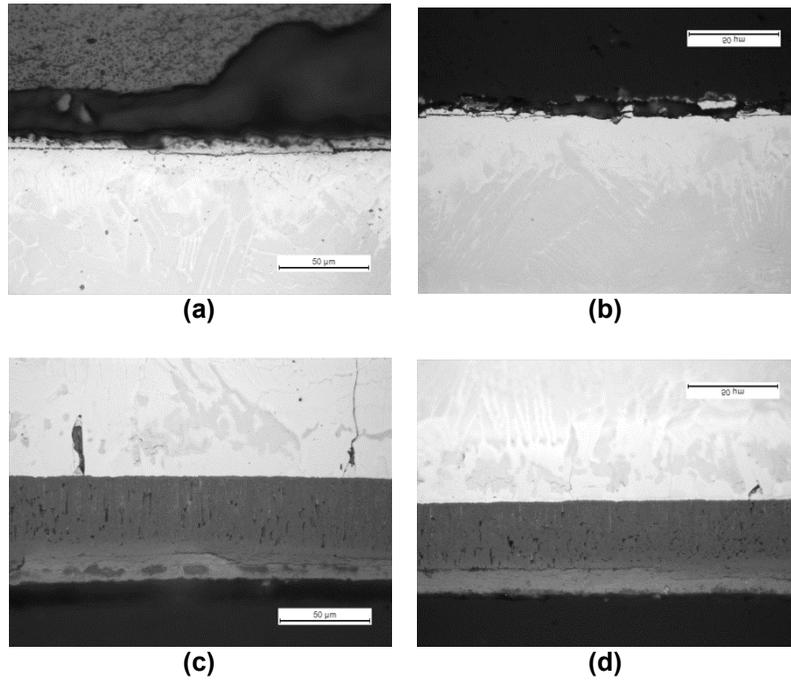
Select, high-resolution images are included in Figure 2-90 from the inner (a) and outer (b) cladding diameter. These images were near the bottom (left) of the axial M/C, approximately 84 millimeters from the original segment bottom of the rodlet tested in LOCA Test 198.

In Figure 2-90 (a), a thin fuel-clad bond layer and an alpha layer microstructure can be seen on the inner diameter. This region of the test segment remained fueled and was far (more than 100 millimeters) from the rupture location. In Figure 2-90 (c and d), the initial oxide layer and transient oxide layer can be seen. Again, it is useful to recall that for Test 198 the calculated CP-ECR was 15 percent, with a hold time at 1185 degrees C of 85 seconds.

Figure 2-90 High-resolution images of the cladding (a and b) inner and (c and d) outer diameter taken from the axial M/C shown above. These images were near the bottom (left) of the axial M/C, approximately 85 mm from the original segment bottom of the rodlet tested in LOCA Test 198.

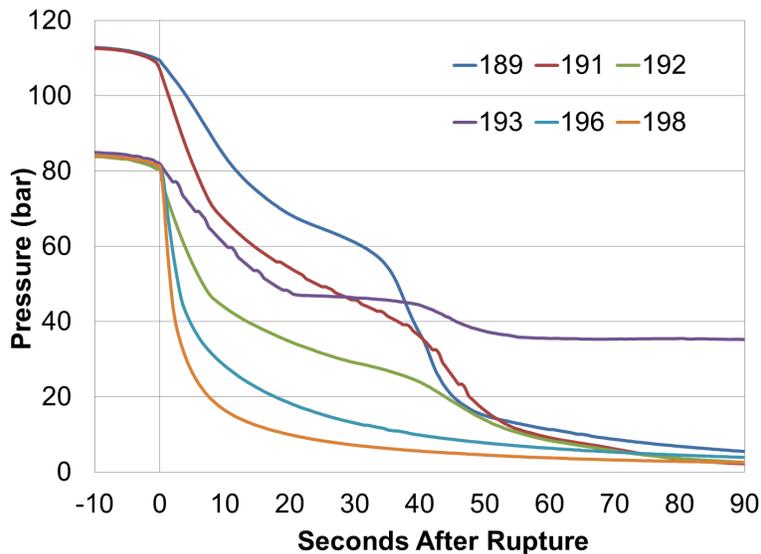
Table 3-2 provides the value of peak cladding temperature, rupture temperature and pressure, and depressurization rate (time in seconds for top/bottom pressure gauge to reach 50 percent of rupture pressure) for each test. The pressure response after rupture in the top plenum as a function of time for all six tests is plotted in Figure 3-1. The rupture conditions for all six tests are relatively similar; however, the depressurization rates for Tests 196 and 198 were notably faster than for Tests 189 and 191-192. The depressurization behavior in Test 193 is unique, with a hold up near 40 bar even after 90 seconds. This is assumed to be attributed to fuel fragments clogging the pressure gauge, thus interfering with the accuracy of the measurement. The relatively slow depressurization rates, particularly the rates for 189, 191-192, suggest that the fuel remaining at the rodlet ends induces some gas flow restriction between the gas plenum at the top and bottom of the rods and the rupture opening.

Figure 3-1 Pressure drop after rupture in the top plenum, plotted as a function of time, for all six tests

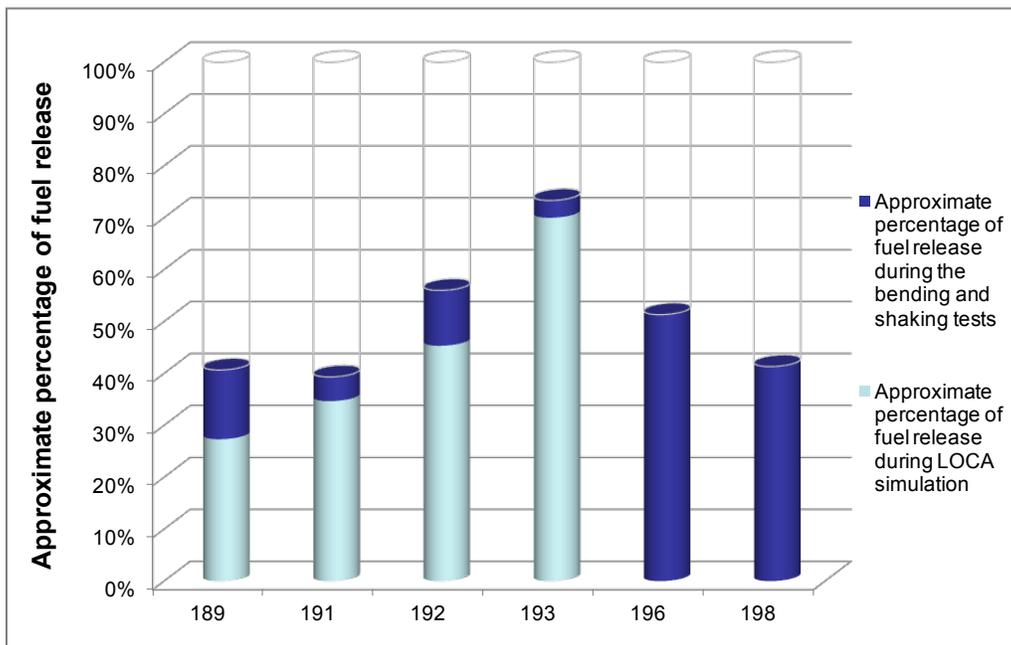
Table 3-3 provides the value of maximum circumferential strain, rupture dimensions and wire probe measurements for each test. In addition, the length of circumferential strain greater than 10 percent was identified for each test and is provided in Table 3-3. Figure 3-2 provides the approximate percentage of fuel loss during each test. In this case, the values provided in the previous section for total mass lost during the LOCA transient and total mass lost during bending and shaking were used to depict mass loss relative to the total segment fuel mass (approximated to be 150 grams).

Figure 3-2 Approximate percentage of fuel loss during each test, color-coded by when fuel loss occurred. Note: Measured mass loss was compared to an estimated initial fuel mass of 150 g for the 300-mm segment.

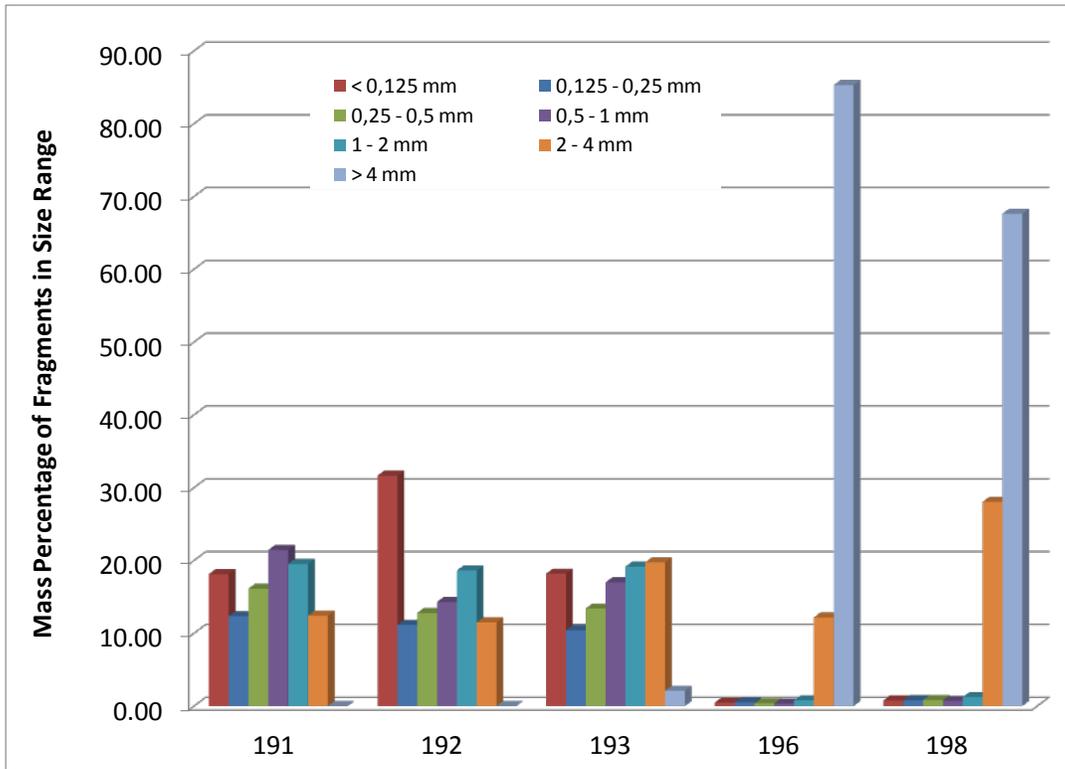
Fuel fragment size measurements were made for the total mass of fuel material found outside of the fuel rod for five of the LOCA tests (the exception is Test 189, which was sent to disposal before fragmentation analysis) and have been tabulated in the previous sections. Figure 3-3 provides the results of the fuel fragment size measurements using a bar chart to more easily depict the distribution of fragments in each test and the comparison of results between tests. One of the first observations that are apparent is a significant difference in distribution between Tests 191-193 and Tests 196 and 198. In Tests 191-193, the fuel was finely fragmented and all fragments measured less than 4 millimeters (except a small amount from Test 193). The mass

of fuel fragments from these tests was approximately evenly distributed between the size groups separated by the six sieves used. In contrast, the fuel in Tests 196 and 198 was not finely fragmented and the fragments measured predominately larger than 4 millimeters.

Figure 3-3 Fragment size distribution for each test
