AEOD/C204

SAN ONOFRE UNIT 1
LOSS OF SALT WATER COOLING EVENT
ON MARCH 10, 1980

Office for Analysis and Evaluation
of Operational Data

July 1982

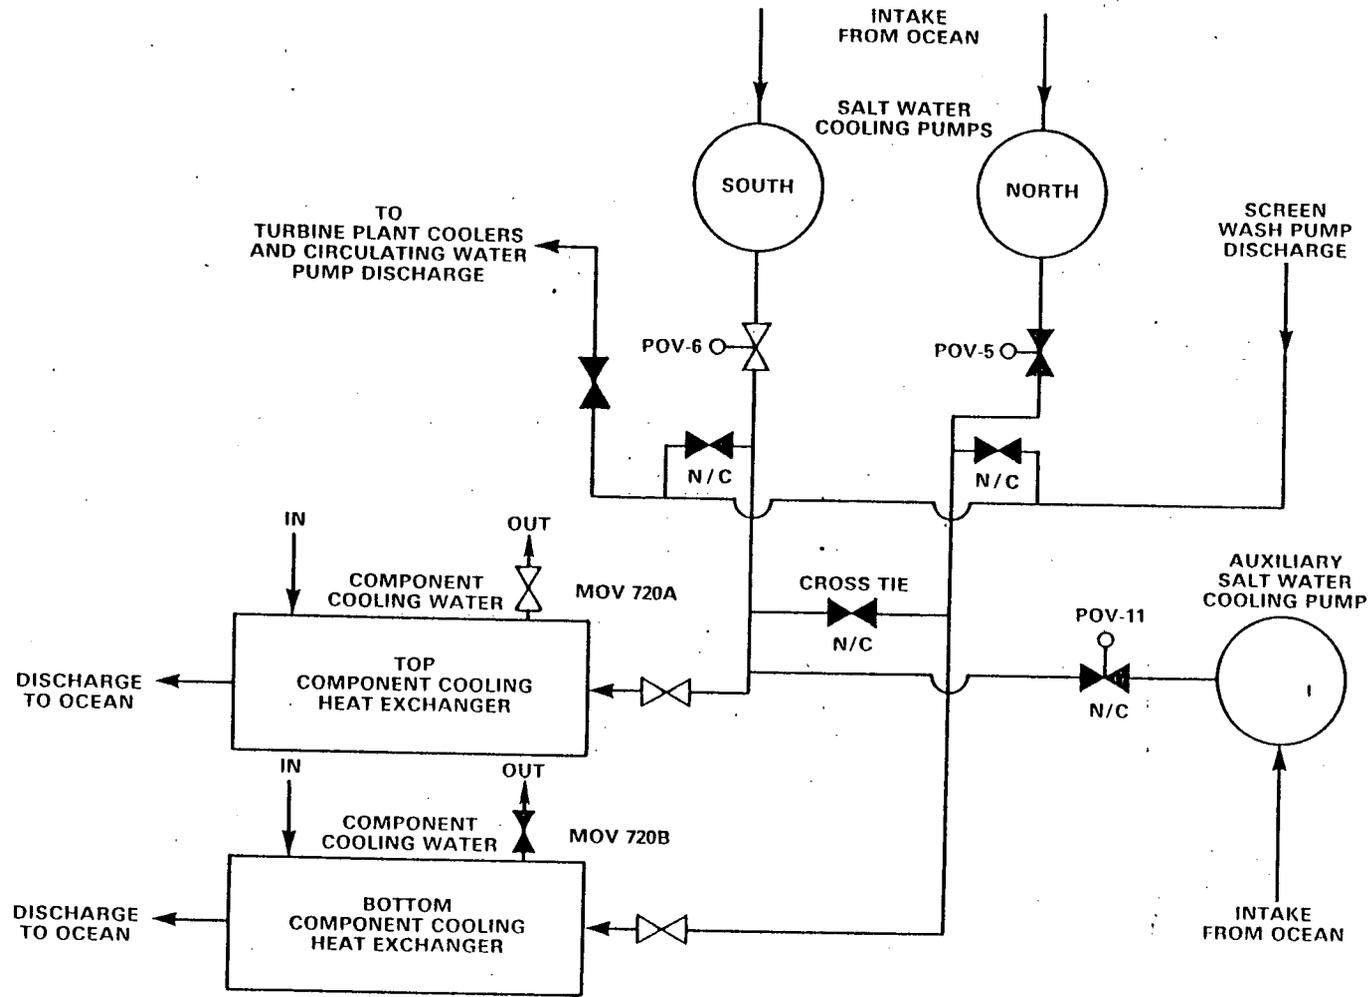
Figure 1 Salt water cooling system.

A schematic diagram of the salt water cooling (SWC) system appears in Figure 1. The SWC system is an essential two-train, open-cycle system which acts as a heat sink for a number of essential and non-essential components such as:

As shown in Figure 1, in addition to the two (north and south) SWC pumps, the SWC system has an auxiliary SWC pump which serves as a backup and has the same flow capacity (4620 gpm design) as the north and south SWC pumps. The auxiliary SWC pump can be aligned to either CCW heat exchanger. (The auxiliary SWC pump is normally aligned to the top CCW heat exchanger, but can be realigned to the
