Subject: 2013 Annual Pond Inspection Report  
Source Materials License SUA-1534  
Docket Number 40-8943

**CROW BUTTE RESOURCES, INC.**

**CROW BUTTE MINE  
DAWES COUNTY, NEBRASKA**

**2013 POND INSPECTION REPORT**

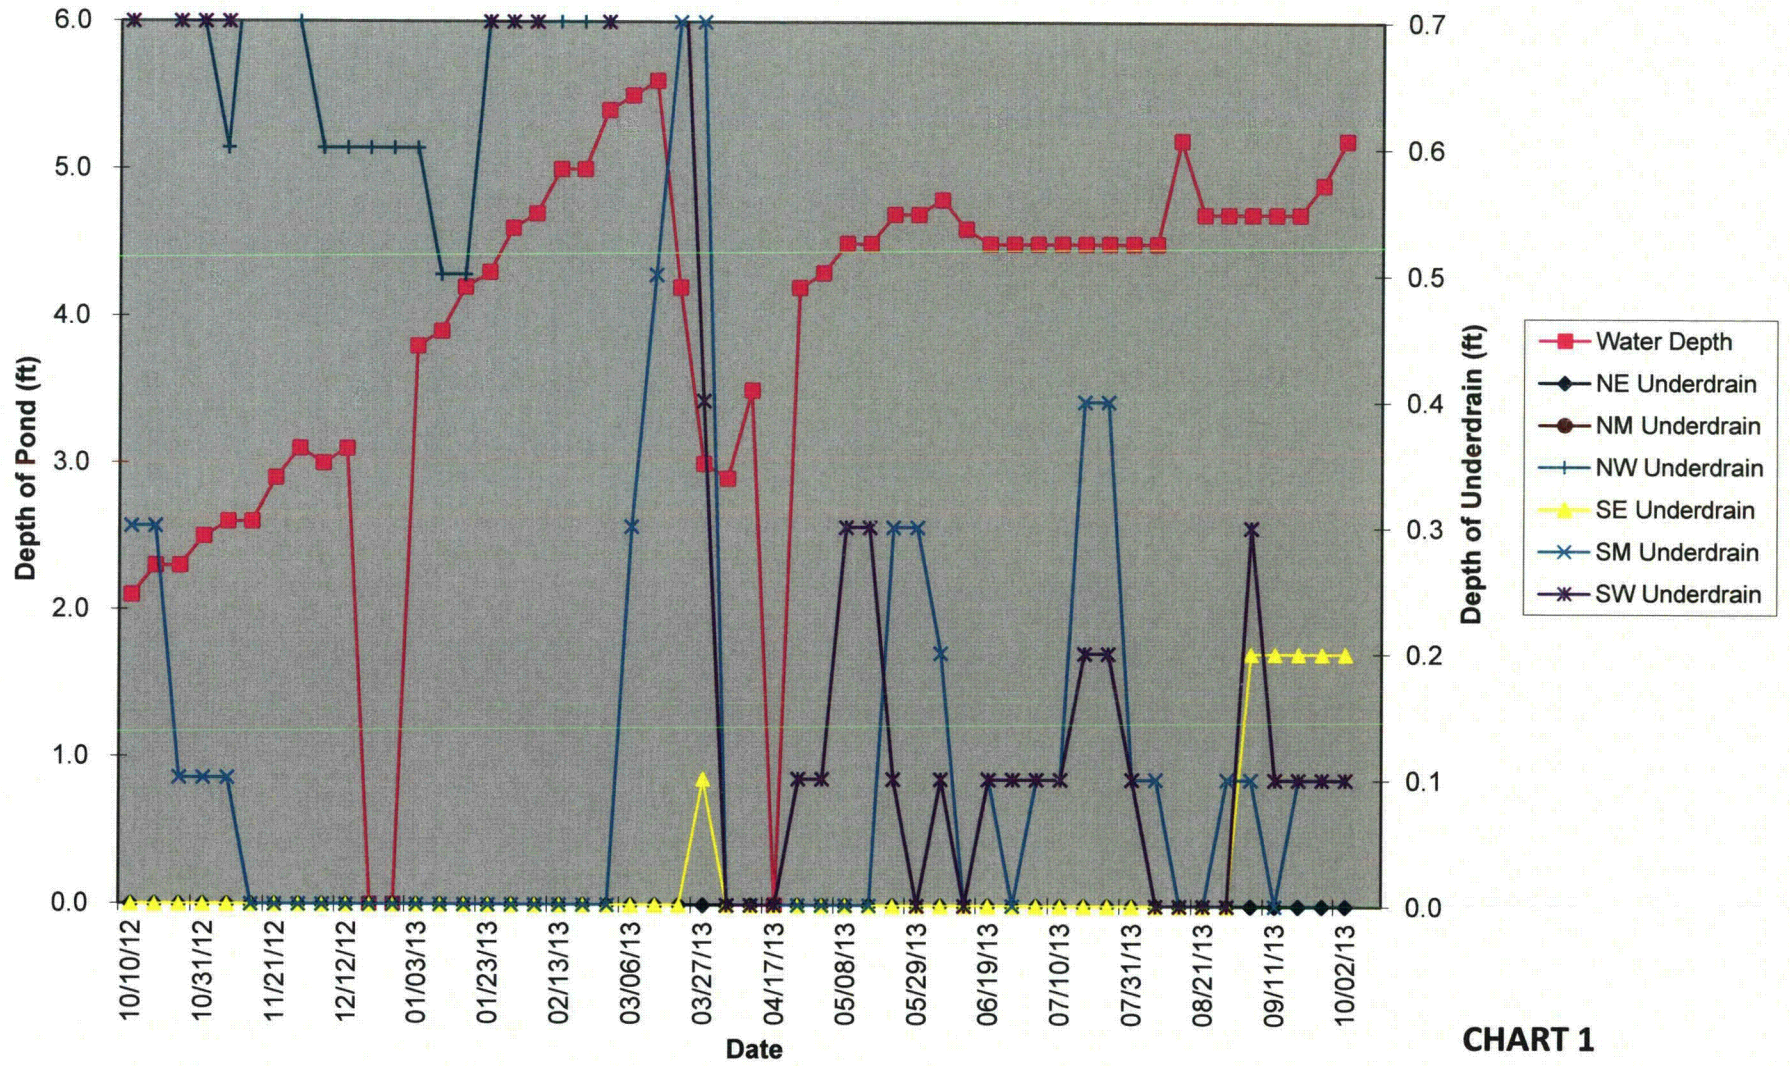
CHART 1

The Evaporation Pond Onsite Inspection Program dated December 1992 as amended calls for systematic inspections on a daily, weekly, monthly and quarterly basis. Data from the inspection reports are shown on Charts 1 through 4 including pond depths and underdrain measurements. **Zero pond depths are shown on the charts as a result of frozen pond conditions. Recordings indicate the existing freeboard along with the pond depth at the time of inspections.**

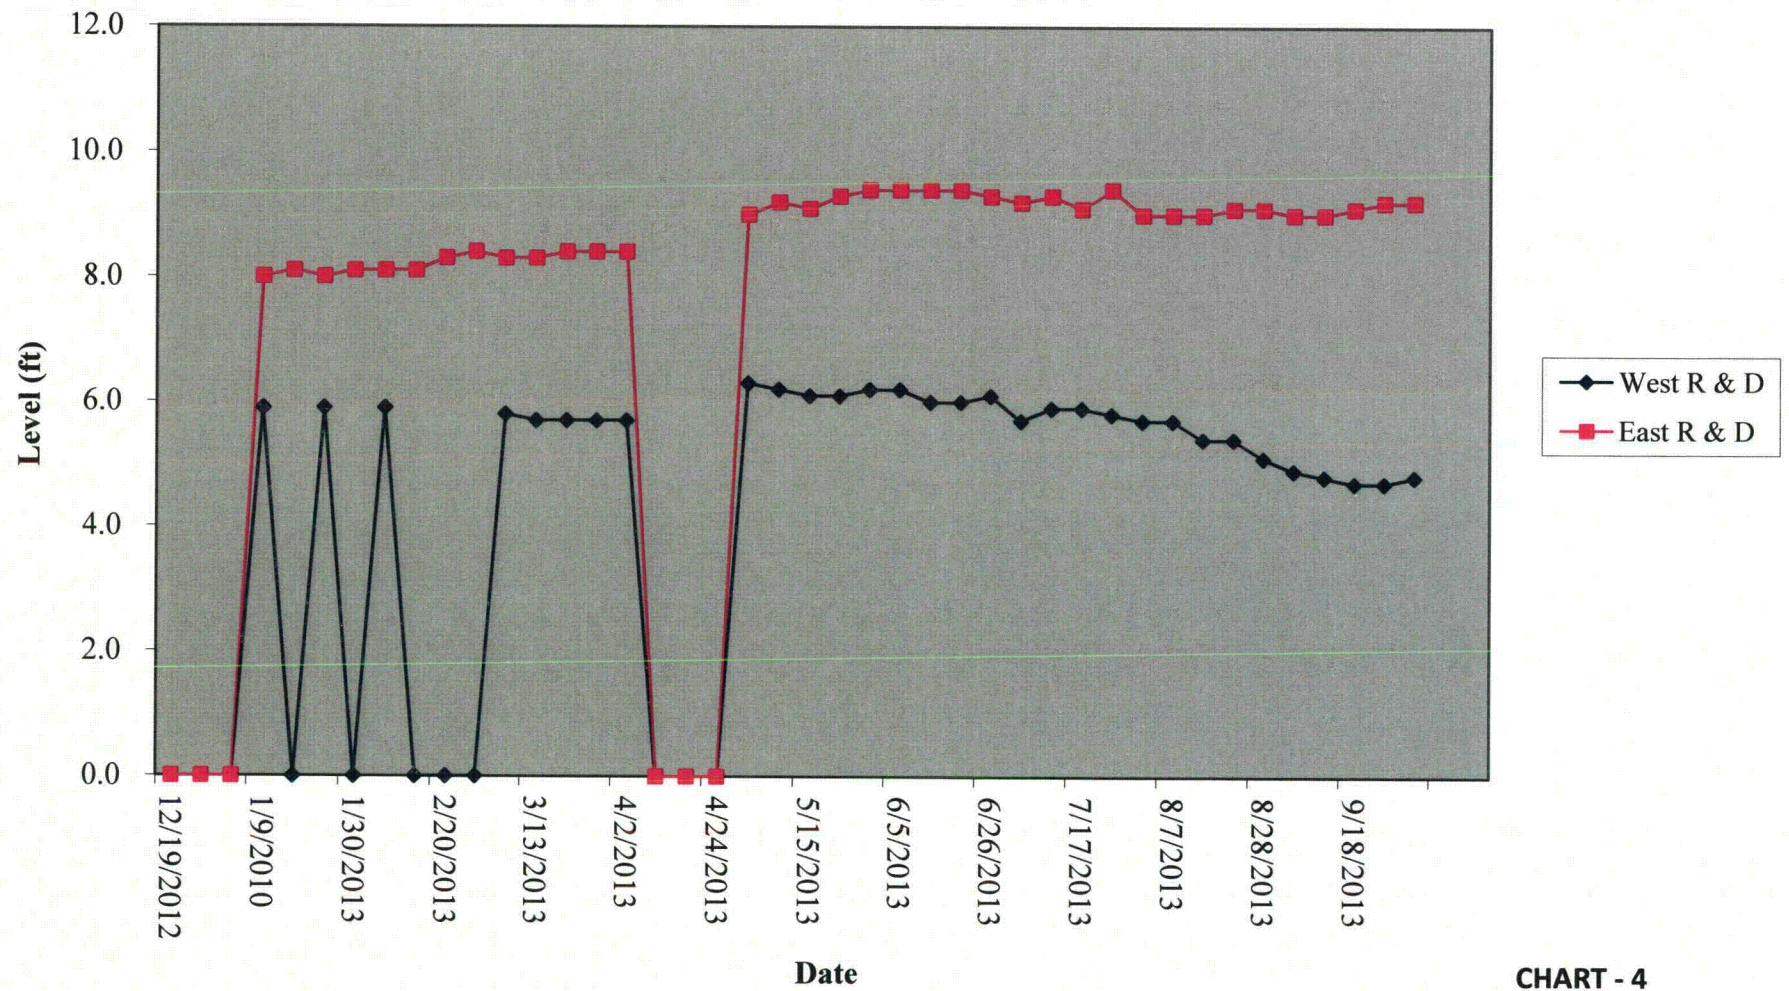
CHART - 4

The R & D ponds have excellent vegetative cover. The safety of the R & D ponds is good.

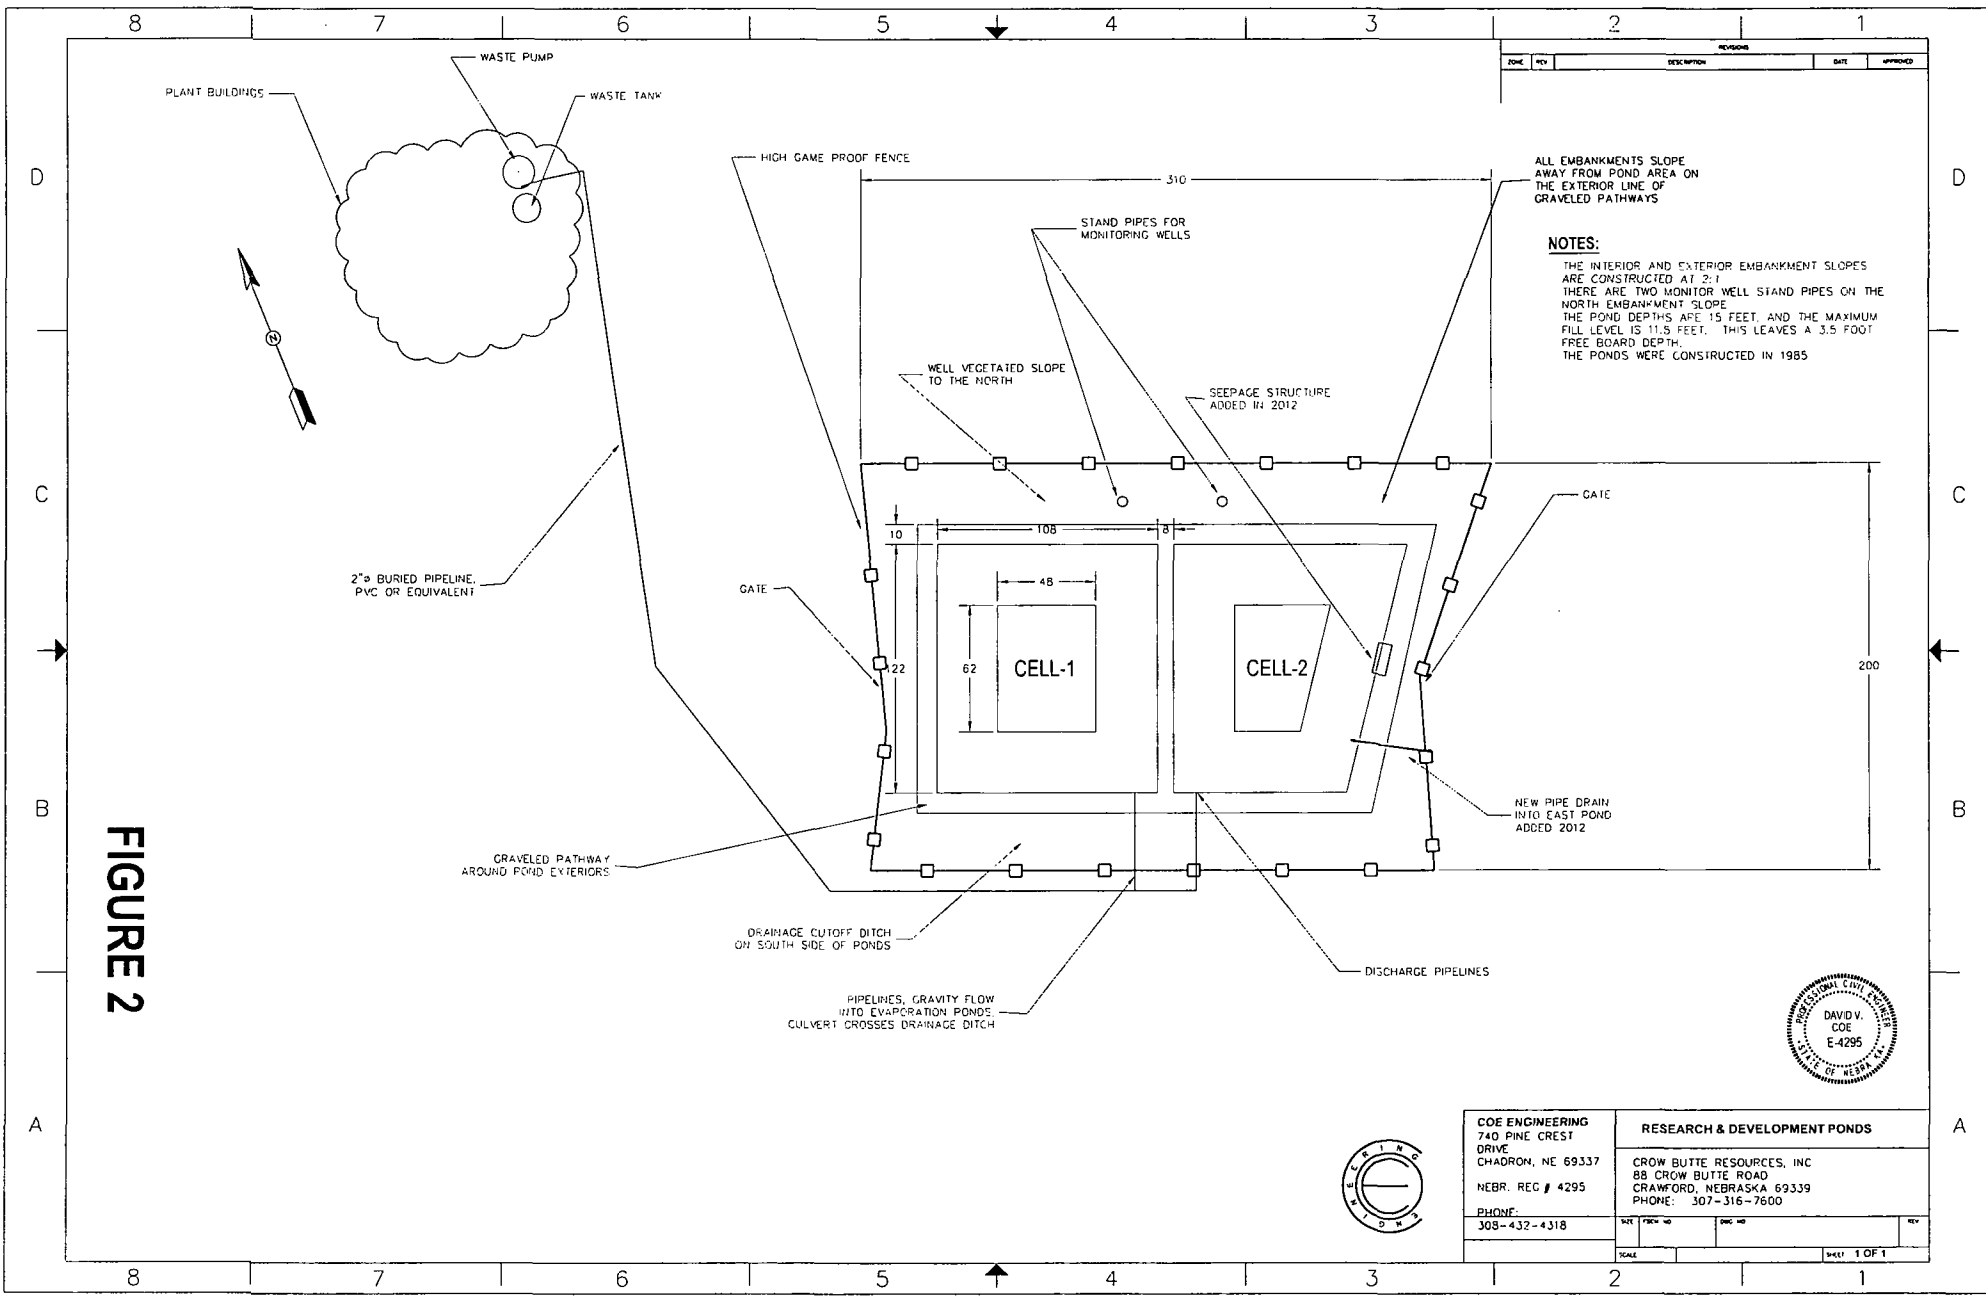
The perimeter fence around the R & D Ponds had a few minor deficiencies, but overall the fence was in good condition.
