U.S. NUCLEAR REGULATORY COMMISSION
REGION IV

Inspection Report: 50-206/94-23

Facility Name: San Onofre Nuclear Generating Station (SONGS), Unit 1

Inspection Conducted: October 3-6, 1994

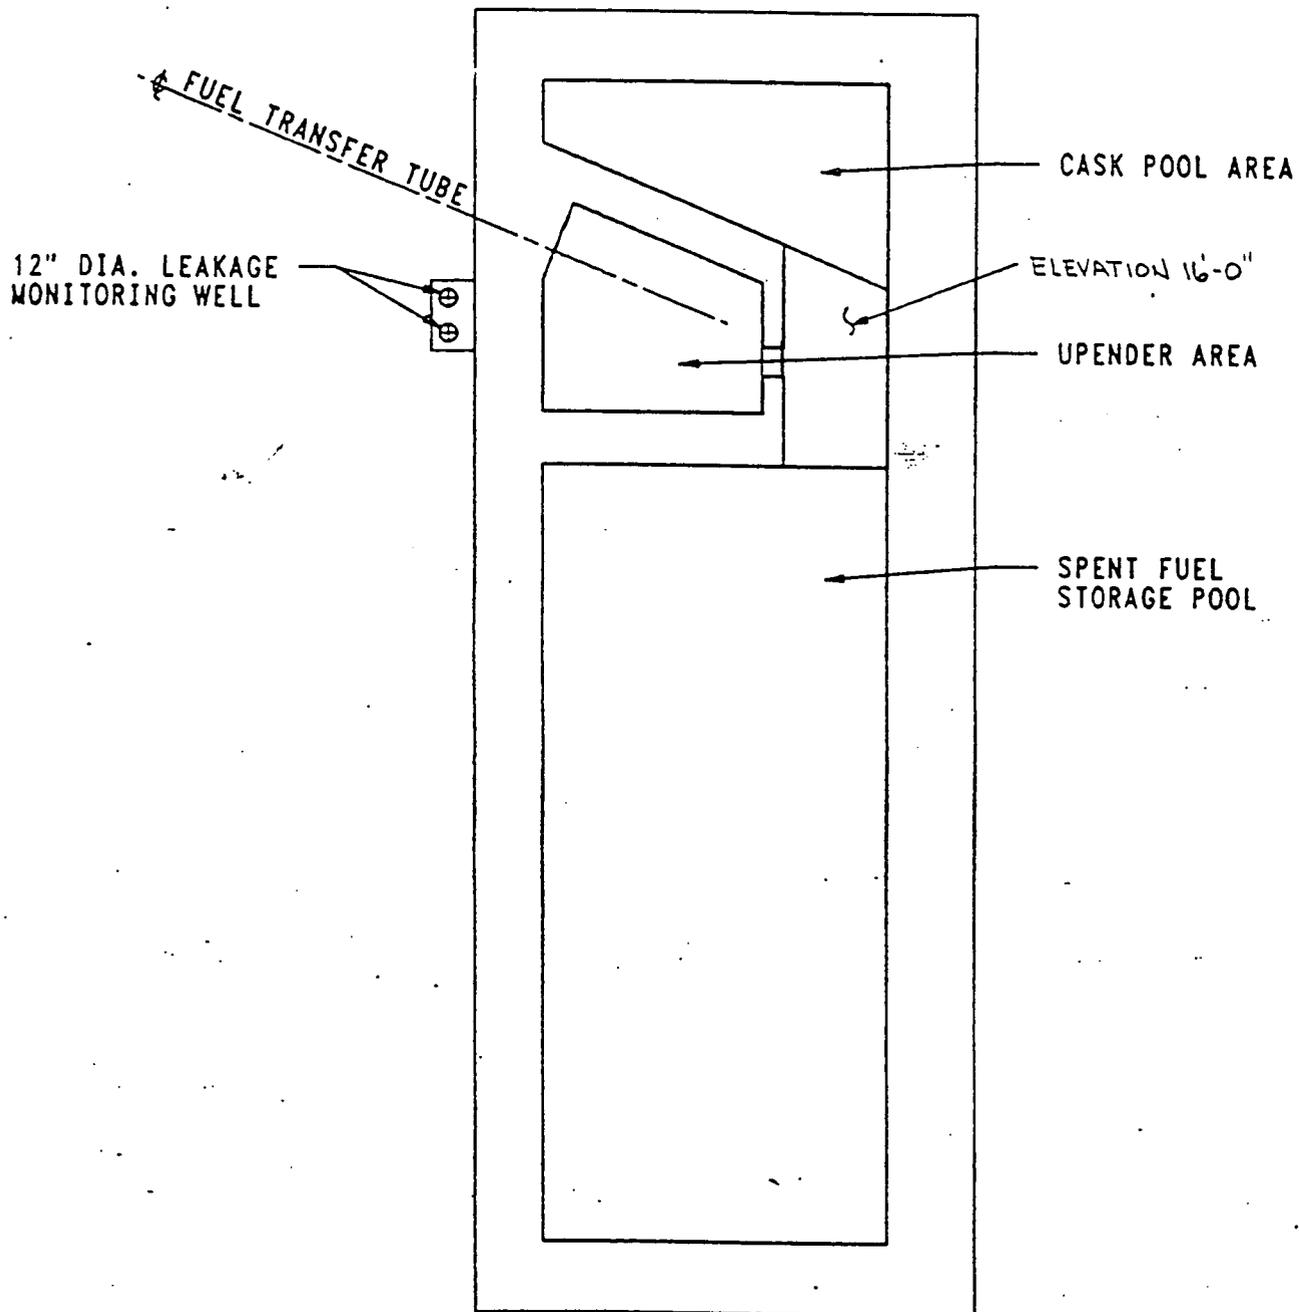
FIGURE 1

The spent fuel pool is located in the Fuel Storage Building and consists of three areas: the spent fuel storage pool, the upender equipment area and the shipping cask pool (see Figure 1). The spent fuel pool is about 66 feet long by 21 feet wide by 40 feet deep and is constructed of reinforced concrete and lined with welded stainless steel. The stainless steel plate is 11 gauge (0.12 inch) below Elevation 4' and 16 gauge (0.06 inch) above Elevation 4'. The stainless steel is ASTM A-240, Type 304. A minimum water level is maintained at Elevation 40'-3".

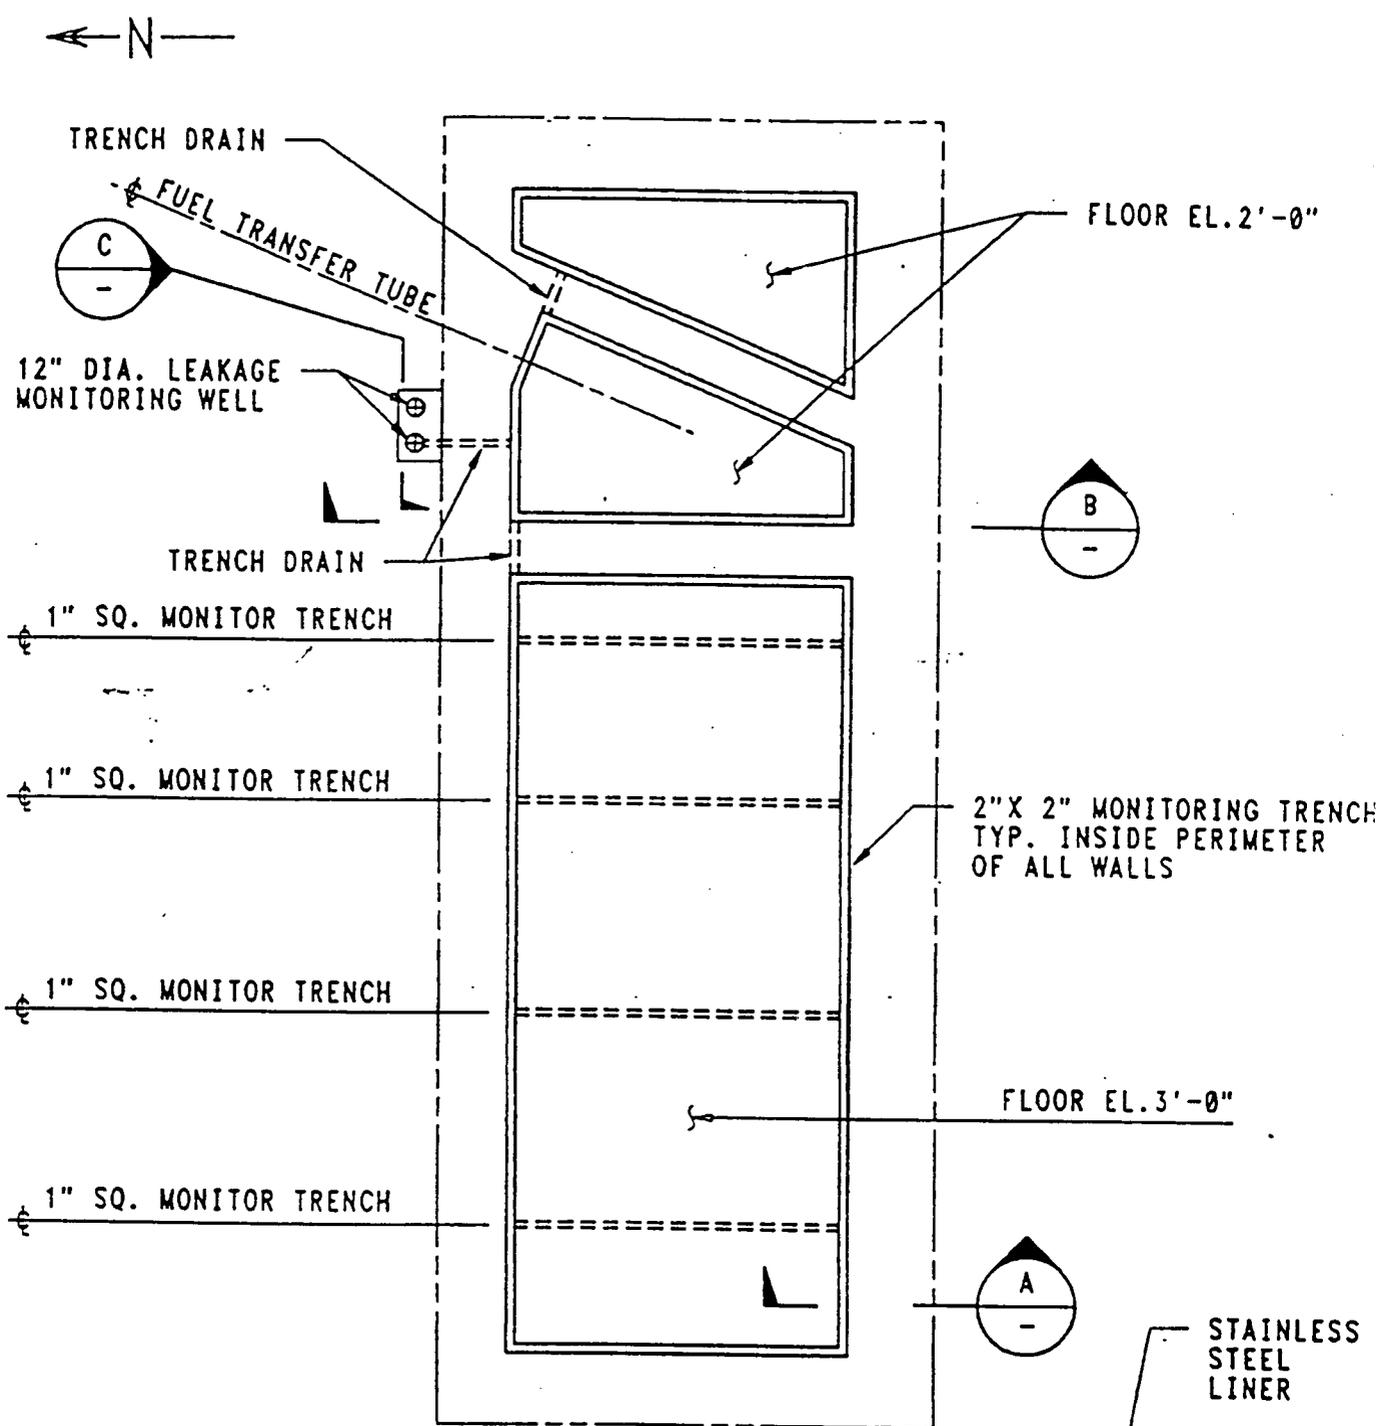
FIGURE 2

The liner is attached to the concrete by welding to embedded plates and structural angles. In order to monitor leakage passing through the liner, there is a leak chase system that is connected to a 12" diameter pipe which serves as the leak detection well (see Figure 2). The leak chase system consists of several 1" square channels that connect to a 2" square perimeter channel. These channels direct any water leakage through a pipe into the leak detection well which is located outside the building north wall. The well extends down below the bottom of the pool to collect water leakage from any portion of the pool liner. The well is covered with a plate, in which there is a vent pipe and a closed inspection nozzle. Liner leakage is checked by measuring any water discharged from the vent, or by removing the inspection nozzle cover and measuring the water level in the well (See Figure 4).

The current leakage from the spent fuel pool is approximately 2 gal/week. Historical leakage rates are tabulated in Table 1 and are approximate. The leakage paths will follow the gap between the liner plate and concrete, and go to either the 1 inch square or 2 inch square trenches underneath the liner plate. The water is then drained to the leak detection monitoring well (see Figure 2).
