Technical Evaluation Report

REVIEW OF  
RESOLUTION OF KNOWN PROBLEMS  
IN ENGINE COMPONENTS  
FOR TRANSAMERICA DELAVAL INC.  
EMERGENCY DIESEL GENERATORS

December 1985

Project Title: Assessment of Diesel Engine  
Reliability/Operability

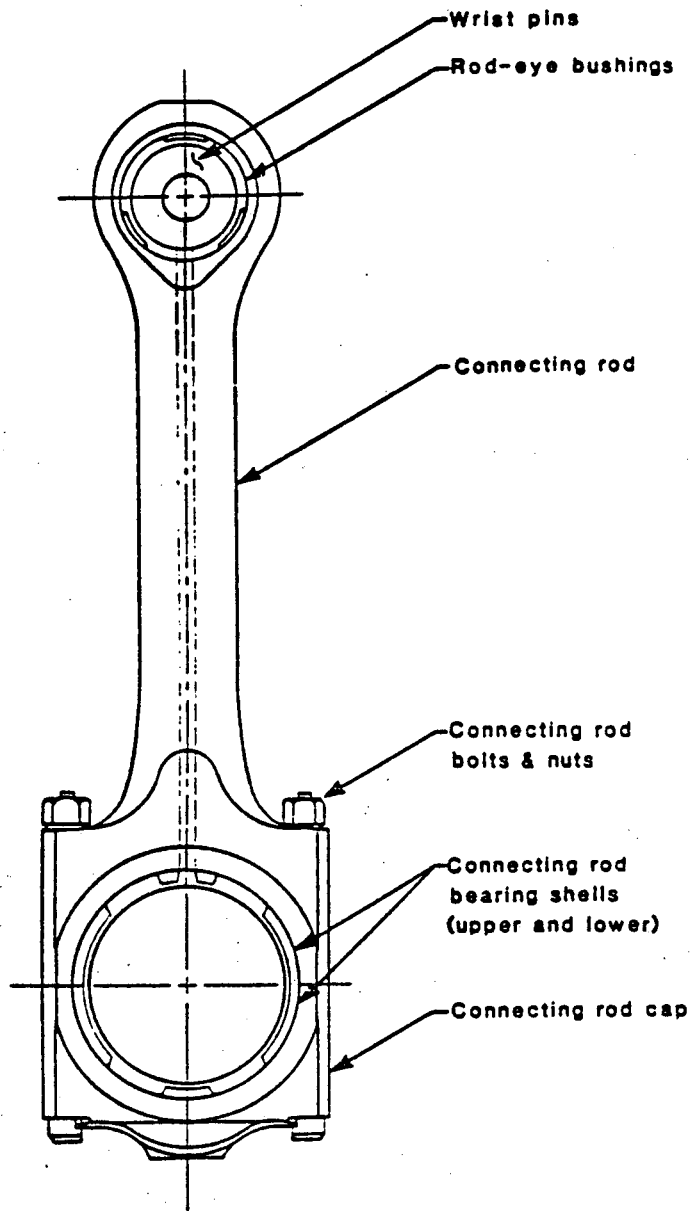
**FIGURE 4.3.1.** Connecting Rod, Model R-4 Inline Engine  
Source: Failure Analysis Associates  
(June 1984, p. 1-4)

The connecting rod assembly for the TDI inline model DSR-48 diesel engine is shown in Figure 4.3.1. This assembly includes the connecting rod, connecting rod cap, connecting rod bolts and nuts, connecting rod bearing shells, and rod-eye bushing. The passageway shown in Figure 4.3.1 at the center of the connecting rod conducts oil pumped via the crankpin journal to the wrist pin. This oil serves to both lubricate the components and cool the piston secured by the wrist pin to the upper end of the connecting rod.

Only one in-service failure of connecting rods in TDI DSR-4 series engines has been reported. This failure consisted of a longitudinal split through the oil hole in a DSR-46 engine at Glennallen, Alaska. According to Failure Analysis Associates (June 1984), the failure report supplied by TDI did not identify the origin of the crack; however, no material abnormalities were reported. The engine reportedly had been operated for over 8000 hours, and had been run extensively at a much higher peak firing pressure (1975 psi) than that measured for the Shoreham engines (1680 psi).

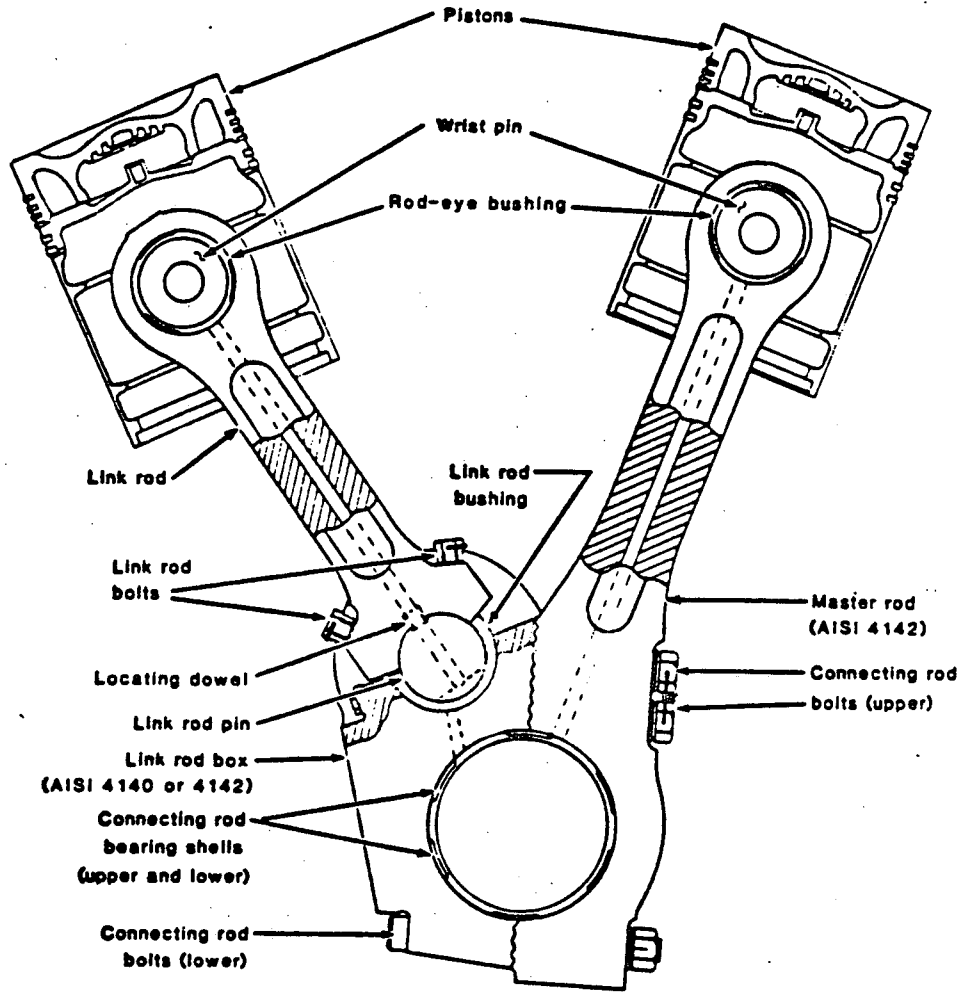
**FIGURE 4.4.1.** Connecting Rod, Model RV-4 V-Engine

The connecting rods used in the DSRV-4 engines are of an articulated design that operates two pistons off each crank throw. This design is illustrated in Figure 4.4.1. The main components of the connecting rod assembly are the master rod, link rod, link rod box, link rod pin, link rod bolts, upper and lower connecting rod bolts, connecting rod bearing shells, and rod-eye bushings.

In report No. FaAA-84-3-14 (August 1984), FaAA documented the results of a telephone survey to determine the extent of connecting rod component failures experienced in DSRV-4 engines in non-nuclear service. This survey included the service experience of 12 owners with a total of 146 connecting rod assemblies. Of these 146 assemblies, two connecting rods with 1-1/2-inch-diameter bolts and
