LICENSEE: Southern California Edison Company

FACILITY: San Onofre Unit No. 1

SUBJECT: REPORT OF JULY 10, 1980 MEETING TO DISCUSS THE RESULTS OF STEAM GENERATOR INSPECTIONS AND CORRECTIVE ACTIONS FOR SAN ONOFRE UNIT 1

SCE - NRC
MEETING ON STEAM GENERATORS
JULY 10, 1980

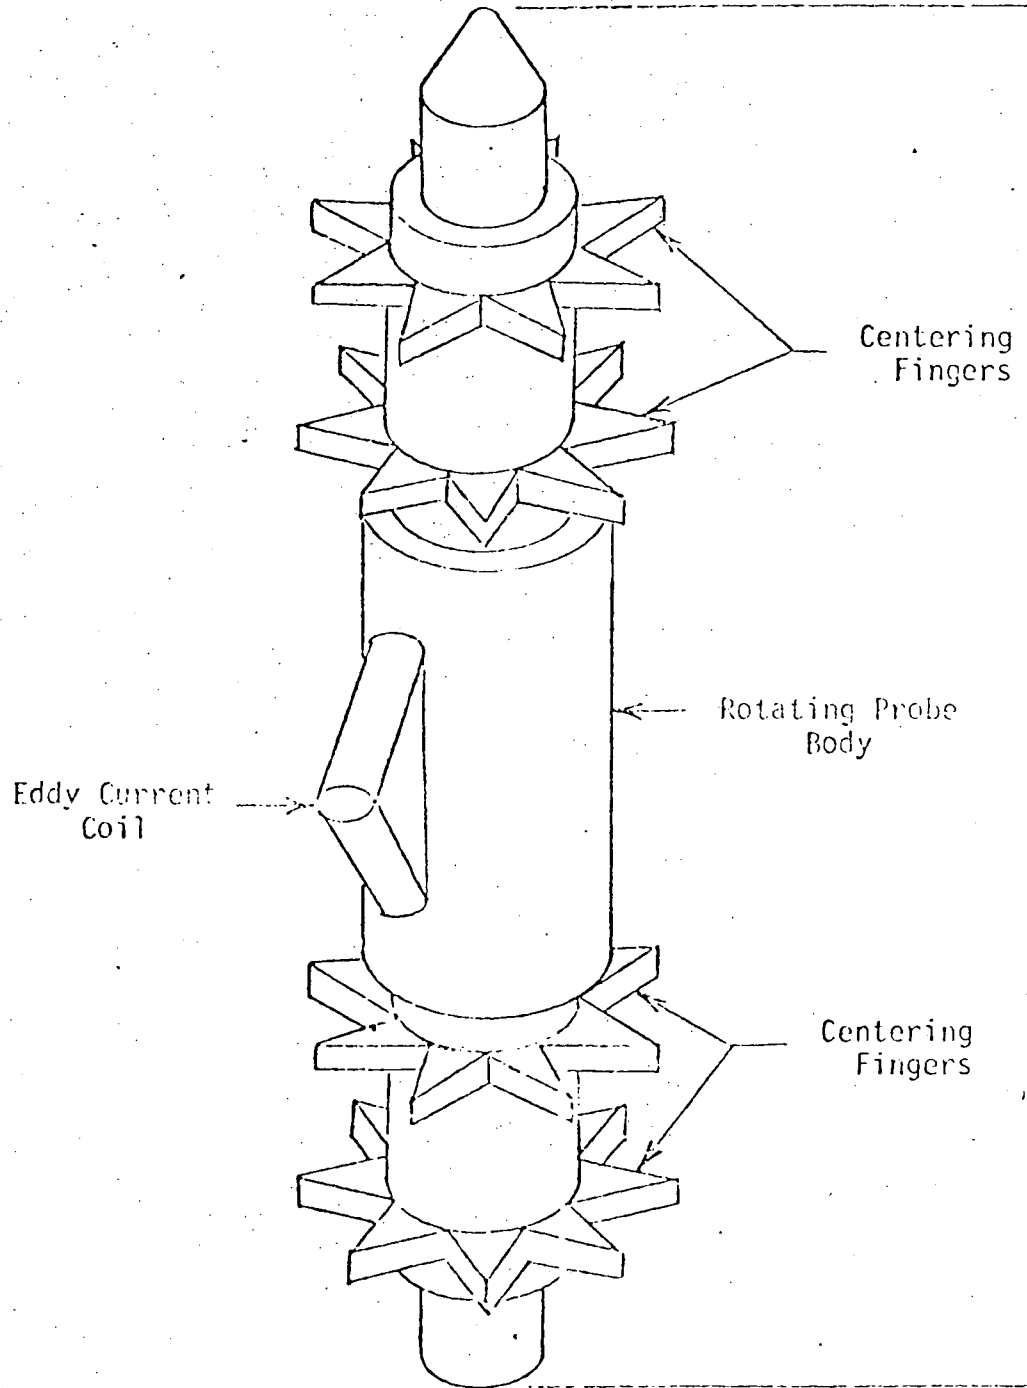
HELICAL SCAN EDDY
CURRENT PROBE

- Multiple, series-wired pancake coils on a straight pull probe did not produce significant improvement over original equipment.
- Backup - a single, rotating pancake coil probe did provide increased sensitivity and circumferential extent of apparent degradation.
