U.S. NUCLEAR REGULATORY COMMISSION

Report Nos. 50-206/92-23, 50-361/92-23, 50-362/92-23

Facility Name: San Onofre Nuclear Generating Station
Units 1, 2 and 3

Inspection conducted: July 17, 1992 through August 26, 1992

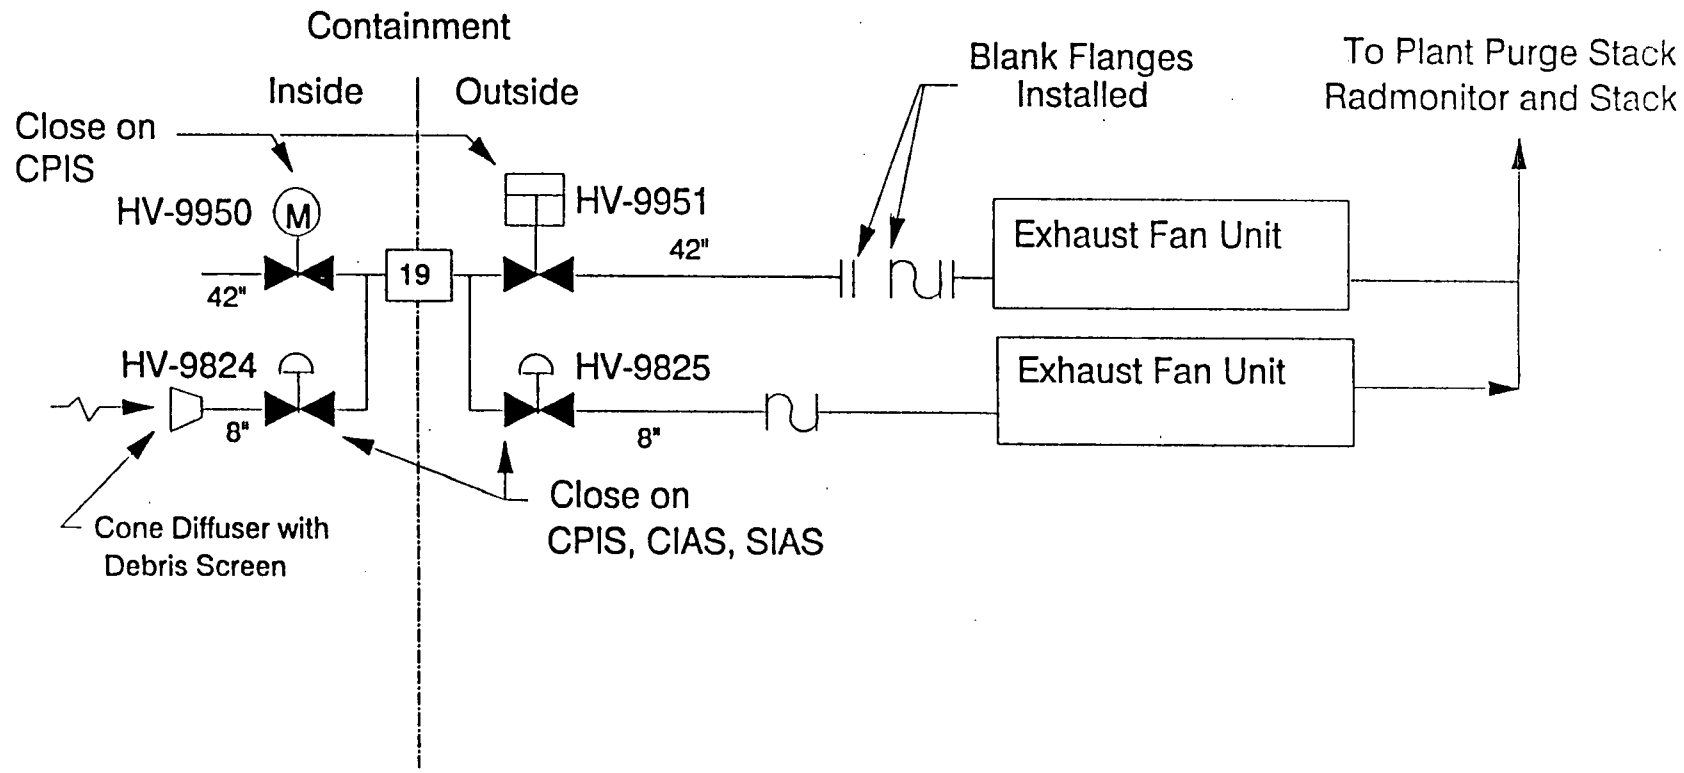
Containment Purge Exhaust System

- 3/30** **Routine Quarterly LLRT Failed**
Entered Penetration to Adjust Outboard 42-inch Valve T-Ring
- Apr/May** **Vented Containment Through Exhaust Penetration Seven Times.**
- 6/9** **Routine LLRT Failed.**
Corrected by blowing particulates from mini-purge valve seats.

6/16-17 **Performed special LLRTs on Penetration**
Performed as Found LLRT, With Virtually No Leakage.
Vented Containment.
Performed As-left LLRT.
Leakage Exceeded 3 Times 0.05 L_a
Blew Particulates From HV-9825 and HV-9824 Seats.
Probable Cause of Valve Failure Determined To Be Particulates

- 7/2** **Performed Pre-venting LLRT, With Virtually No Leakage Found.
Containment Vented.
Post-Venting LLRT Found Excessive Leakage.
Blew Off Valve Seat of HV-9825 - LLRT Satisfactory.
Postulated That Particulates Originated Within The Penetration
And Not Within Containment.**
- 7/10** **7/2 Test Repeated At Reduced Pressure And Flow.
Confirmed That Failures Caused By Particulates From Inside The
Penetration.**

PLANS TO CORRECT CAUSE OF LLRT FAILURE

LONG TERM CORRECTIVE ACTIONS
