Shearon Harris Nuclear Power Plant, Unit No. 1
Docket No. 50-400

Subject: Relief Request I3R-13, Reactor Vessel Closure Head Nozzle 37,
Inservice Inspection Program – Third Ten-Year Interval

Relief Request I3R-13
Reactor Vessel Closure Head Nozzle 37
Inservice Inspection Program – Third Ten-Year Interval

Proposed Alternative
in Accordance with 10 CFR 50.55a(a)(3)(i)
Alternative Provides Acceptable Level of Quality and Safety

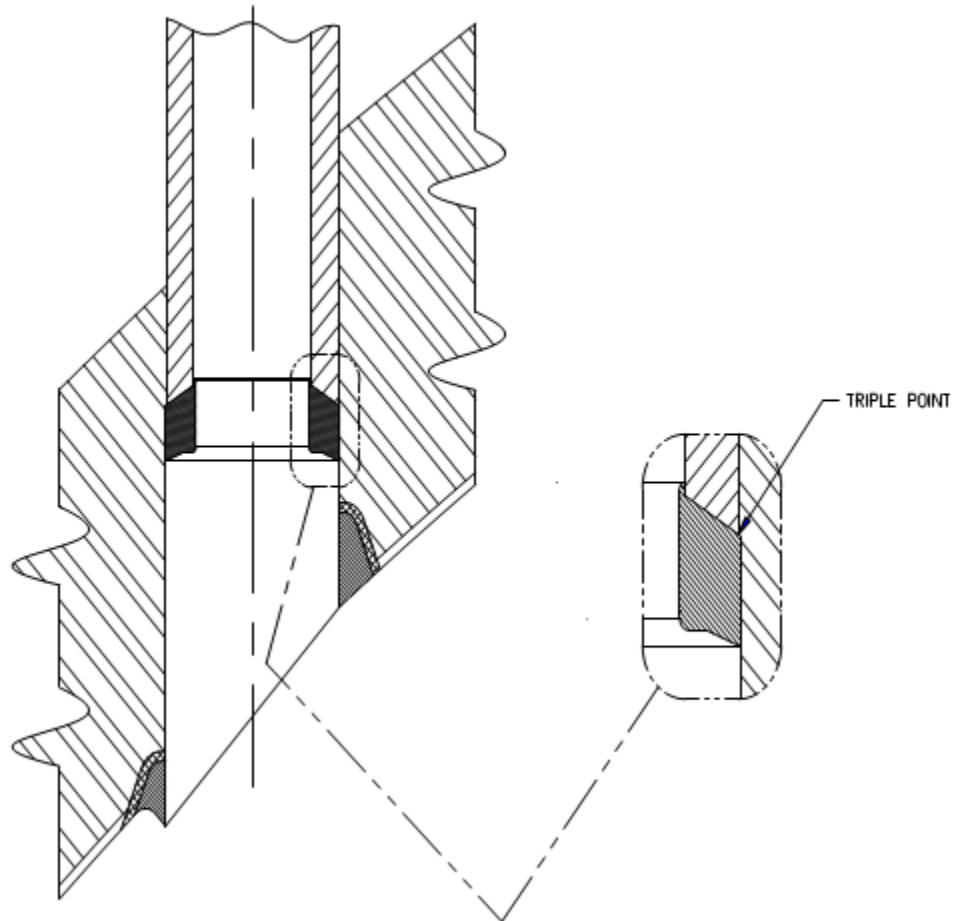
Figure 2. Welding

An artifact of ambient temperature temper bead welding is an anomaly in the weld at the triple point. The triple point is the point in the repair weld where the low alloy steel RVCH base material, the Alloy 600 nozzle, and the Alloy 52M weld intersect. The location of the triple point anomaly is shown in Figure 2. This anomaly consists of an irregularly shaped very small void. Mock-up testing has verified that the anomalies are common and do not exceed 0.10 inches in length and are assumed to exist, for purposes of analysis, around the entire bore circumference at the triple point elevation.

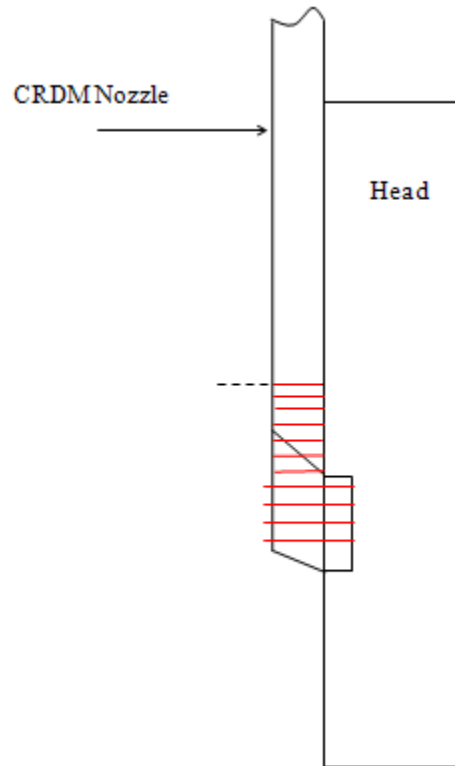
**Figure 4. UT 0° and 45° L-wave Beam Coverage Looking
Clockwise and Counter-clockwise**

of the weld taper. The scanning is performed using 0° L-wave, 45° L-wave, and 70° L-wave transducers. Approximately 70% of the weld surface will be scanned by UT. Approximately 83% of the RVCH ferritic steel heat affected zone will be covered by UT. The UT examination coverage volumes are shown in Figures 4 through 8 for the various scans.

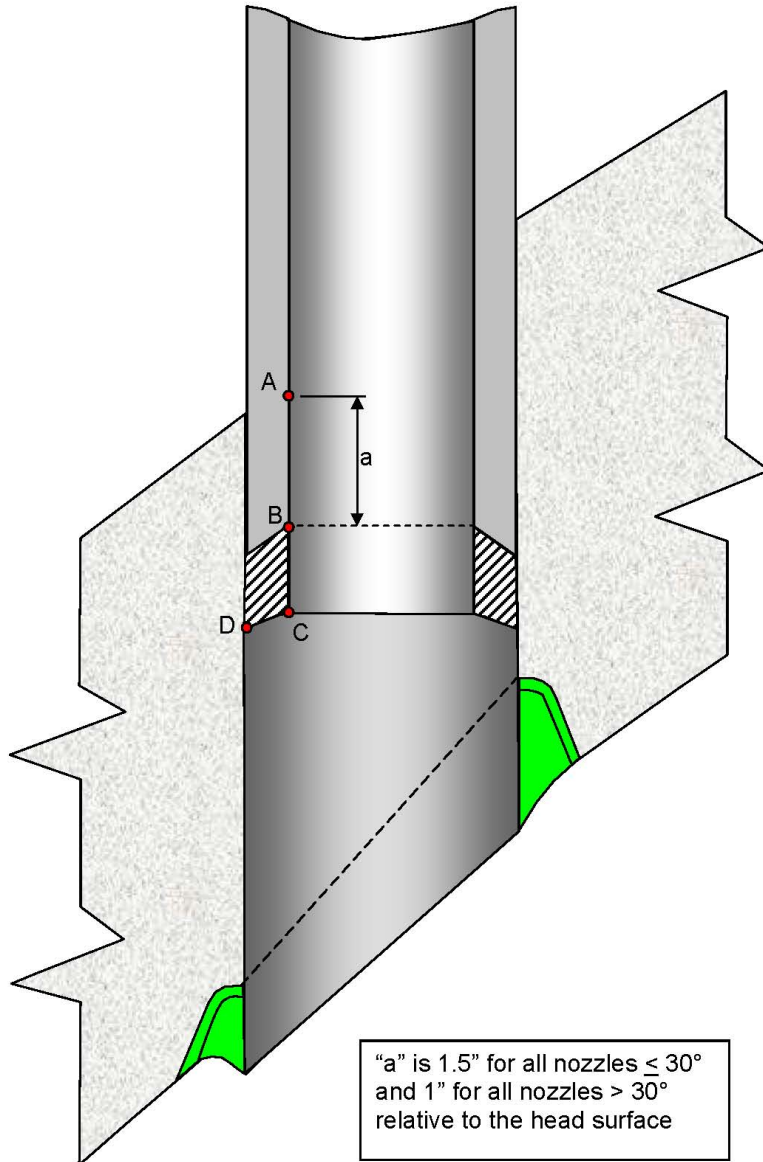
**Figure 9. PSI and ISI Weld and Nozzle Base Metal
Surface Examination Area (A-B-C-D)**

Code Case N-729-1 provides requirements for the inservice inspection of RVCHs with nozzles having partial penetration welds. Code Case N-729-1 Table 1, Item 4.20, permits either volumetric or surface examination. Item 4.20 examination requirements are specified in Figure 2 of Code Case N-729-1. The repair proposed by this relief request removes much of the examination area depicted in this figure at several locations. Figure 9 of this relief request will be used to establish the examination area for the preservice inspection following repair and for future inservice inspections. This examination area is equivalent to that required by Figure 2 in Code Case N-729-1, as it examines the nozzle weld and the same area above the nozzle weld as would be required by Figure 2 in the Code Case.

Therefore, inservice inspection will comply with Code Case N-729-1 as modified by 10 CFR 50.55a(g)(6)(ii)(D) and as depicted in Figure 9.
