SOIL BACKFILL CONDITIONS

SAN ONOFRE NUCLEAR GENERATING STATION

UNIT 1

AUGUST 31, 1983

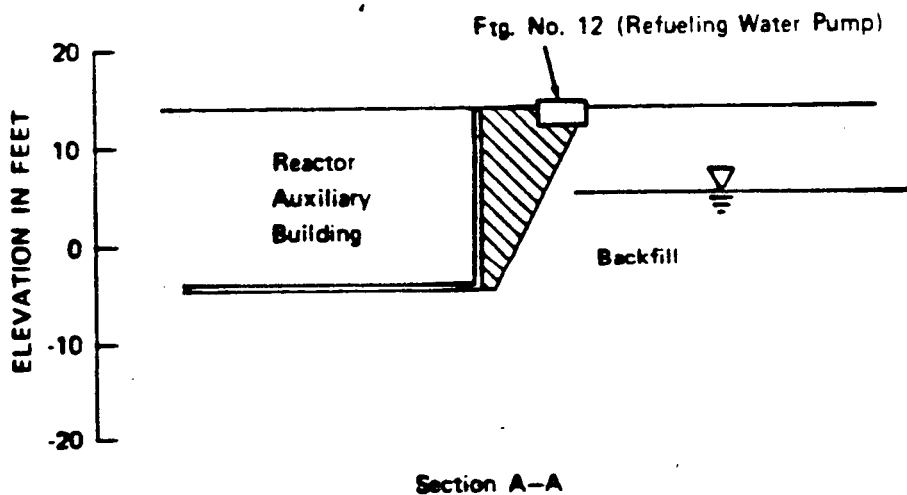
FIGURE 5-13

As indicated in Figure 5-13, the foundation of the Refueling Water Pump is founded on up to 6 to 7 feet of category D fill above the water table with the fill becoming deeper to the north. Based on a settlement evaluation, performed in accordance with procedures documented in Section 3, the potential seismically induced settlement of the backfill soil beneath this foundation is estimated to be about 1 inch, all of which would occur during seismic shaking. This foundation may tend to tilt toward the Reactor Auxiliary Building.

The piping and the supports connected to the pump were evaluated for differential settlements of 3 inches which is greater than the estimated value of about 1 inch. It was found that support modifications would be needed so that the piping and supports would satisfy the seismic reevaluation criteria. However, relocation of the pump to an area where native soil exists would eliminate the settlement concern and thus restore the design margins consistent with the seismic reevaluation criteria. A conceptual relocation of the pump is shown in Figure 5-13A. Alternatively, reevaluation based on the lower settlement may preclude the need for this modification.

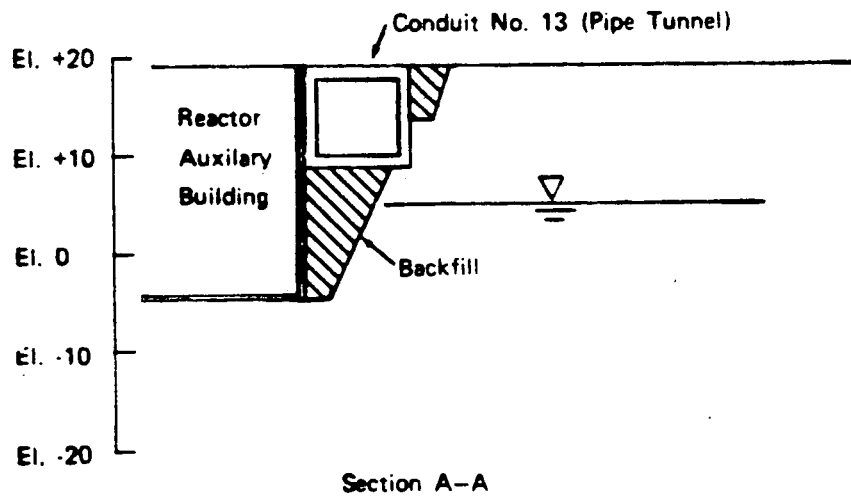
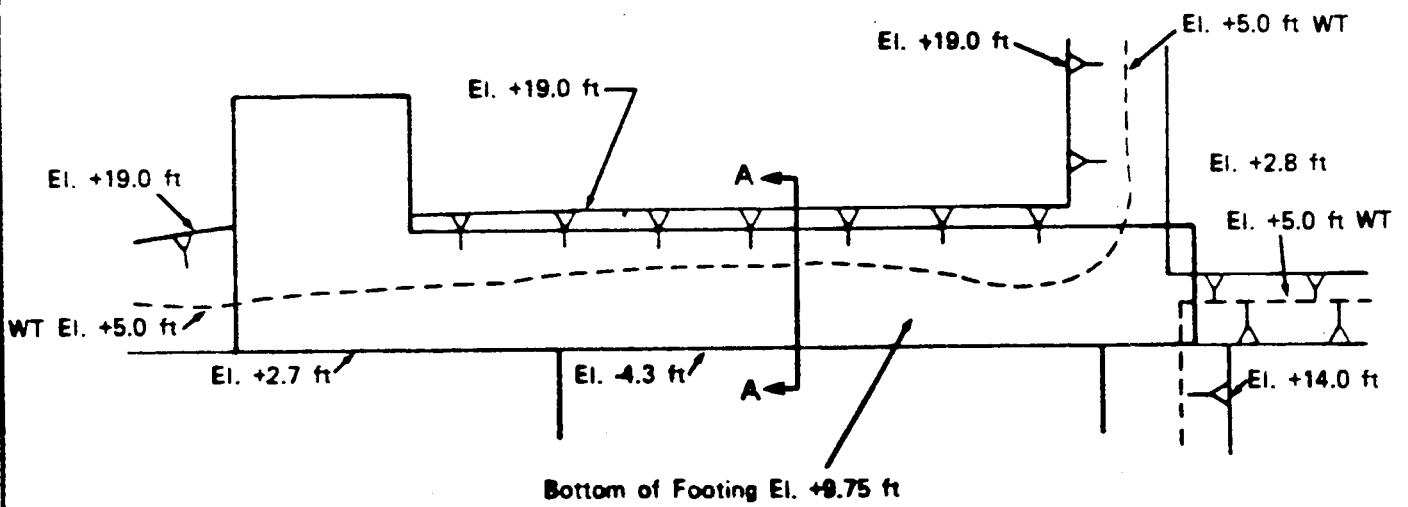
LOCAL SOIL CONDITIONS UNDER
CONDUIT - NO. 13
FIGURE 5-14

As indicated in Figure 5-14 the northeastern corner and eastern edge of the Pipe Tunnel are founded on native soil with the western portion being founded

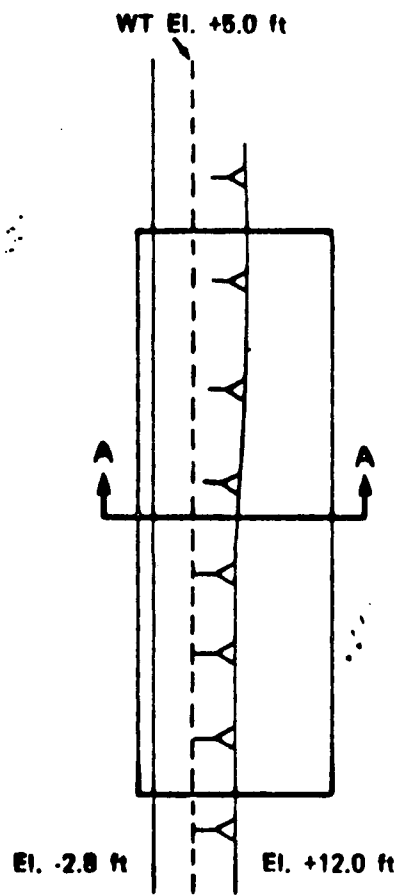
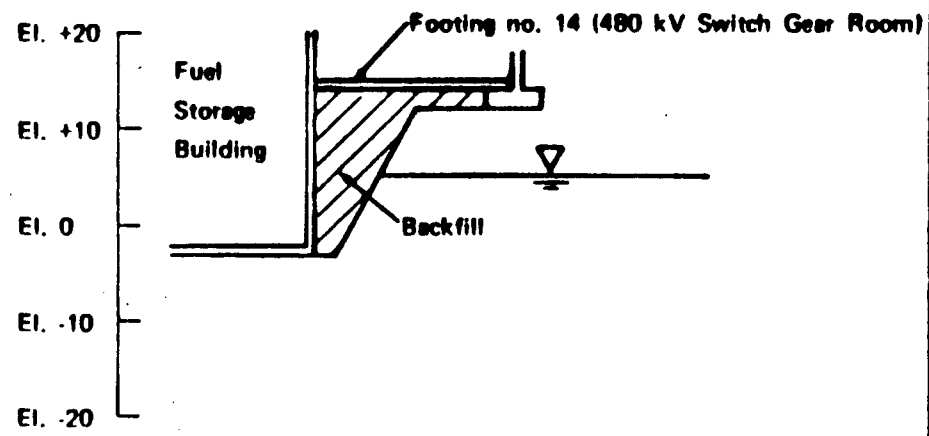
LOCAL SOIL CONDITIONS UNDER
FOOTING NO. 14
FIGURE 5-15

As indicated in Figure 5-15 the southern portion of the floor slab of the 480V switchgear room is founded on native soil with the northern portion founded on up to 17 feet of category D fill, of which 9 feet is below the water table. Based on a settlement evaluation, performed in accordance with procedures documented in Section 3, the potential seismically induced settlement of the backfill soil beneath the northern portion of the slab is estimated to be about 2 to 3 inches with little or no settlement expected beneath the southern portion. It is estimated that up to 1 inch of this settlement would occur during seismic shaking.

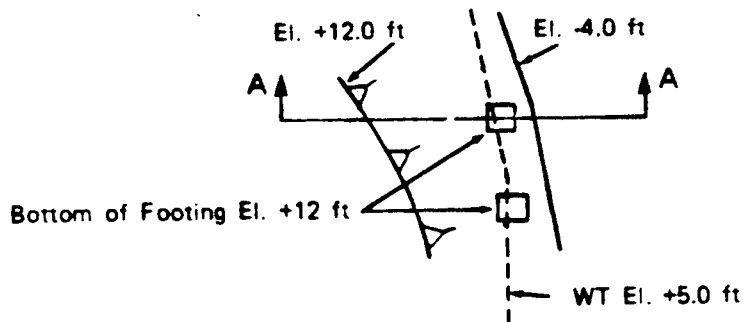
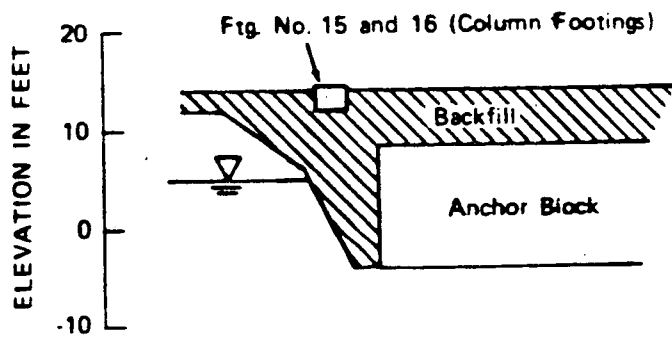
FIGURE 5-16

As indicated in Figure 5-16, both of the footings for item Nos. 15 and 16 are founded on up to 16 feet of category D fill of which 9 feet is below the water table. Based on a settlement evaluation, performed in accordance with procedures documented in Section 3, the potential seismically induced settlement of the backfill soil beneath the footings is estimated to be about 2 to 3 inches. As indicated in Table 5-1, up to 1 inch of this settlement would occur during seismic shaking.

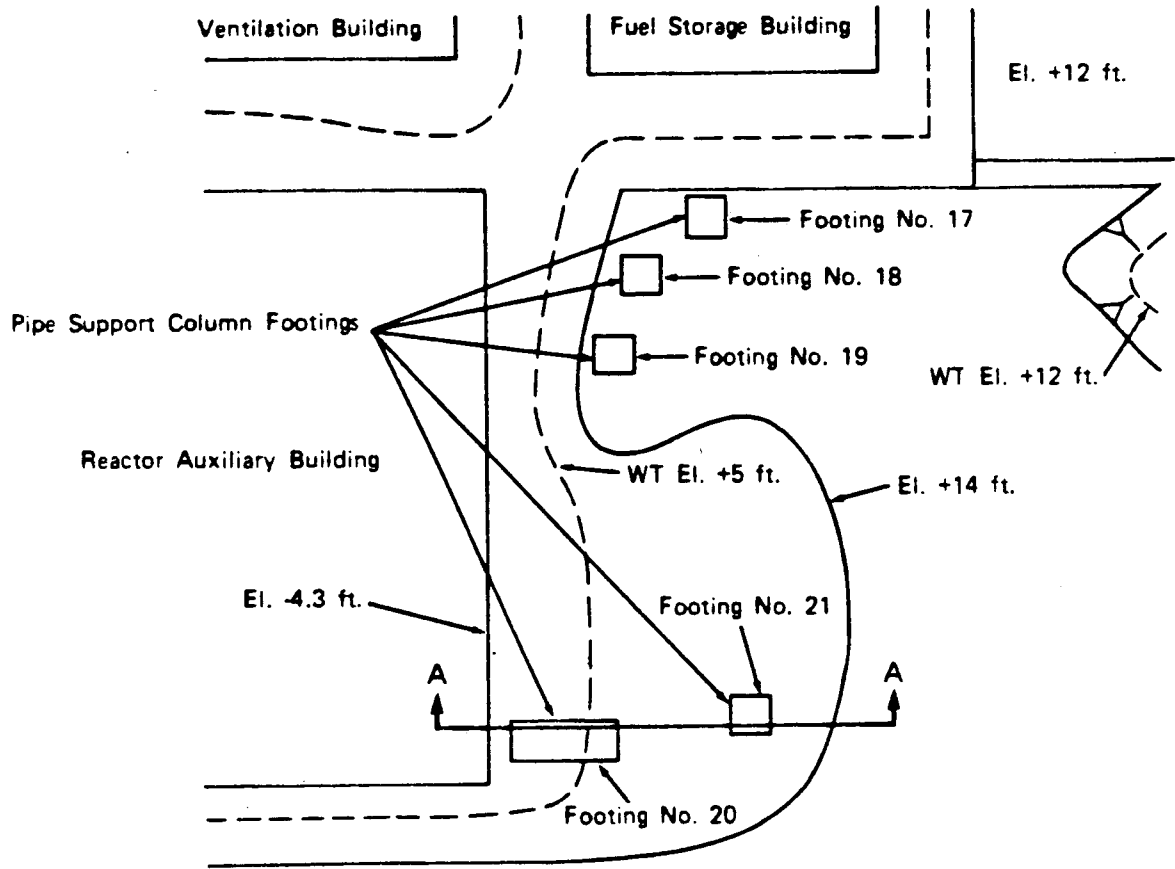
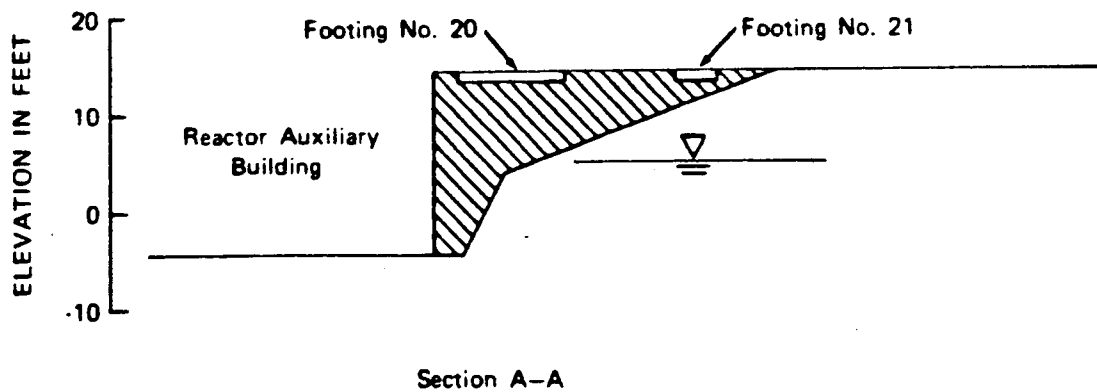
LOCAL SOIL CONDITIONS UNDER
 COLUMN FOOTINGS FOR PIPING SUPPORTS
 ITEMS NO. 17-21
 FIGURE 5-17

Figure 5-17 indicates that footings 17, 18 and 19 are founded on native soil. As such, no seismically induced settlement is expected beneath these footings, consequently they require no further consideration.

As indicated in Figure 5-17 footing 20 is founded on up to 18 feet of category B and D fill of which 10 feet is below the water table. Footing 21 is founded on up to 3 feet of category B fill. Based on a settlement evaluation, performed in accordance with procedures documented in Section 3, the potential seismically induced settlement of the backfill soil beneath these footings is estimated to be 1 to 2-1/2 inches for footing 20 and 1/4 inch for footing 21. As indicated in Table 5-1, up to 1 inch of the footing 20 and all of the footing 21 settlements would occur during seismic shaking.

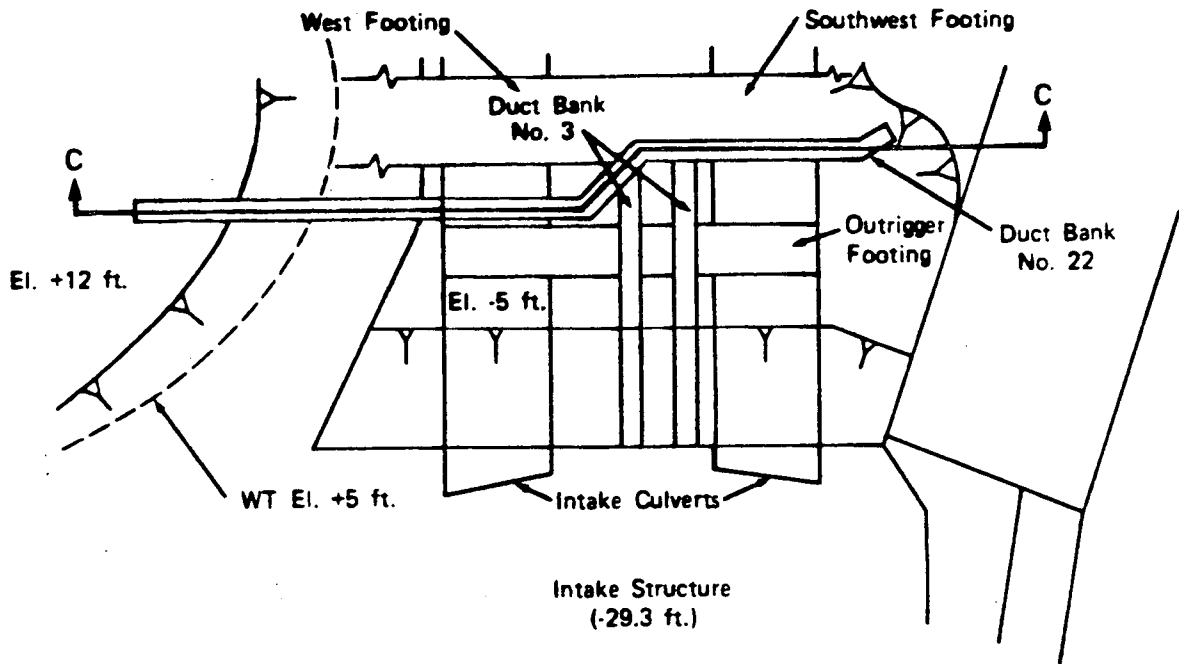
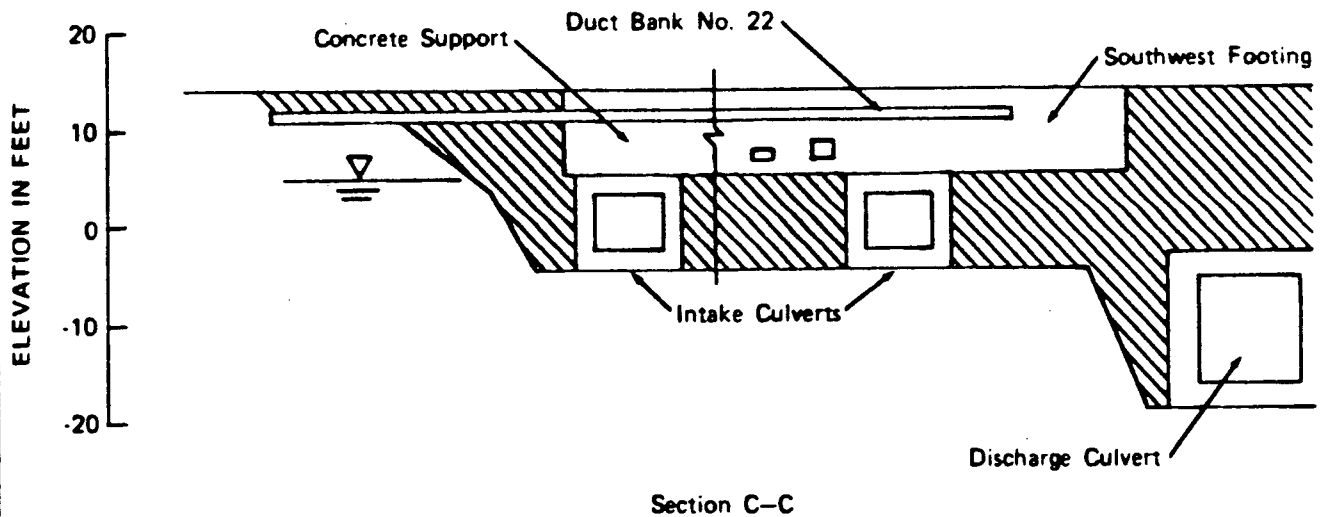
LOCAL SOIL CONDITIONS UNDER
DUCK BANK - NO. 22
FIGURE 5-18

As indicated in Figure 5-18 the east segment of the duct bank is founded on the existing west extension footing with the remaining portions founded on up to 15 feet of category B and C fills, of which up to 10 feet is below the water table.

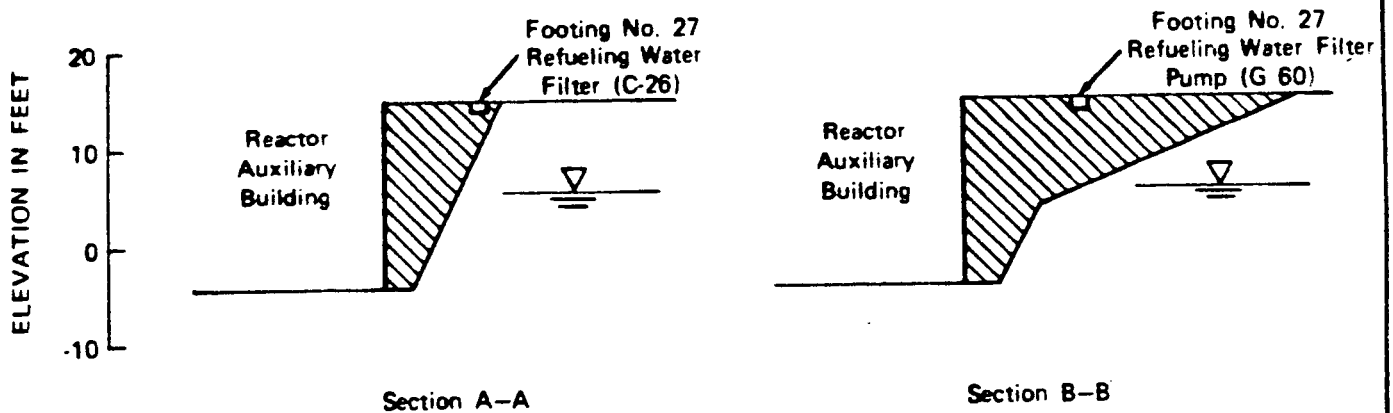
LOCAL SOIL CONDITIONS FOR
REFUELING WATER FILTER PUMP
ITEM NO. 27
FIGURE 5-22

As indicated in Figure 5-22, the Refueling Water Filter and Refueling Water Filter Pump are located on up to 5 and 10 feet of category D fill, respectively. The potential seismically induced settlements of the Refueling Water Filter and the Refueling Water Filter Pump would be less than 1/2 inch. All of this settlement would occur during seismic shaking.
