**SAFETY ENGINEERING
ROOT CAUSE REPORT**

**SONGS 1 THERMAL SHIELD LOWER
SUPPORT BLOCK FASTENERS
ROOT CAUSE EVALUATION
RCE-91-002
REVISED MARCH 21, 1991**

ROOT CAUSE EVALUATION RCE-91-002

March 21, 1991

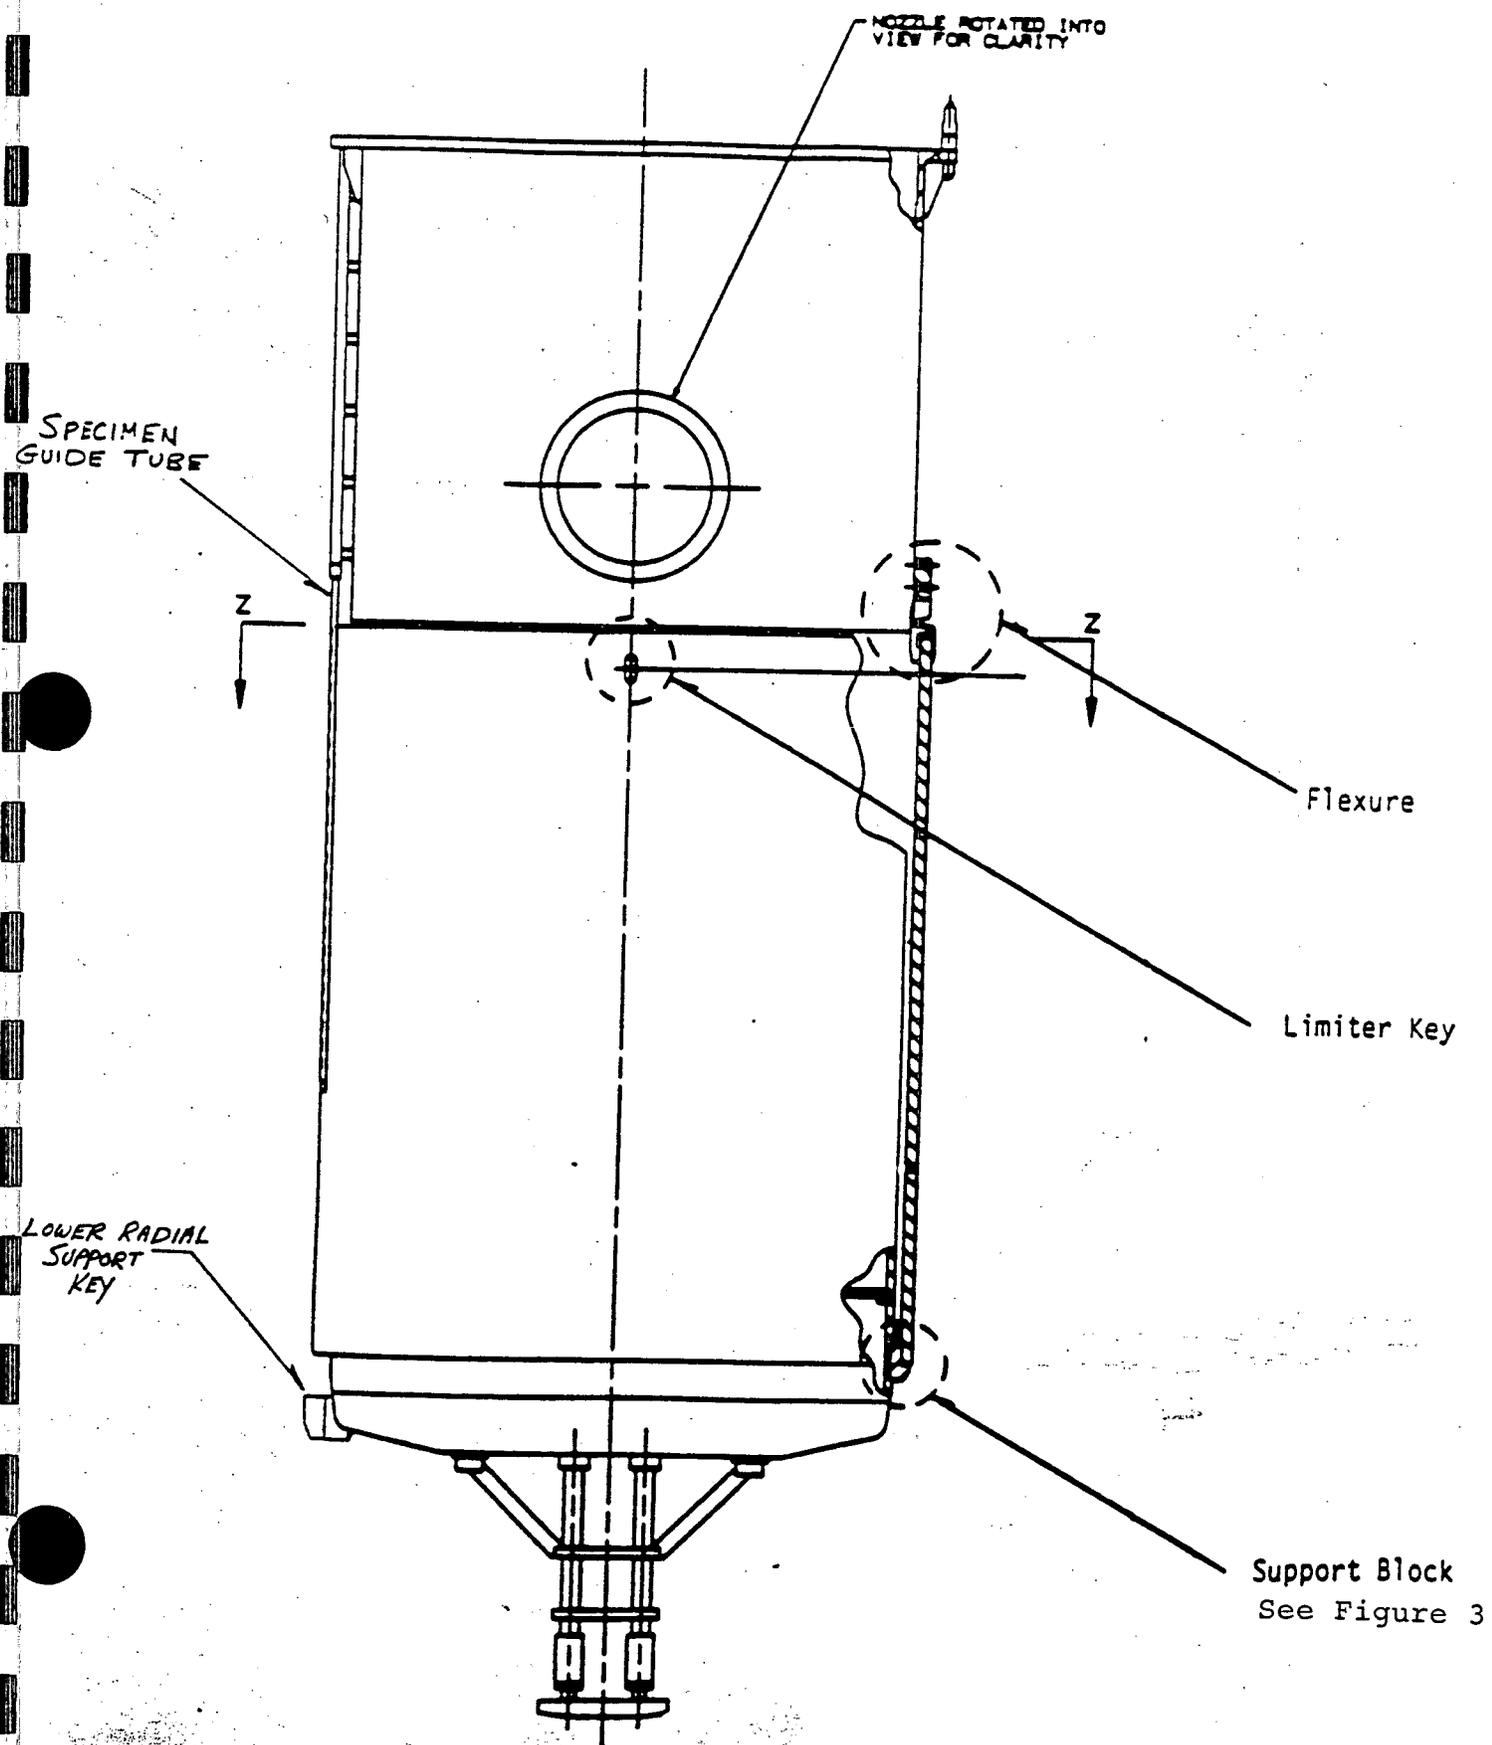
FIGURE 1. Schematic of the Thermal Shield Support System

The reactor vessel thermal shield at SONGS 1, is supported at the bottom by six fixed support blocks on which the bottom of the thermal shield rests. These support blocks are located at 0, 60, 120, 180, 240, and 300 degrees around the perimeter, as illustrated in Figures 1 and 2.

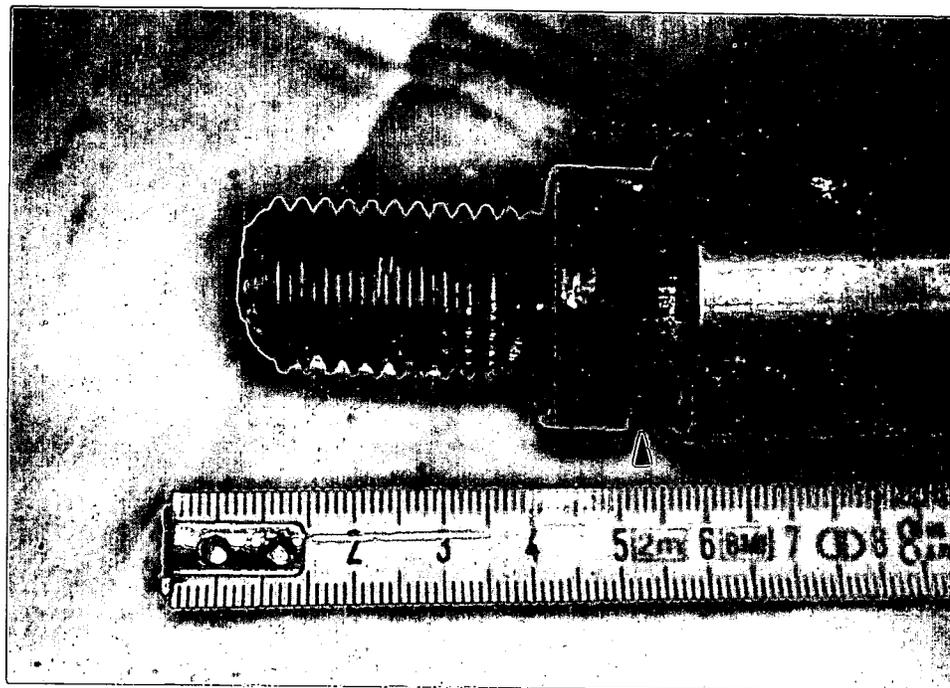
According to the initial blue prints of the support block fasteners, all bolts should have a smooth shank below the bolt head, see Figure 3.d. The retrieved four hidden bolts were threaded to the head and did not conform to the original drawings.
