SEAWALL INSPECTION
SAN ONOFRE NUCLEAR GENERATING STATION, UNIT 1

Prepared for:
SOUTHERN CALIFORNIA EDISON

Prepared by:
Impell Corporation
350 Lennon Lane
Walnut Creek, California 94598

Impell Report No. 01-0310-1473
Revision 1

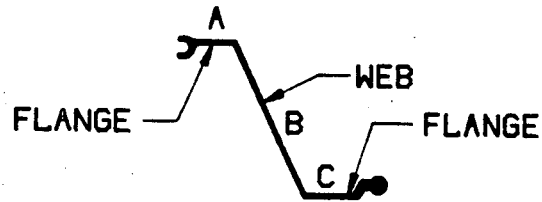
TYPICAL CROSS SECTION OF SHEET PILE
(PZ27 OR PZ32)

- The below grade gunite cover on the seaward side of the seawall was still adhering to the wall and the steel surface was in excellent condition.
- It was observed that the seawall between stations S11+66 and S13+41.5 was constructed with PZ32 sheet piling instead of the PZ27 section shown on the design drawings (see Figure 2). This sheet pile section has higher section properties (about 27% stronger) than the specified sheet pile section (PZ27). See Appendix A for comparison of section properties.
