**Steam Generator Inspection Program  
Return to Power Report  
San Onofre Nuclear Generating Station  
Unit 1  
September, 1982  
Southern California Edison Company**

**Volume I**

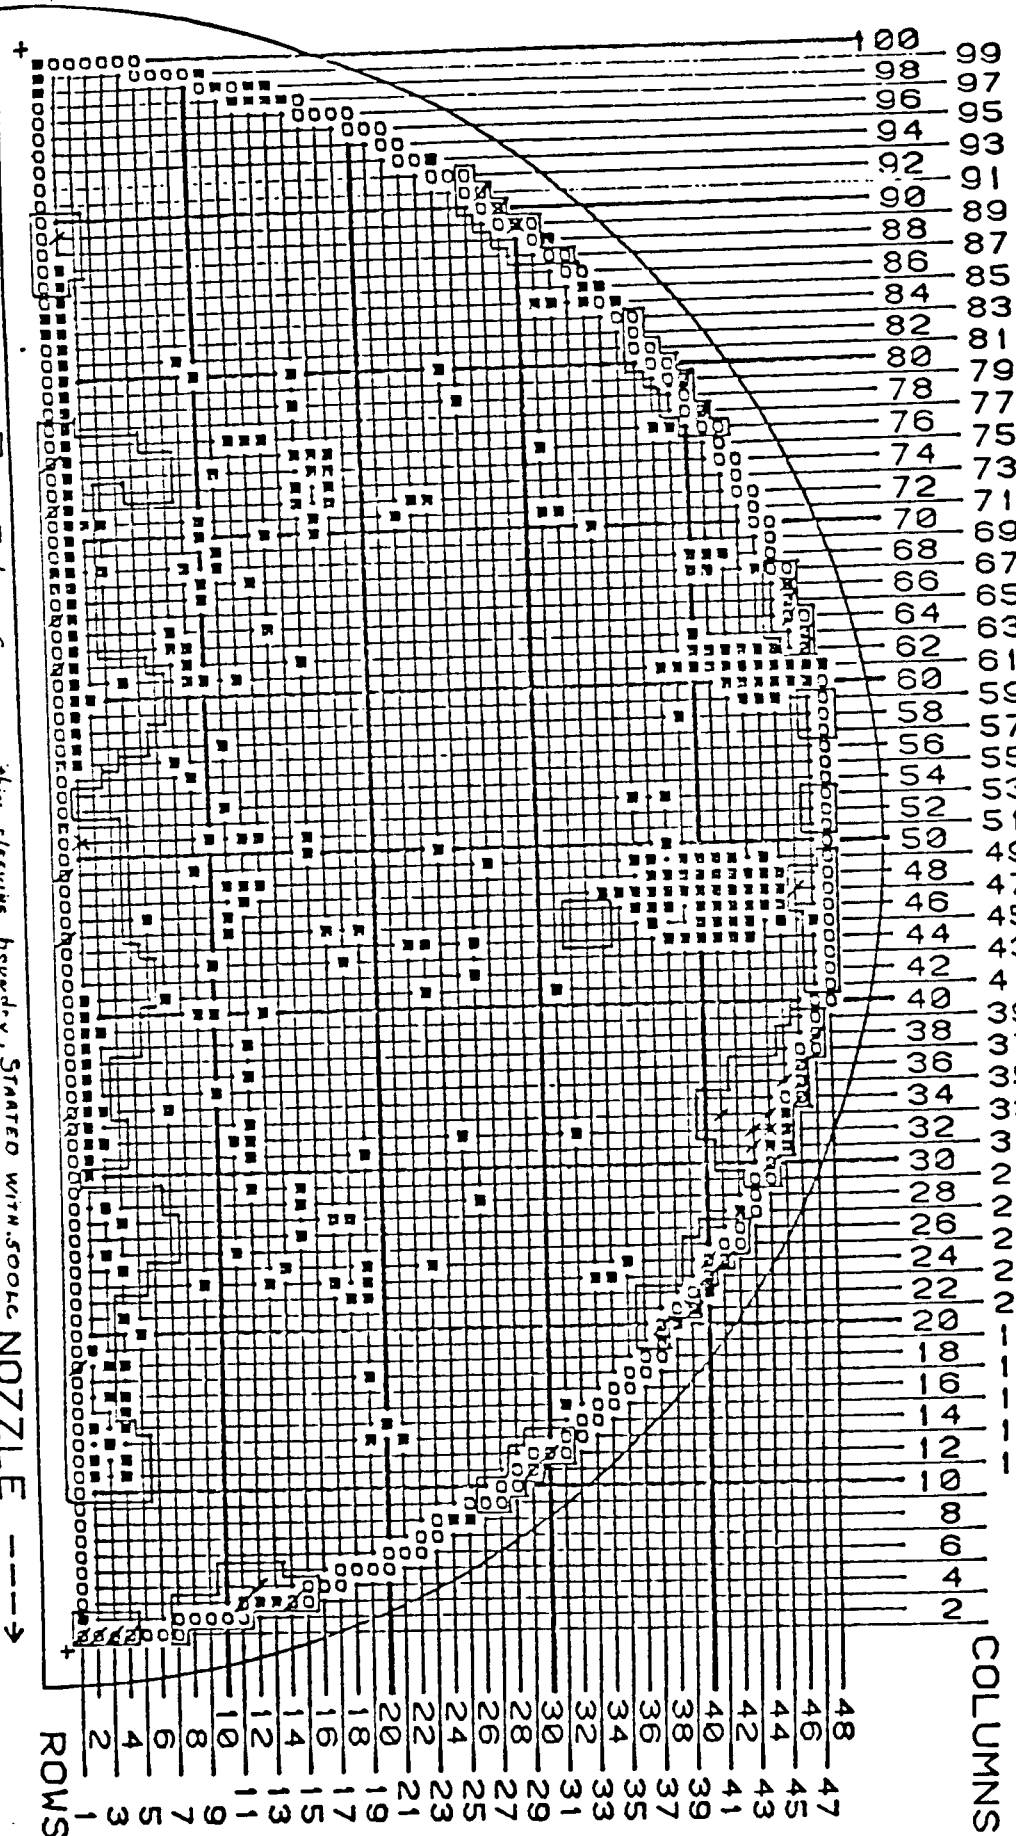
1 - RESTRICTS .560 PROBE PASSES .500 PROBE (41) X - RESTRICTS .500 PROBE PASSES .460 PROBE (6)  
 INLET

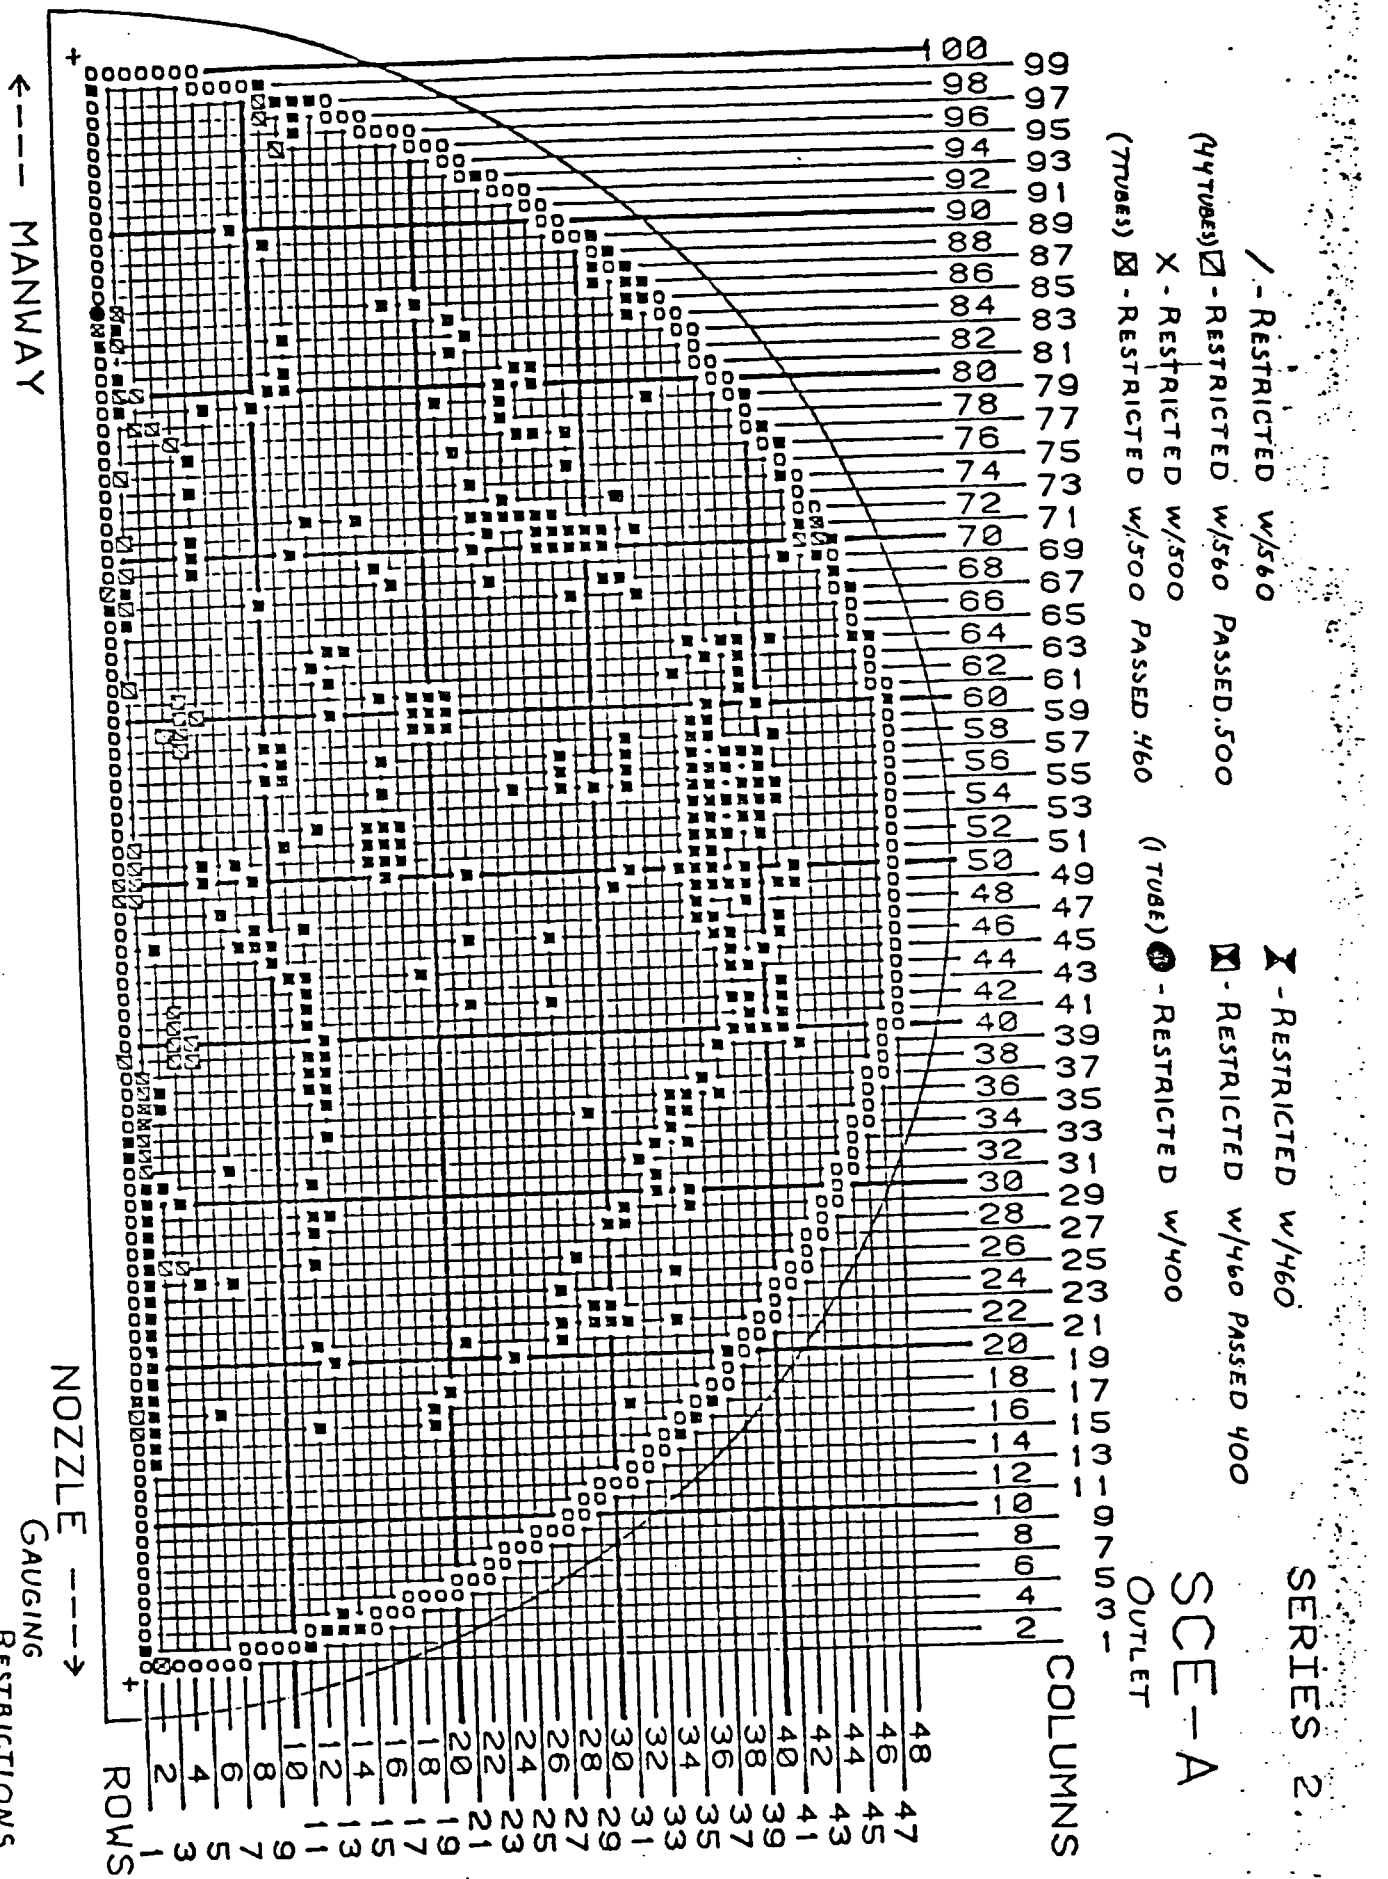
FIGURE B-8: RESTRICTION LOCATIONS, SG-A COLD LEG

747 TUBES - 70 PLUGS = 677 TUBES TO BE TESTED THRU 4" TSP

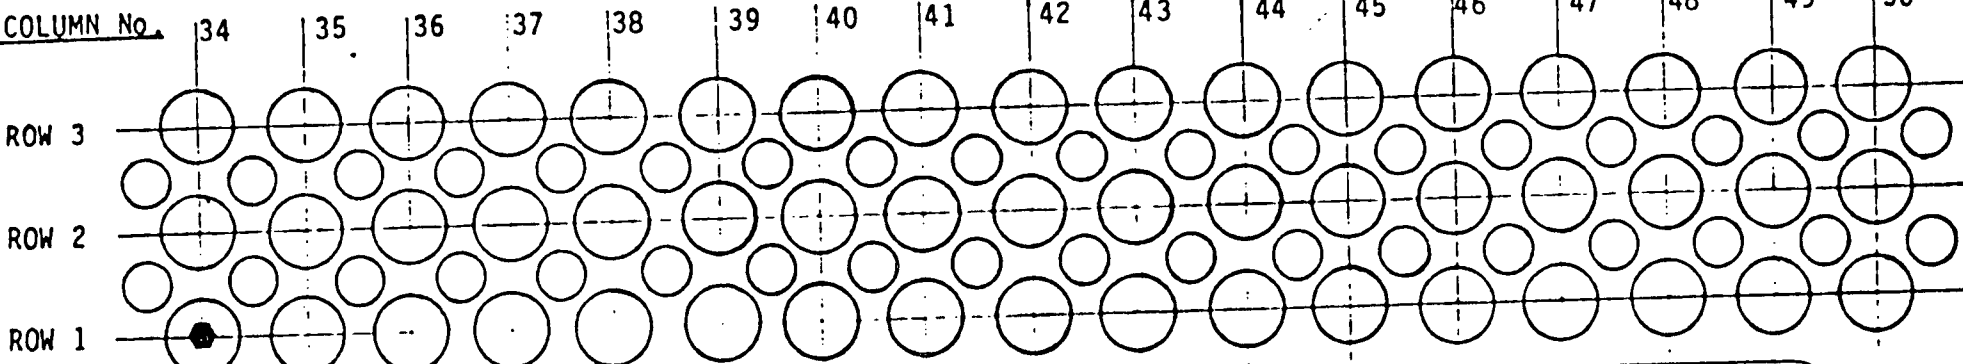
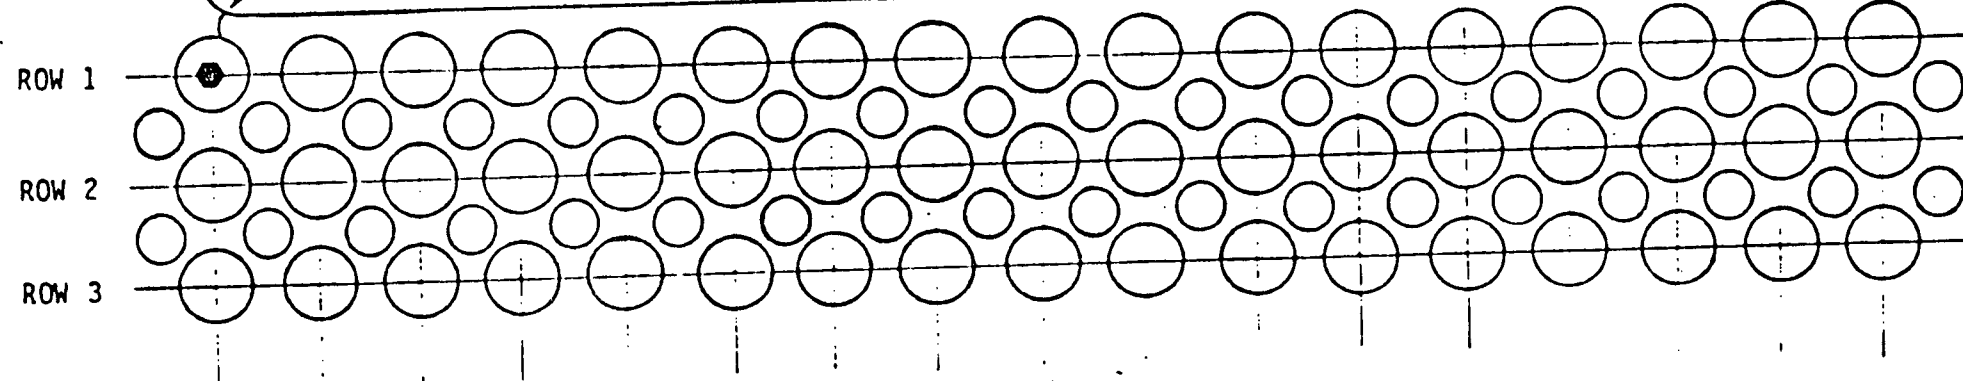
FLOW SLOT WIDTH  
.984" (PHOTO 7-11)

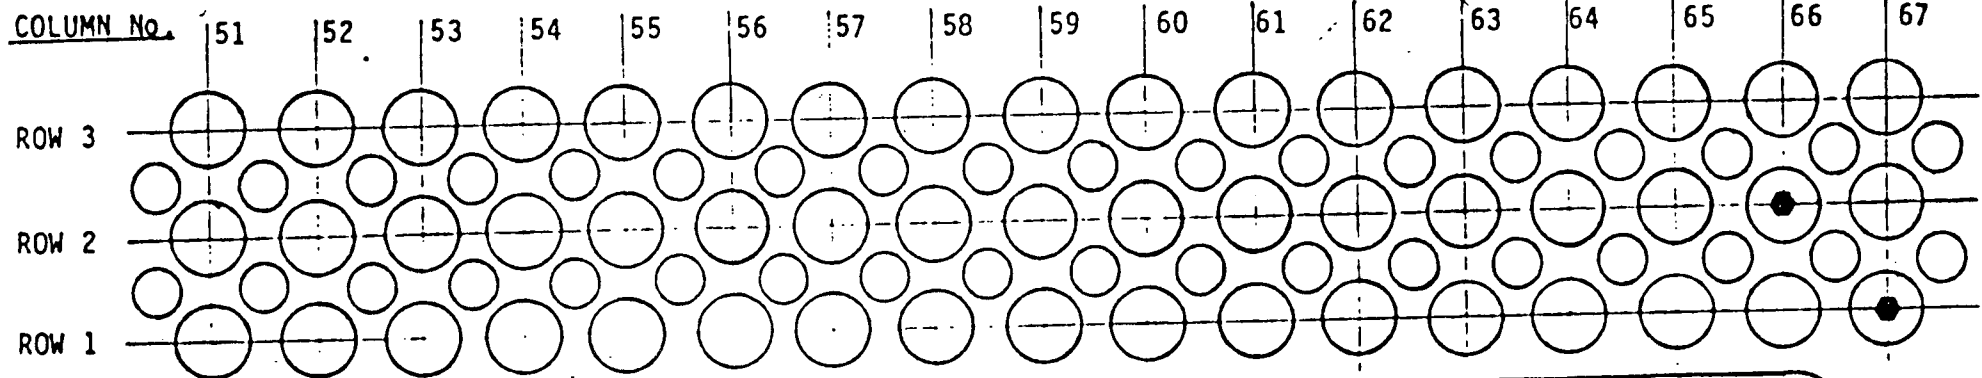
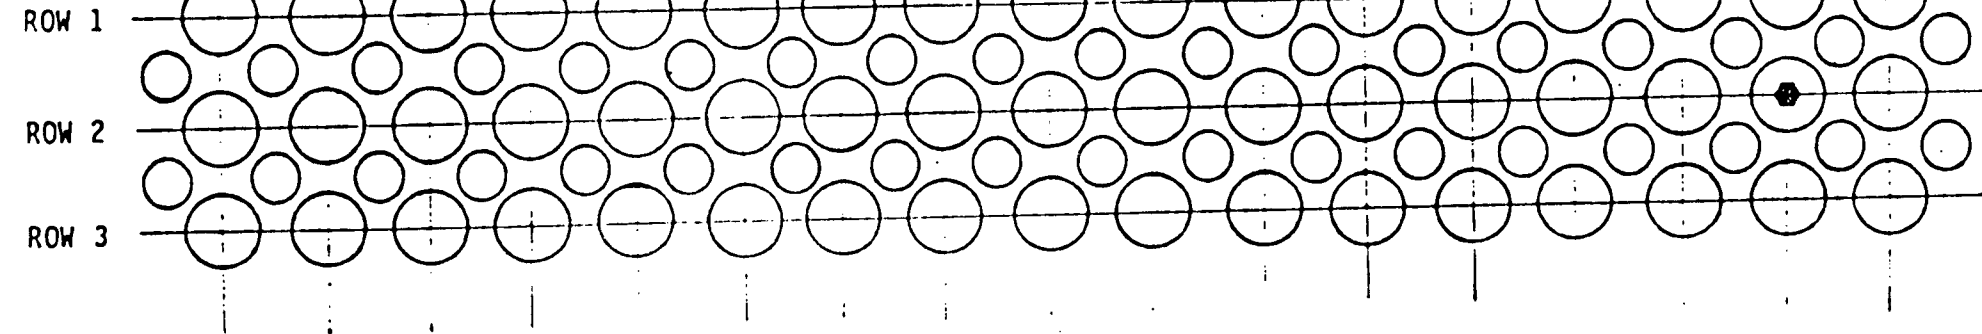
FLOW SLOT WIDTH

.930" (PHOTO 8-19)

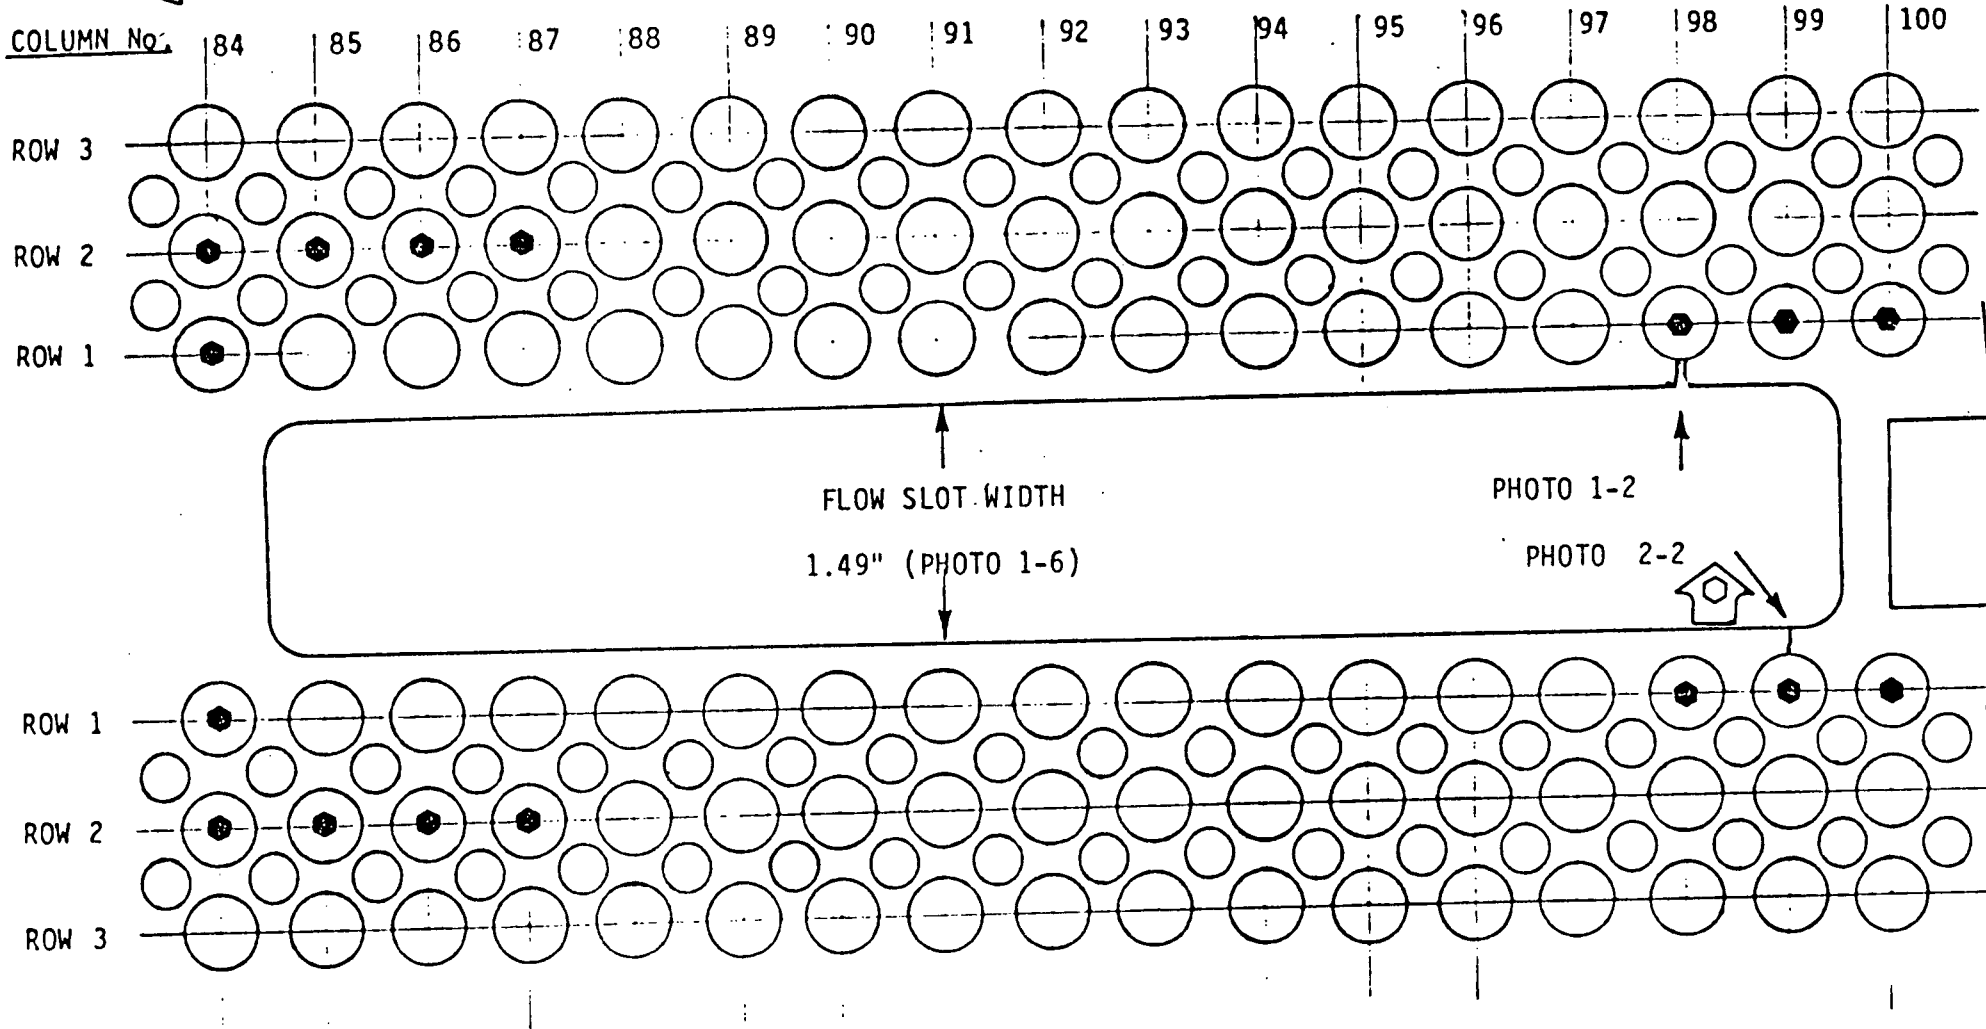
FLOW SLOT WIDTH  
1.49" (PHOTO 1-6)

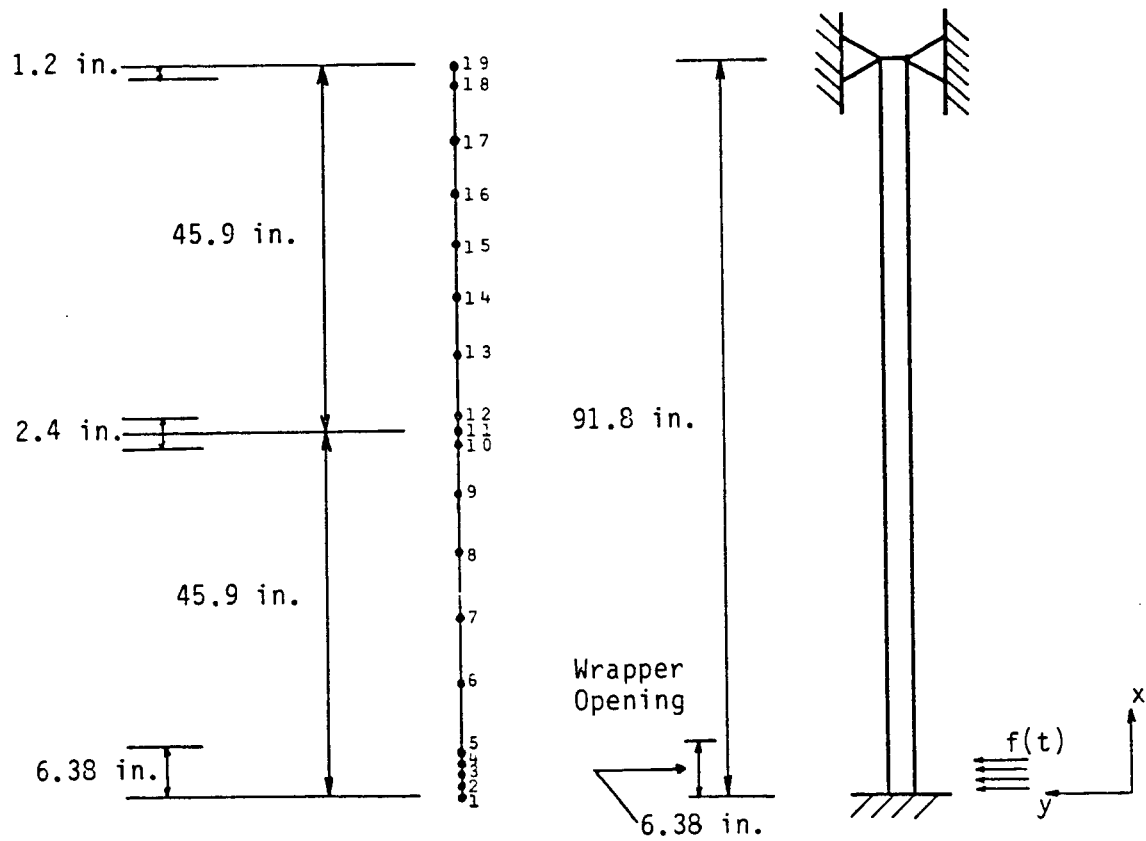
Figure 2  
 Nodal Point Locations for Case A

Case A corresponds to a clamped-simply supported SG tube with the first TSP missing. This case is a linear problem and serves as the basis for calibration of the normal load. Figure 2 shows the nodal point locations for Case A.

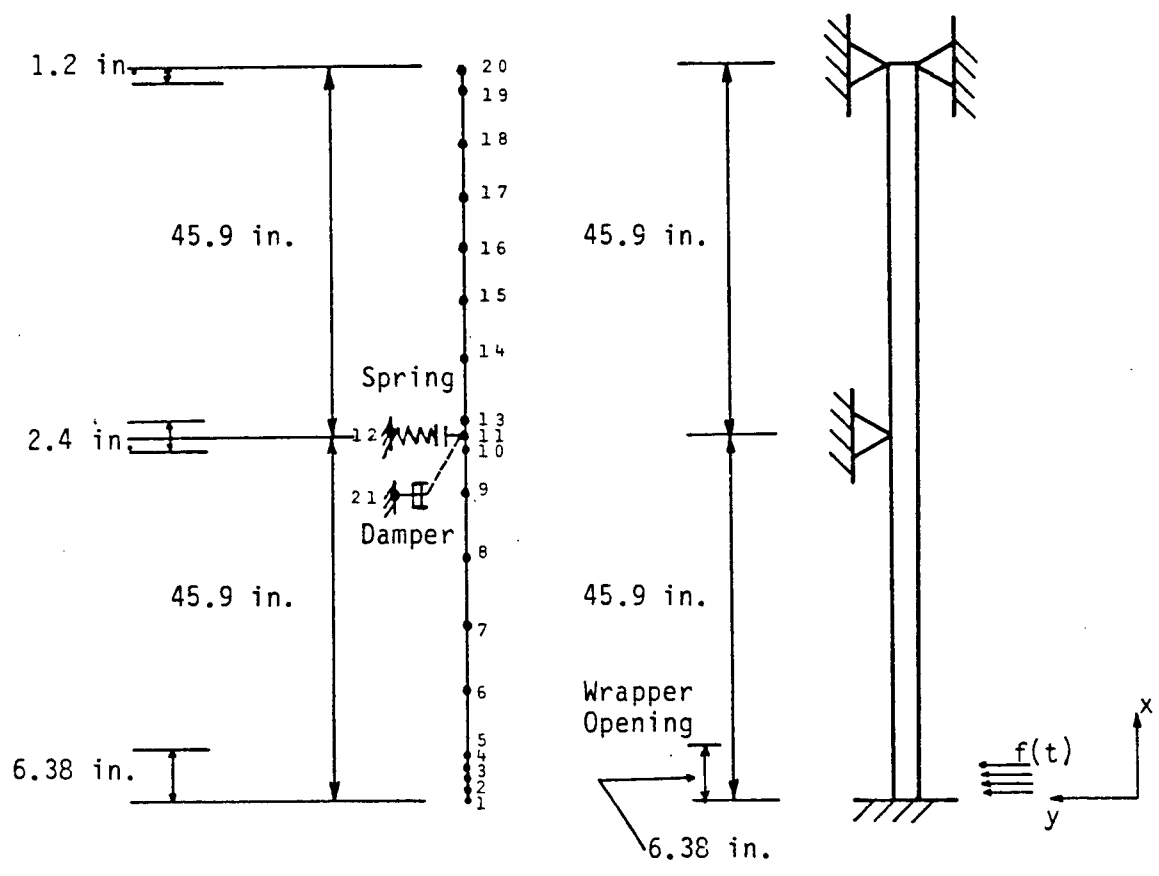
Figure 3  
 Nodal Point Locations for Case B

Case B simulates an SG tube with a cracked first TSP providing one-way support at mid-span. Two more nodes are placed in the center of the beam to account for the interface between the SG tube and the TSP. Figure 3 shows nodal point locations for Case B.

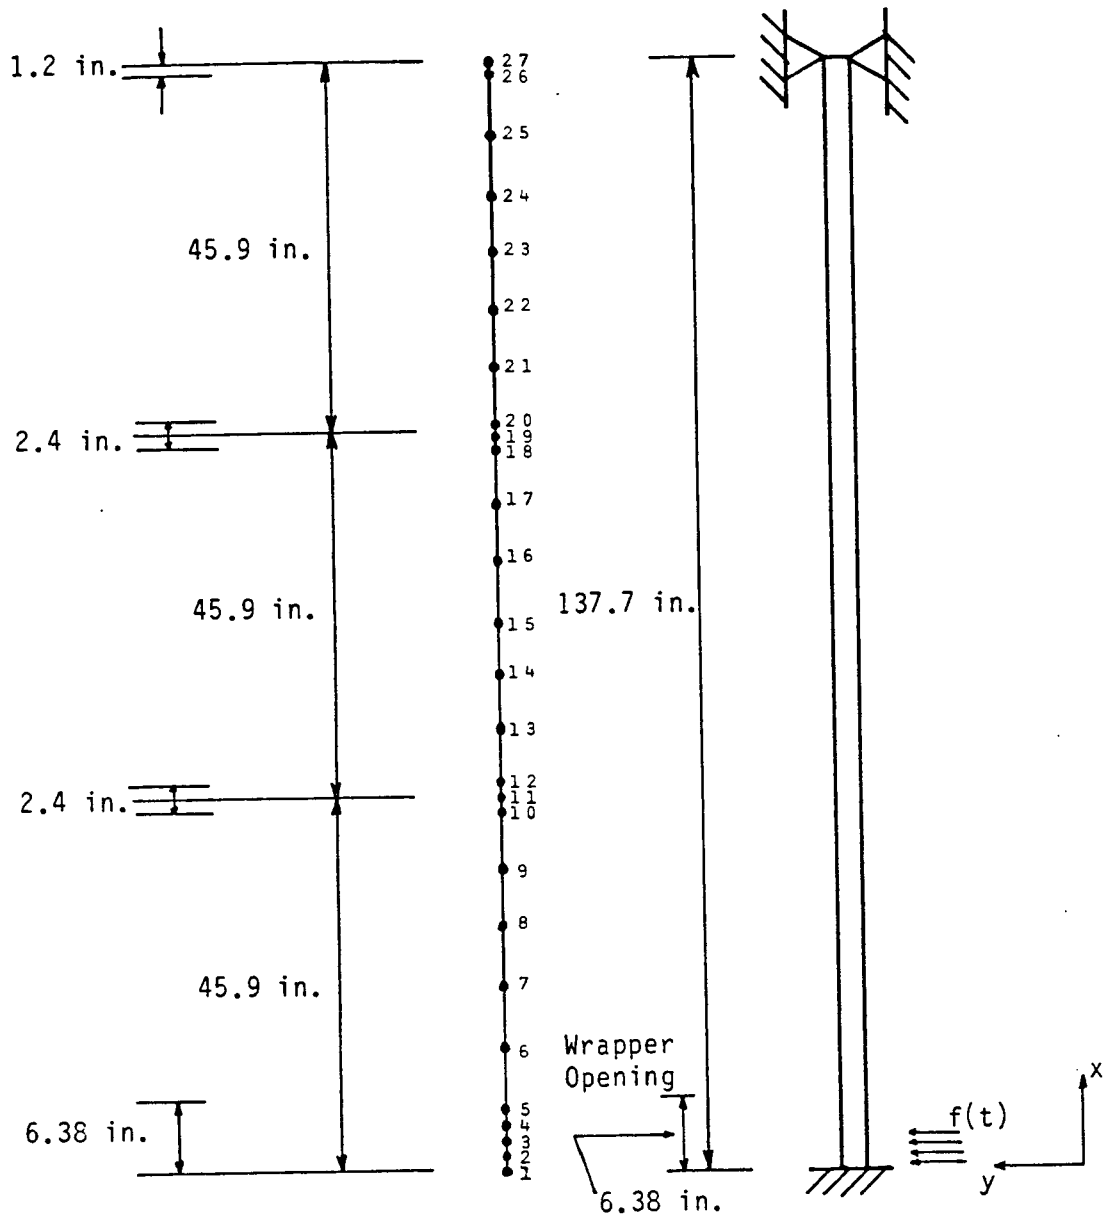
Figure 4  
 Nodal Point Locations for Case C

Case C is similar to Case A, but has a longer length. It represents a clamped-simply supported SG tube with the first and second TSPs missing. Figure 4 shows the nodal point location for Case C.

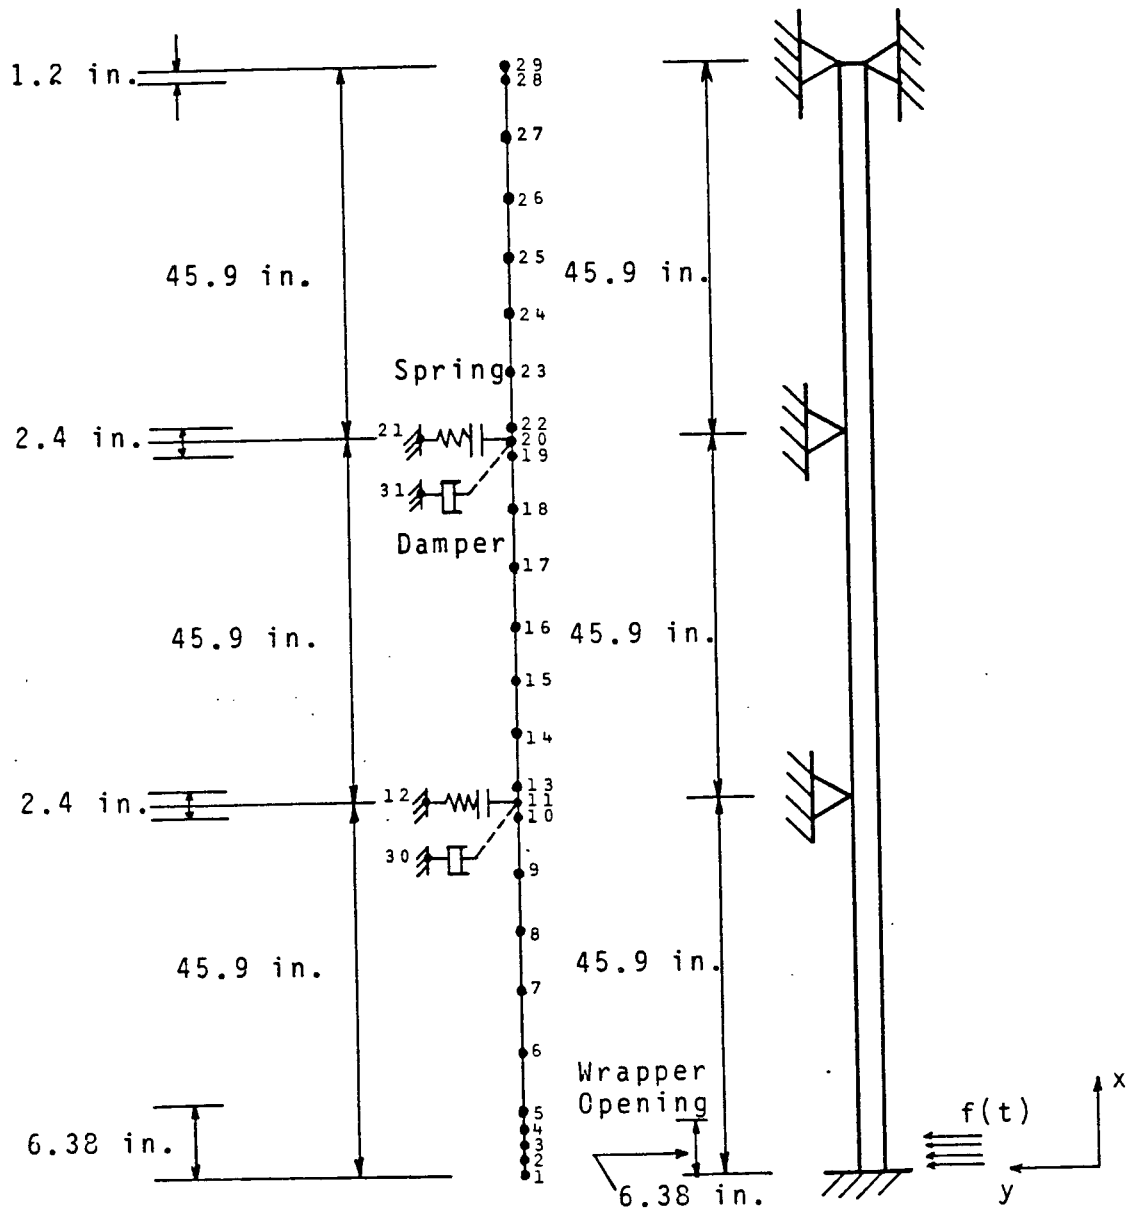
Figure 5  
 Nodal Point Locations for Case D

Case D consists of a beam divided in thirds by two one-way supports. This represents an SG tube with two cracked TSPs. Two more nodes have been placed at each of the two partial support locations to account for the supports. Figure 5 shows nodal point locations for Case D.

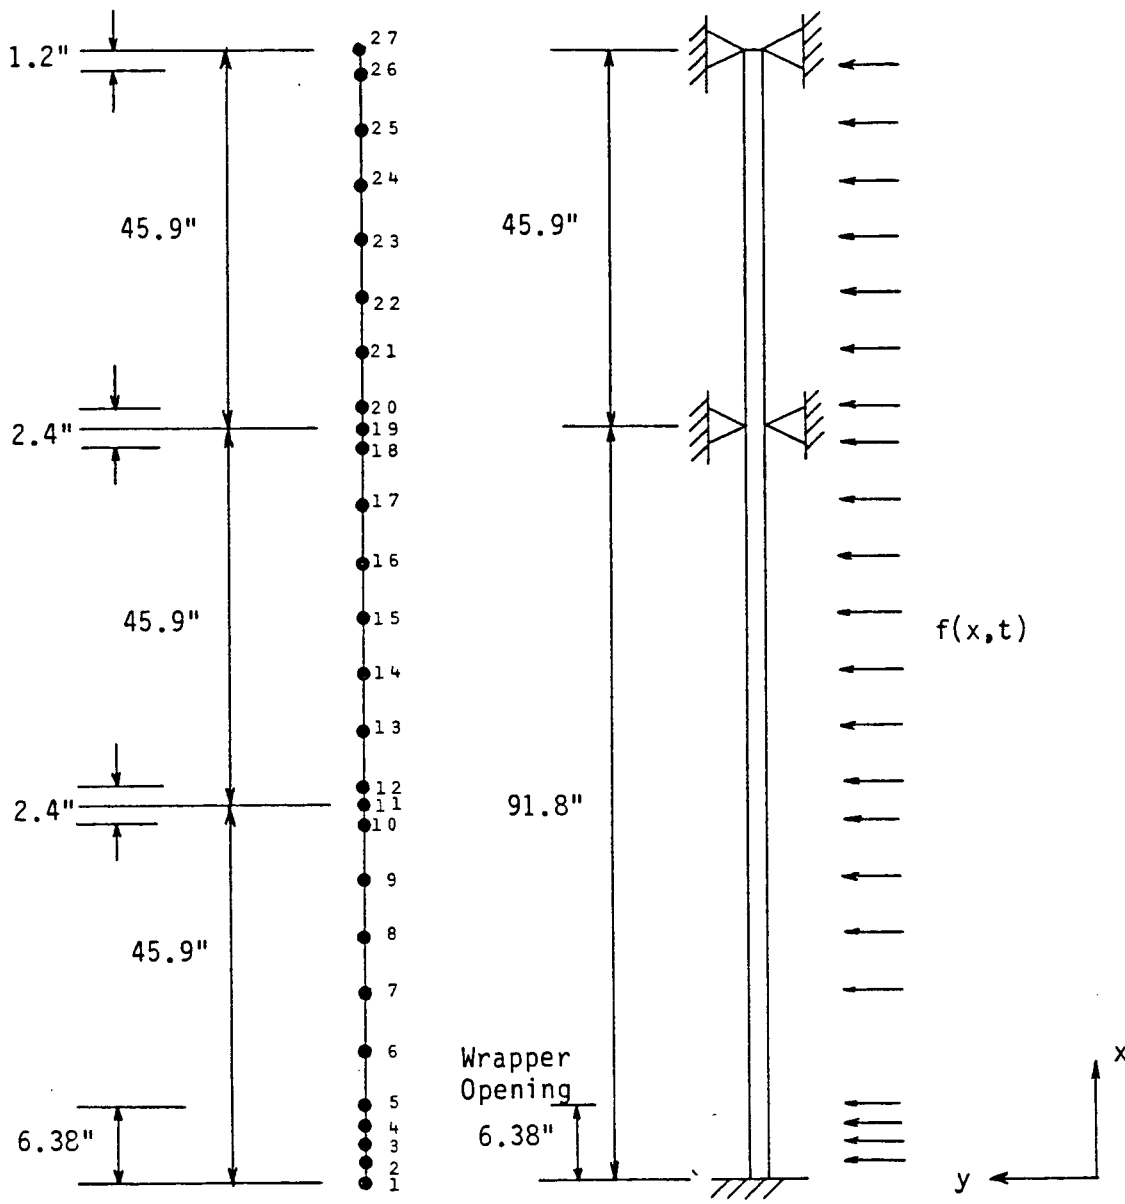
Figure 6  
 Nodal Point Locations for Case E

Case E is a modification of Case A for the steamline break (SLB) accident condition. The beam is divided into two sections by the two-way support. This case is used for calibration of the SLB load. Figure 6 shows the nodal point locations for Case E.

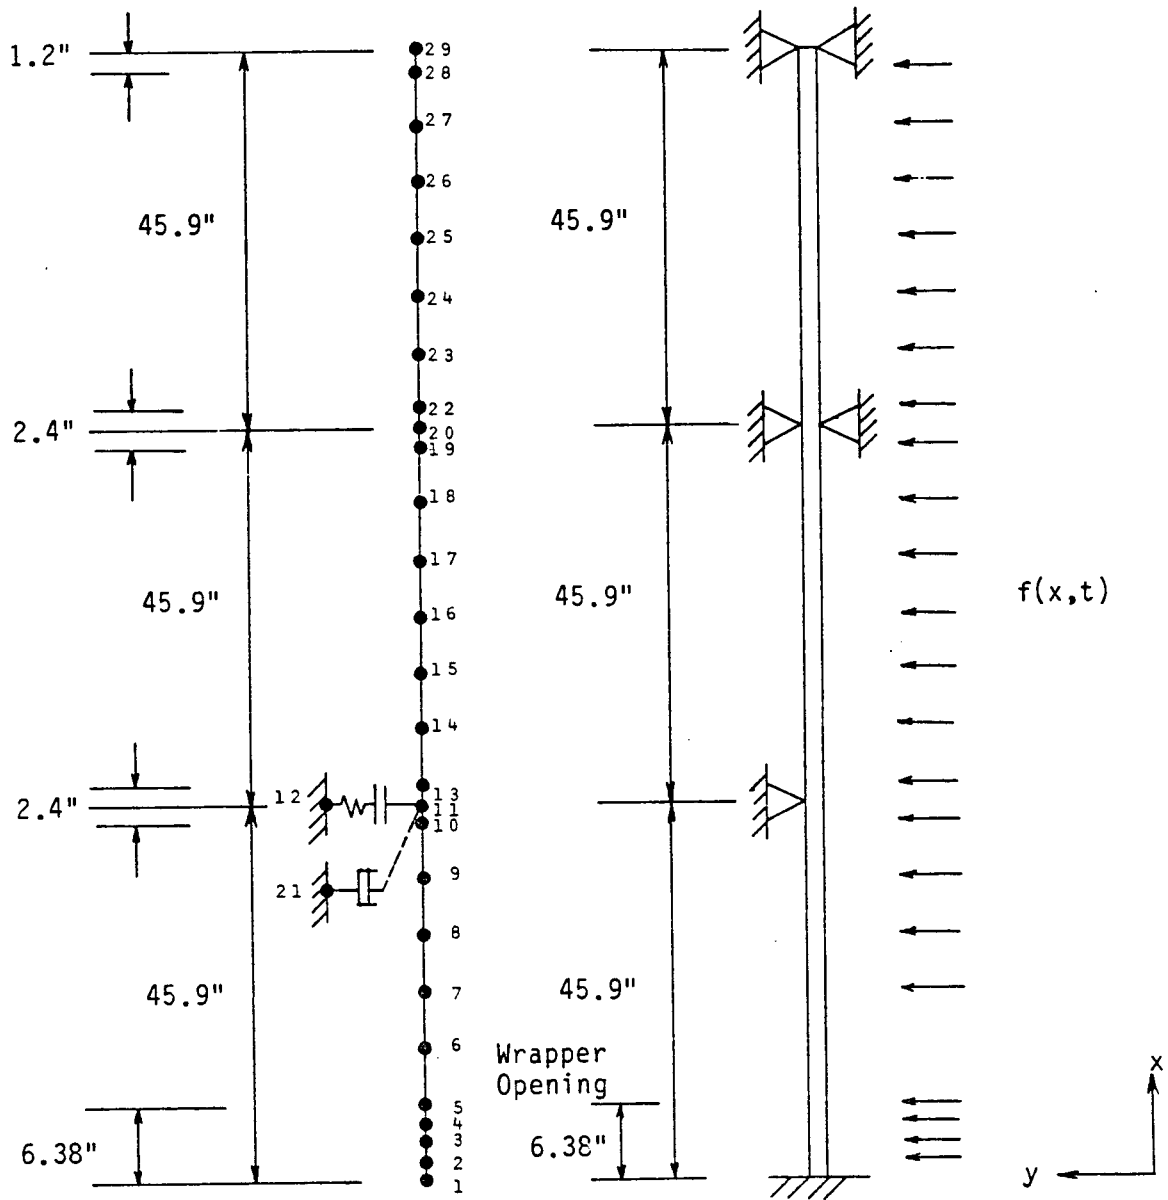
Case F is similar to Case E, but has a cracked first TSP providing one-way support at the lower section. Figure 7 shows nodal point locations for Case F.

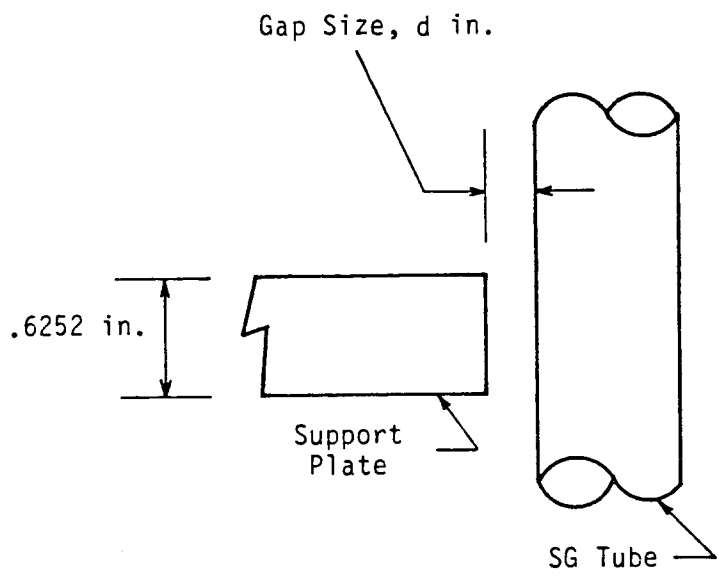
Figure 8  
One-Way Support

When the SG tube has only one-way support, it may maintain or break physical contact with the cracked TSP. This situation results in a gap condition which applies in Cases B, D and F. Figure 8 shows a SG tube with a one-way support. This one-way support is modeled by a gap together with a spring and a damper connected to the ground as shown in Figures 3, 5 and 7.

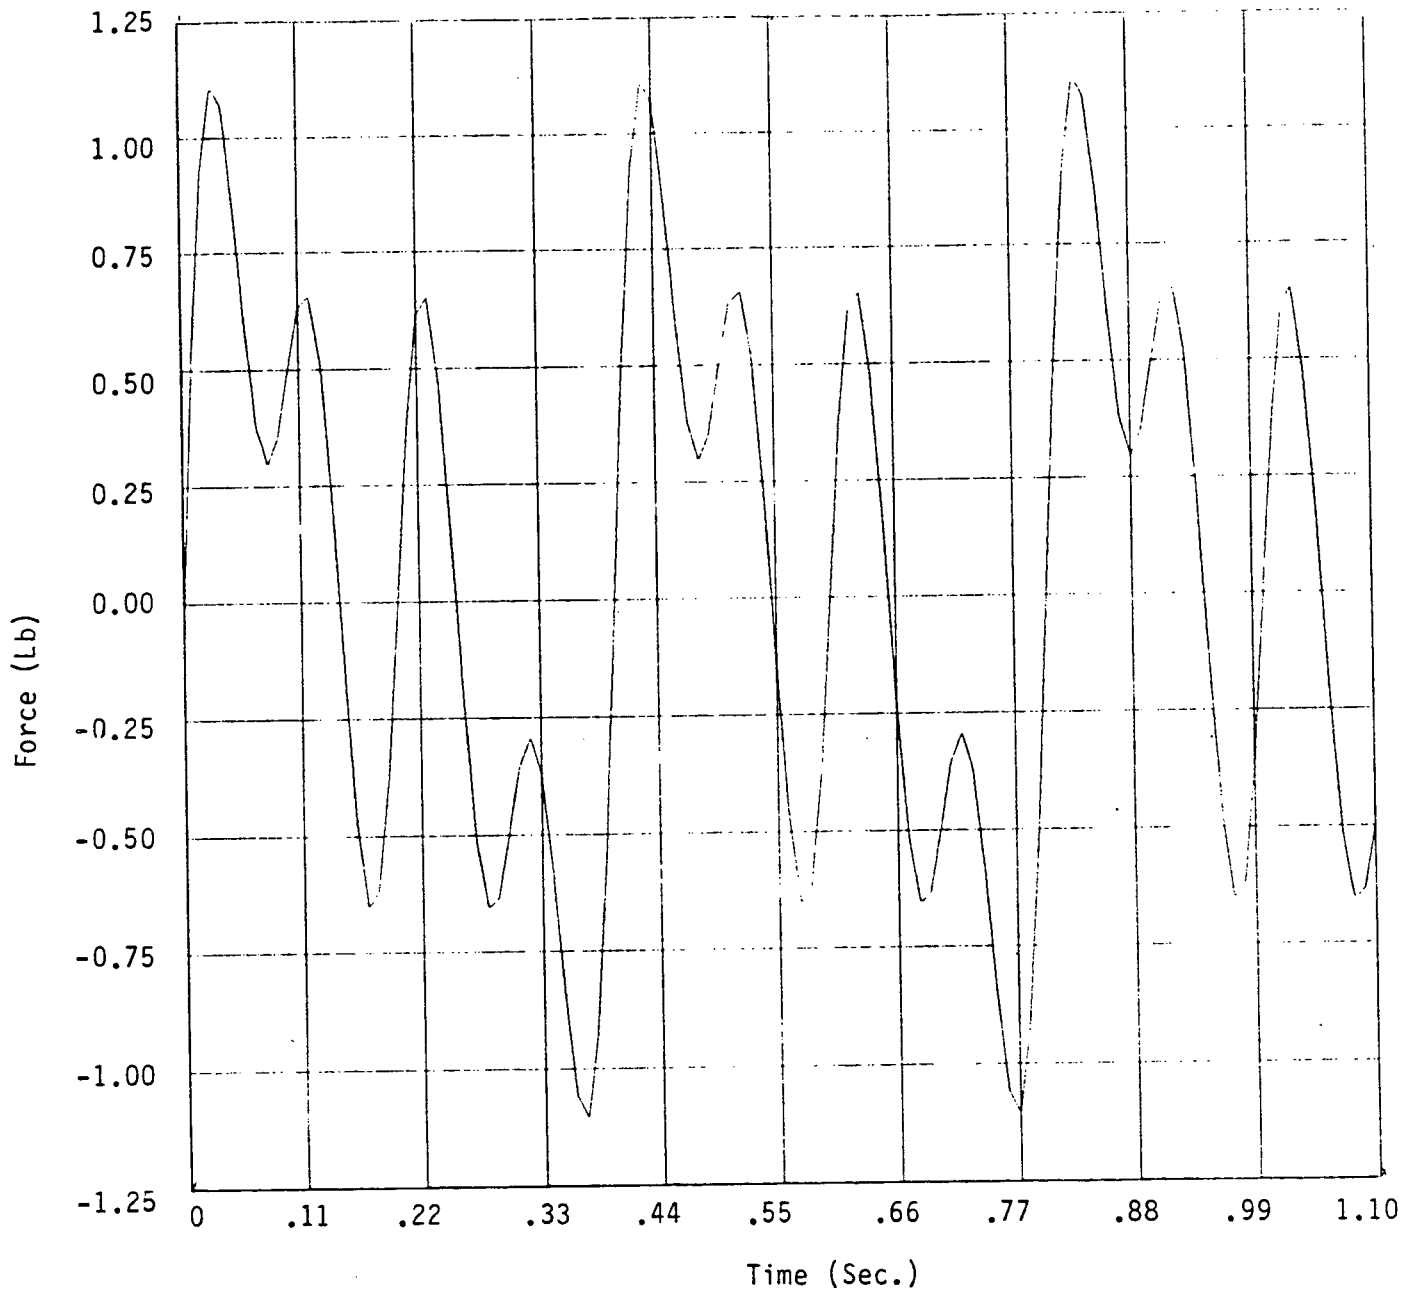
Figure 9  
Simulated Normal Load  $F(t)$

The plot of the time history of  $F(t)$  for  $t \in [0, 1.1]$  sec. is shown in Figure 9. Note that the maximum forcing amplitude is about 1.1 lbs.

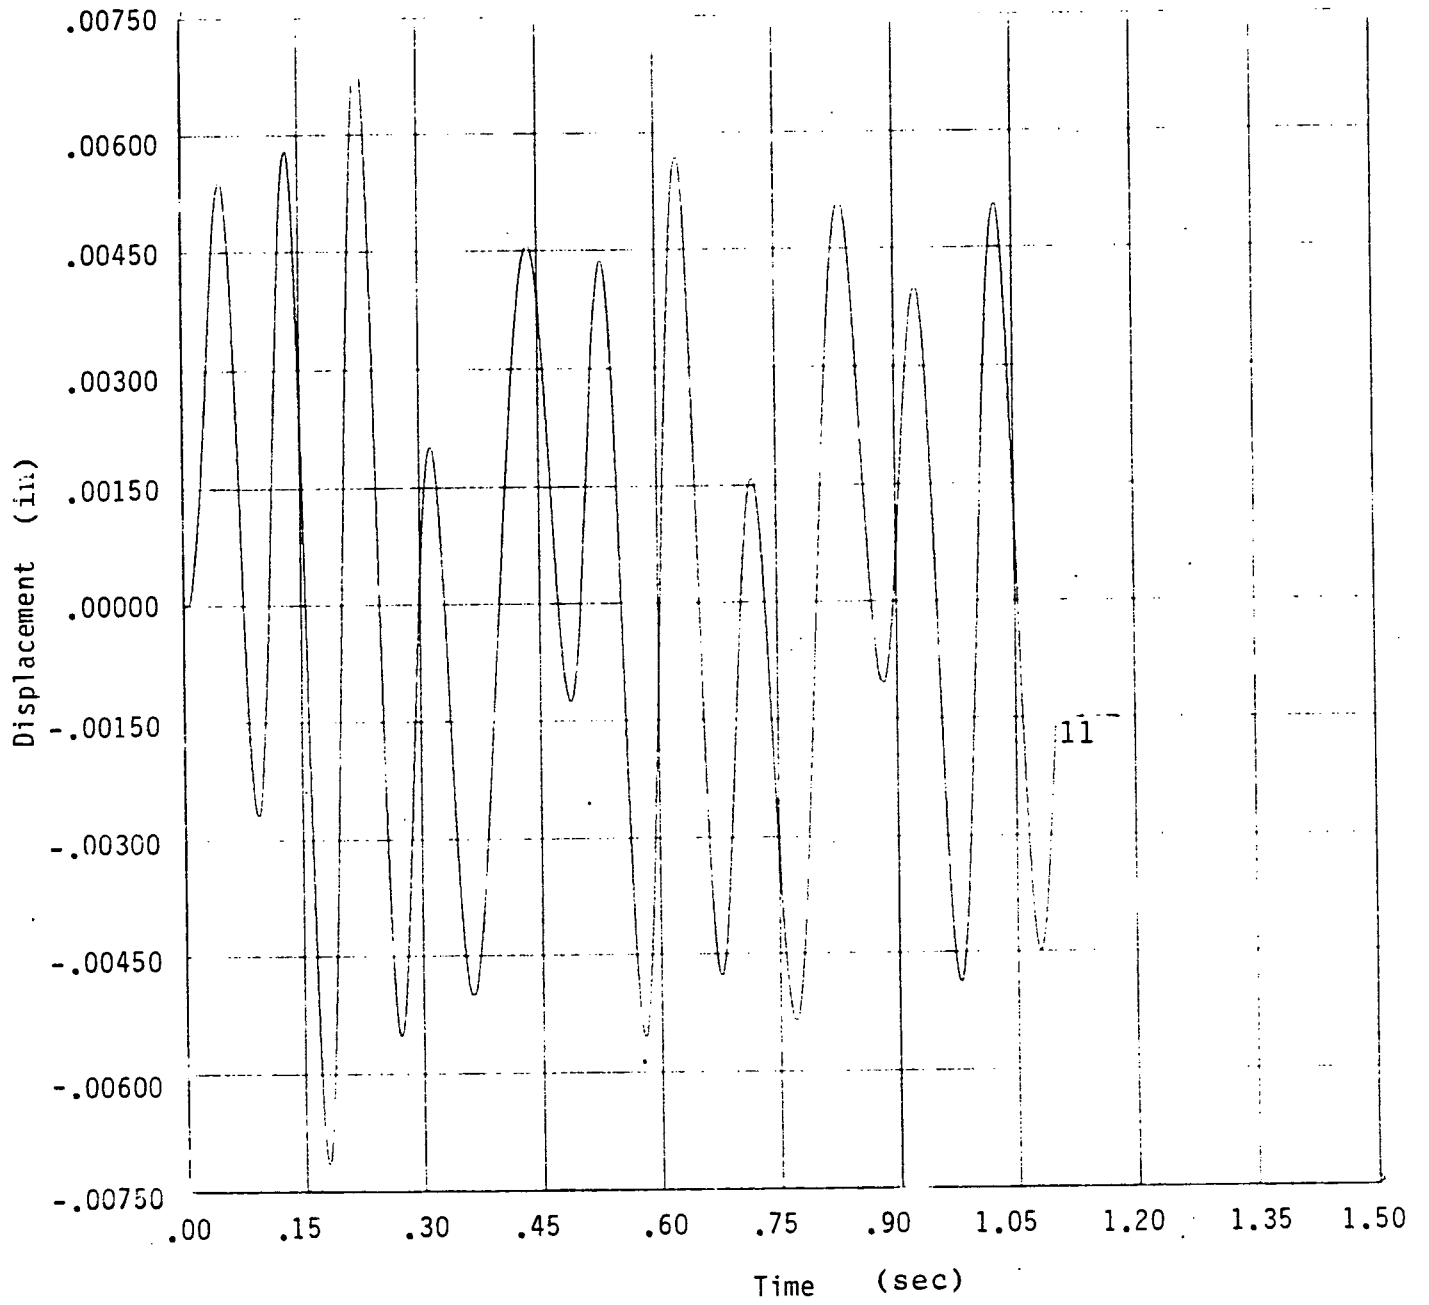
Figure 10  
 Dynamic Response of Node 11 for Case A  
 During Normal Operation

If there was a TSP, it would be placed at node 11. A plot of the displacement time history for node 11 is used as a reference for Case B and shown in Figure 10.
