**Steam Generator Inspection Program  
Return to Power Report  
San Onofre Nuclear Generating Station  
Unit 1  
September, 1982  
Southern California Edison Company**

**Volume I**

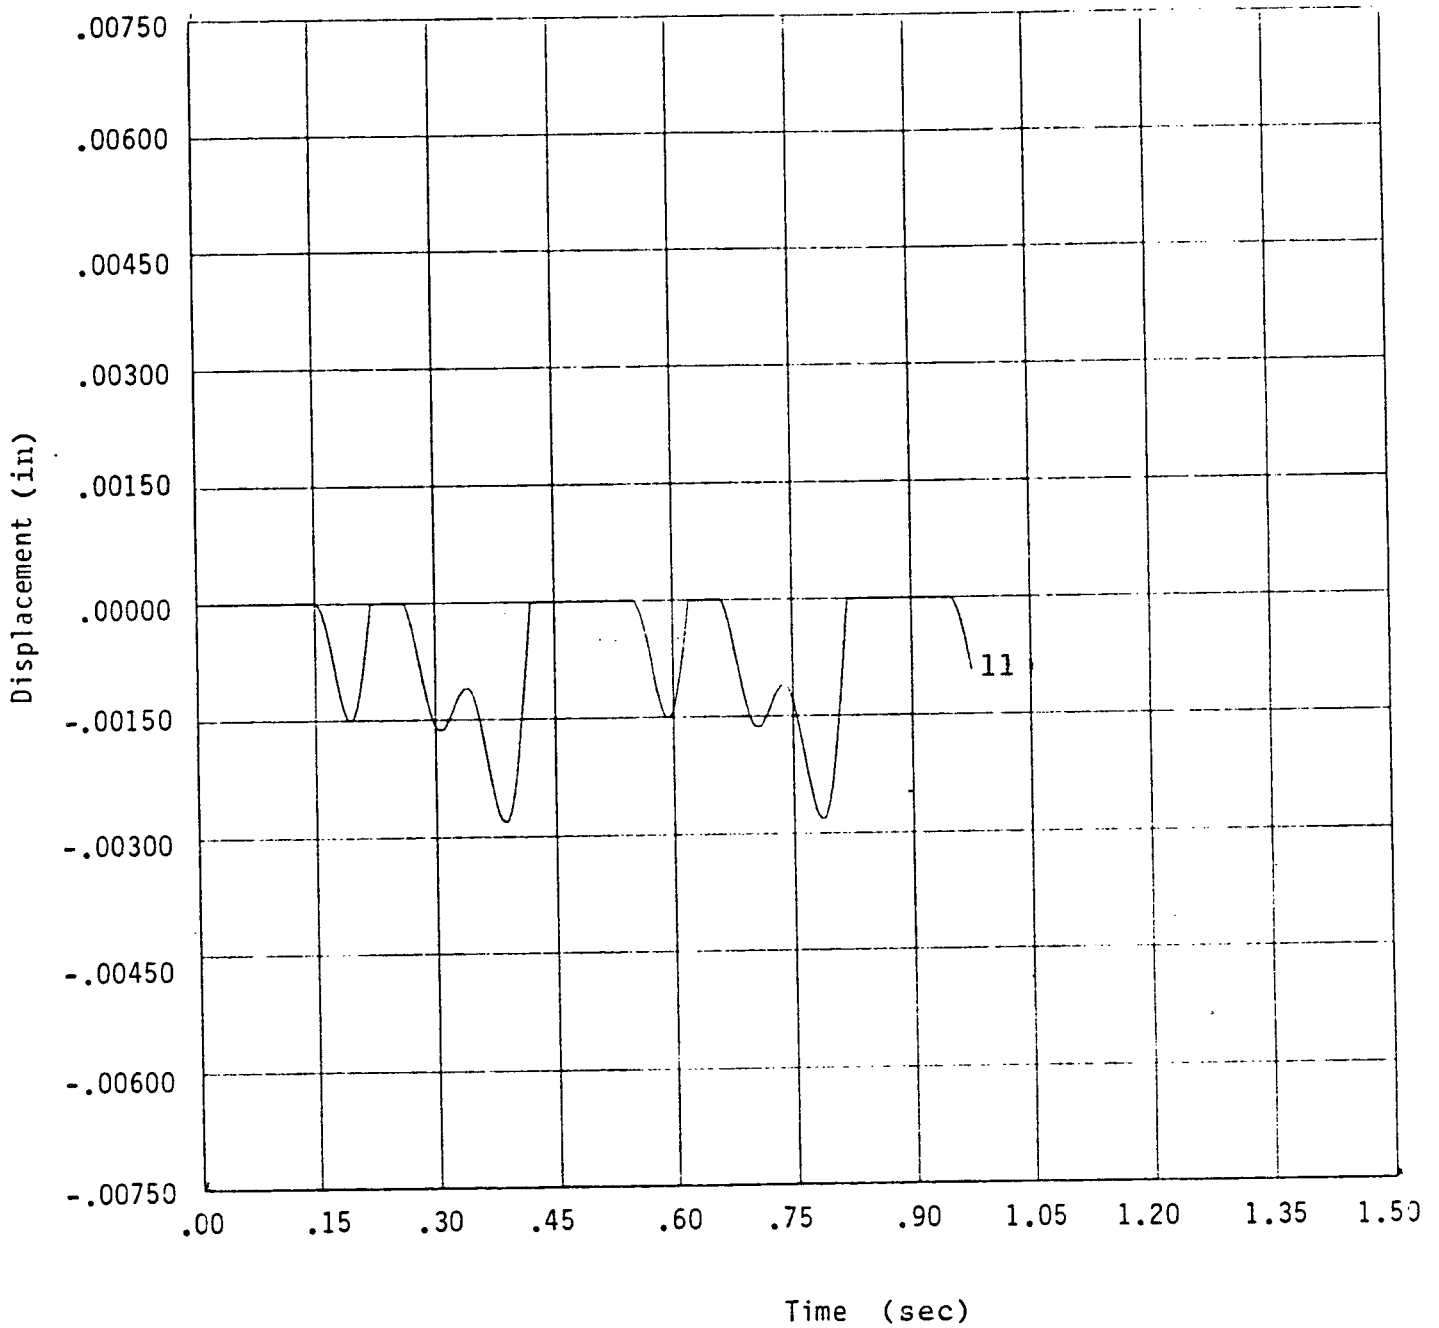
Figure 11  
 Dynamic Response of Node 11 (at first TSP) for Case B  
 With No Lateral Load During Normal Operation

For Case B with no lateral load, the gap size,  $d$ , is 0 in., as discussed in Section 2.1.2. For comparison, the same Case A scale as shown in Figure 10 is applied to the displacement time history plot of node 11 which is given in Figure 11.

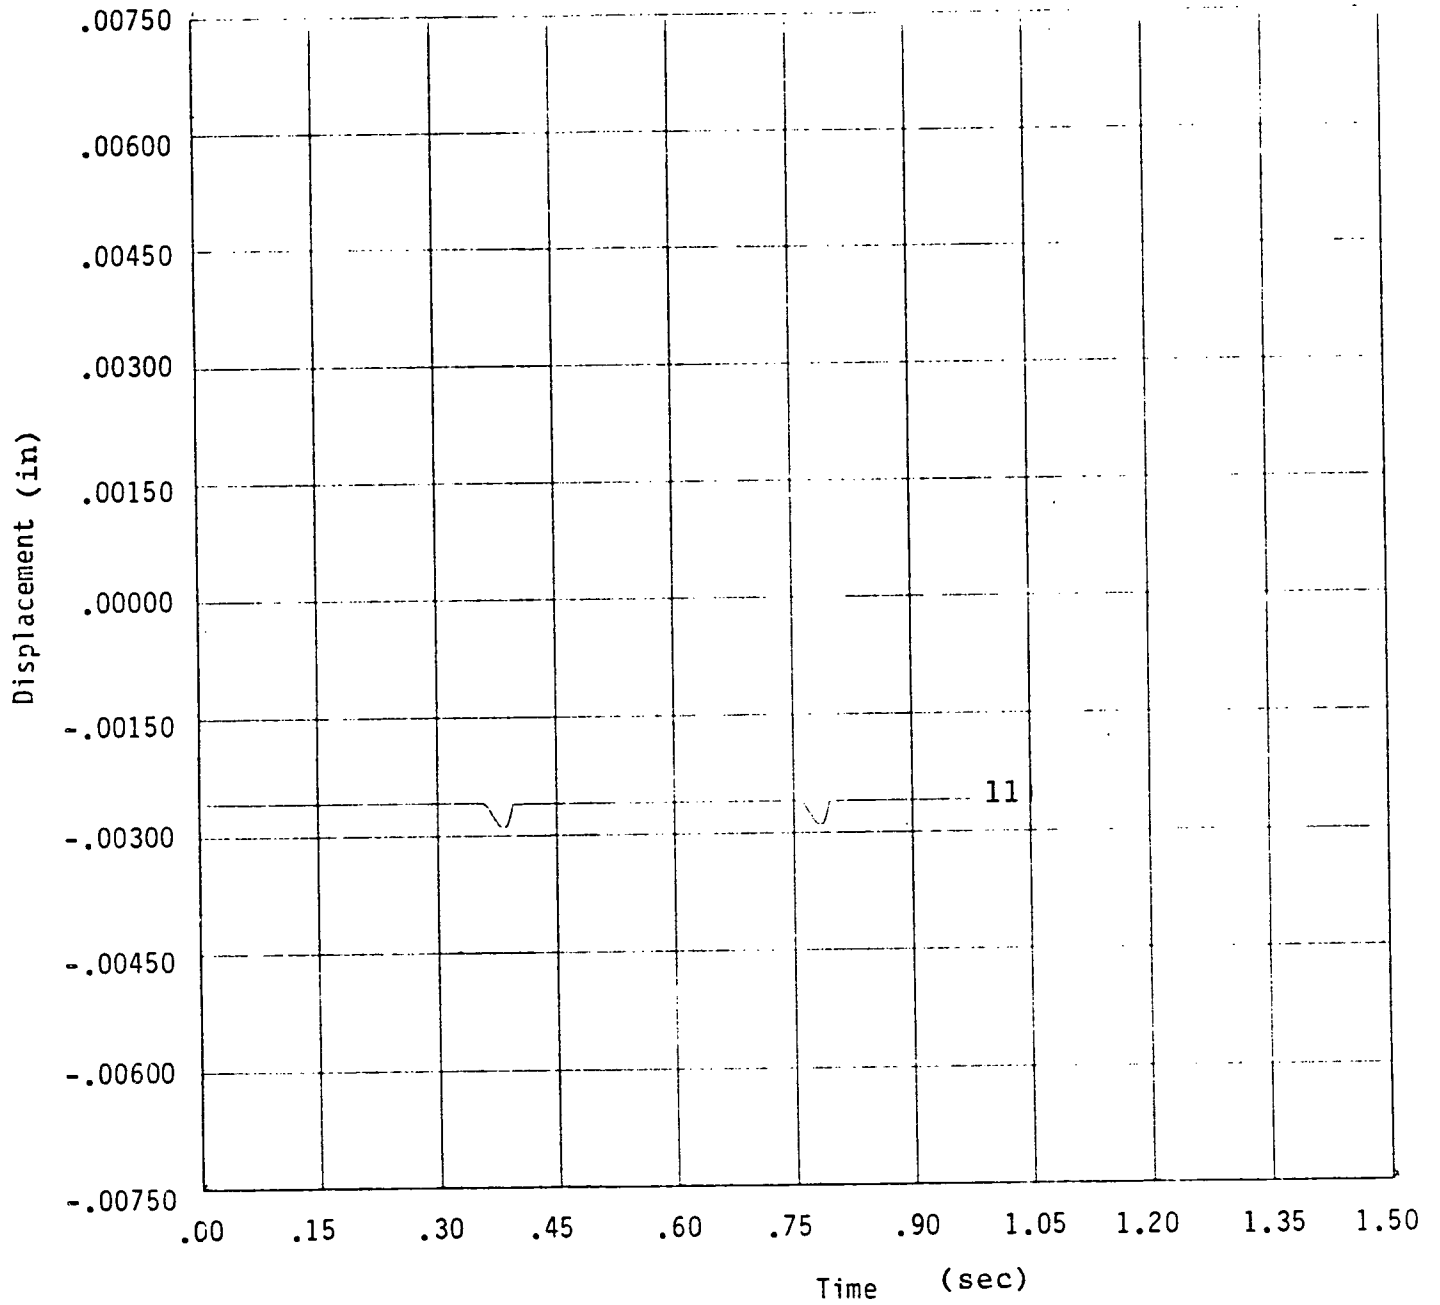
The displacement time history given in Figure 12 was plotted for node 11 using the same Case A scale.

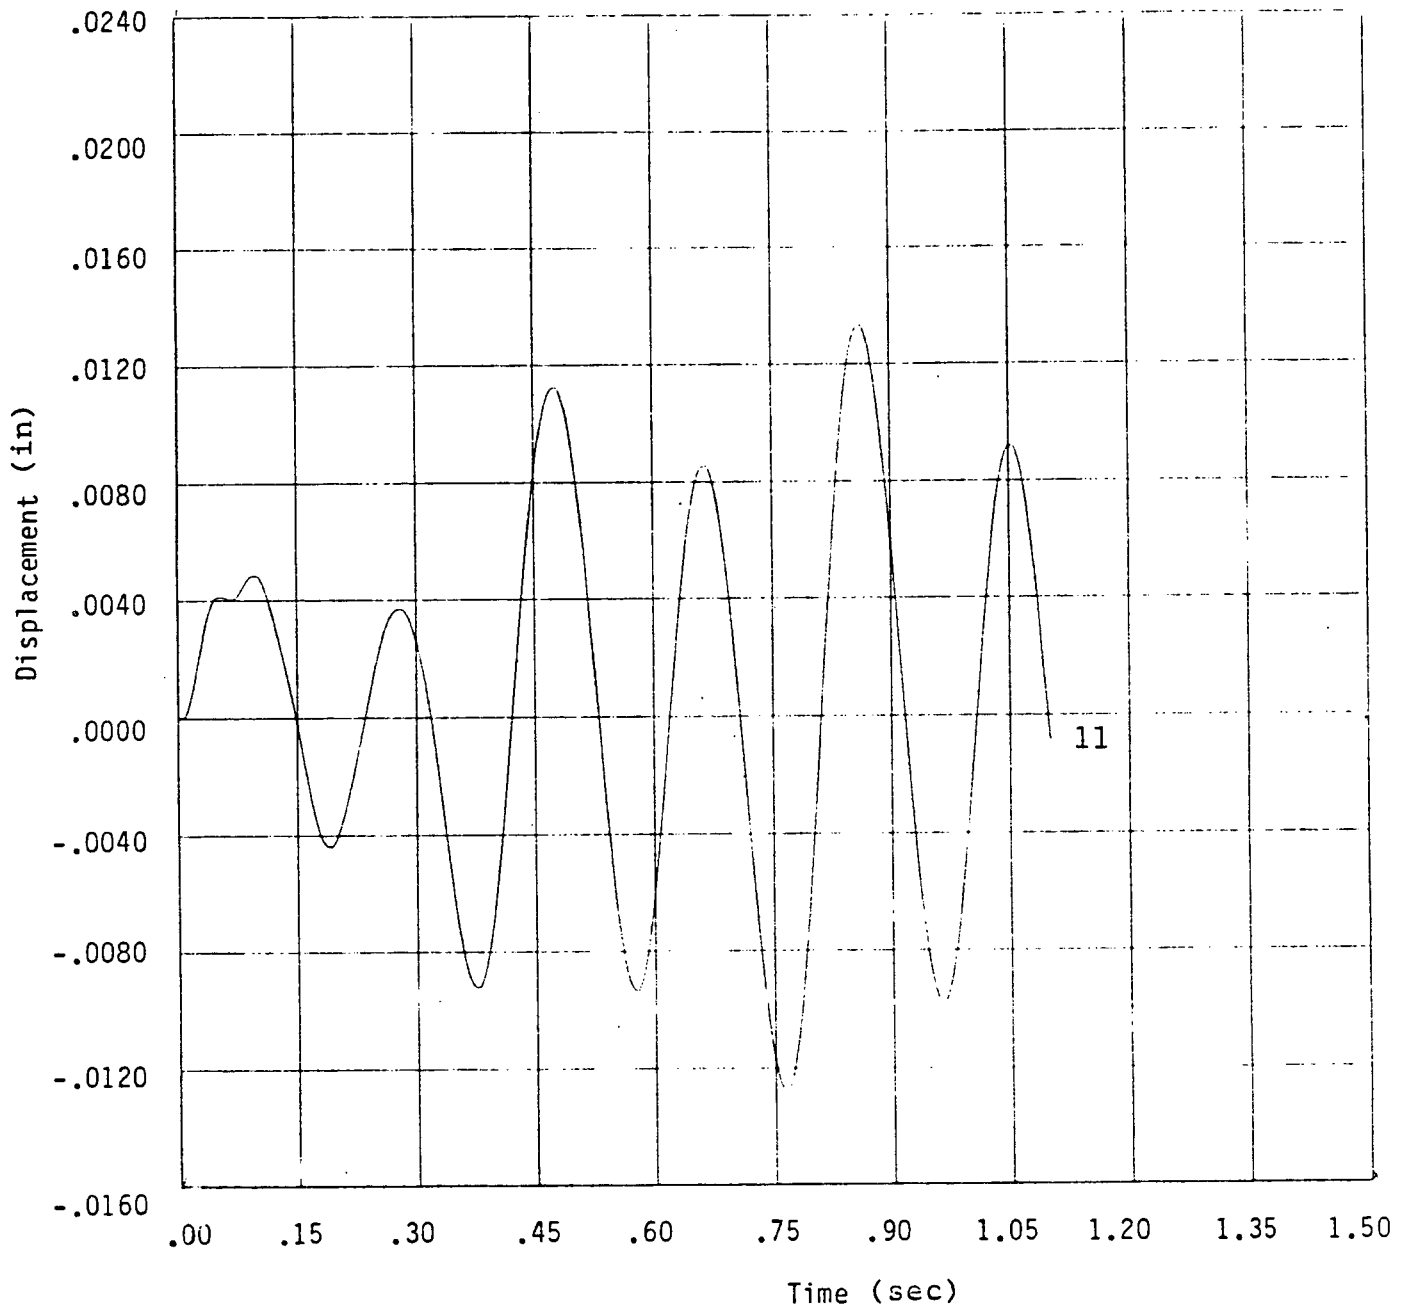
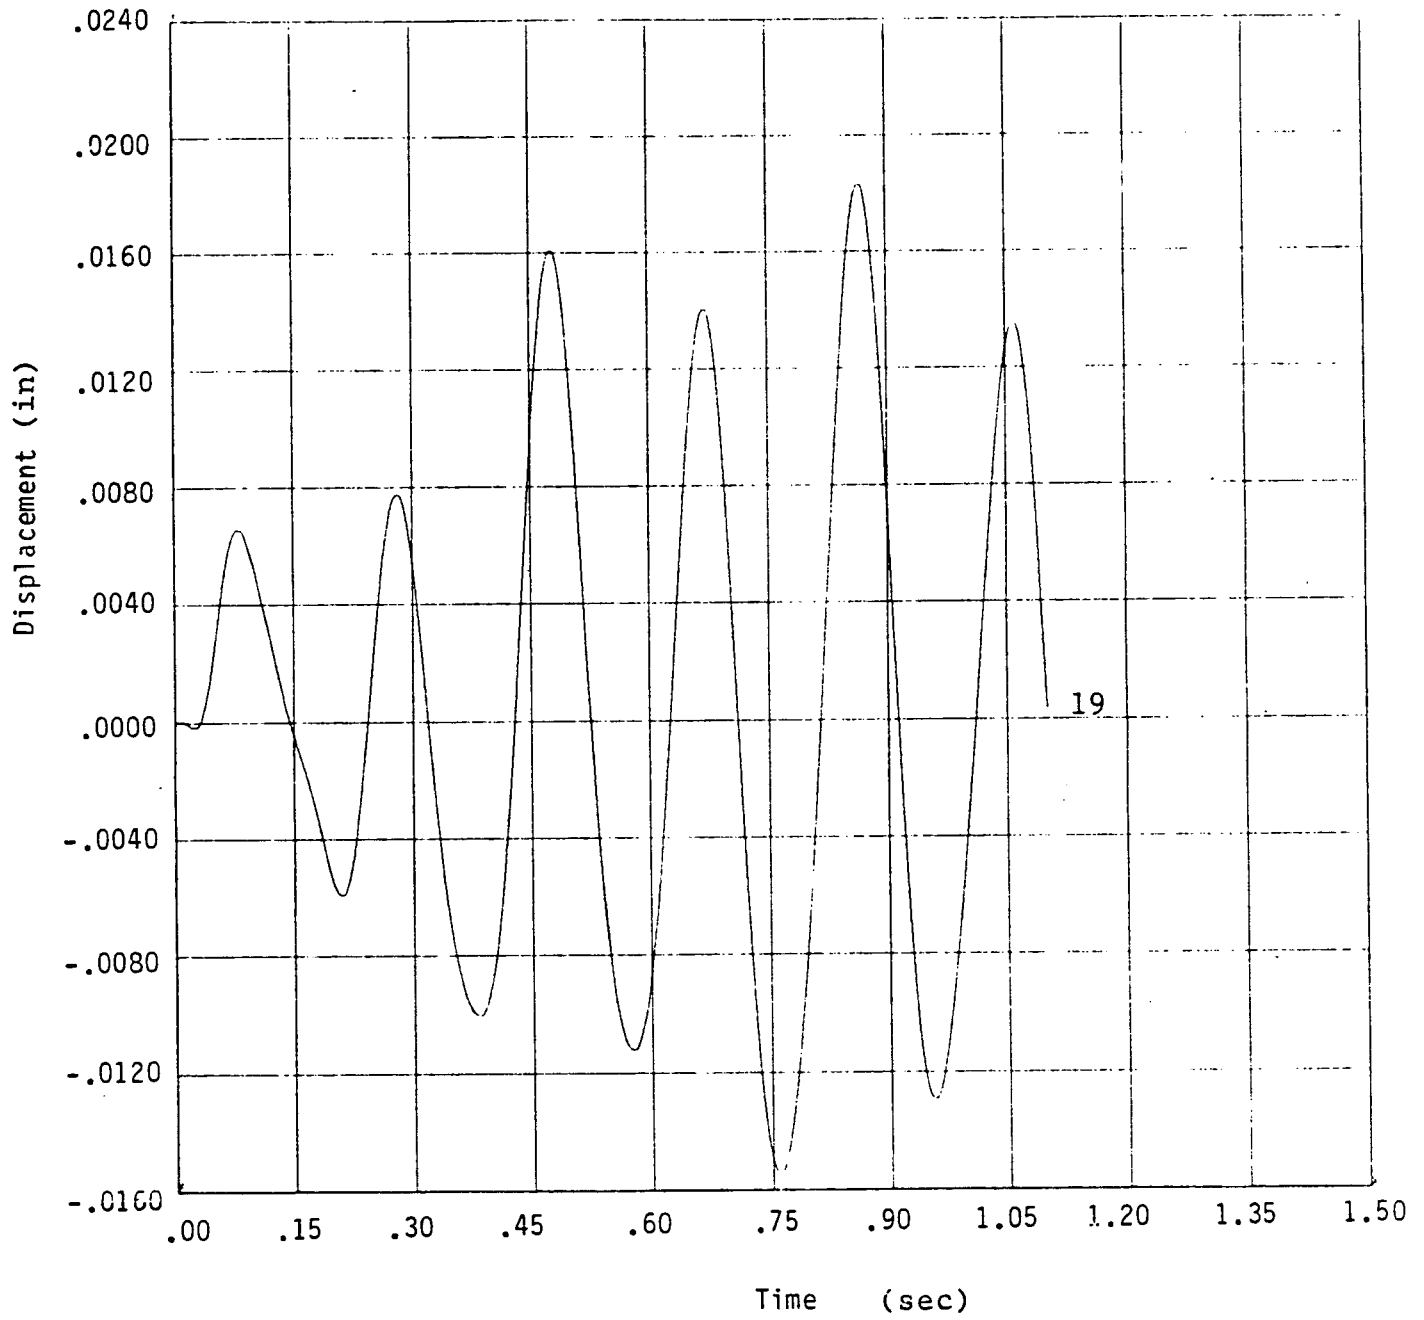
The displacement time history plots of the first and second TSP locations which correspond to nodes 11 and 19 are shown in Figures 13 and 14, respectively.

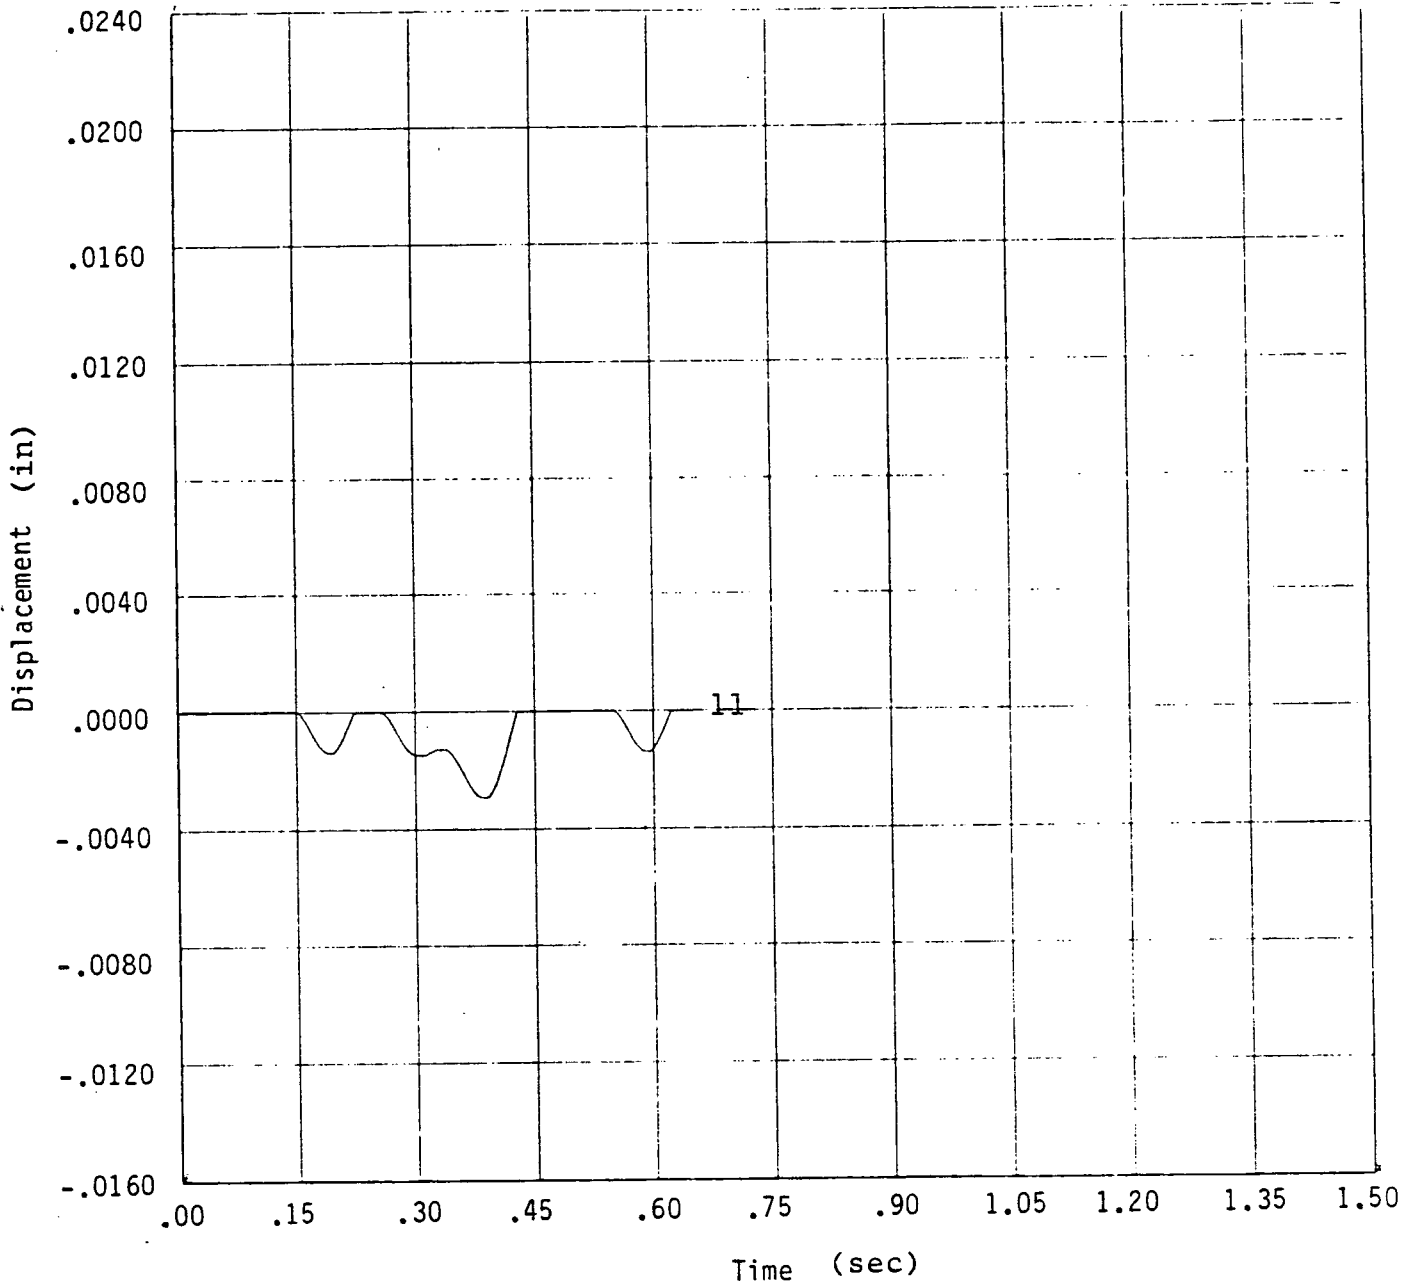
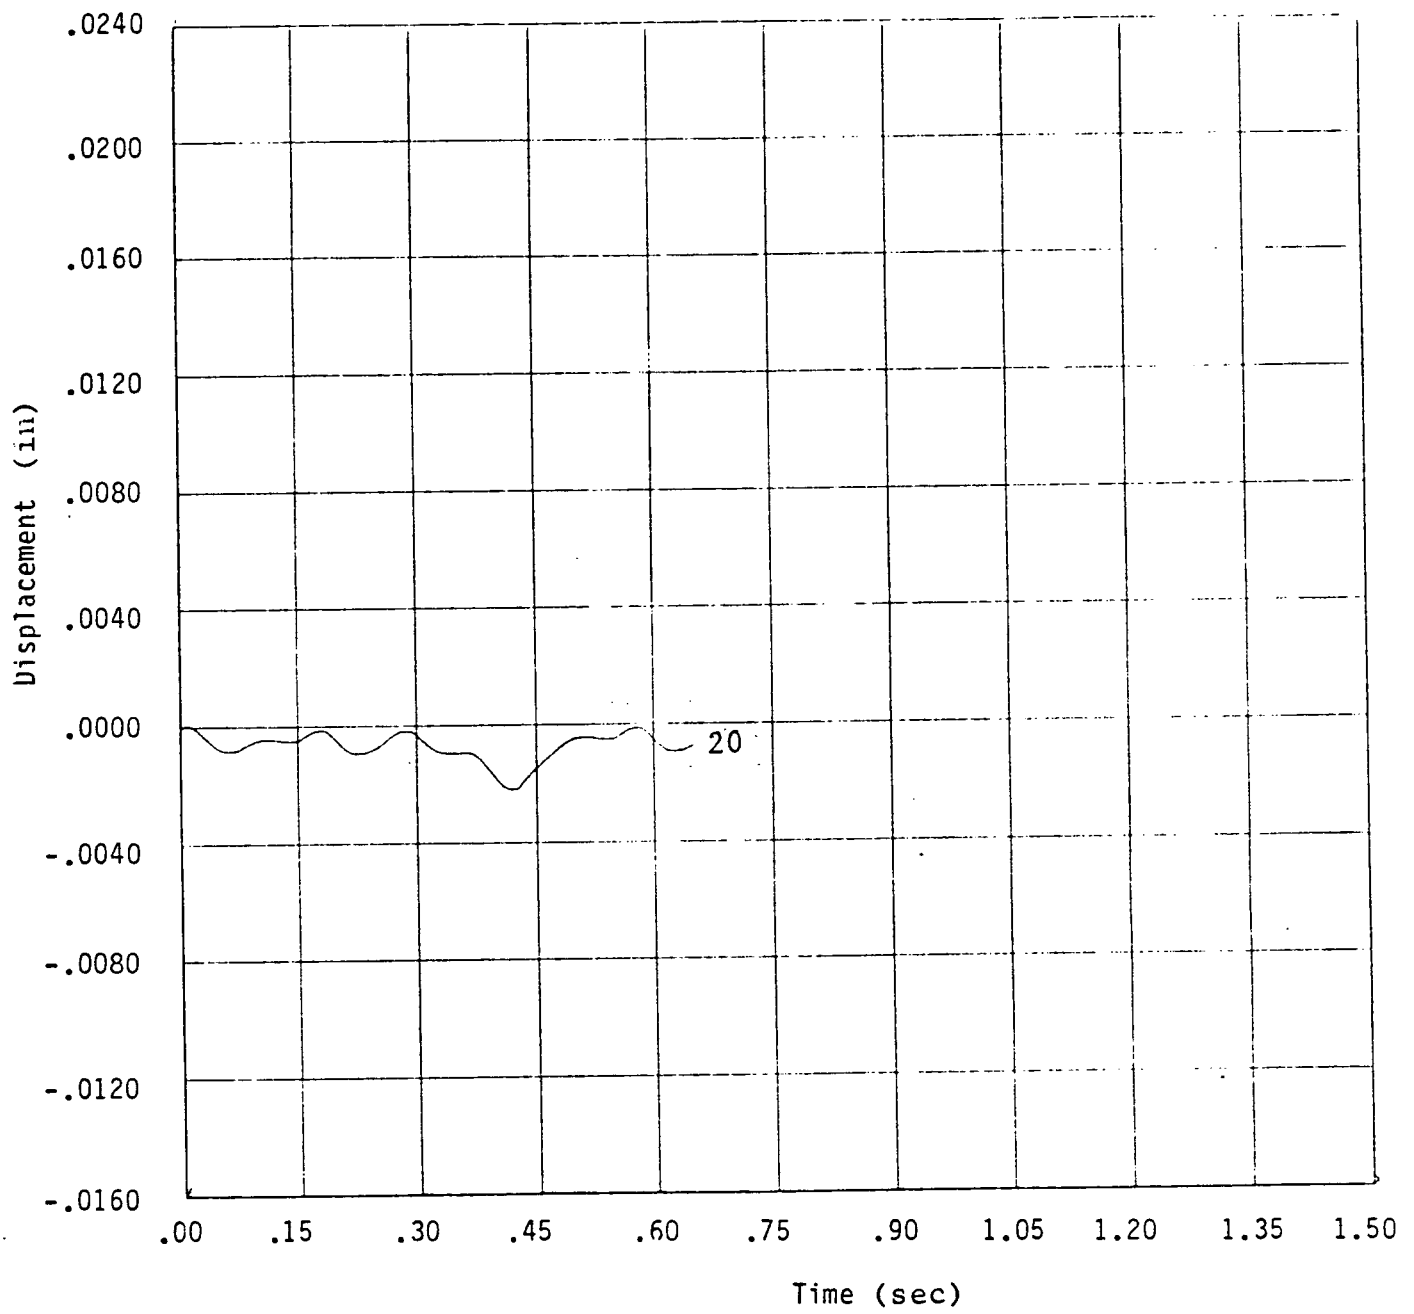
The displacement time histories were plotted for the two TSPs which correspond to nodes 11 and 20. These time histories used the same scale as Case C and are shown in Figures 15 and 16.

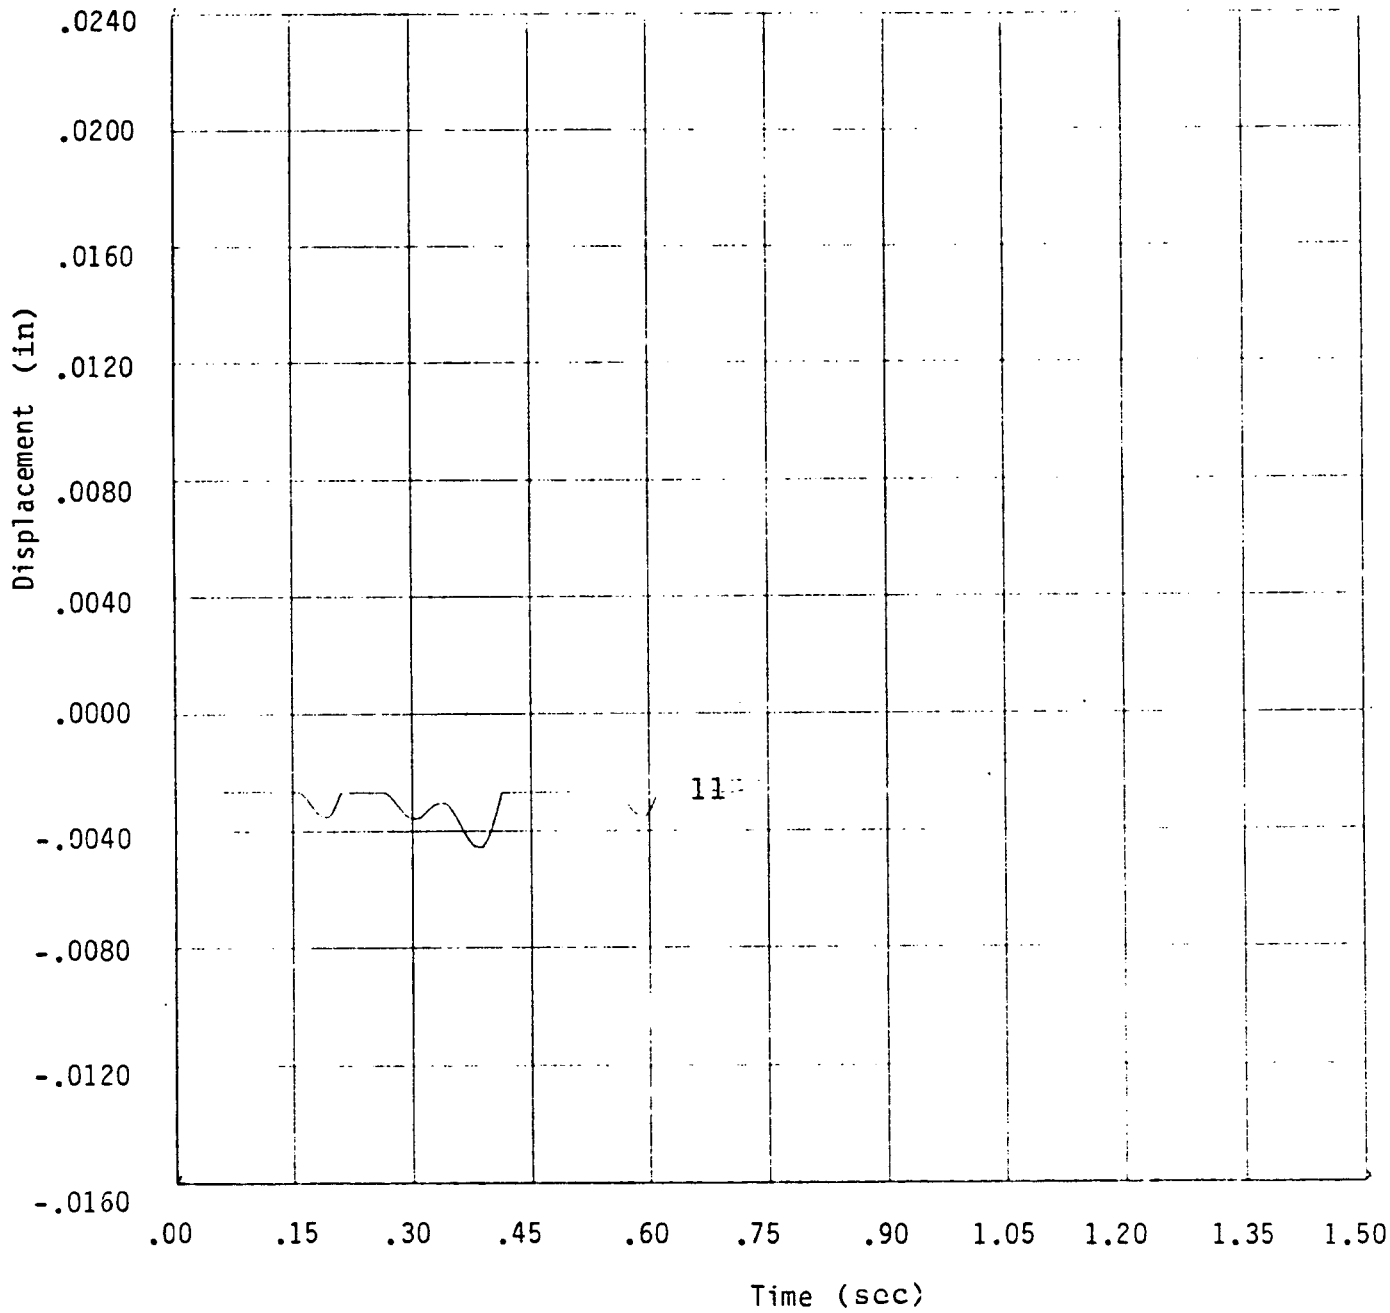
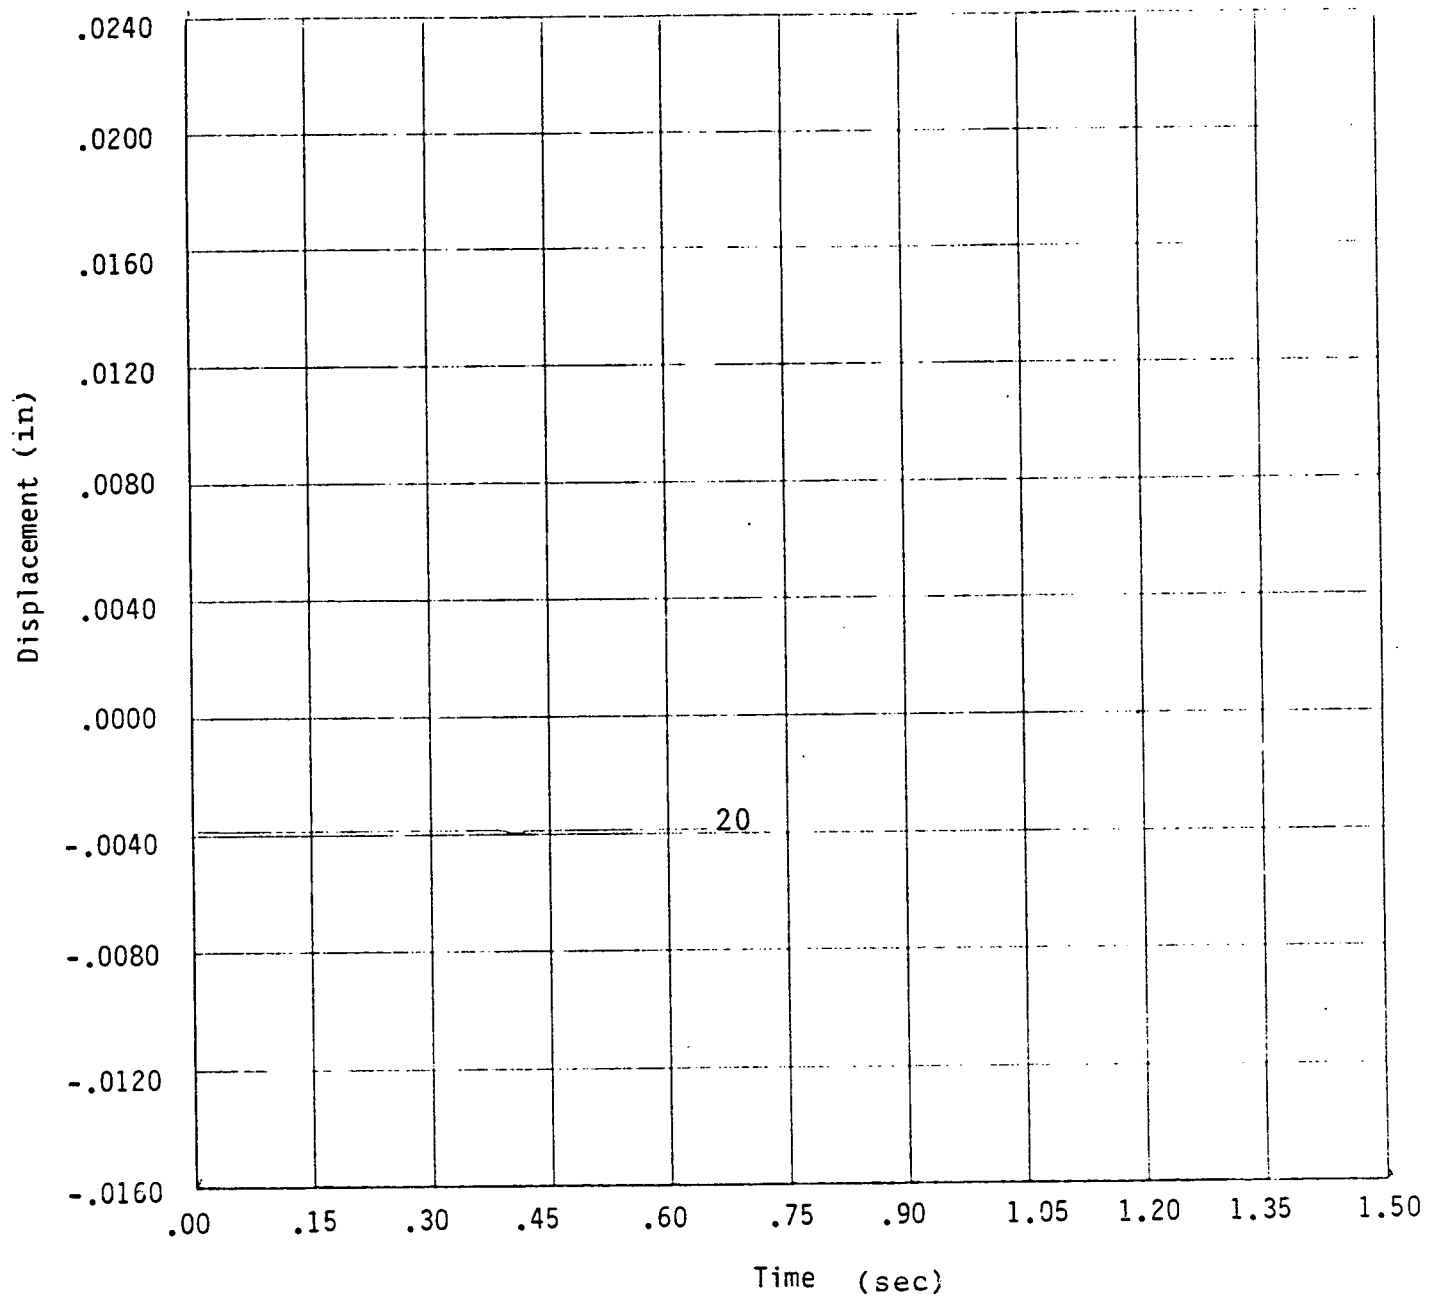
The displacement time histories of the TSPs were plotted using the same scale as Case C and are shown in Figures 17 and 18.

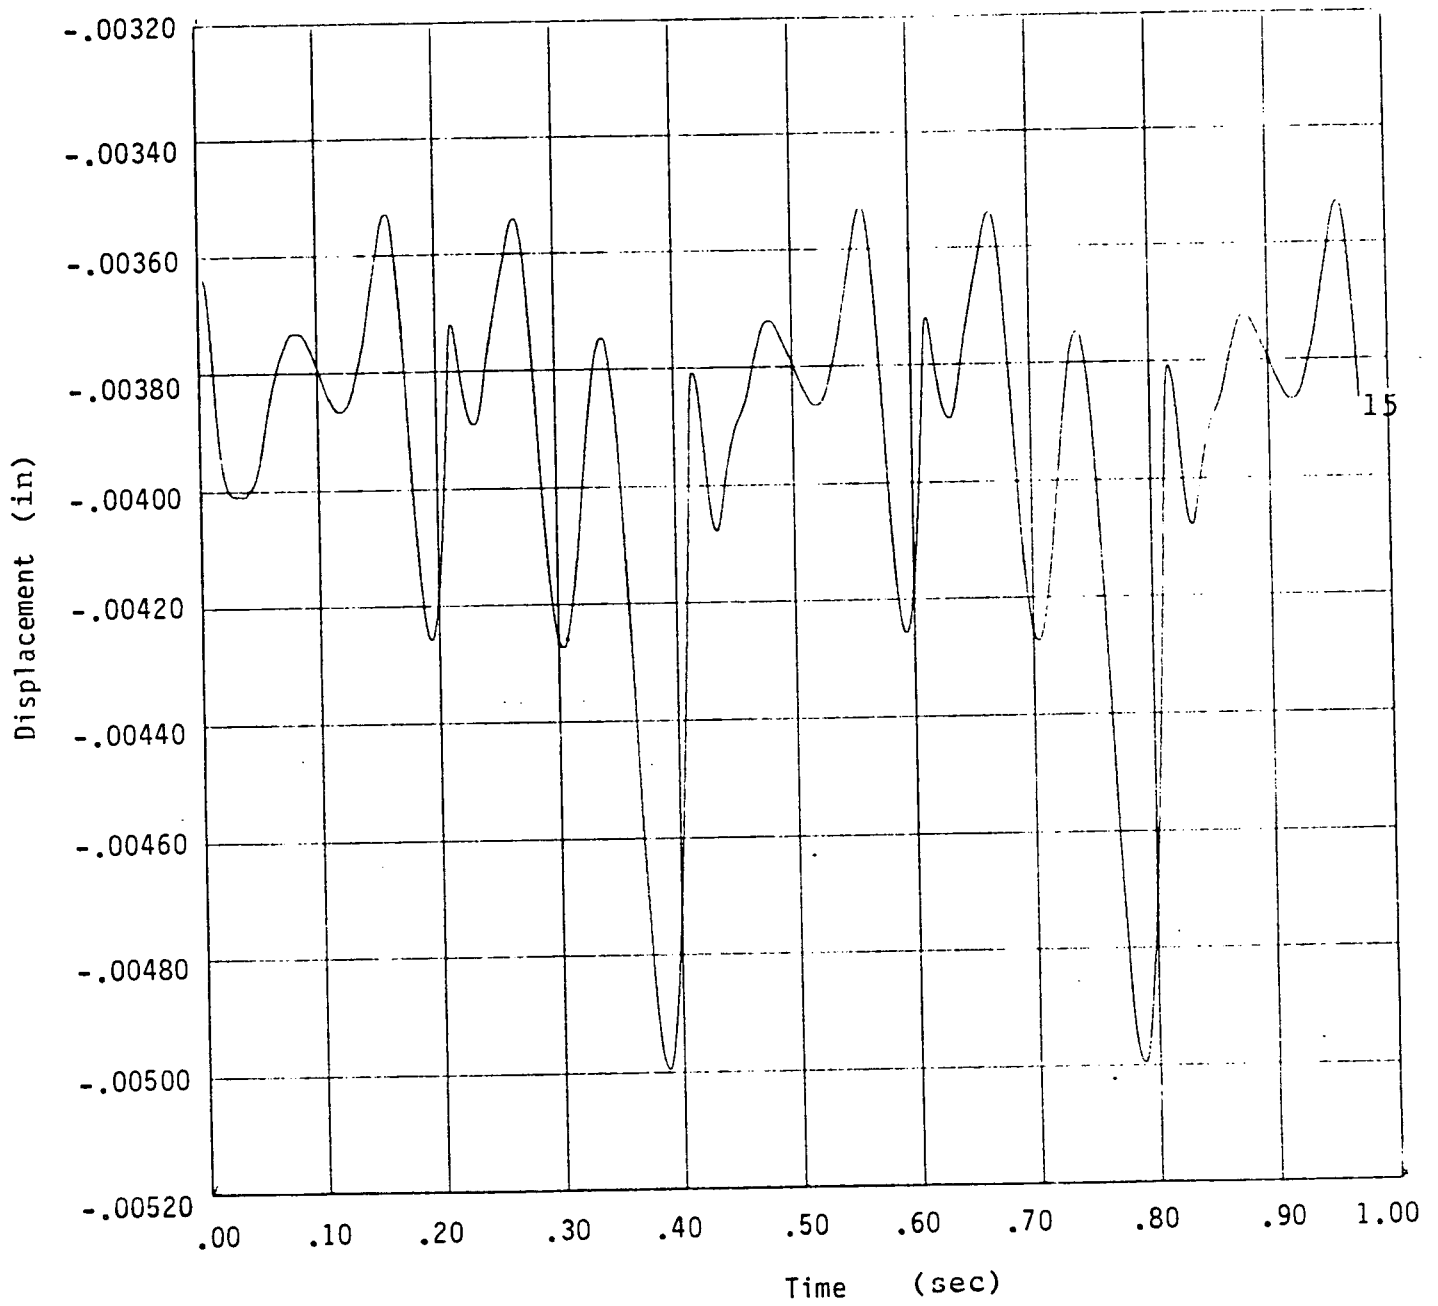
Figure 19  
 Dynamic Response of Node 15 for Case D with Lateral Load  
 During Normal Operation

For this case, the maximum negative displacement took place in node 15 as shown in Figure 19. This time history plot for node 15 provides a comparison with the time history plots of the TSPs shown in Figures 17 and 18.
