**Steam Generator Inspection Program  
Return to Power Report  
San Onofre Nuclear Generating Station  
Unit 1  
September, 1982  
Southern California Edison Company**

**Volume I**

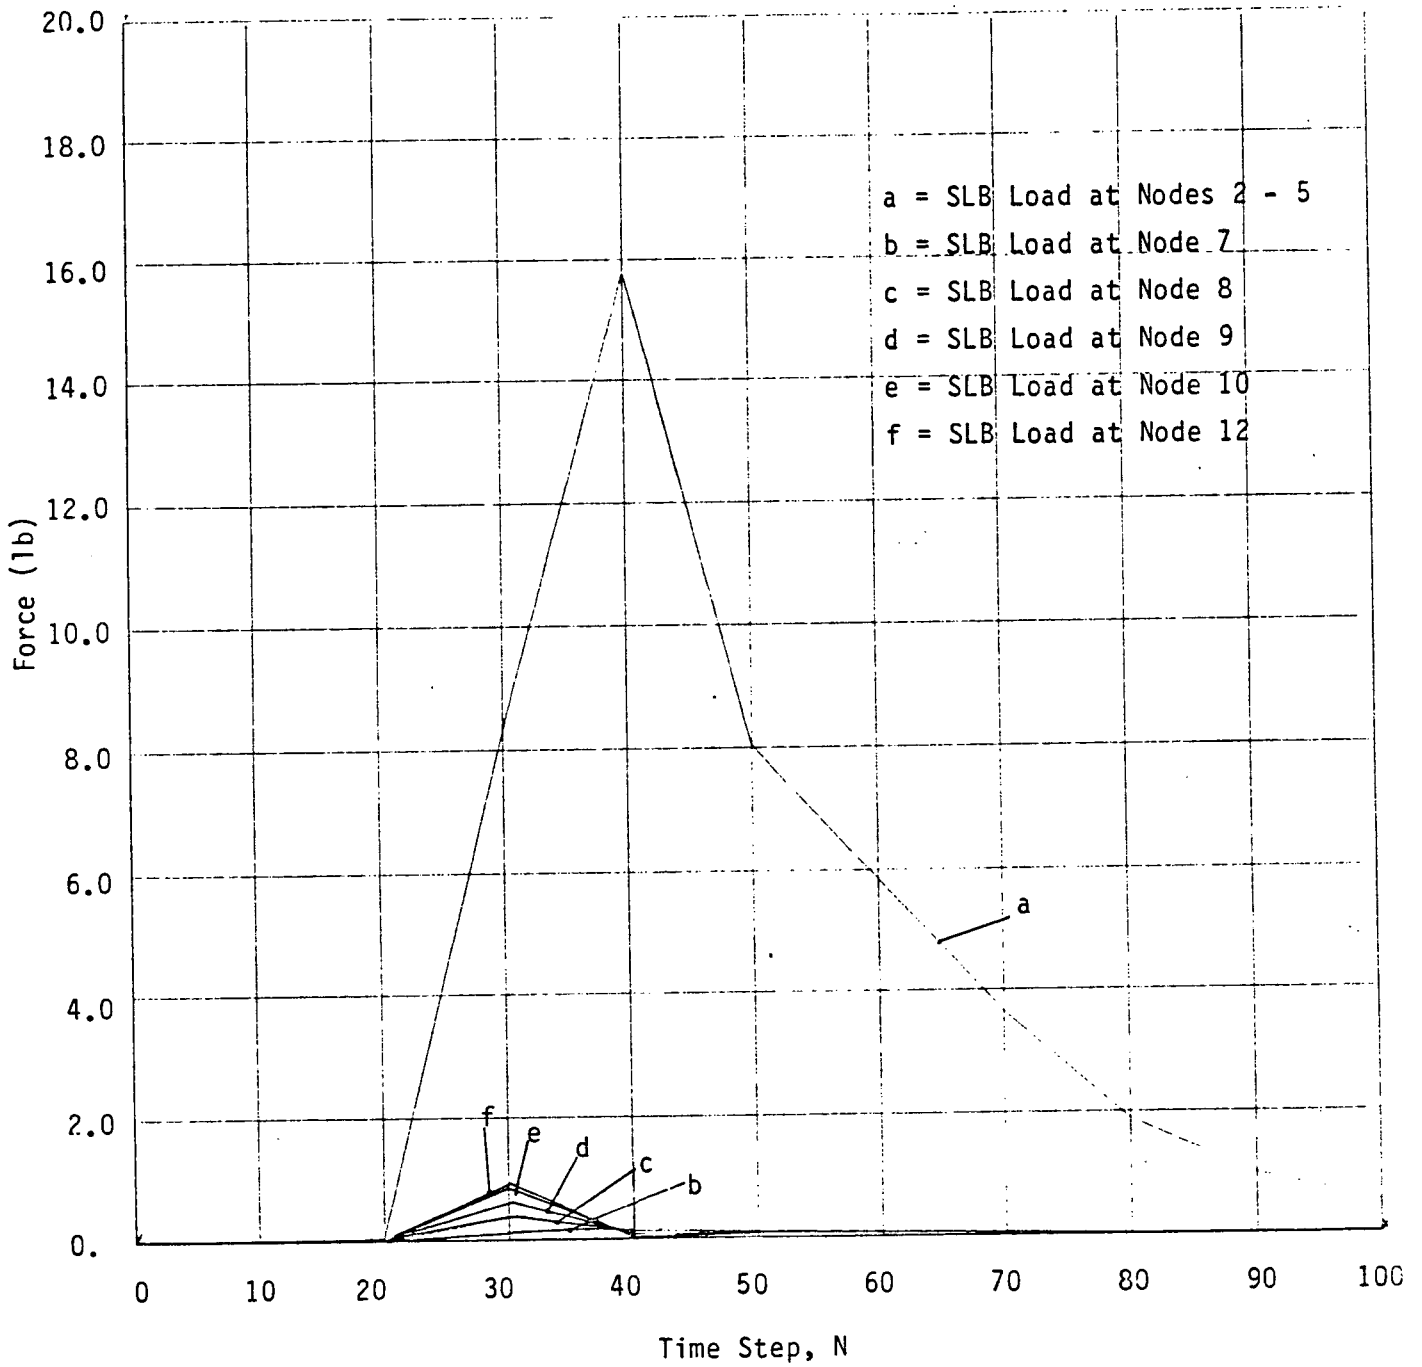
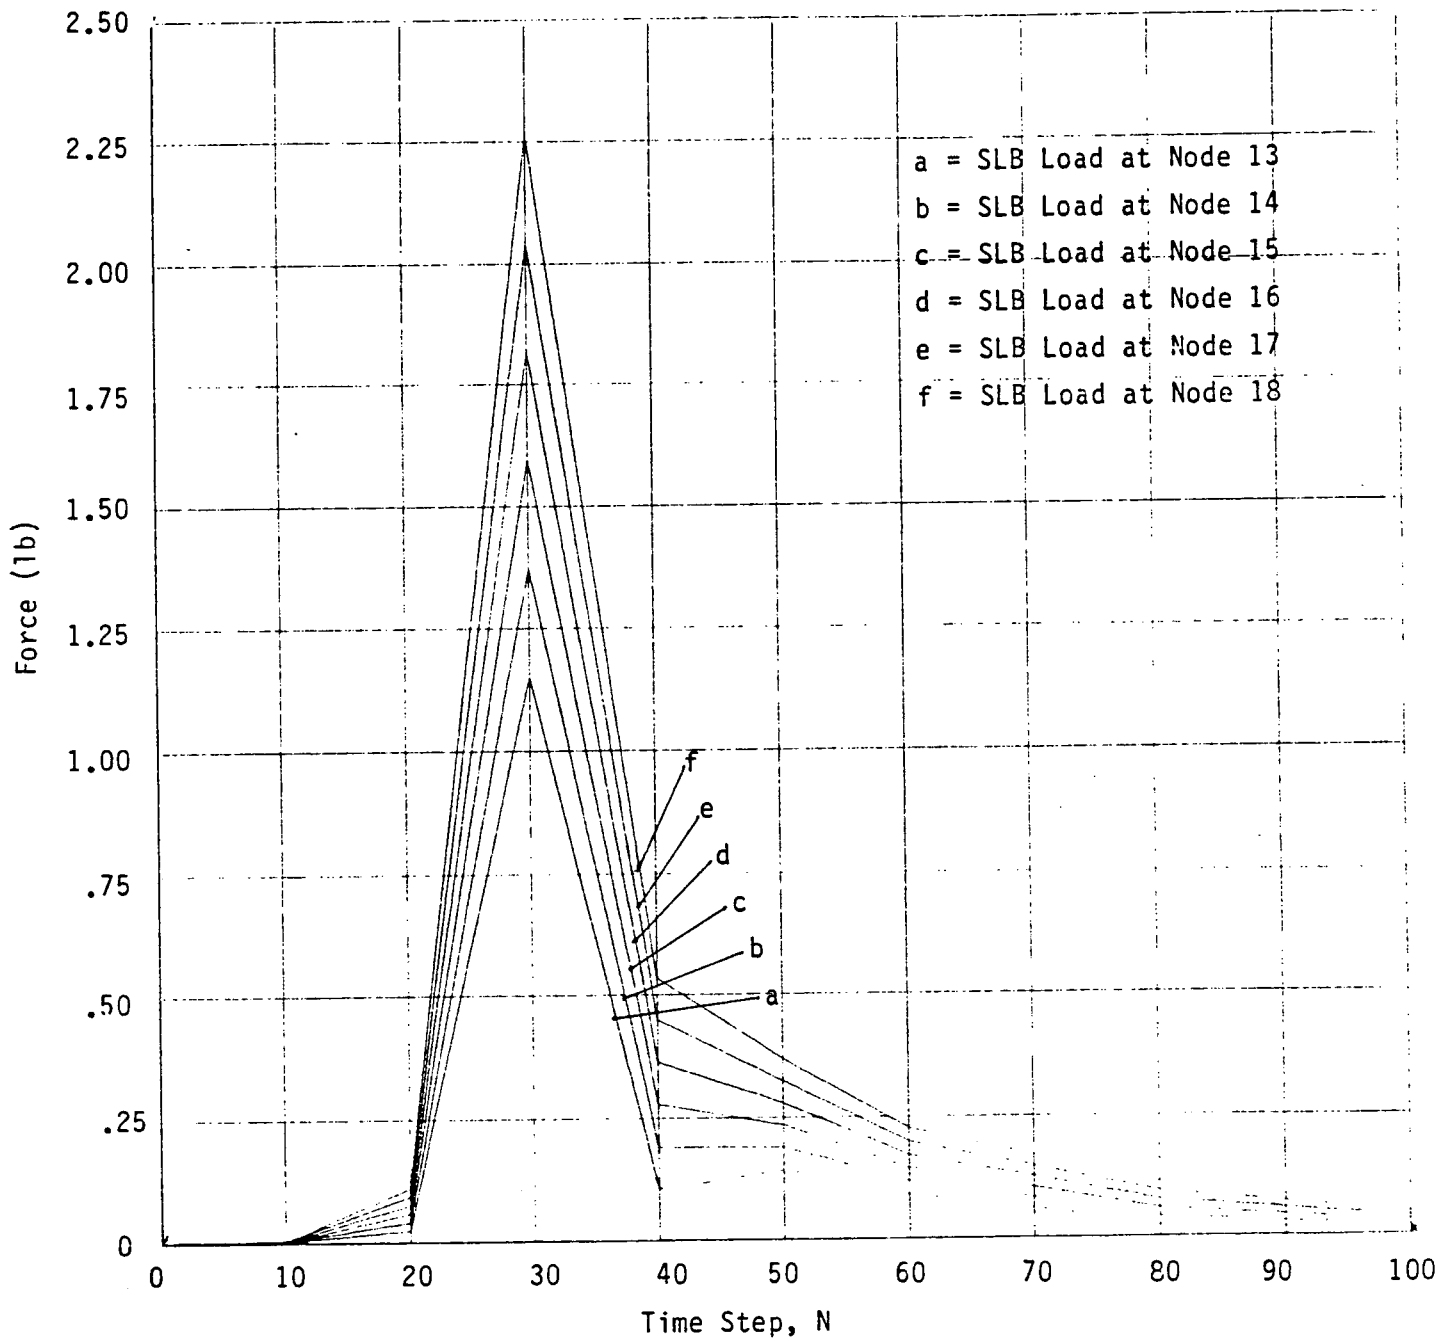
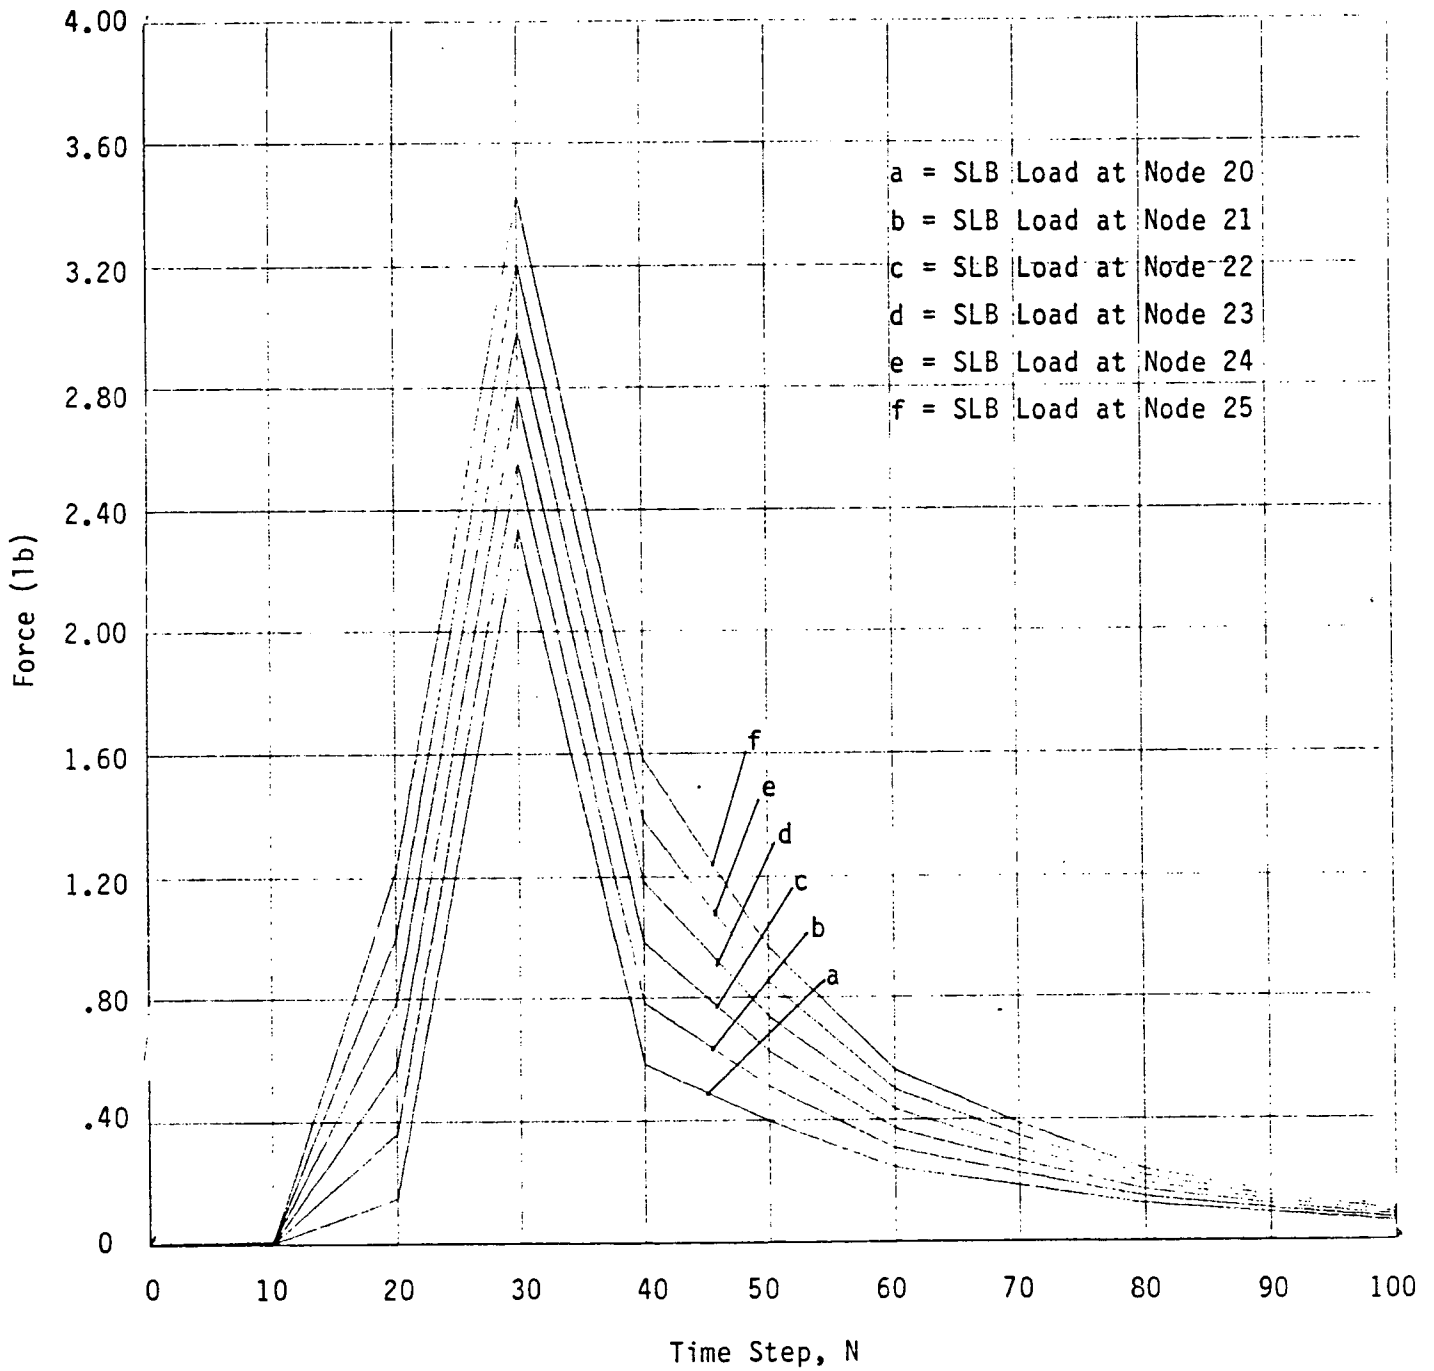
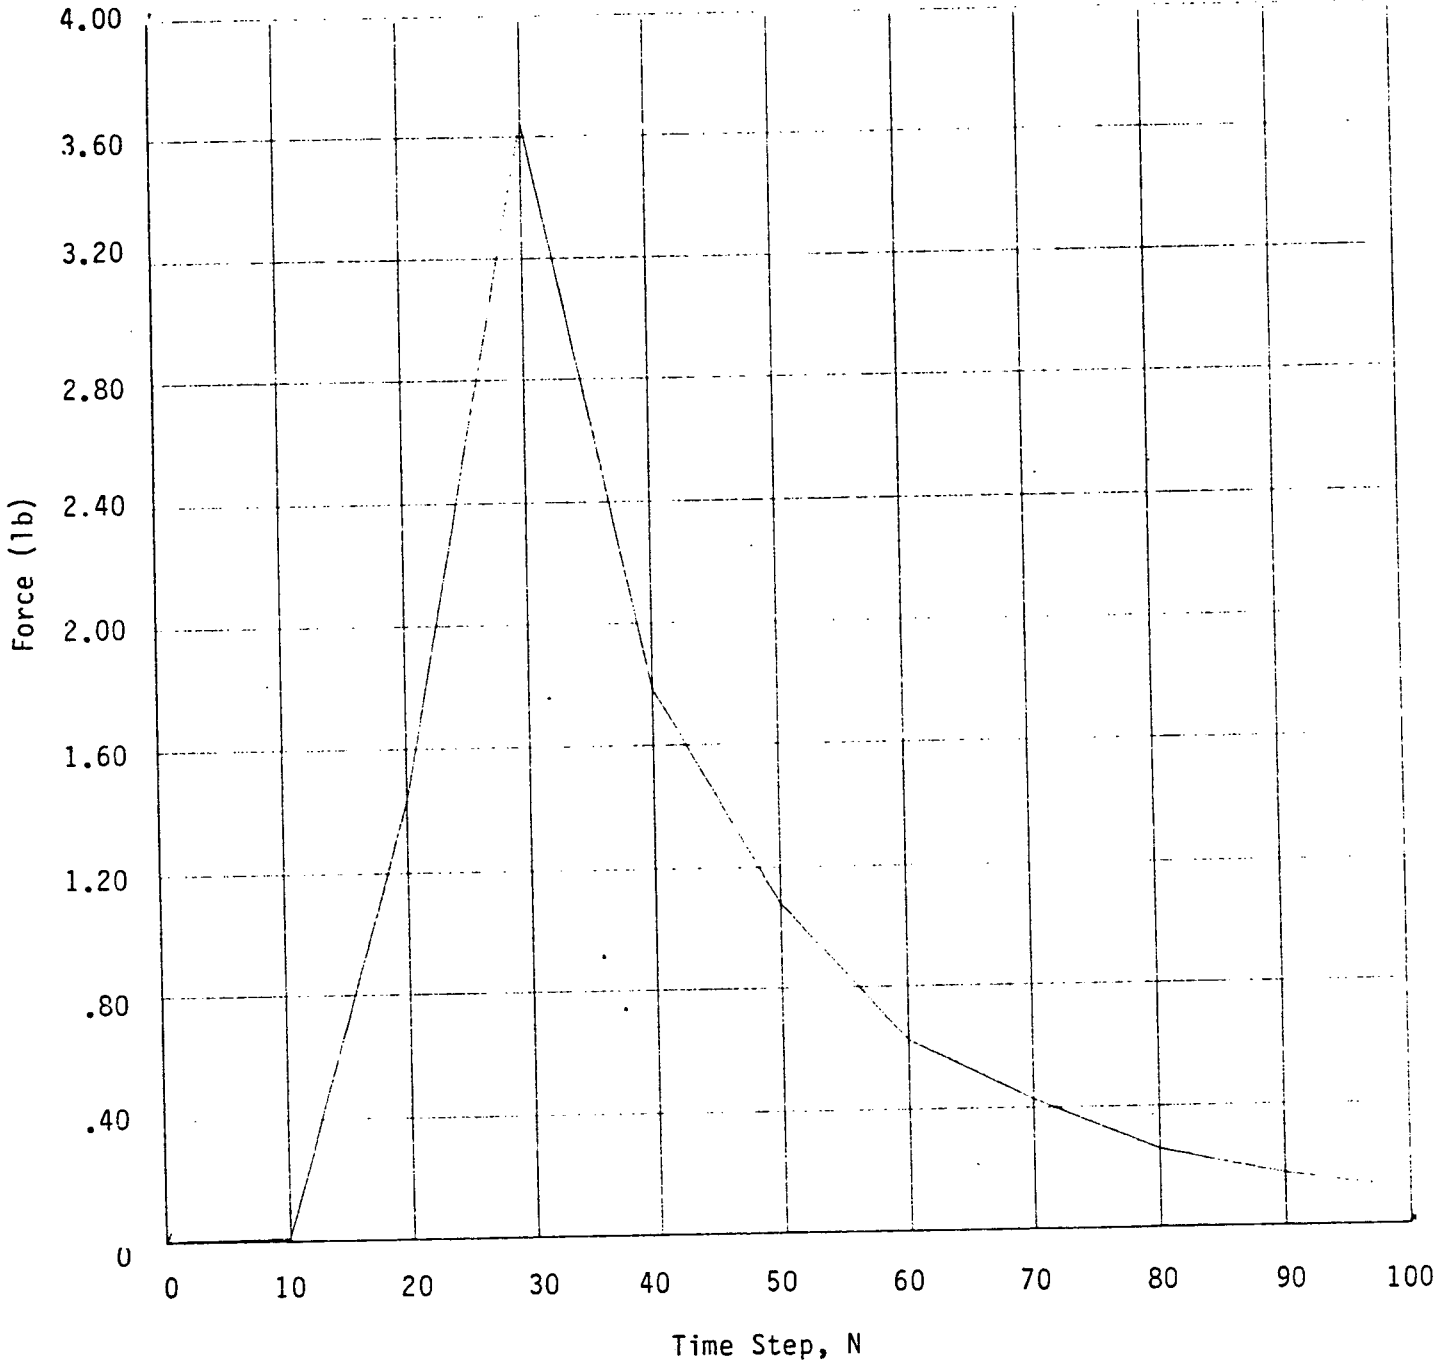
There are a total of 19 SLB loads and the forcing time step histories for Case E are shown in Figures 20, 21, 22 and 23 (see Table 6).

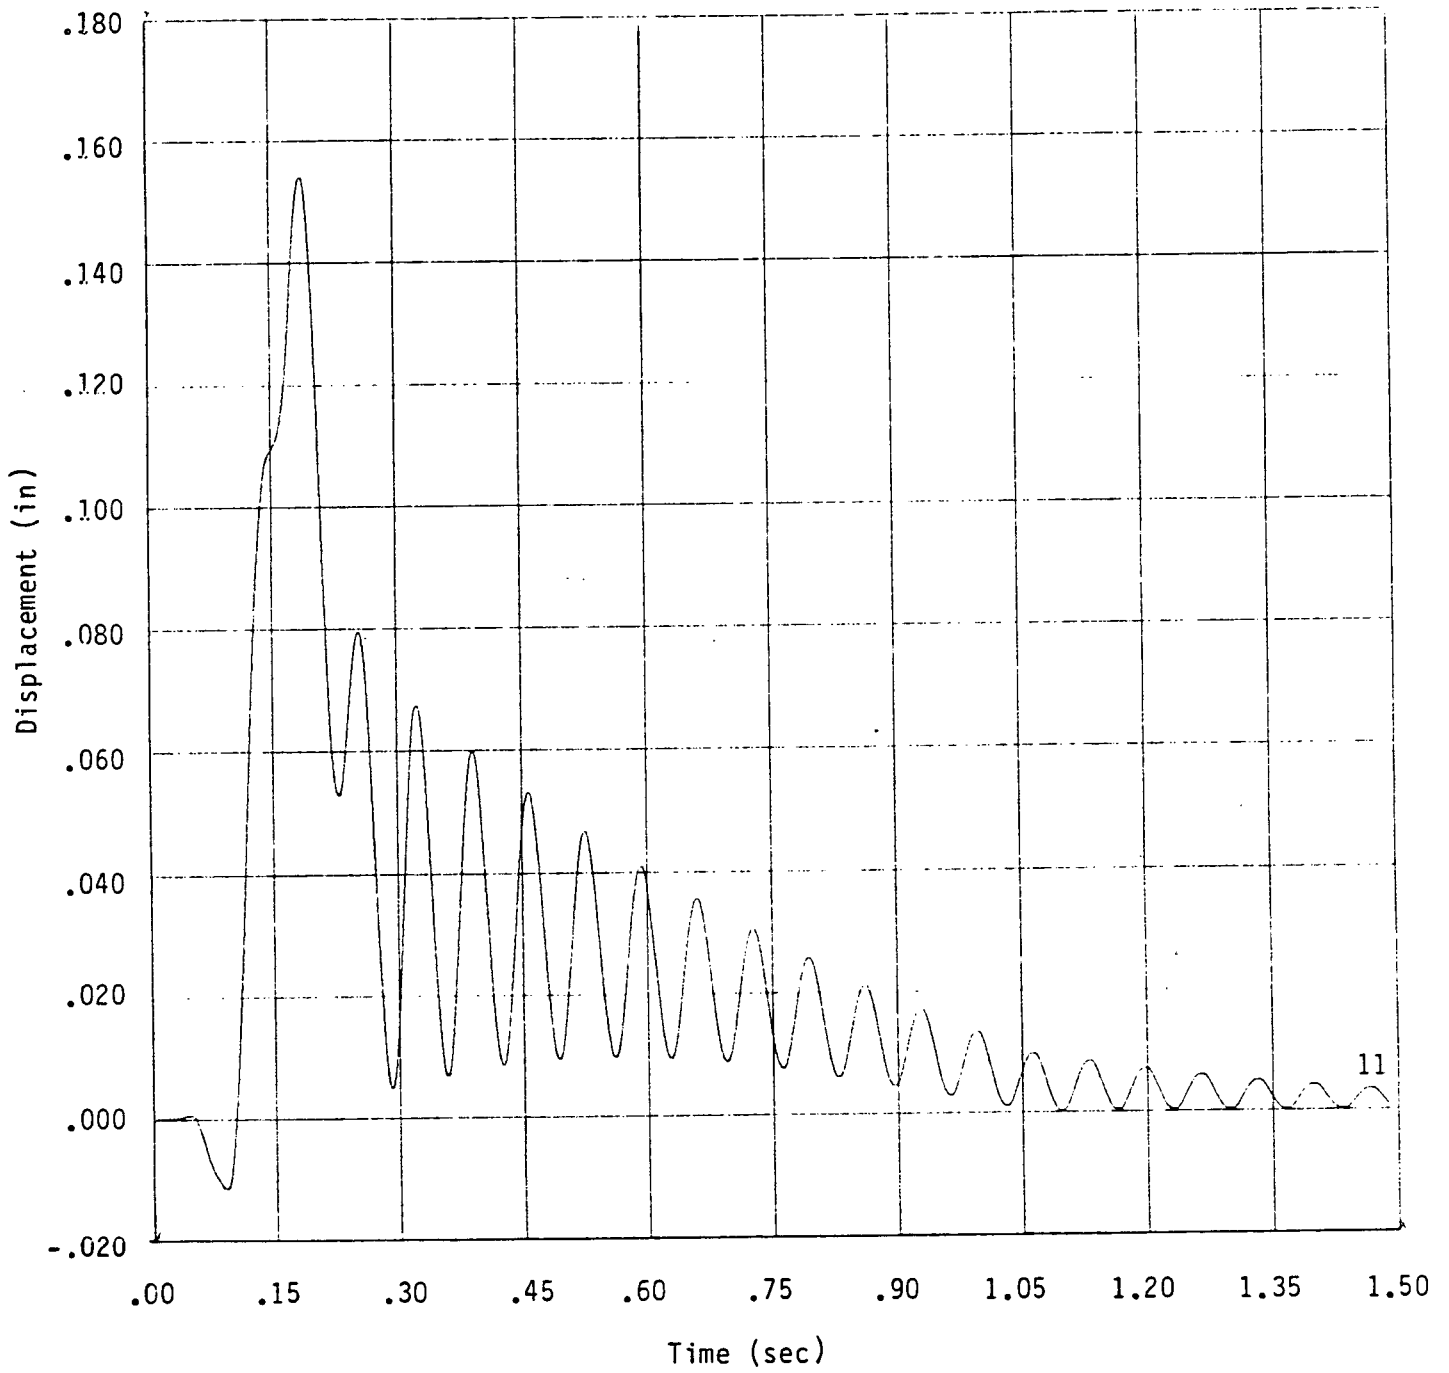
Figure 24  
 Dynamic Response of Node 11 for Case E in a SLB Accident

A plot of the displacement time history for node 11 is used as a reference for Case F and shown in Figure 24.

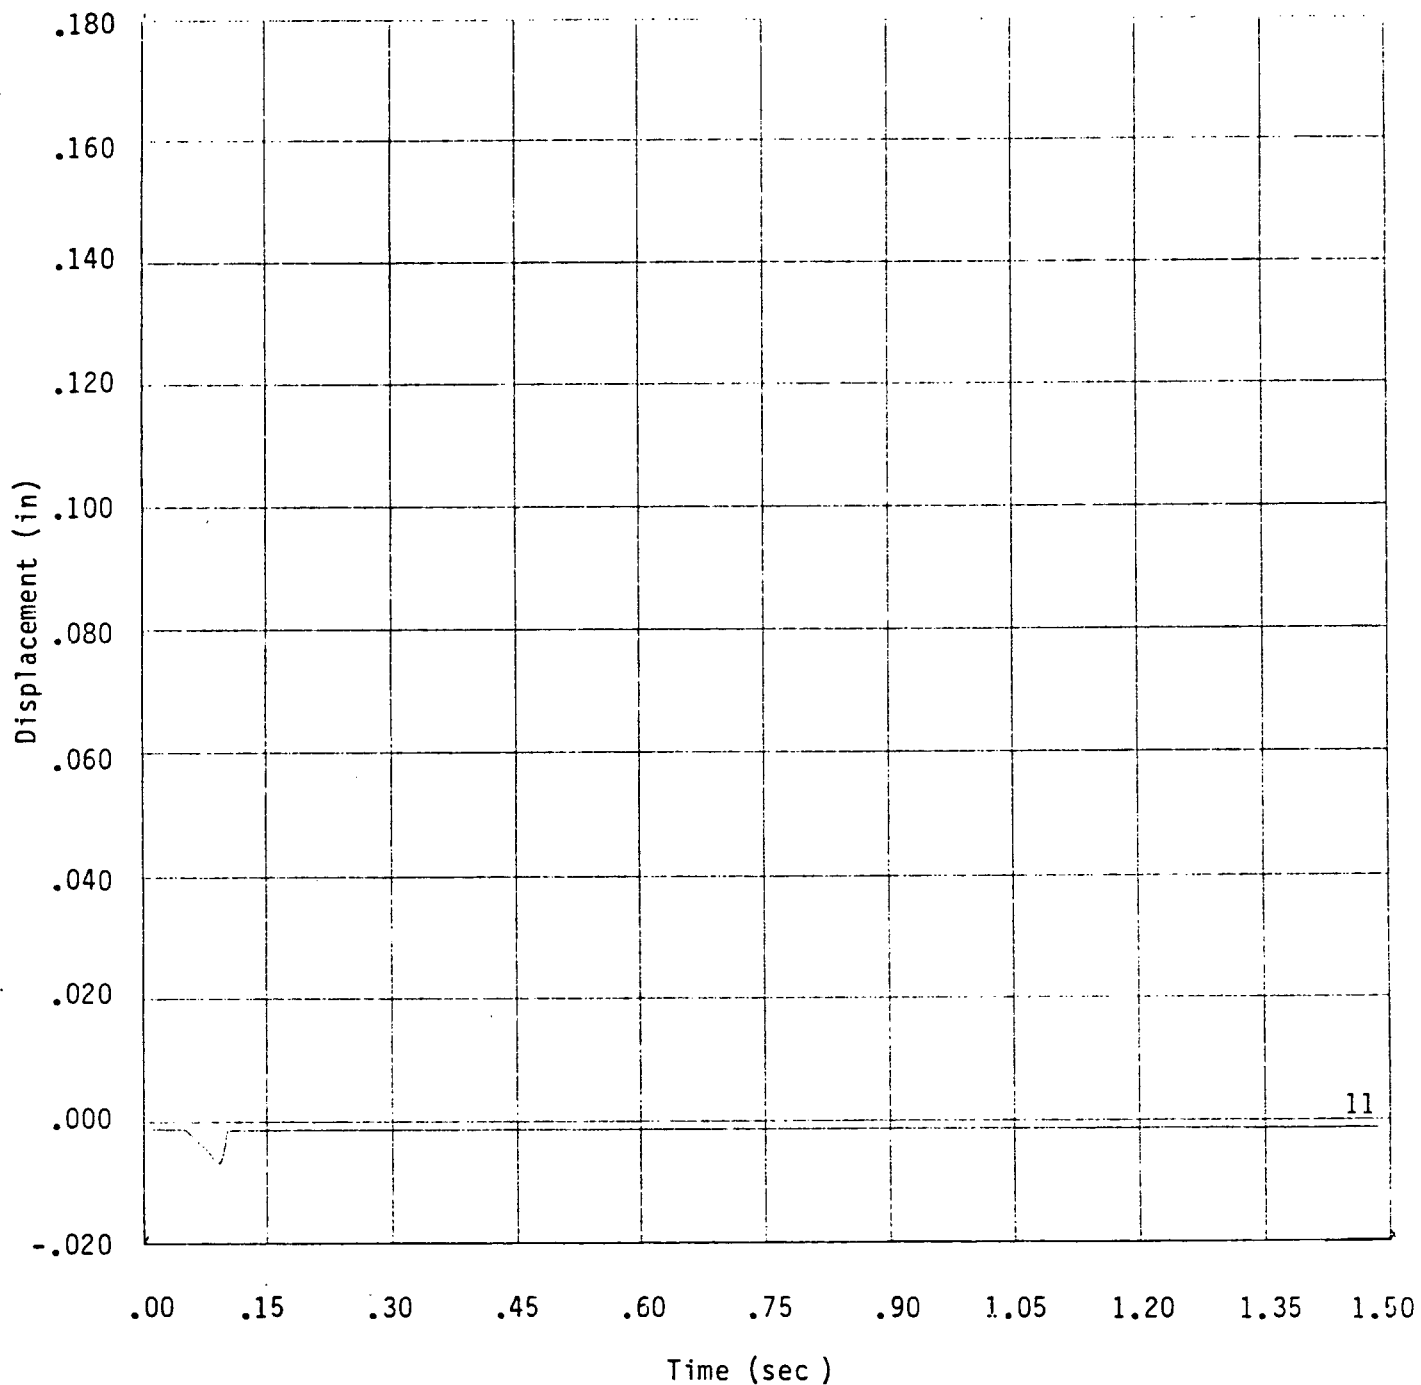
Figure 25  
 Dynamic Response of Node 11 (at first TSP) for  
 Case F with Lateral Load in a SLB Accident

The displacement time history given in Figure 25 was plotted for node 11 using the same Case E scale.

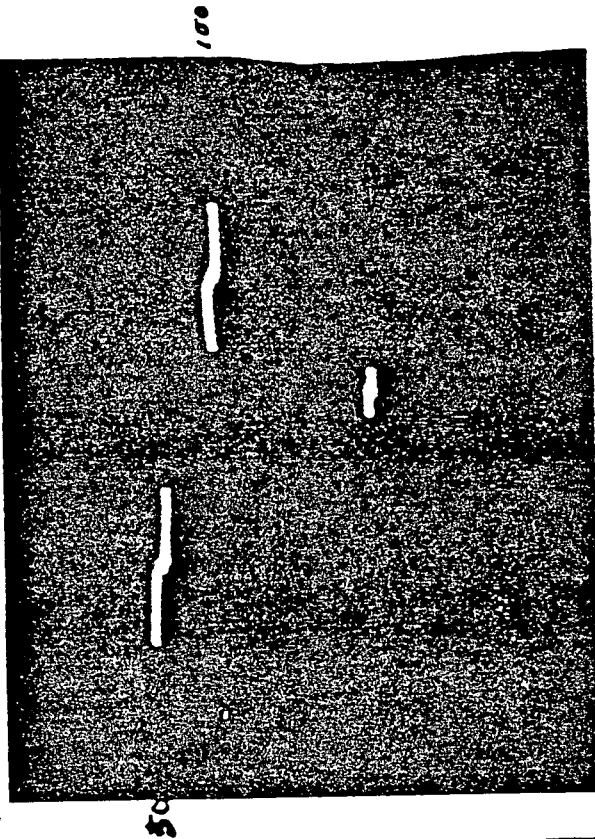
R7C18 BRAZE CONVERTED SLEEVE 5/81

From the simulations shown in Figures 4.2-2 and 4.2-3, it is concluded that the signals found in the transition region of the sleeves installed at Unit 1 are consistent in eddy current response with the presence of magnetite in the annulus between the sleeve and the tube at the transition.

FIGURE 4.2-1 A COMPARISON OF THE EDDY CURRENT RESPONSE OF FOUR MECHANICAL JOINTS IN UNIT I S/G C FROM THE 2/81 AND 3/82 INSPECTIONS. DATA WAS OBTAINED AT [ a,b,c ]

4V/D SIGNAL AT TOP OF 20 UPPER MECH. EXP.

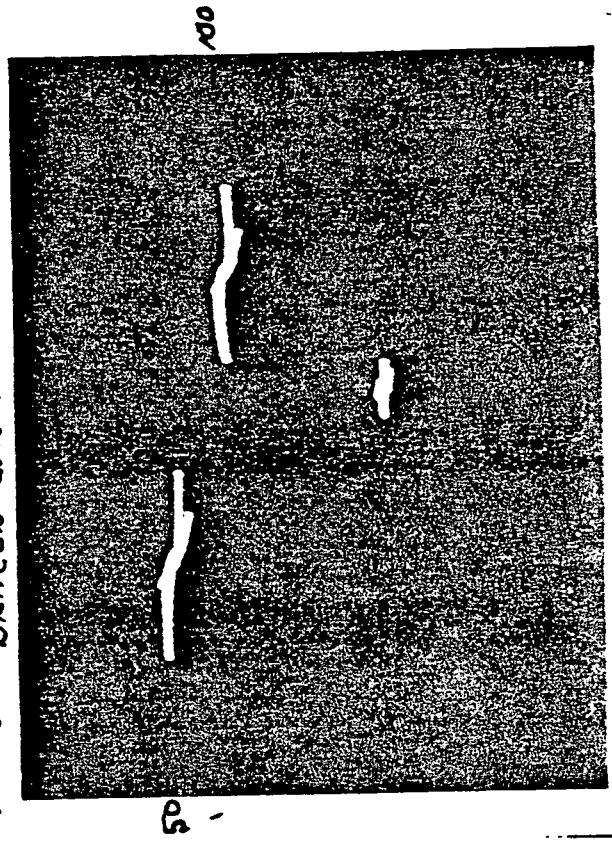
R7C21 BRAZED CONV. SLEEVE 5/81

4V/D SIGNAL AT TOP OF 20 UPPER MECH EXP.

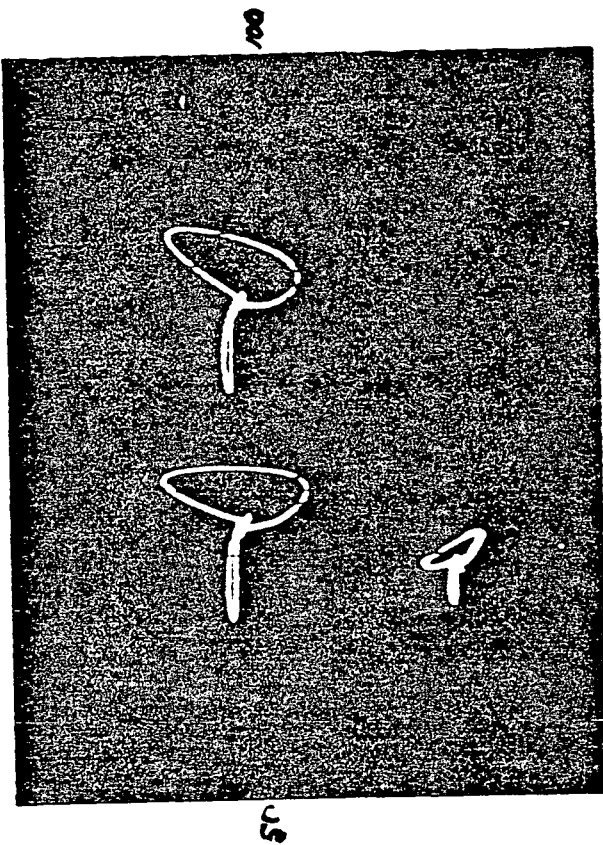
R7C18 BRAZED CONVERTED SLEEVE 1982

4V/D 25 SIGNAL AT TOP OF UPPER MECH. EXP.

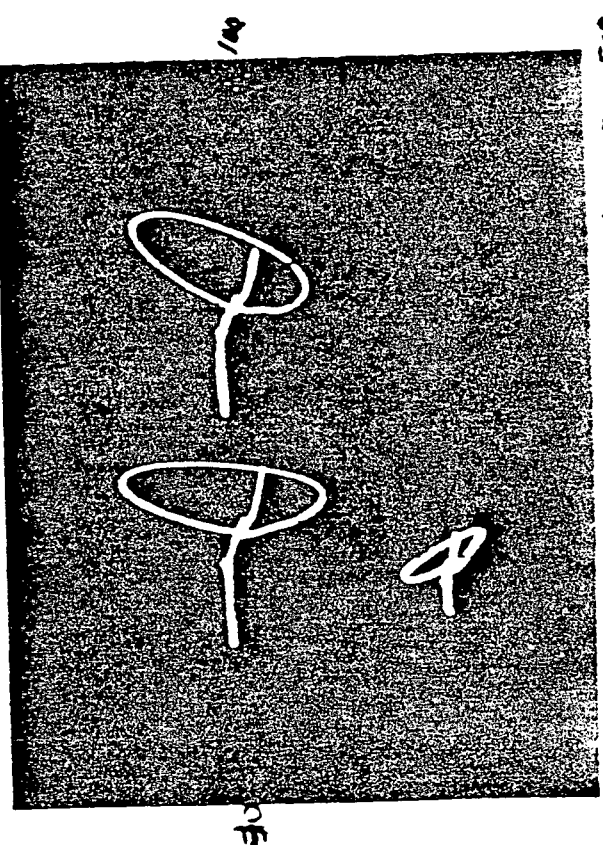
R7C21 BRAZED CONVERTED SLEEVE 1982

4V/D 25 SIGNAL AT TOP OF UPPER MECH EXP.

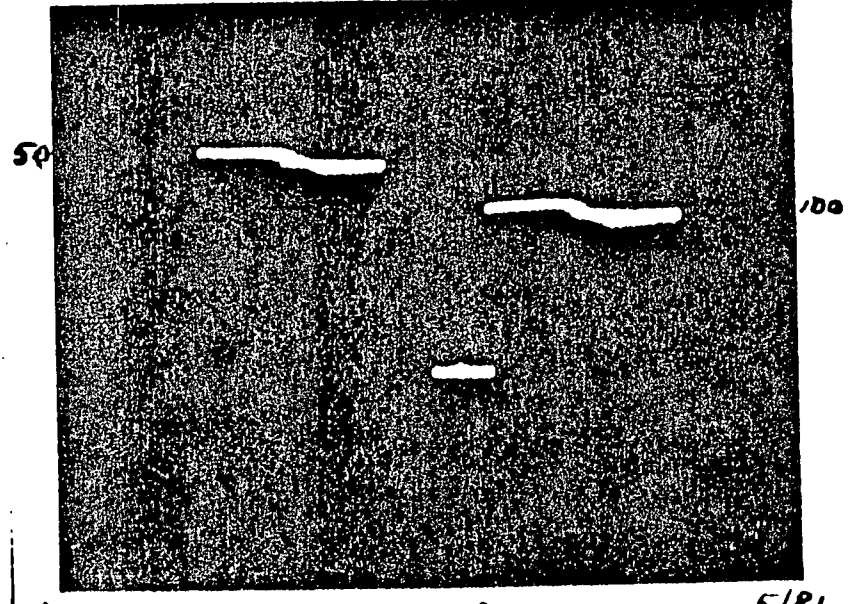
R19C75

SIGNAL AT UPPER TRANS. UPPER EXP

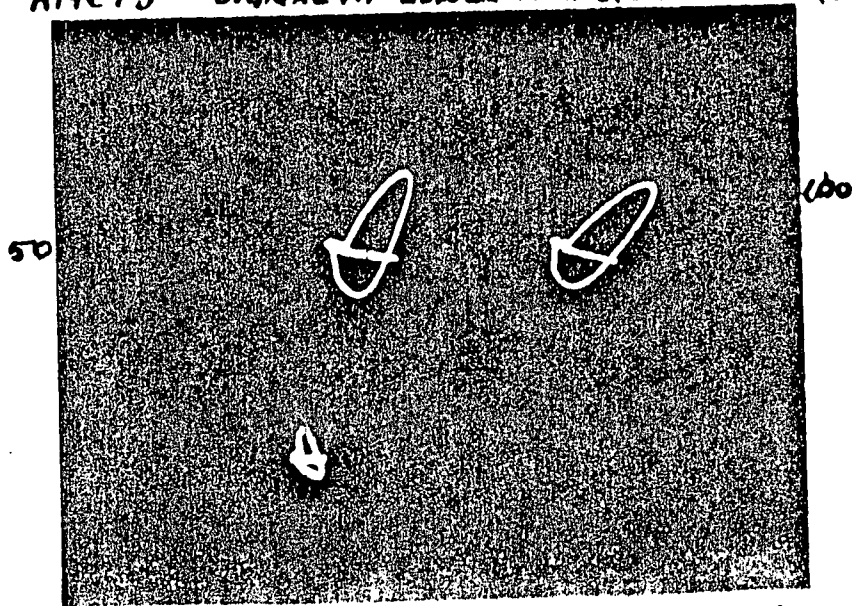
R19C75

SIGNAL AT LOWER TRANS. OF LOWER EXP

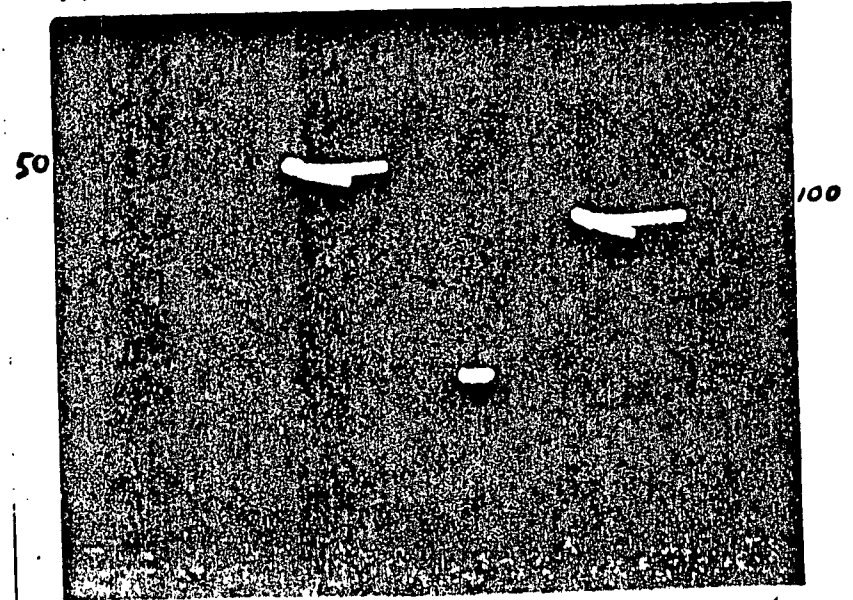
R19C75

In order to account for a number of indications (Figure 4.2-1) found during the eddy current inspection of the sleeved portion of the steam generators at San Onofre Unit 1, a number of simulations were performed. The simulations involved the placement of magnetite in the annulus between the sleeve and the tube. Figures 4.2-2 and 4.2-3 show a number of these simulations. In Figure 4.2-2, both the eddy current response of a normal transition as well as a ring of magnetite are shown for reference. Also in Figure 4.2-2 are two simulations with magnetite in the transition region. Figure 4.2-3 shows further simulation with various amounts and location of the magnetite in the transition region.

SIGNAL AT LOWER TRANS. LOWER EXP.

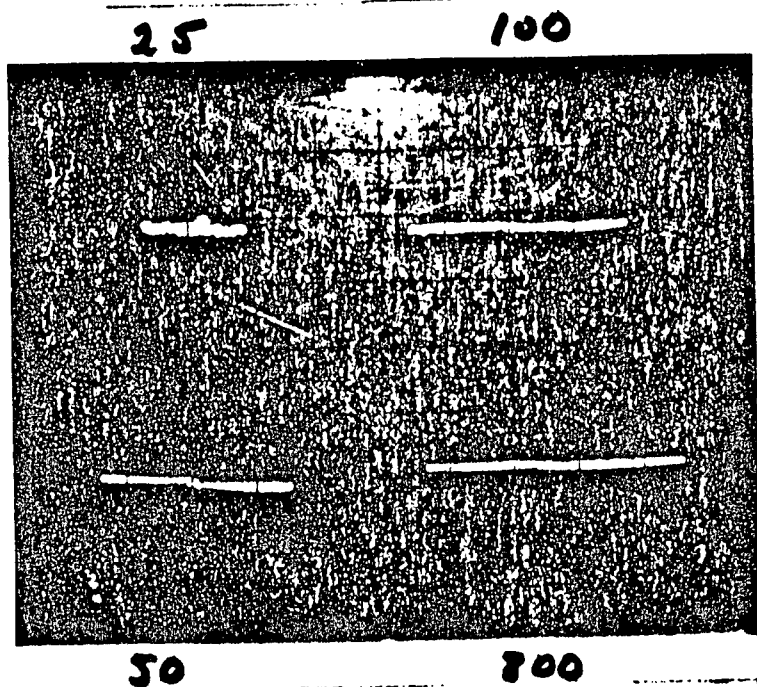
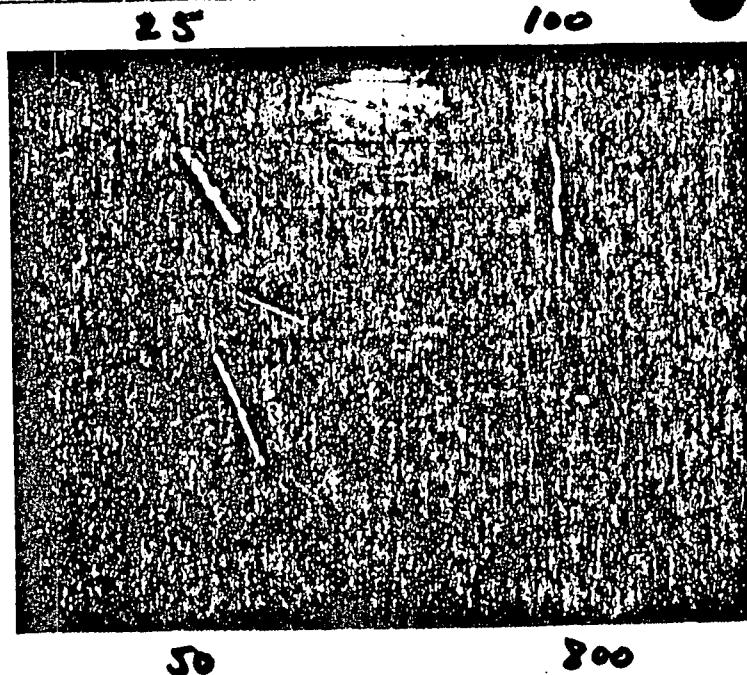
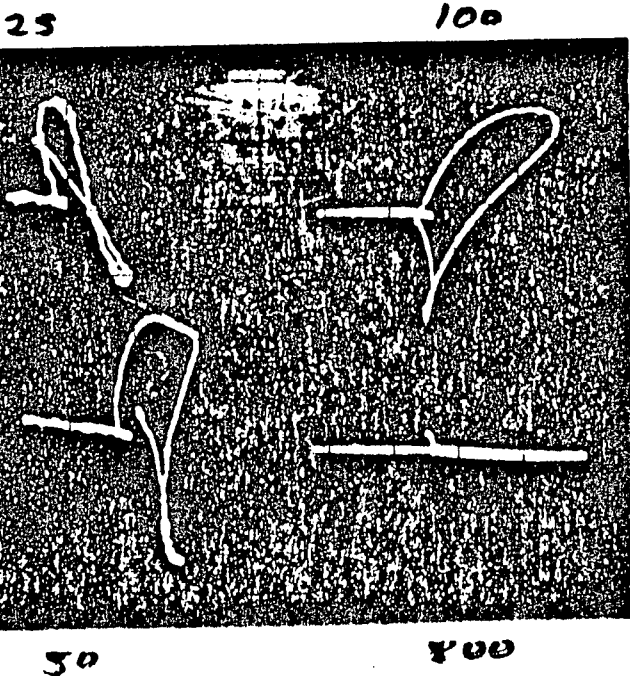
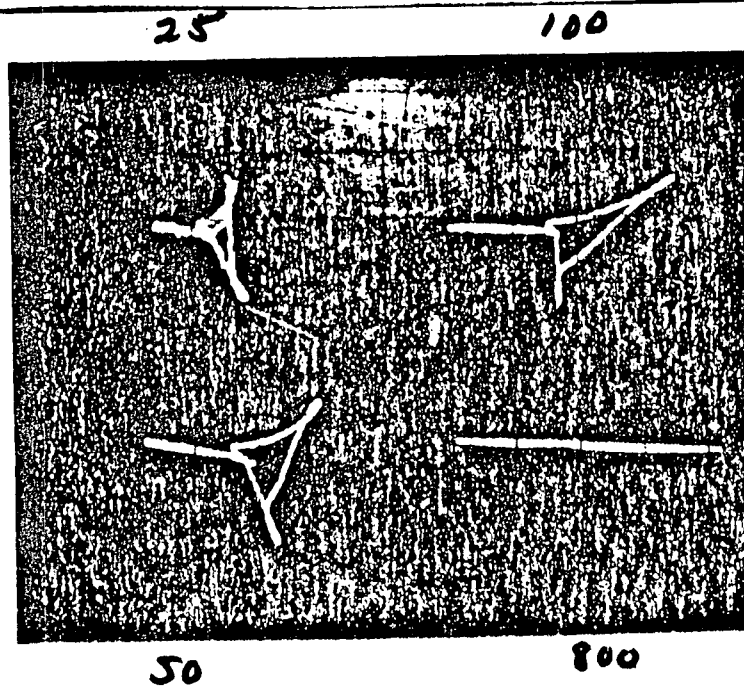
FIGURE 4.2-2 THE EDDY CURRENT RESPONSE OF MAGNETITE & EXPANSION TRANSITIONS [ a, b, c ]

TRANSITION ALONE

MAGNETITE IN ANNULUS ALONE

TRANSITION & MAGNETITE

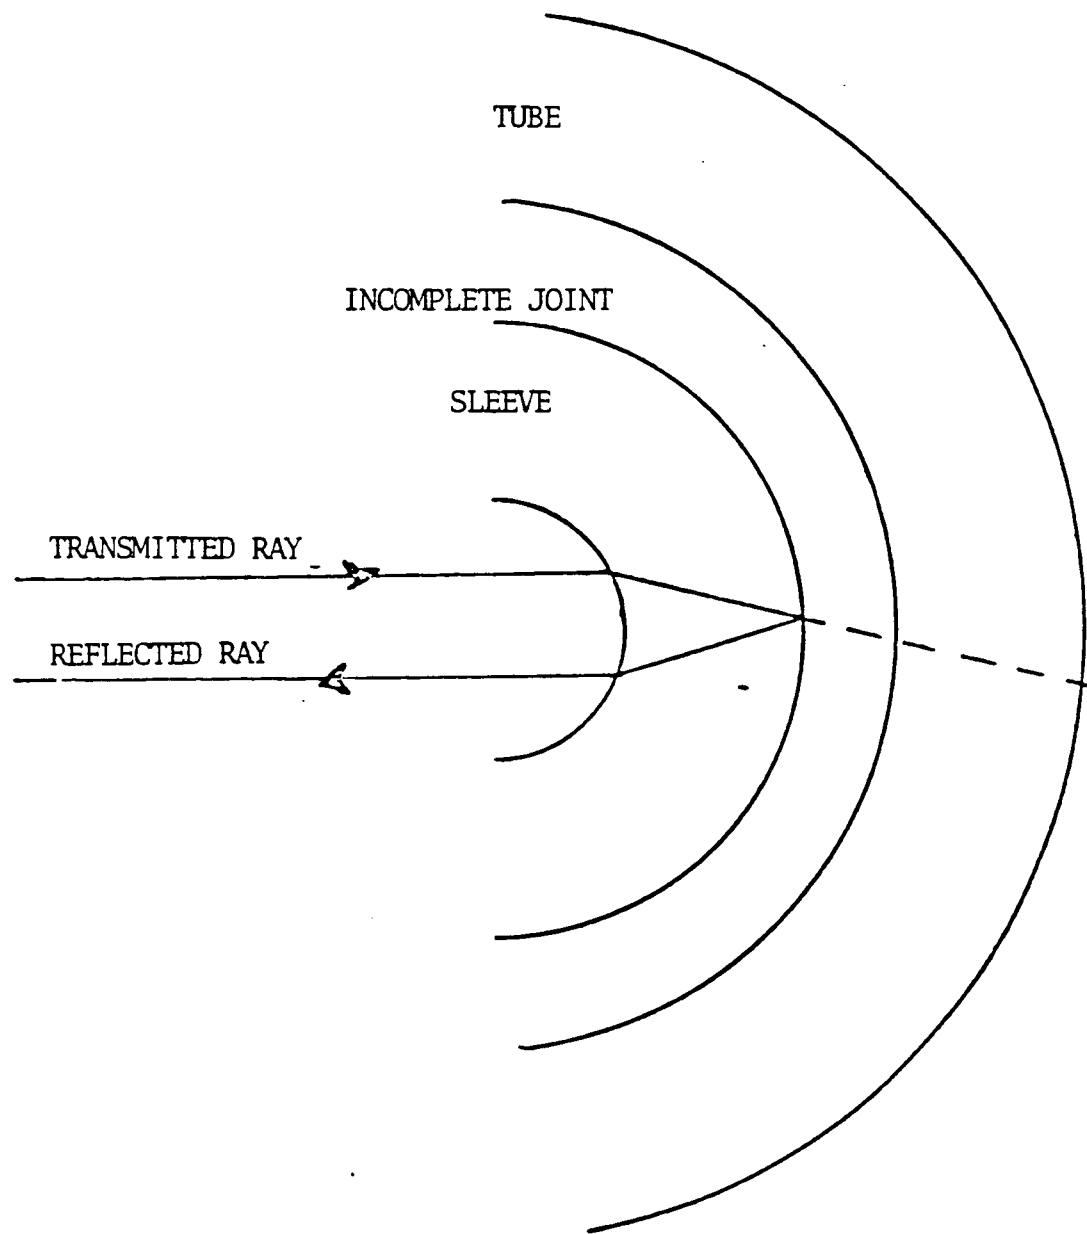
FIGURE 4.4.2-1

Other types of UT inspection of the assembly could be postulated; however, it is not clear how these techniques would deal with the problem of intermittent joint integrity. For example, in the limit of a total lack of joining, there is no path for the sound to reach the tube and therefore no inspection of the tube could be performed (Figure 4.4.2-1). For the near term, UT is not considered a viable means of inspecting the joint, except in those regions where a baseline exists and the joint was initially acceptable.

NEAR-TERM USAGE IS VIABLE ONLY FOR REGIONS WITH  
ACCEPTABLE JOINT INTEGRITY.

ULTRASONIC RAY DIAGRAM FOR CASE WHEN THE JOINT IS NOT FULLY FORMED. NO SOUND ENERGY REACHES THE TUBE TO PERFORM THE INSPECTION.
