# LEAK IN CONTROL ROD DRIVE MECHANISM HOUSING, PALISADES NUCLEAR PLANT

David Alley<sup>(1)</sup>, Paul Deniston<sup>(2)</sup>, James Hyres<sup>(3)</sup>

This paper is the first of a series of 3 papers which address a leak in a control rod drive mechanism housing which occurred at Palisades Nuclear Power Plant in the August 2012. This paper will: provide some background concerning control rod drive mechanisms; describe the event and associated inspections; provide some background regarding other, related events; describe plans for future activities; and provide some regulatory context. This paper will also begin a discussion of the failure mechanism and the laboratory analysis performed in response to this failure. These last two topics are the subjects of the companion papers.

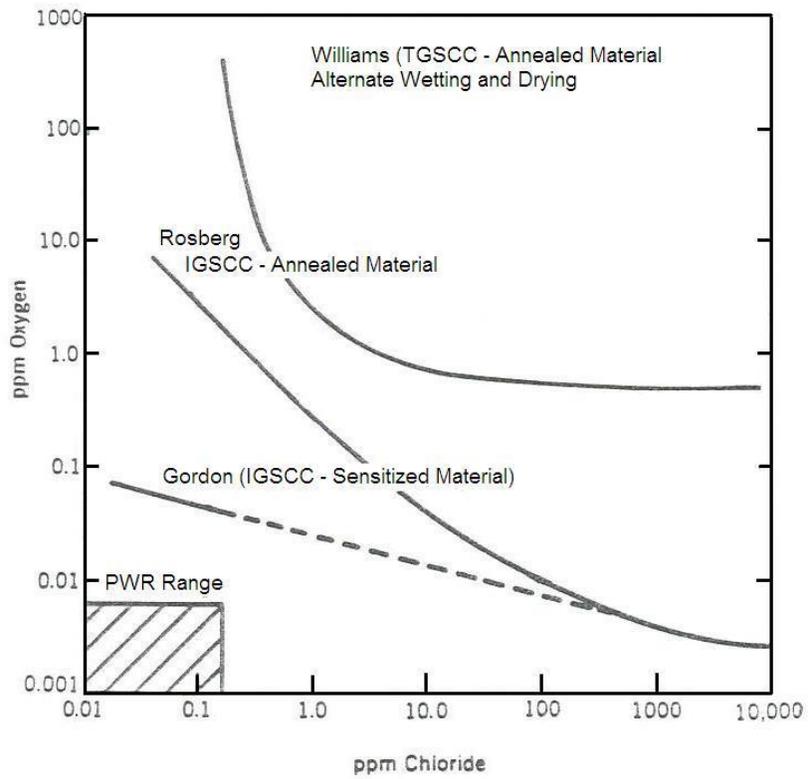
Figure 2: Concentrations of oxygen and chlorides leading to stress corrosion cracking after [2]

CRDM housings are primarily constructed from 300 series austenitic stainless steel and may or may not contain components constructed from nickel alloy or martensitic stainless steel. As shown in Figure 2 [2], 300 series stainless steel is subject to stress corrosion cracking in water containing chlorides and

It should be noted, however, that, as describe in Nuclear Regulatory Commission<sup>4</sup> (NRC) Information Notice 2006-27 [6], intergranular stress corrosion cracking has occurred in dead leg components constructed from sensitized stainless steel. As shown in Figure 2, intergranular cracking of sensitized stainless steels may occur at contaminant levels which are significantly lower than are required to produce transgranular stress corrosion cracking in non-sensitized material.

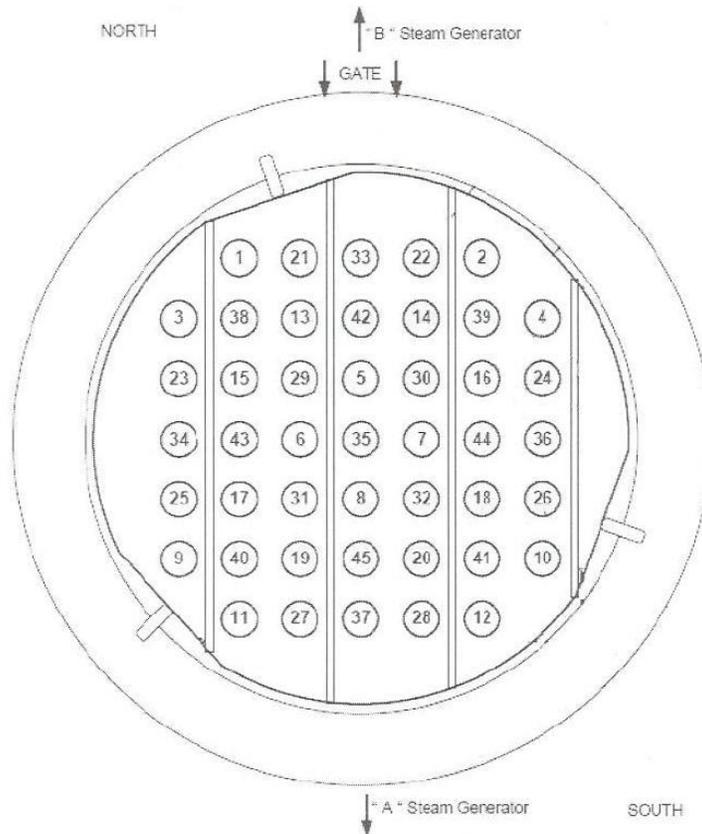
Figure 8: Diagram showing arrangement of CRDM housings (After [9])

In 2001 Palisades detected leakage from CRDM housing number 21. The location of this CRDM housing in relation to other CRDM housings is shown in Figure 8. CRDM housing 21 is an active housing as opposed to a spare as had previously occurred at Fort Calhoun. As shown in Figure 6, the failure analysis performed in response to this event identified both axial and circumferential cracks associated with weld number 3. Extent of condition inspections revealed additional, non-through wall cracks associated with weld 3 in 41 of the 44 remaining housings for a total of 42 of 45 housings containing cracks.

On August 12, the unidentified leakage rate remained well within allowable technical specification limits but exceeded a plant administrative limit. At this point the plant reduced power to permit inspection of the reactor head and CRDM housings. In this inspection tour, a steam leak was identified in CRDM housing 24 pointing toward CRDM housing 44 (see Figure 8). The leak was located approximately 1 foot above the CRDM housing to reactor head flange.
