**Area Walk-By Checklist (AWC)**

Location (Bldg, Elev, Room/Area): **Area 40 - AB2, 633, 9**

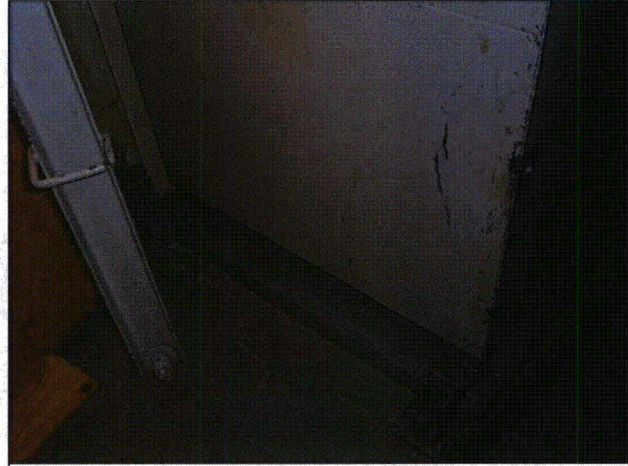
**Note:** Lead shielding hung for Unit 1 Cycle 25 Outage (P4010130)

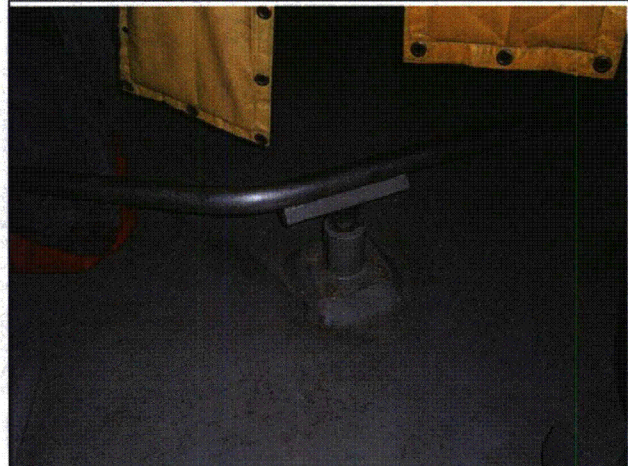
**Note:** Lead shielding hung for Unit 1 Cycle 25 Outage(P4010133)

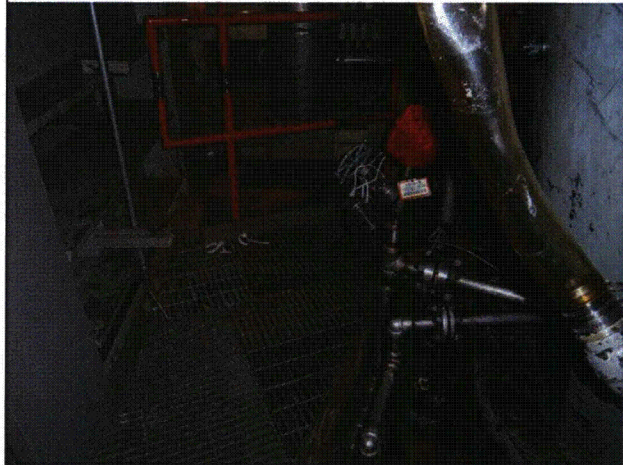
**Note:** Red FME cover in place for the Unit 1 Cycle 25 Outage (P5081552)

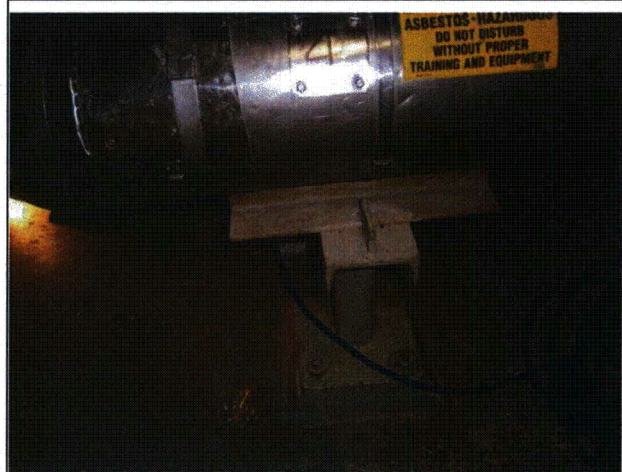
**Note:** Cord staged for Radiation Protection remote coverage for the Unit 1 Cycle 25 Outage (P4010155)

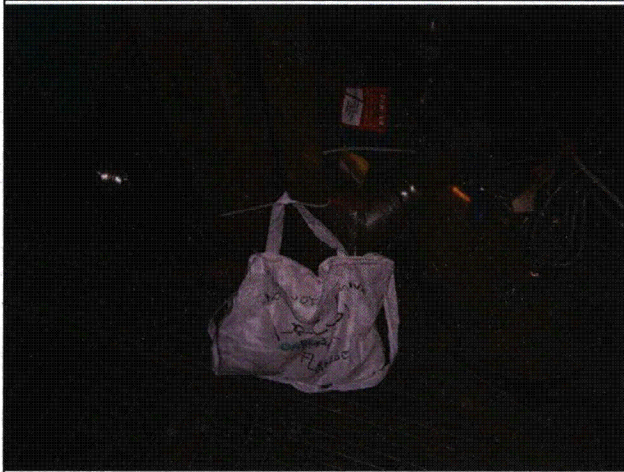
**Note:** White bag tied off for Unit 1 Cycle 25  
Outage (P3280058)

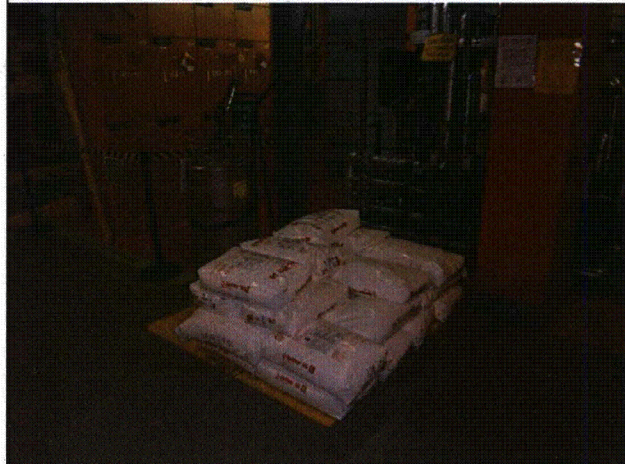
*Note: Boric acid storage area (P4050295)*

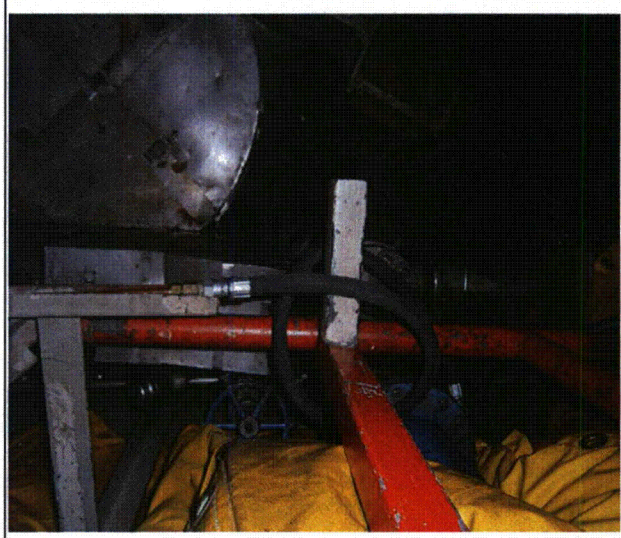
**Note:** (PA-040458) Lead shielding hung for Unit 2 Cycle 21 Outage.

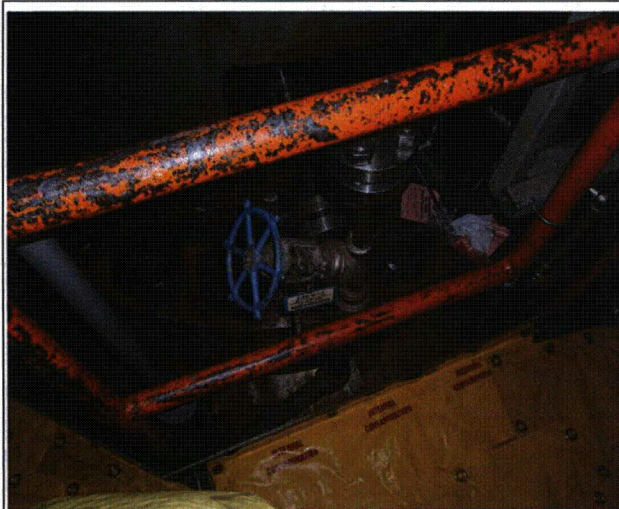
**Note:** (PA-040454) Lead shielding and plastic and maintenance in use equipment hung for Unit 2 Cycle 21 Outage

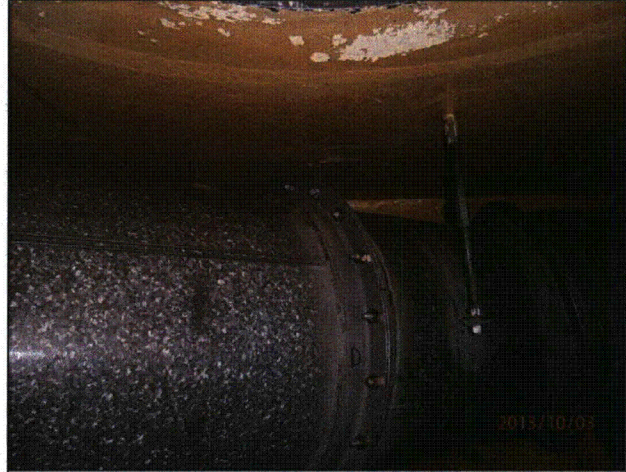
**Note:** Overhead ductwork (PA030042)

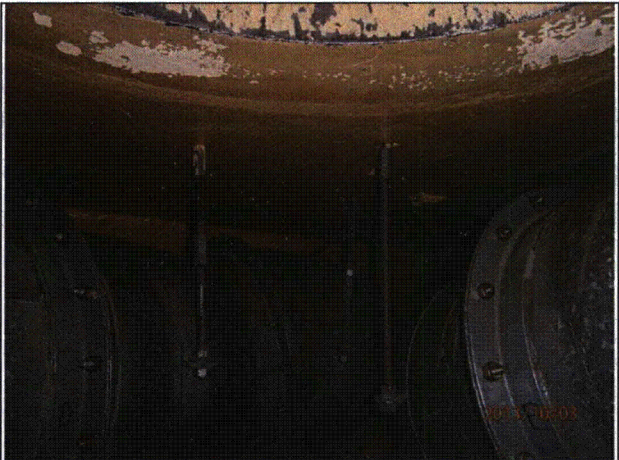
**Note:** Overhead ductwork (PA030045)

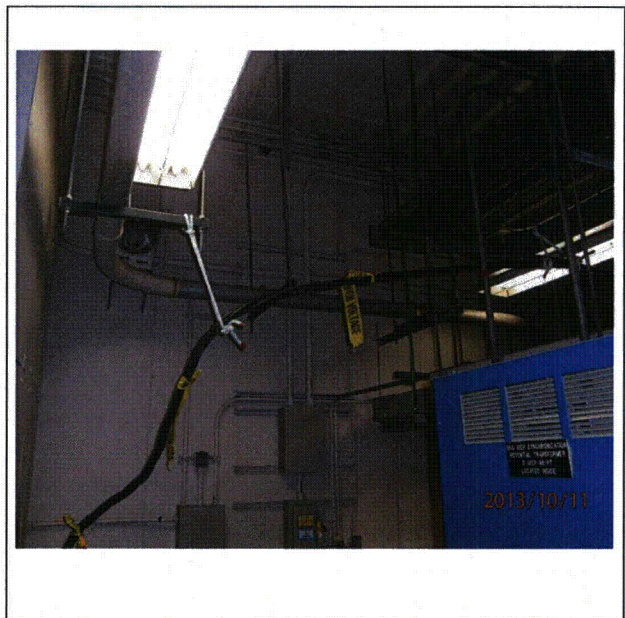
**Note:** (PA110630) Temporary power for Unit 2 Cycle 21 refueling outage.
