**CALCULATION  
PACKAGE**

Calc. Pkg No. VSC-04.3101  
File No.: VSC-04.3101  
Revision: 3

VSC-04 / VSC-24 General Licensees

VSC-24 CoC Renewal Aging Management Review

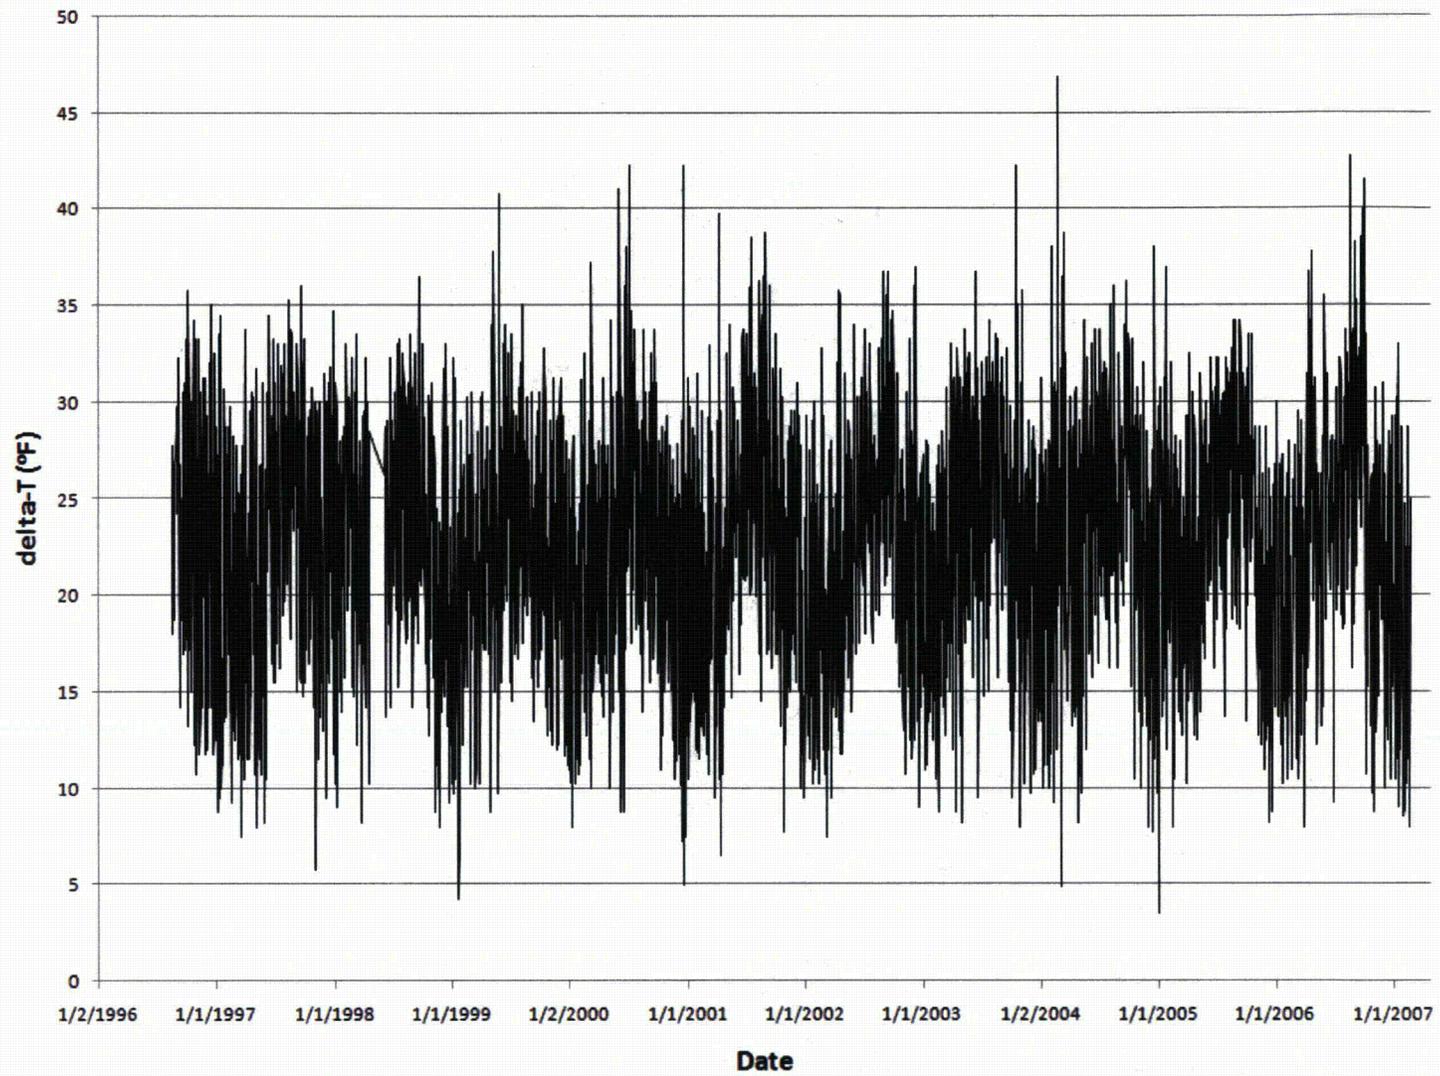
**Figure 8 - Ventilation Air Temperature Rise for a Typical Cask**

The historical outlet temperature monitoring records from the three VSC-24 ISFSI sites have been reviewed to identify any potential trends that may indicate aging effects in the casks. A plot of the temperature rise measurements over the initial storage period is shown for a typical cask in Figure 8. The daily measurements of the temperature increase (i.e., the difference between the air outlet temperature and ambient air temperature) in each VSC-24 cask during the initial storage period show that the average temperature rise has not changed significantly over time. The data does show cyclic behavior, with larger  $\Delta T$  values generally occurring in the summer months. In all cases, the data show that the  $\Delta T$  values are much less than the 110°F limit (generally less than half, i.e., 55°F), and are in line with what would be expected given the heat generation levels of the MSBs.

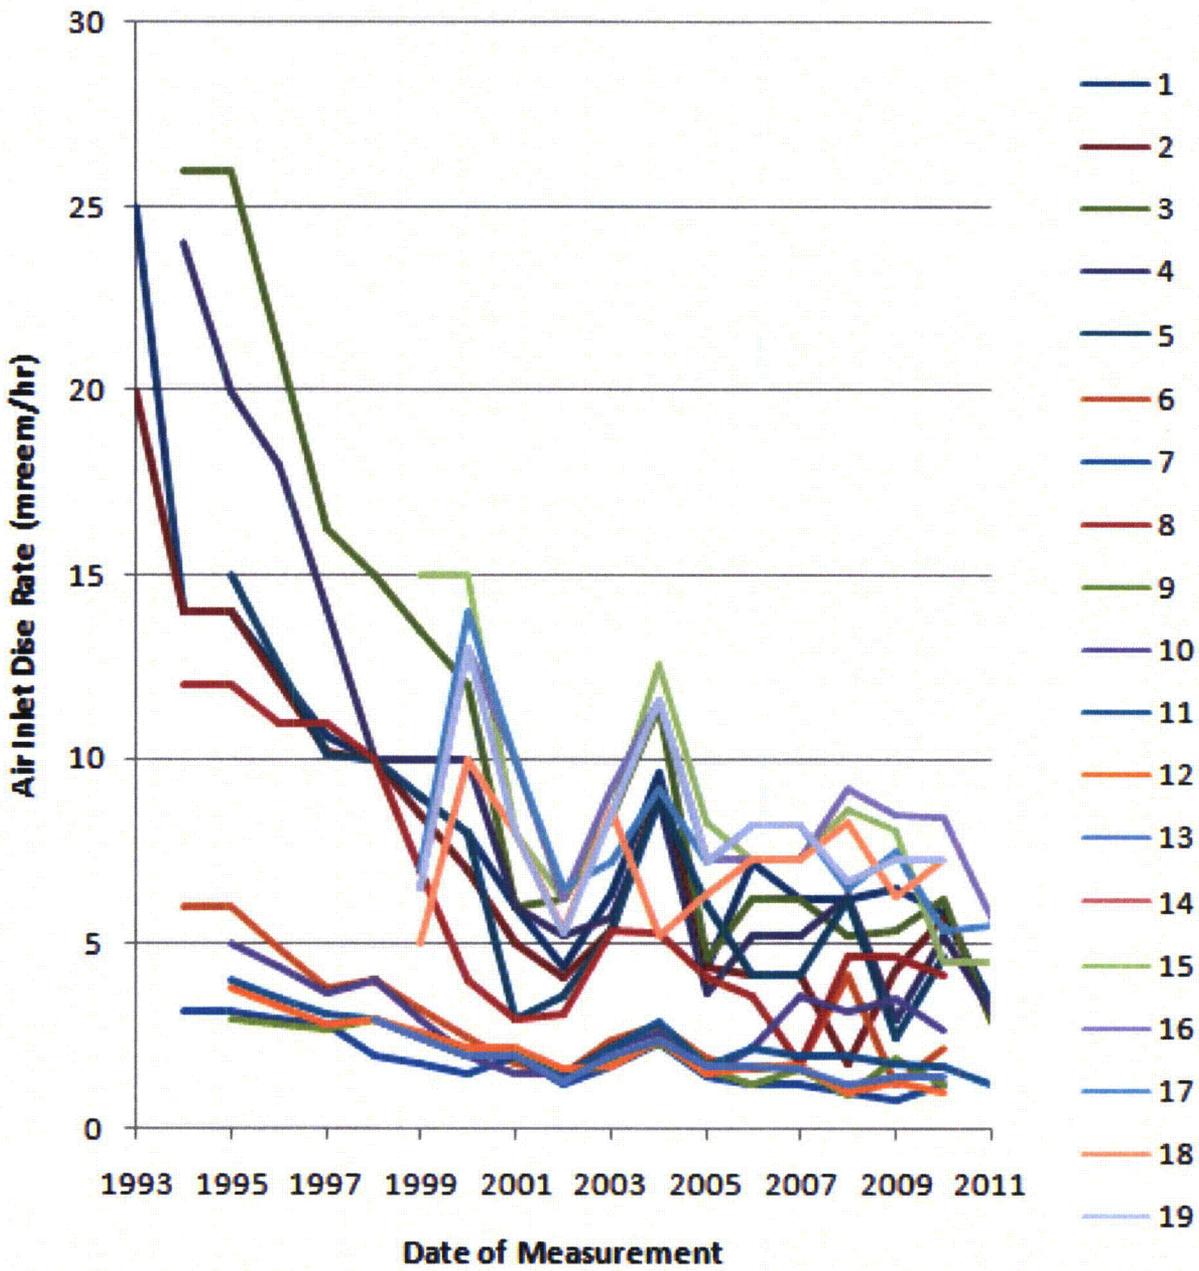
**Figure 9 - Palisades Air Inlet Duct Dose Rate Trends**

At the Palisades plant, regular dose rate readings were taken at the inlet ducts of the 18 casks in the ISFSI. Those inlet duct dose rate readings, and their trend with time, are shown in Figure 9. The data clearly shows a decreasing trend of air inlet dose rate with time, which is expected given the decay of spent fuel. In all cases, the measured inlet duct dose rates are far below the dose rate limit given in the TS.

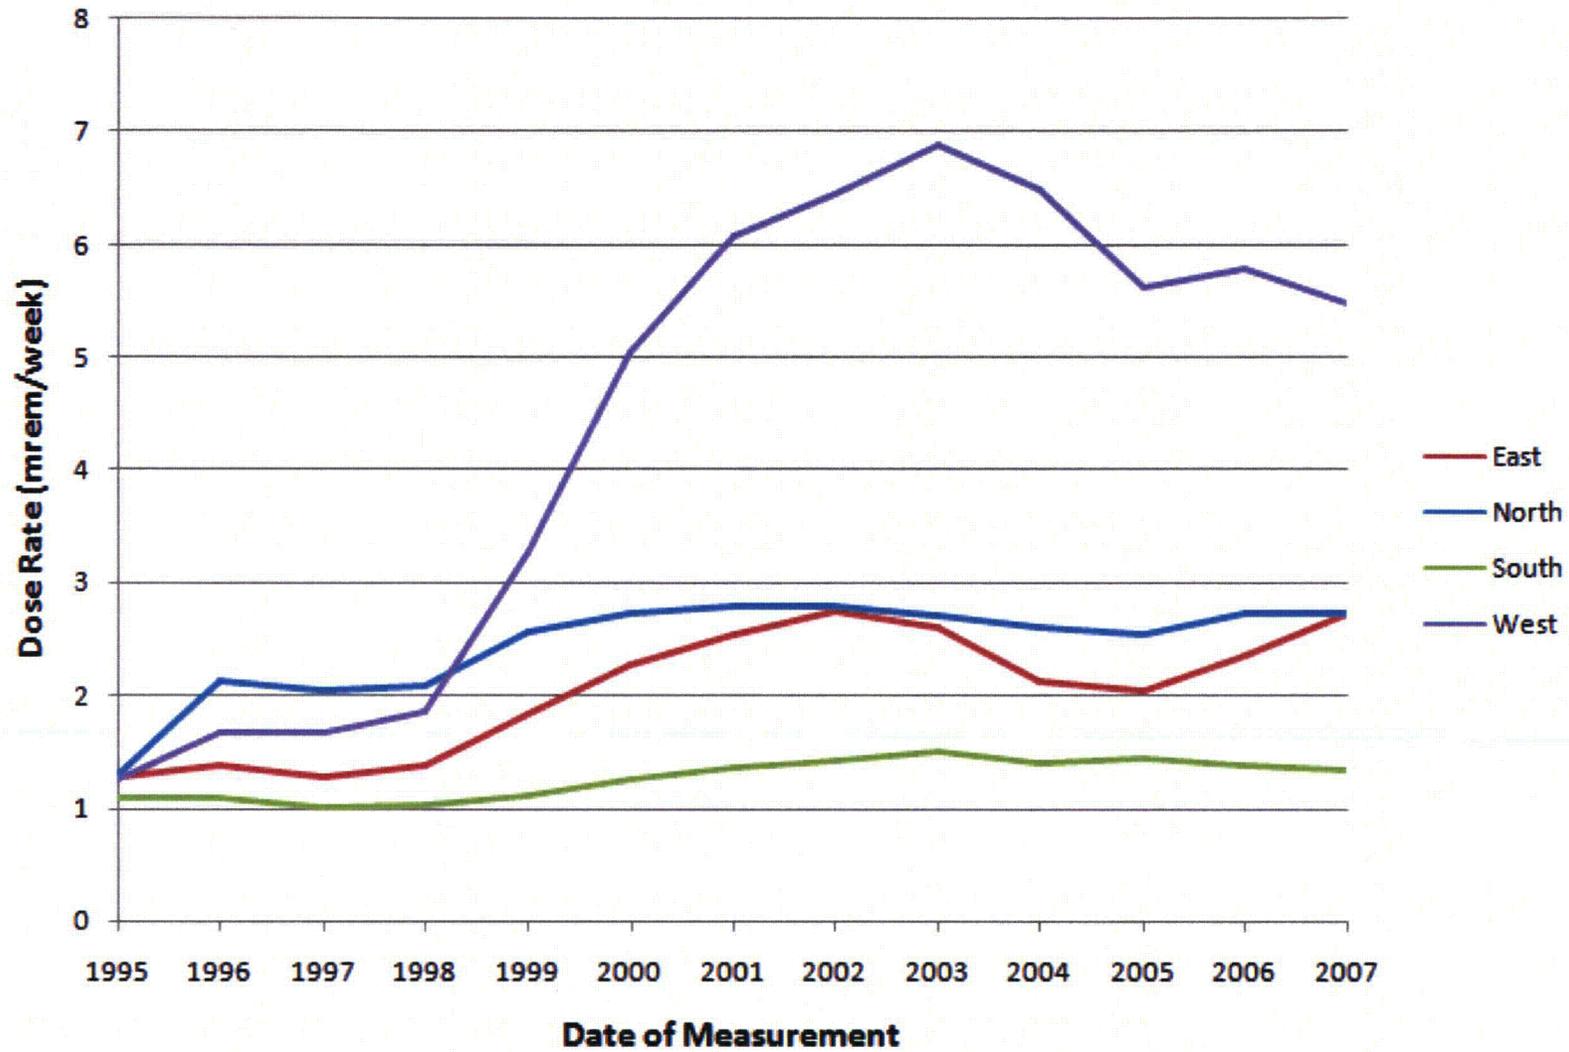
**Figure 10 - Point Beach ISFSI Fence Dose Rate Trends**

At Point Beach, dose rates were monitored on the West, East, North and South fences around the ISFSI. The results of those dose rate measurements are summarized in Figure 10. The data show no significant increasing trend of area dose rate with time, after the last of the 16 casks was placed in the ISFSI in 2003. Dose rates did increase while casks were being added, particularly on the West fence, which was affected by casks being added to the VSC-24 ISFSI pad, as well as the addition of other cask types to a neighboring ISFSI pad.
