FOIA/PA-2011-0357

From: Thomas Hipschman *GBS*
Sent: Tuesday, August 23, 2011 5:19 PM
To: Elizabeth Hayden
Cc: Scott Burnell; Joshua Batkin
Subject: Seismic Requirements for North Anna

North Anna Independent Spent Fuel Storage Installation Response to Earthquake

GENERIC ISSUE 199 (GI-199)
**IMPLICATIONS OF UPDATED PROBABILISTIC SEISMIC HAZARD
ESTIMATES IN CENTRAL AND EASTERN UNITED STATES ON
EXISTING PLANTS**
SAFETY/RISK ASSESSMENT

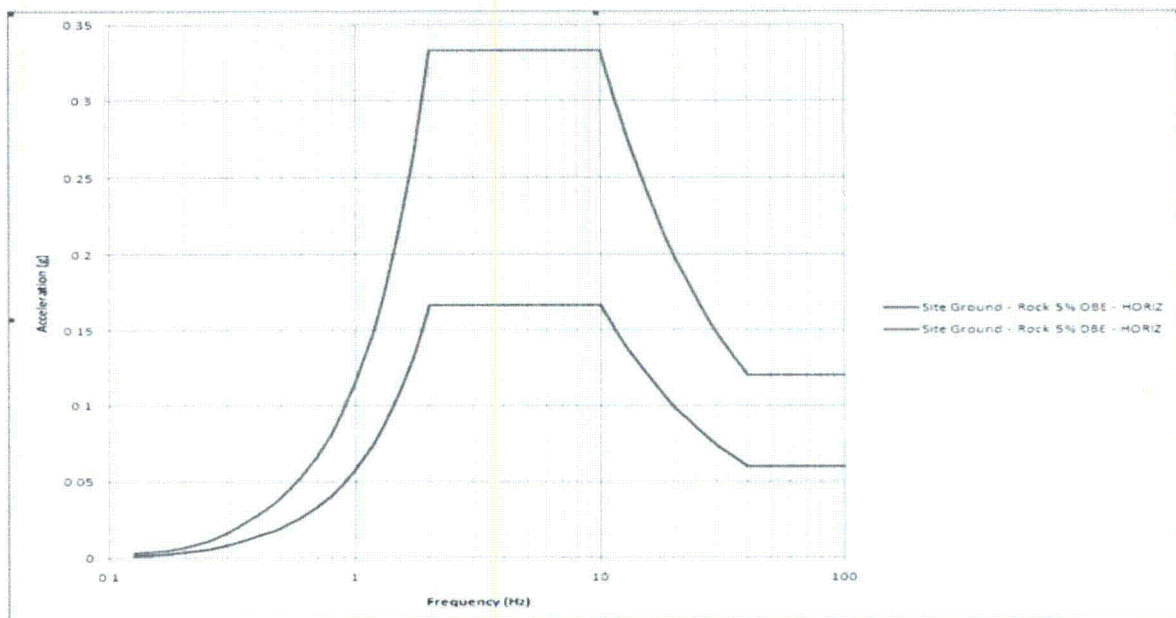
Figure 1 – Horizontal OBE and DBE Response Spectrum Curves for Rock at 5% Damping

North Anna UFSAR Section 3.7 provides the OBE and DBE ground response spectra and peak ground acceleration values. The DBE horizontal PGA for rock-founded structures is 0.12g and for soil founded structures it is 0.18g. Vertical direction PGAs are two-thirds of the horizontal accelerations and the OBE is half of DBE in the entire frequency range. The horizontal OBE and DBE curves for rock at 5% spectral damping are shown in Figure 1 and the horizontal OBE and DBE curves for soil at 5% spectral damping are shown in Figure 2.

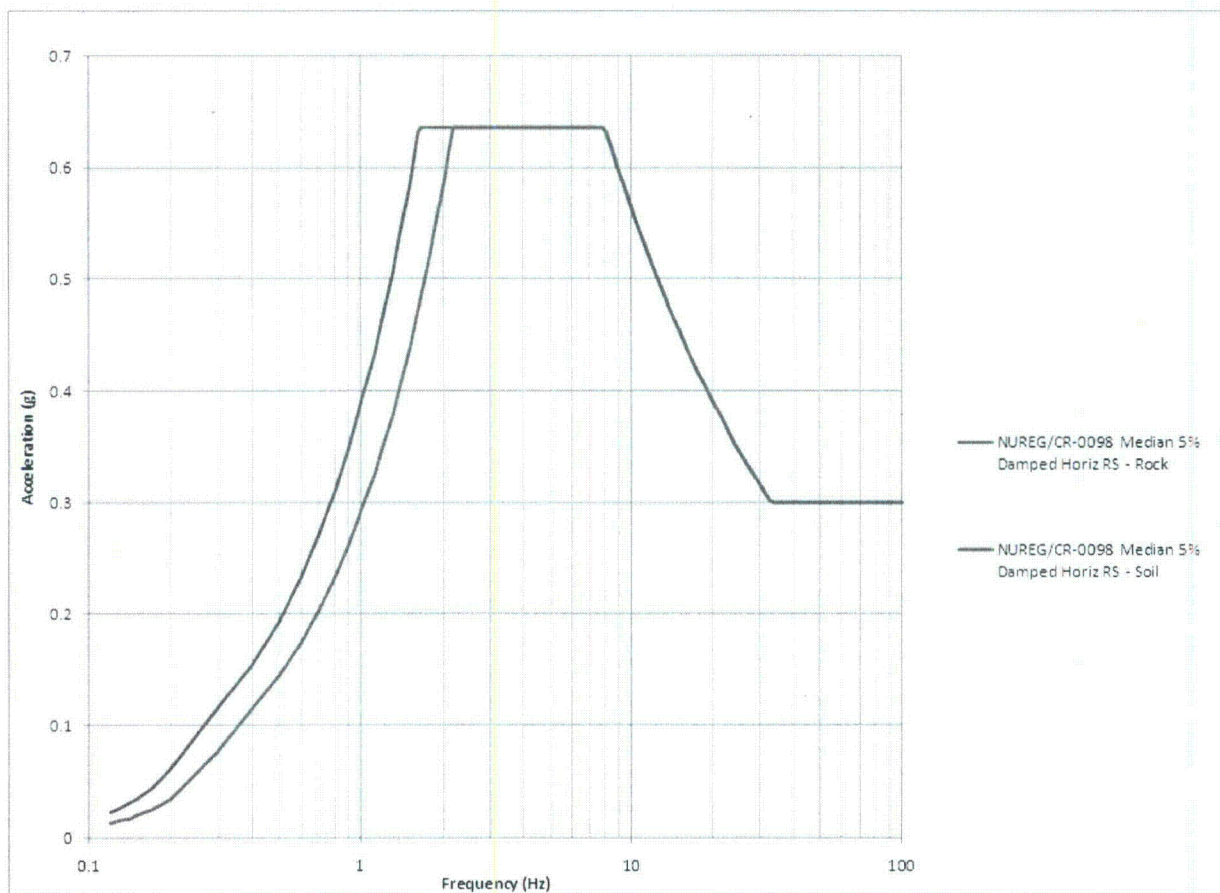
Figure 3 - Review Level Earthquake used in IPEEE – Rock & Soil Founded Structures – Horizontal Direction, 5% Spectral Damping

The rock and soil free-field median-centered response spectra, based on NUREG/CR-0098 and anchored to a 0.3g PGA, were used as the Review Level Earthquake for IPEEE. These spectra are shown in Figure 3.

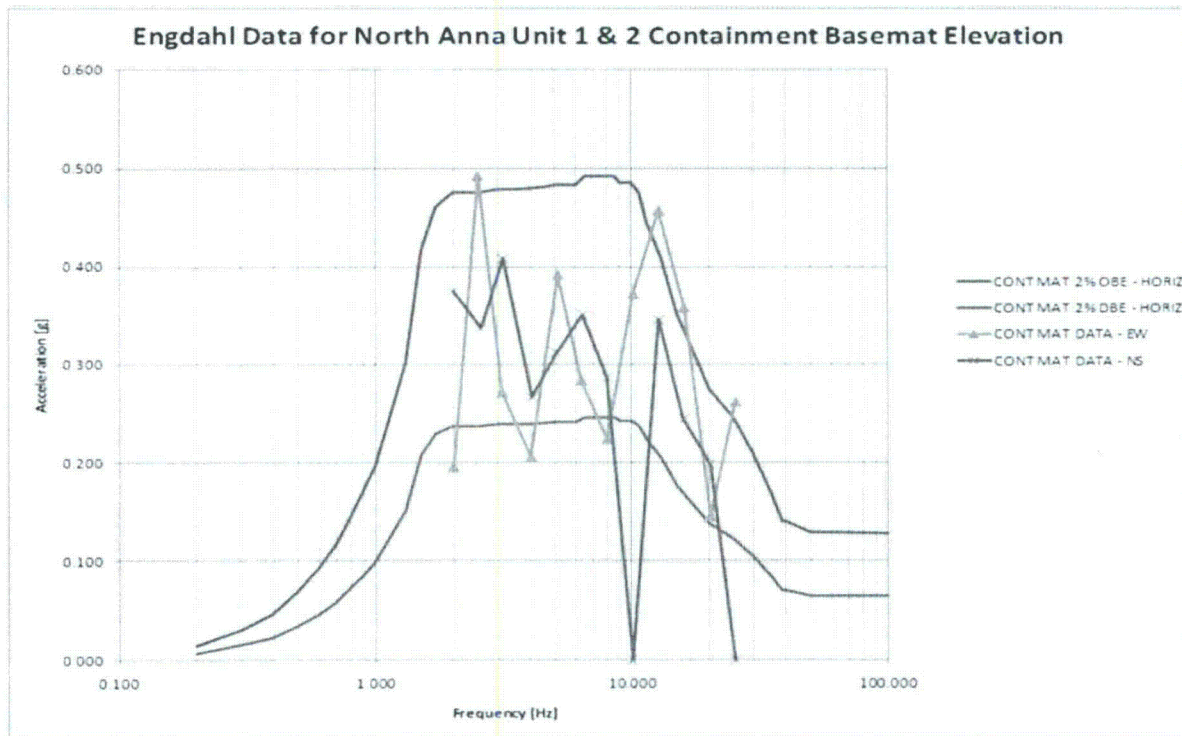
Figure 2.1 – Engdahl Data from Containment Basemat Recorder – Horizontal Directions

A comparison of the recordings from the Engdahl scratch plates at the containment basemat to OBE and DBE criteria (see Figures 2.1 and 2.2 in Attachment 2 to this Enclosure) showed that the plant OBE was exceeded. DBE criteria were slightly exceeded, but an analysis of data captured by the Kinometrics recording was needed to make a final determination on whether DBE criteria had been exceeded. Dominion, together with several industry experts, considers the Kinometrics analog recorder data to be more reliable. The Kinometrics data shows that the OBE and DBE were exceeded in all three directions (see Figures 3.1 and 3.2 in Attachment 3); however, in the frequency range most damaging to equipment, 2 to 10 Hz, the DBE was not exceeded in the E-W direction, and the earthquake exceeded the DBE, on average, by about 12% in the N-S direction with the sharpest peak exceeding the corresponding DBE spectral ordinate by a factor of about 1.3, and about 21% in the vertical direction with the sharpest peak exceeding the DBE by a factor of about 1.6.

As demonstrated in Figure 2.1 for horizontal directions and Figure 2.2 for vertical directions, the Engdahl data for the Containment basemat elevation shows that OBE levels were exceeded. For DBE, however, there are only slight exceedances at a few frequencies.

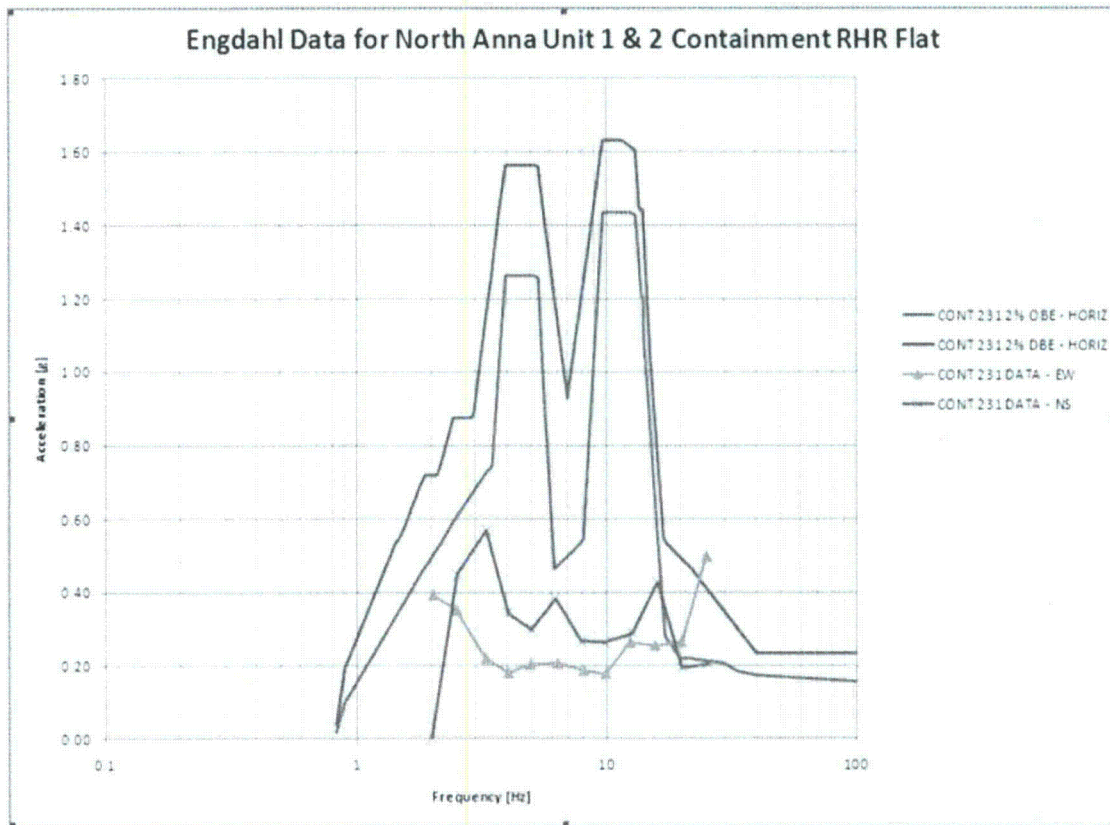
Figure 2.3 – Data from Containment RHR Flat Recorder – Horizontal Directions

As demonstrated in Figure 2.3, Engdahl recorded data in East-West and North-South directions at the RHR Flat elevation of Containment are less than OBE and DBE for frequency ranges up to approximately 16 Hz. Exceedances over DBE in the East-West direction occur around 25 Hz, in the high frequency range.

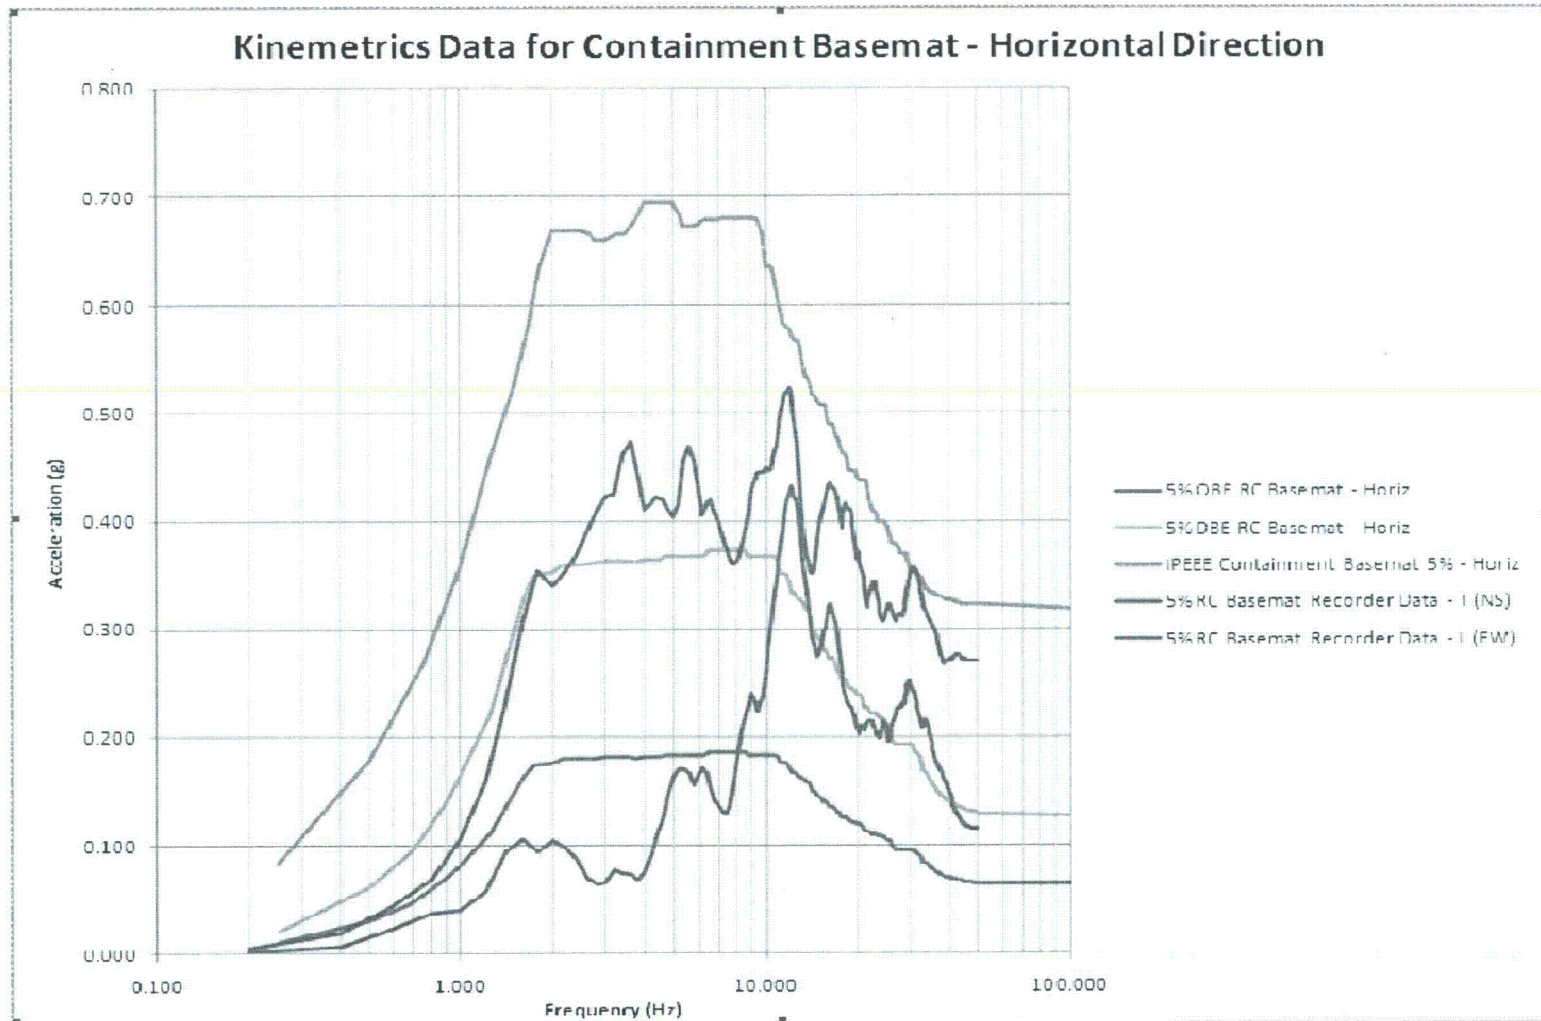
Figure 3.1 – Containment Basemat - Horizontal

Figure 3.1 in Attachment 3 also compares the response spectra created from the Kinematics data in the horizontal directions to the Containment basemat spectra used for IPEEE, which is considered close to the free-field rock. The IPEEE curves envelop the spectra from the recorded data for the Containment basemat elevation. Similarly, Figure 3.2 in Attachment 3 shows that for the vertical direction the IPEEE also envelops the recorded data.

As shown in Figures 3.1 and 3.2, the data shows that the OBE and DBE were exceeded in all three directions; however, for purposes of quantifying how much the recorded response spectra exceeds the design basis earthquake spectra, the average exceedance is calculated in the frequency range from 2 to 10 Hz. This calculation is made for the north-south and vertical directions only since the recorded spectrum in the east-west direction is completely enveloped in that range by the DBE spectrum. The range of 2 to 10 Hz is chosen since this is the range of frequencies associated with damage to engineered structures and much of the plant equipment as defined in EPRI report NP-5930 and Reg. Guide 1.166.

As shown above, the earthquake exceeded the DBE, on average, by about 12% in the N-S direction with the sharpest peak exceeding the corresponding DBE spectral ordinate by a factor of about 1.3, and about 21% in the vertical direction with the sharpest peak exceeding the DBE by a factor of about 1.6.

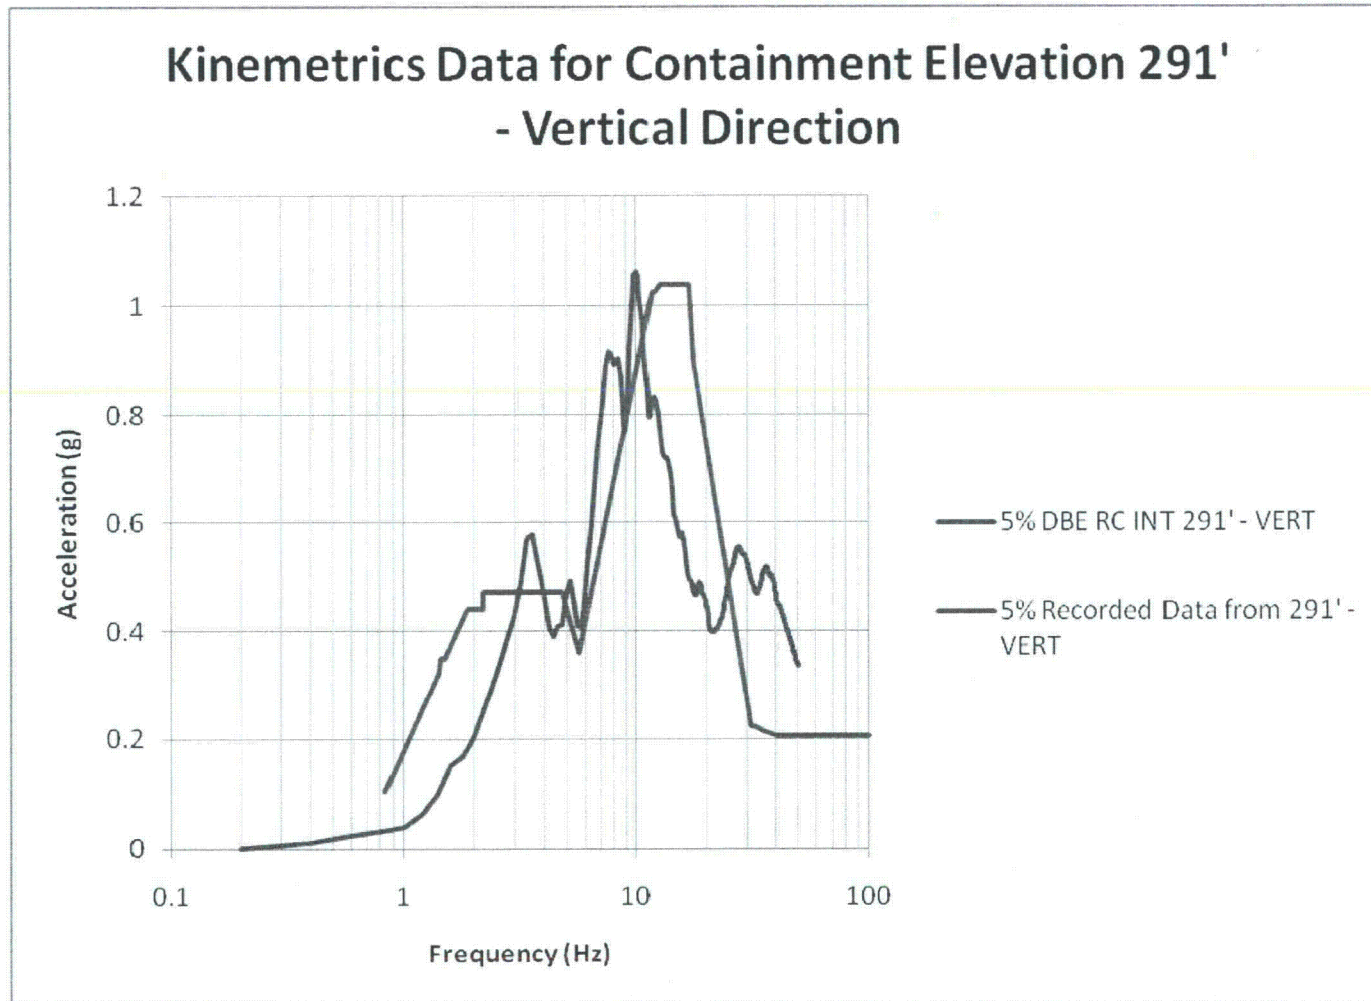
Figure 3.4 – Containment 291' Elevation - Vertical

See Figures 3.3 and 3.4 for horizontal and vertical comparison, respectively.
